Missoula County Control Point Datasheet

Project Name: Seeley Lake

CERTIFIED CORNER RECORDATION

Corner Common to Sections 10, 11, 14 and 15
T. 16 N. R. 15 W. P.M., M. Missoula County, Montana

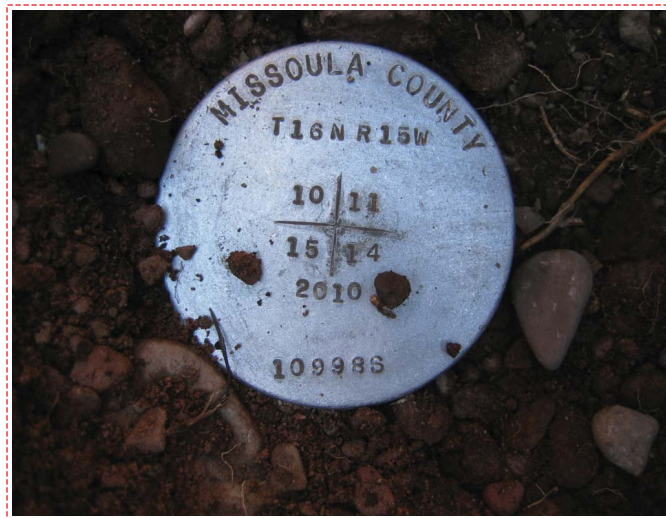
Photo of Monument

FOUND: (August 16, 2010) A 1-1/2" aluminum cap, marked 2923S, on a bent 5/8" rebar, in a plowed field.

SET: A 5/8" x 24" rebar, with a 3-1/4" aluminum cap, marked as shown, in the position of the bent rebar, 1 1/2 feet below the ground surface. From which:
A steel post with MDOH decal bears N 28° W, 19.7 feet, (REC #3 N 24° W, 19.6 feet).
A steel post with MDOH decal bears N 73° W, 18.7 feet, (REC #3 N 71° W, 18.8 feet).
