March 3, 2021

Clark Fork and Bitterroot Rivers Channel Migration Mapping Missoula County

Karin Boyd
Applied Geomorphology, Inc.
211 N Grand Ave, Suite C
Bozeman, MT 59715

Tony Thatcher
DTM Consulting, Inc.
211 N Grand Ave, Suite D2
Bozeman, MT 59715

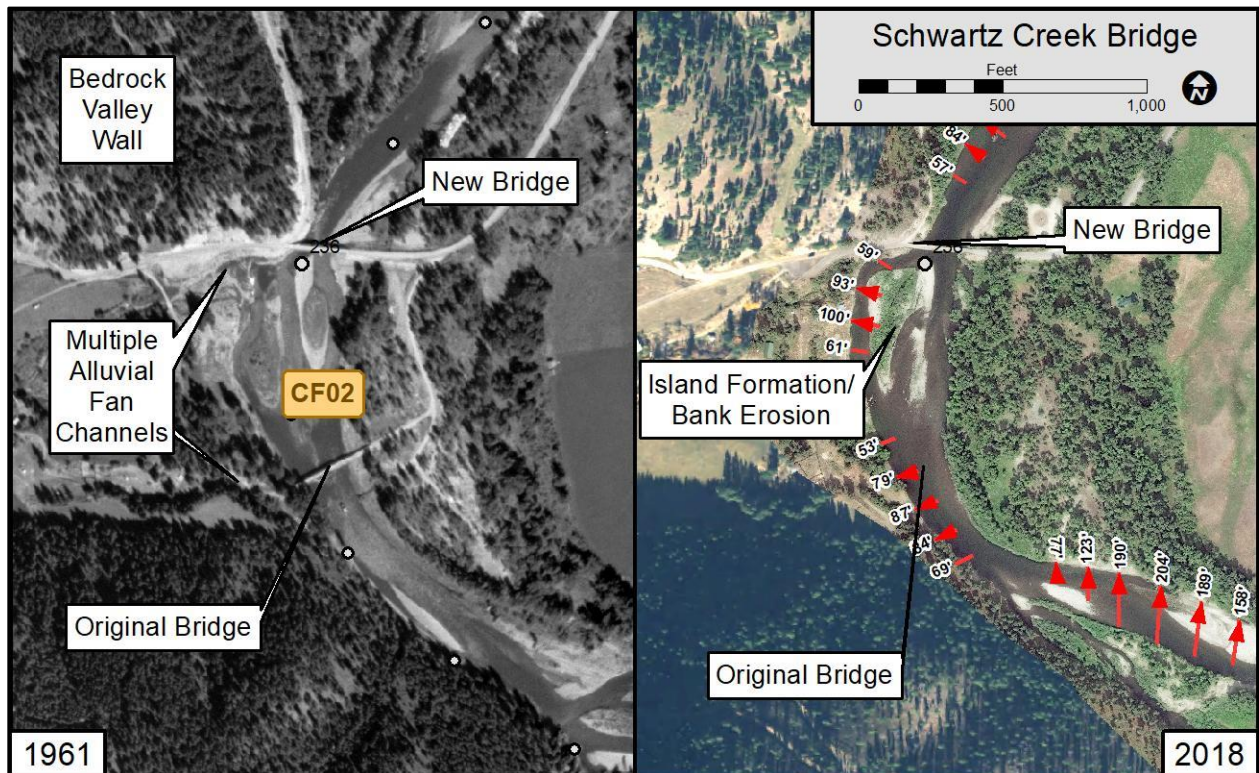
Figure 53. Swartz Creek Bridge in 1961 (top) and 2018 (bottom) showing ~100 feet of left bank erosion just upstream of bridge and loss of right angle approach of Clark Fork River to bridge opening.

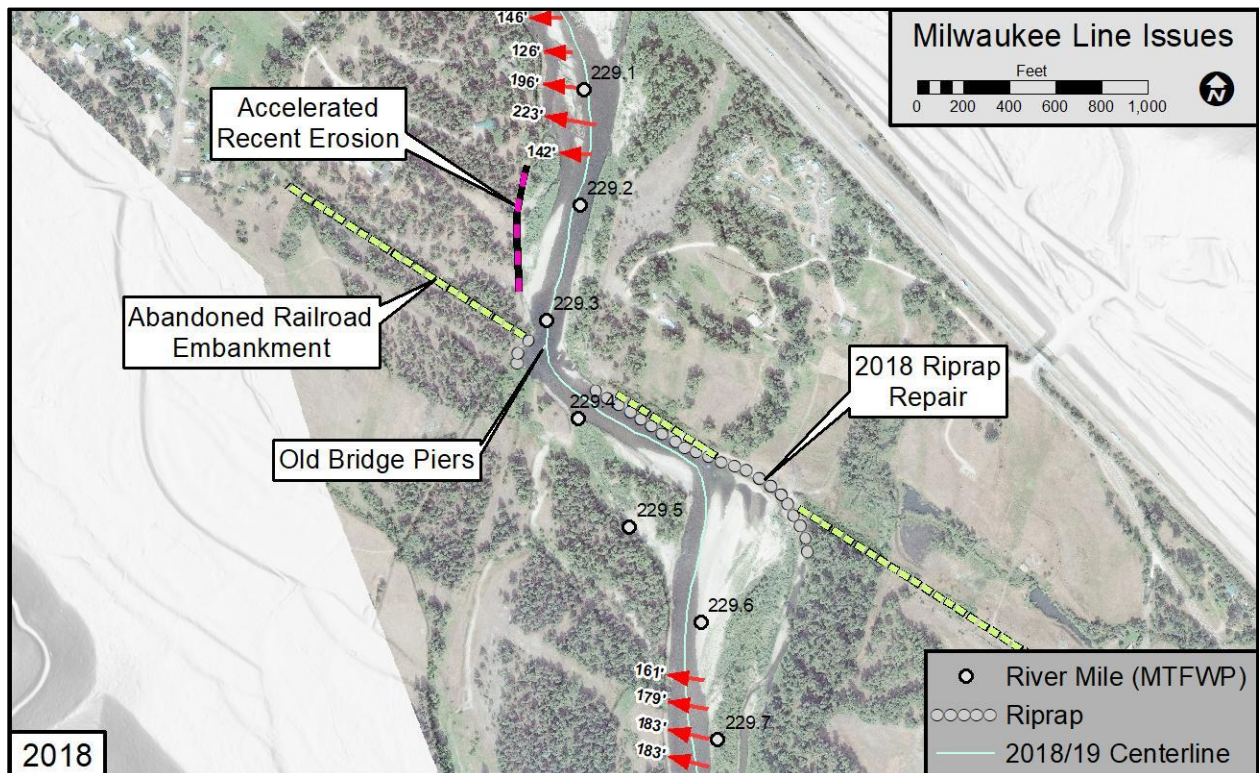
Figure 57. Clark Fork River issues at Milwaukee Line Railroad Embankment, RM 229.3.

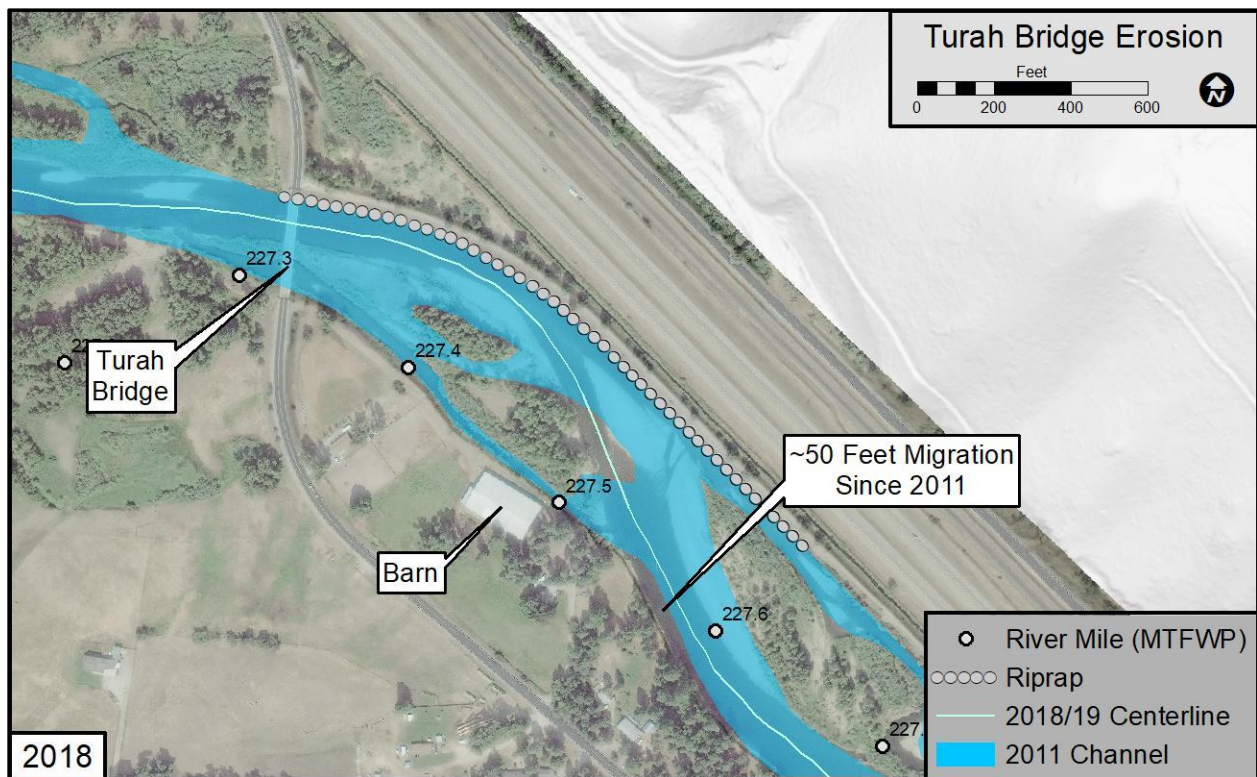
Figure 58. 2018 image of buildings just upstream of Turah Bridge with mapped 2011 banklines showing ~50 feet of migration towards barn in 7 years.

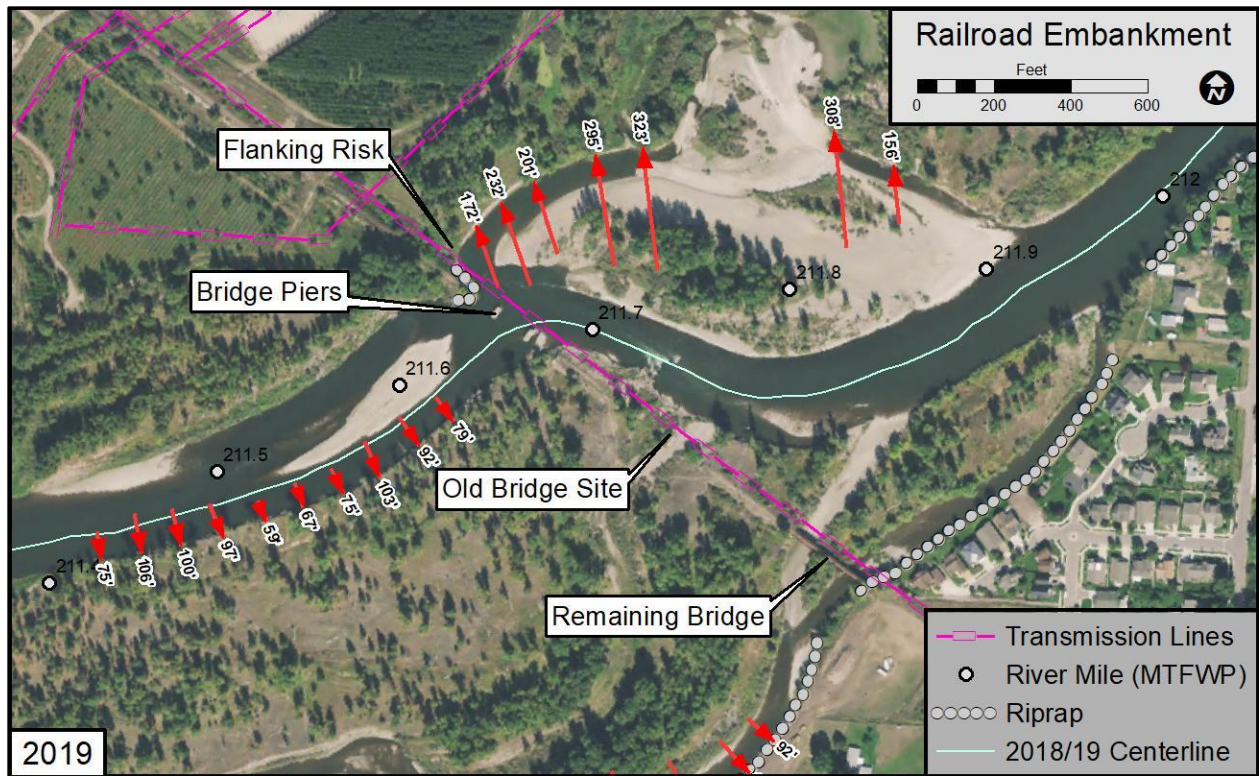
Figure 69. 2019 air photo showing major issues at abandoned railroad crossing, RM 211.6.

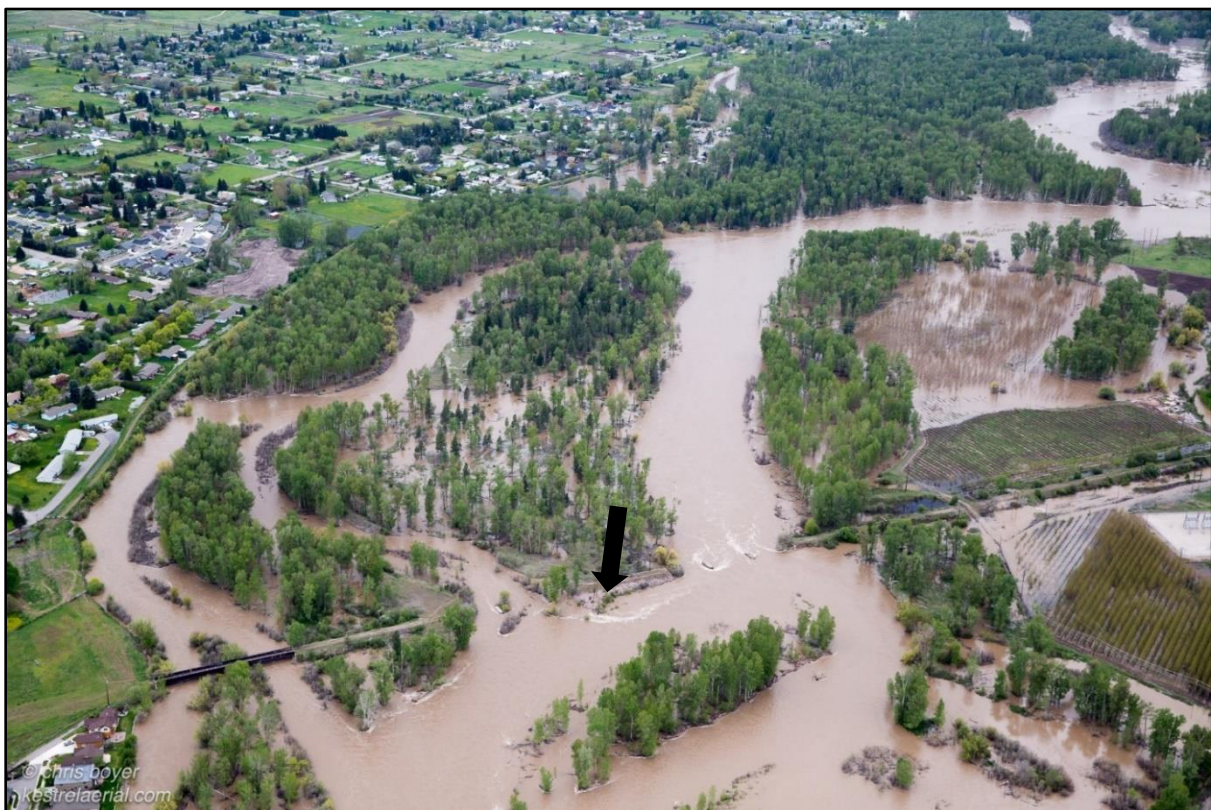
Figure 70. View downstream showing flow paths through abandoned rail line crossing; rock-reinforced utility pole is noted by black arrow (May 10, 2018).

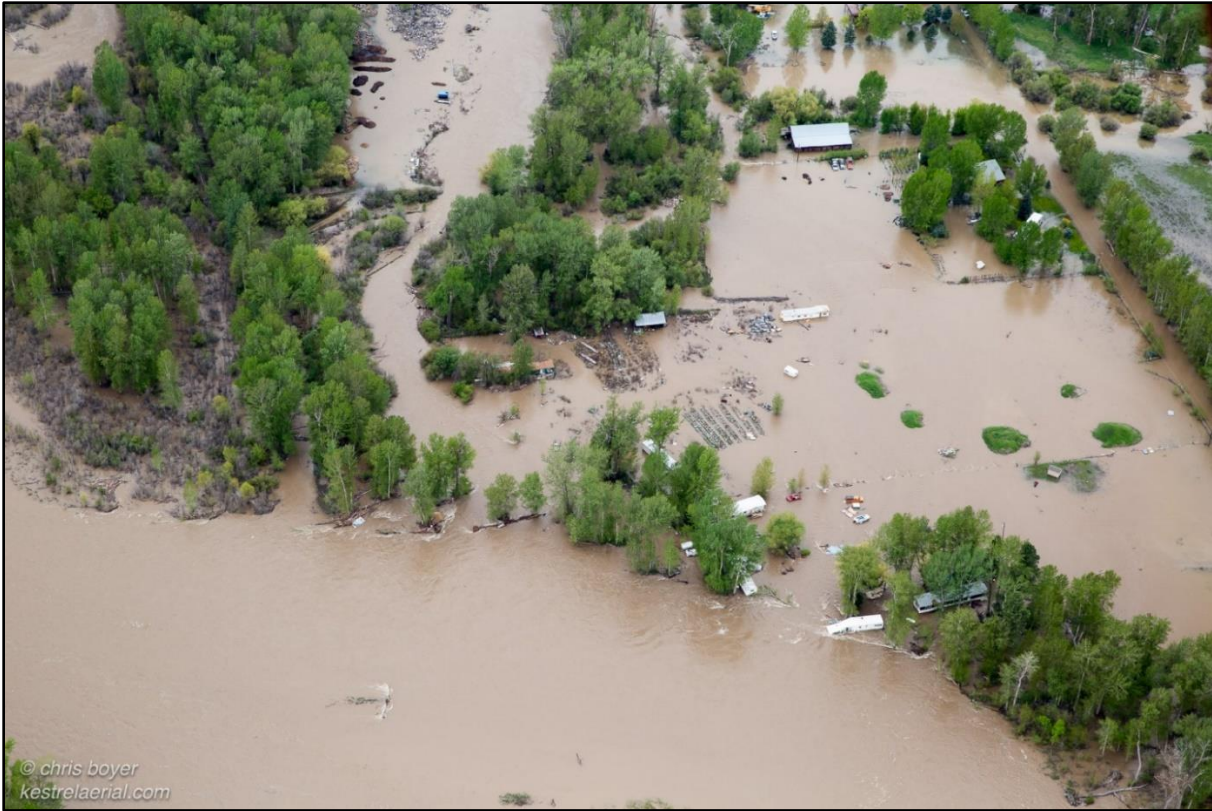
Figure 72. Floodwater breakouts point on downstream limb of rapidly migrating bendway, RM 201.8R; structures in foreground were lost during the flood (May 10, 2018).

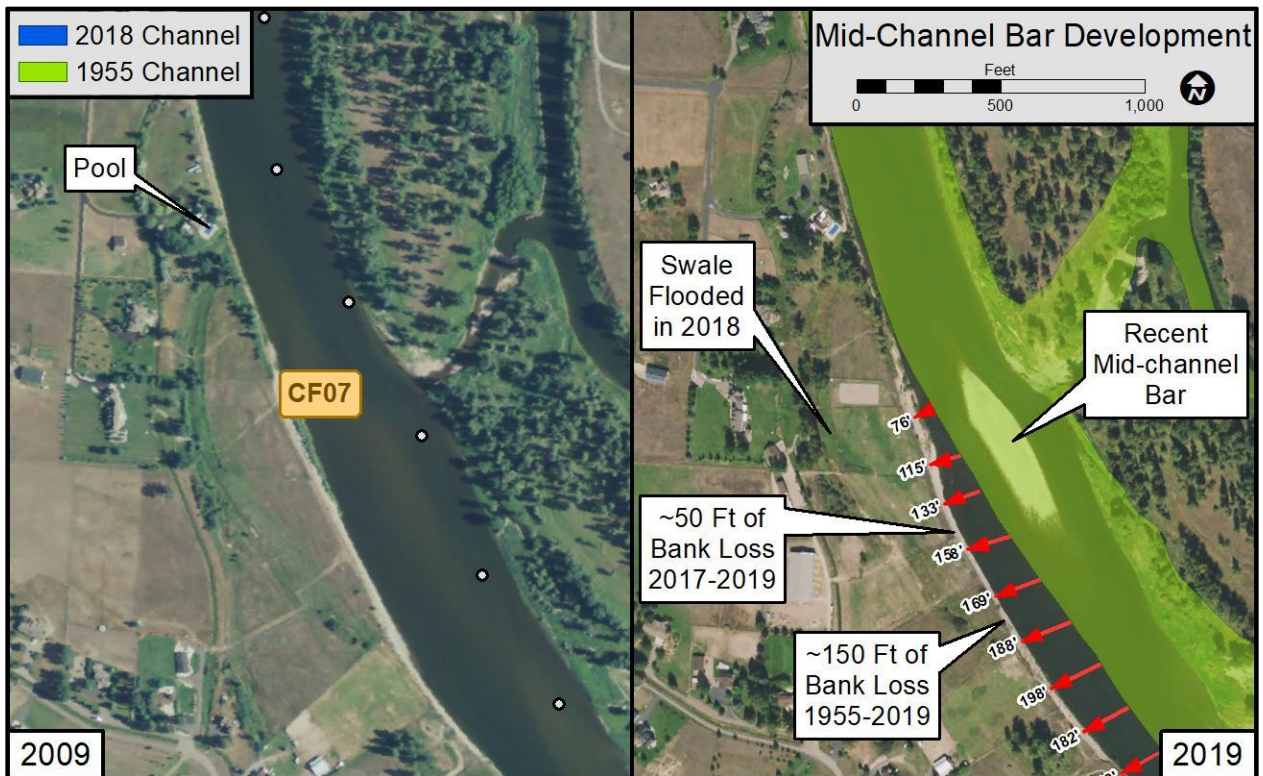
Figure 80. Area of primary bank erosion in Reach CF07 showing newly developed mid-channel bar adding pressure to left bank.

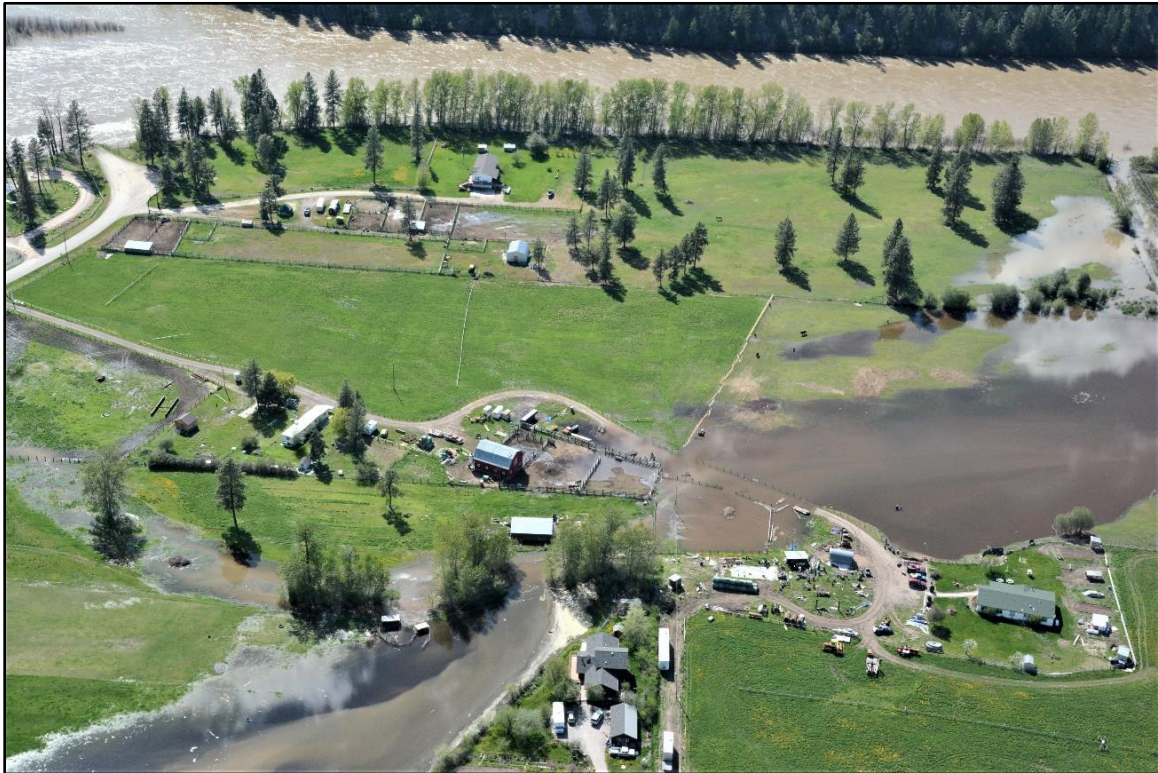
Figure 87. Flooding below overtopping section of Harpers Bridge Road; flow direction is left to right. (CAP May 8, 2018)

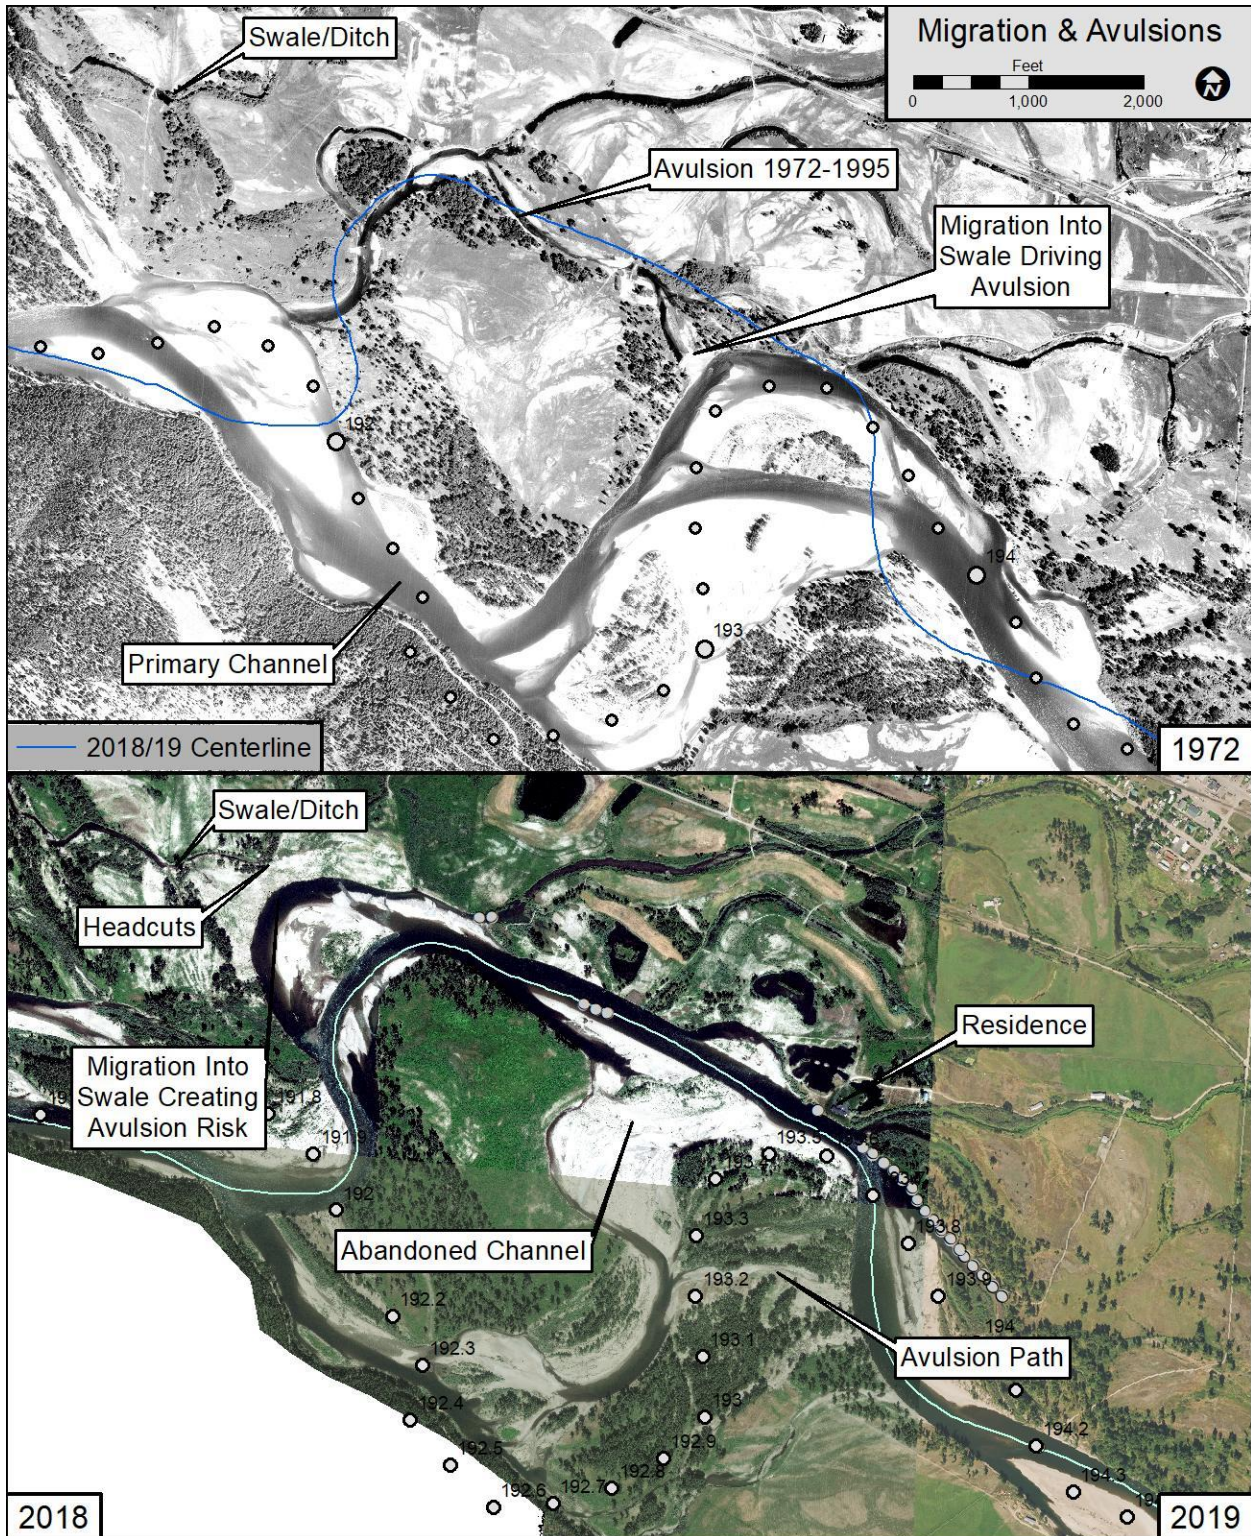
Figure 91. Major avulsion into floodplain swale at RM 193; recent migration and headcut formation has created threat of another avulsion downstream.

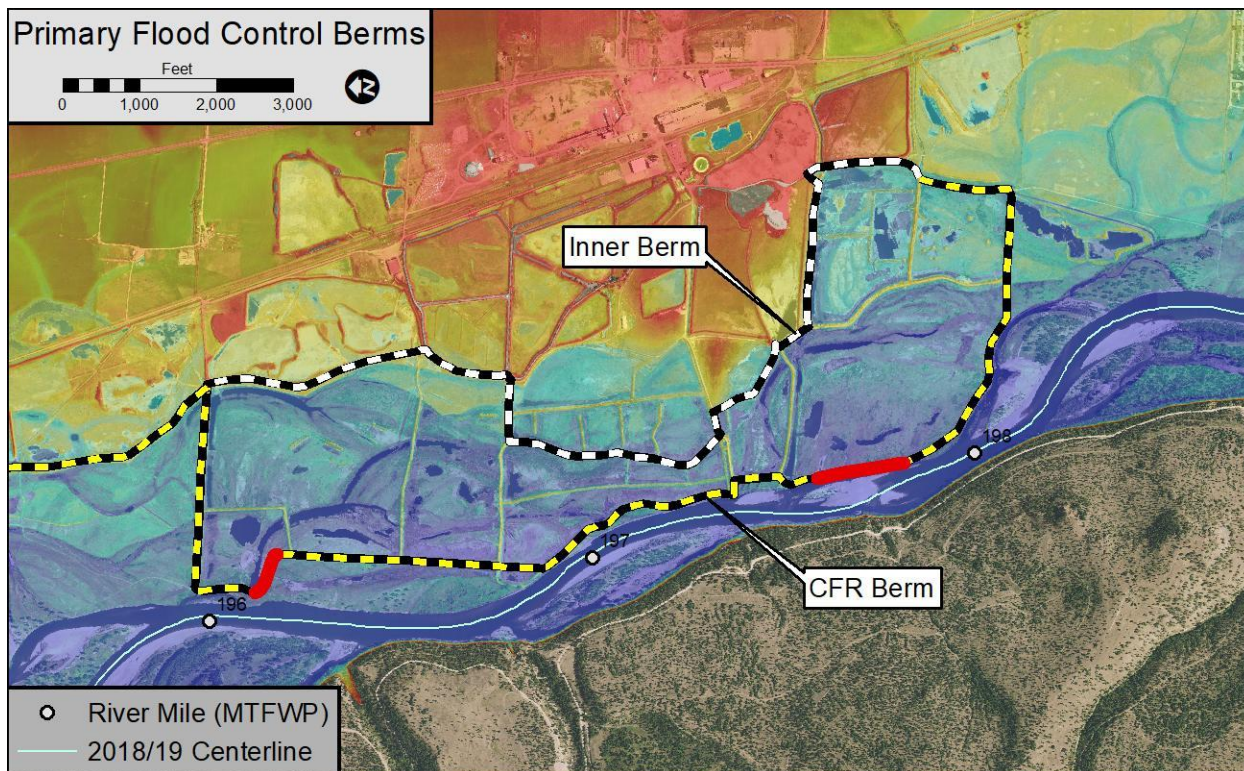
Figure 111. Primary flood controls berms at Smurfit Stone; red lines denote EPA “Special Attention Areas” following 2018 flood review (Newfields, 2019).

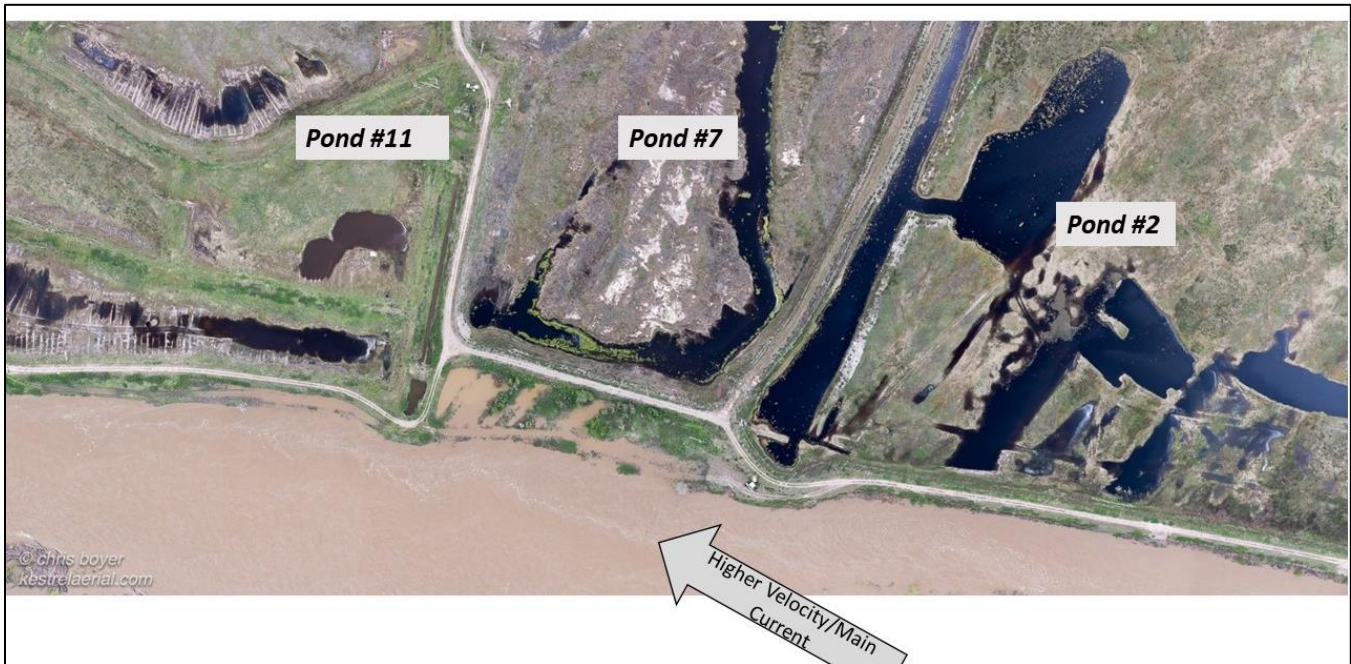
Figure 112. 2018 photo of floodwaters against Smurfit Stone berms (Ponds #2, #7, and #11 from right to left).

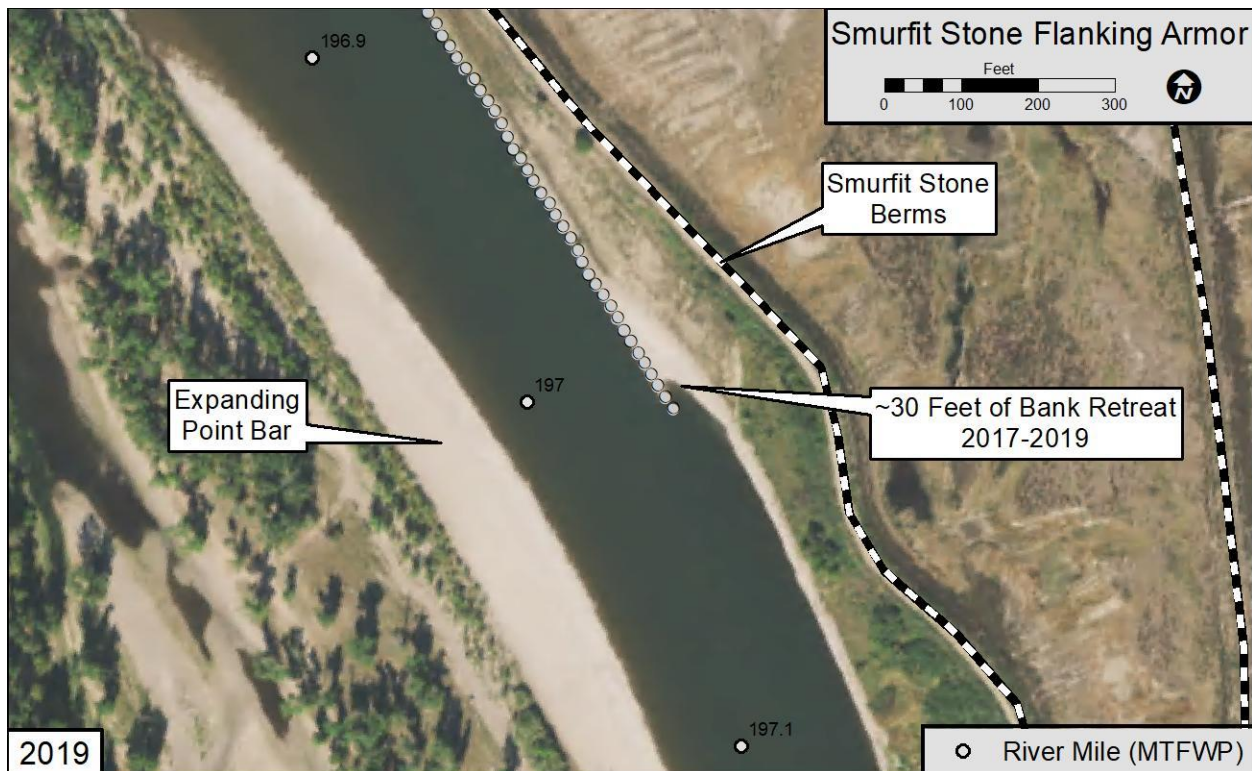
Figure 115. 2019 image showing local scour behind bank armor at RM 197 at Pond #11.

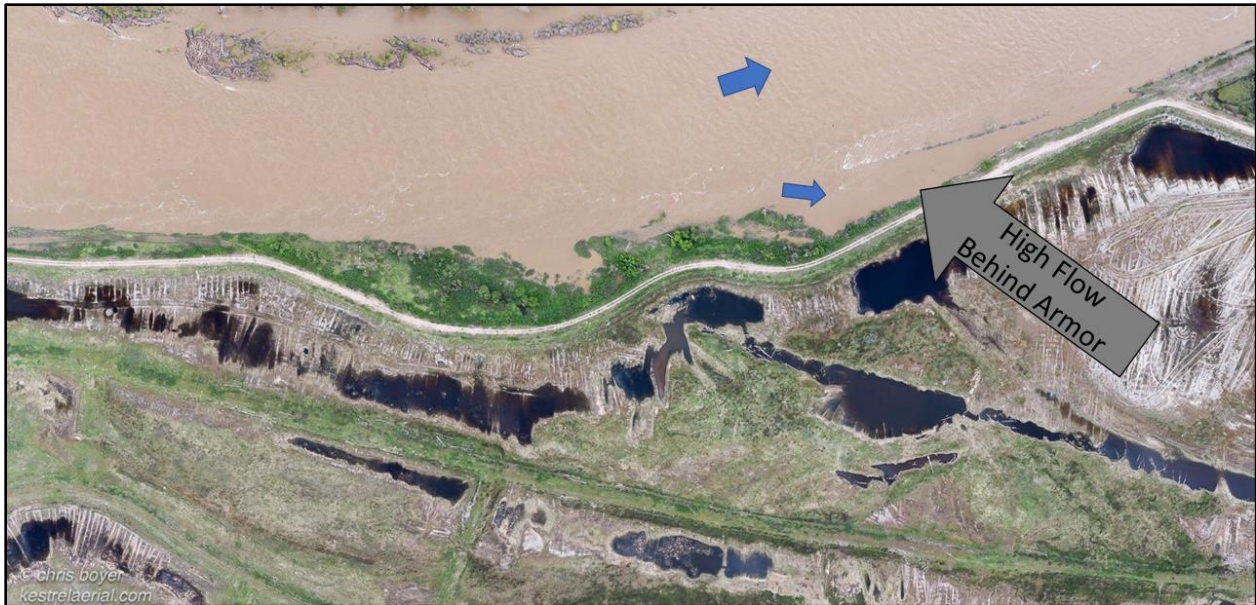
Figure 116. 2018 flood photo of bank armor at RM 197 (Pond #11) showing linear rock treatment largely submerged; note high flow velocities visible on upper end of treatment.

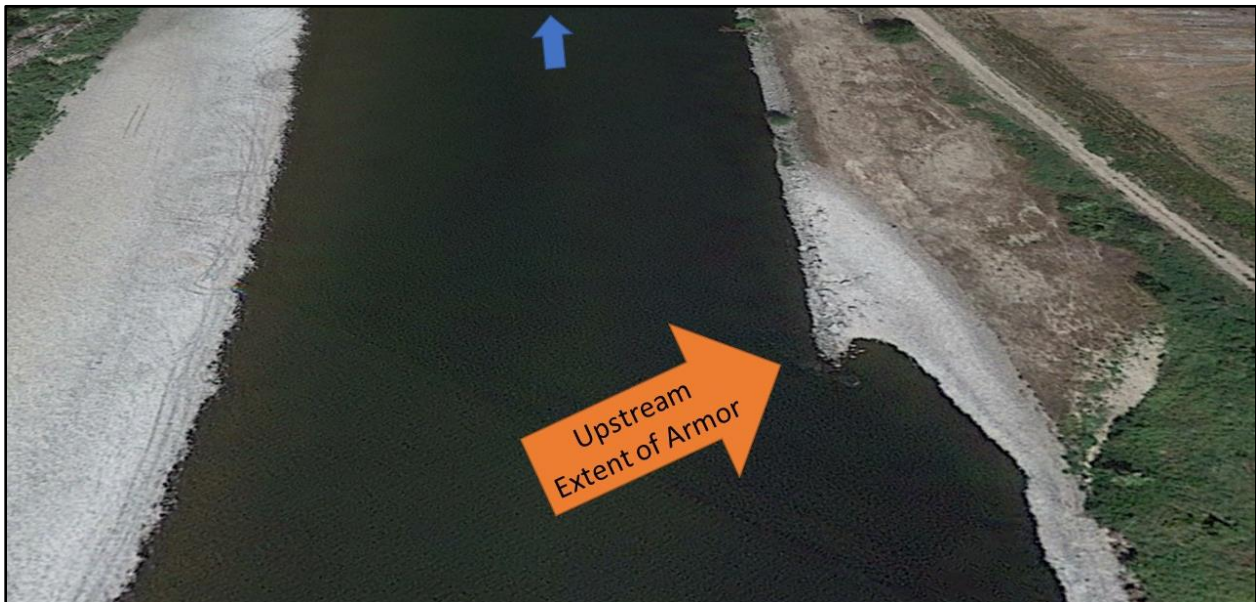
Figure 117. Google Earth image showing scour behind armor at RM 197.

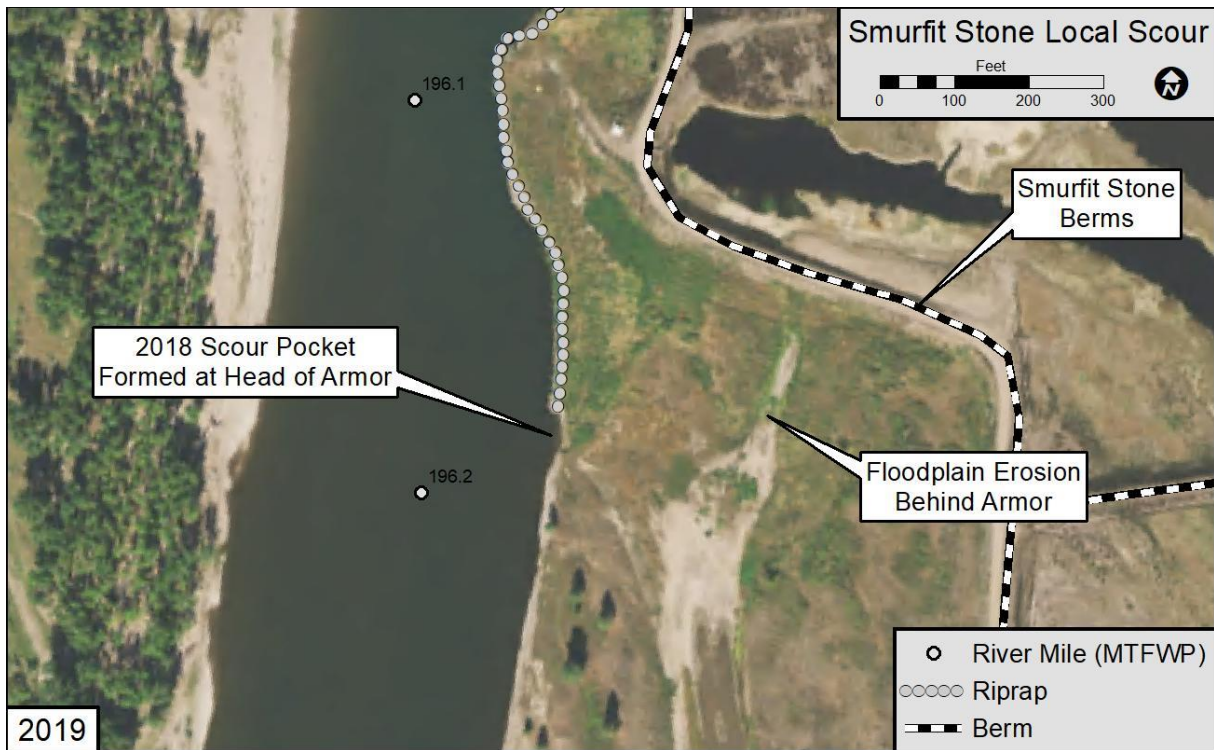
Figure 118. Local scour pocket formed during 2018 flood at head of riprap bank treatment, RM 196.15 (Pond #13a).

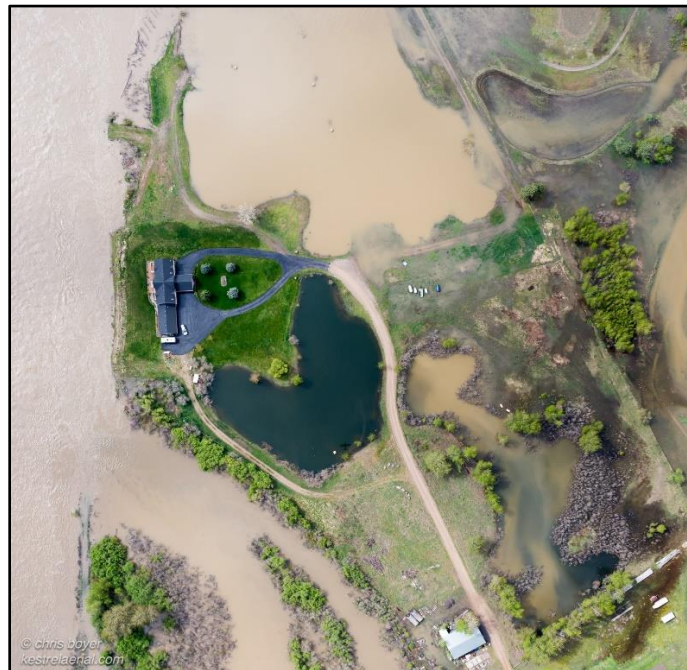
Figure 121. Residential development within EHA of Clark Fork River during the 2018 flood near Frenchtown (May 10, 2018).
