July 31, 2020

Sun River Channel Migration Mapping

Executive Summary

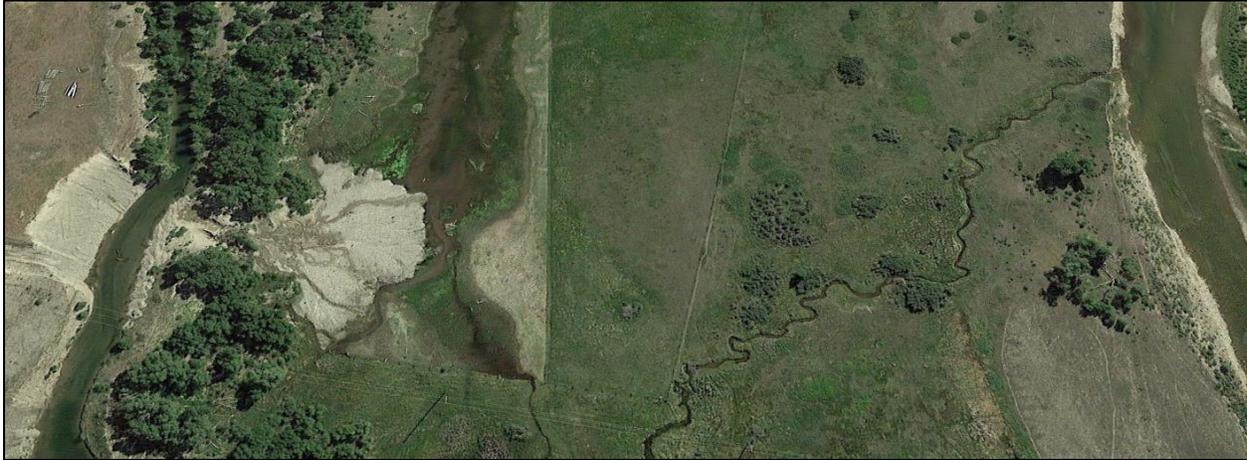
Figure 10. Google Earth photo showing Floweree Canal hillslope failure causing canal breach (left); Sun River is to right.

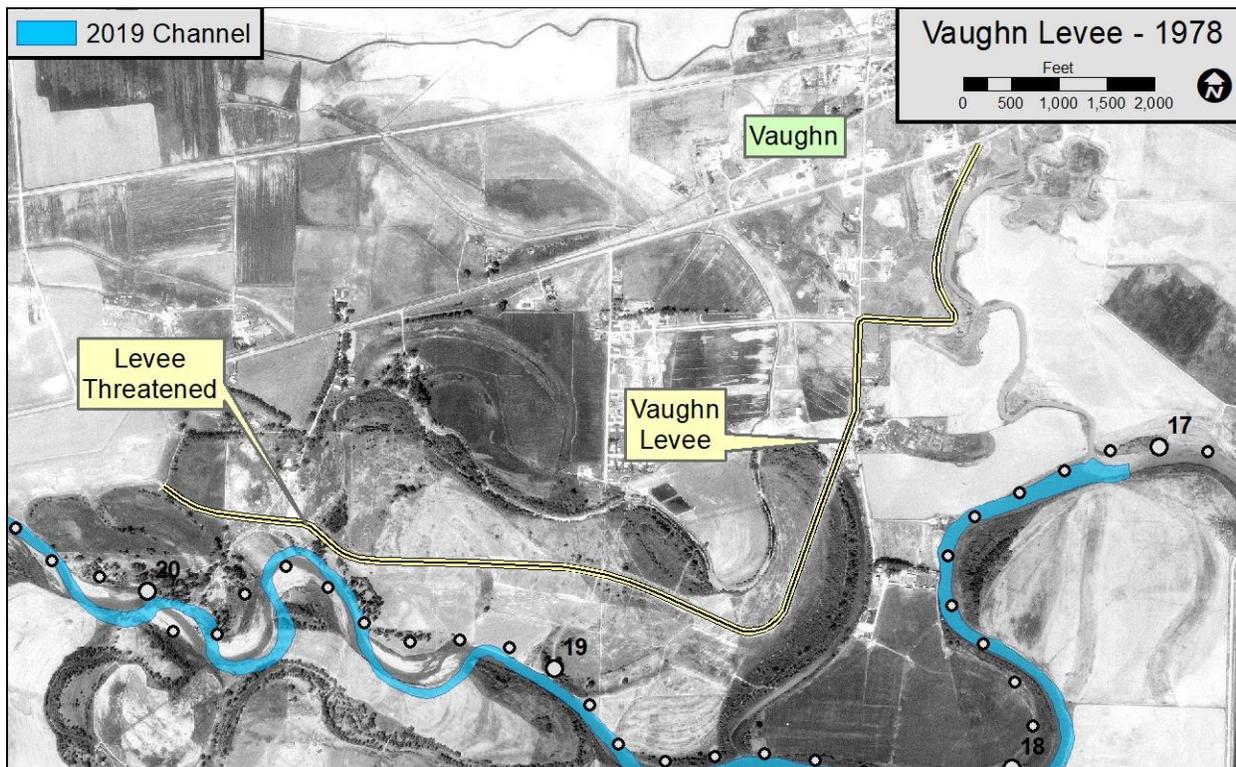
Figure 32. Vaughn Levee showing conditions a decade after it was built (1978 air photo); blue shows 2019 Sun River course and highlights large meander approaching and threatening levee.

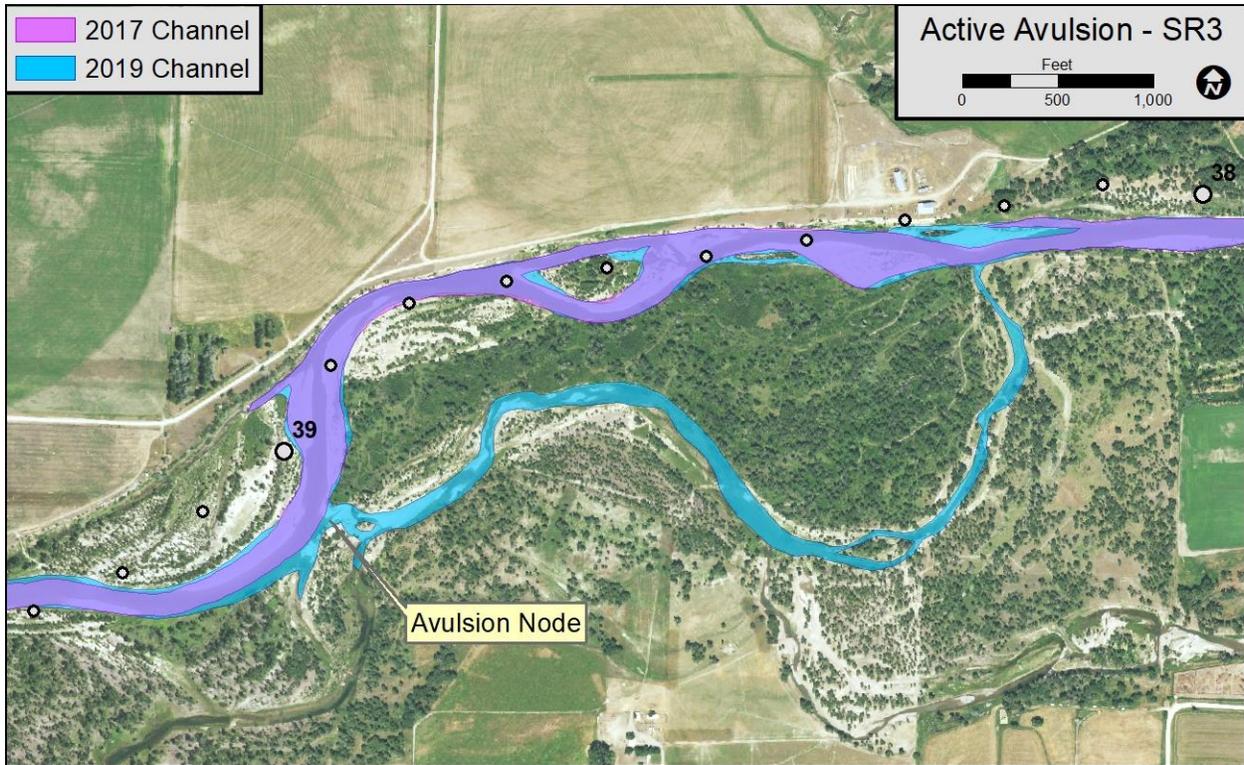
Figure 51. Active avulsion at RM 39, Reach SR3.

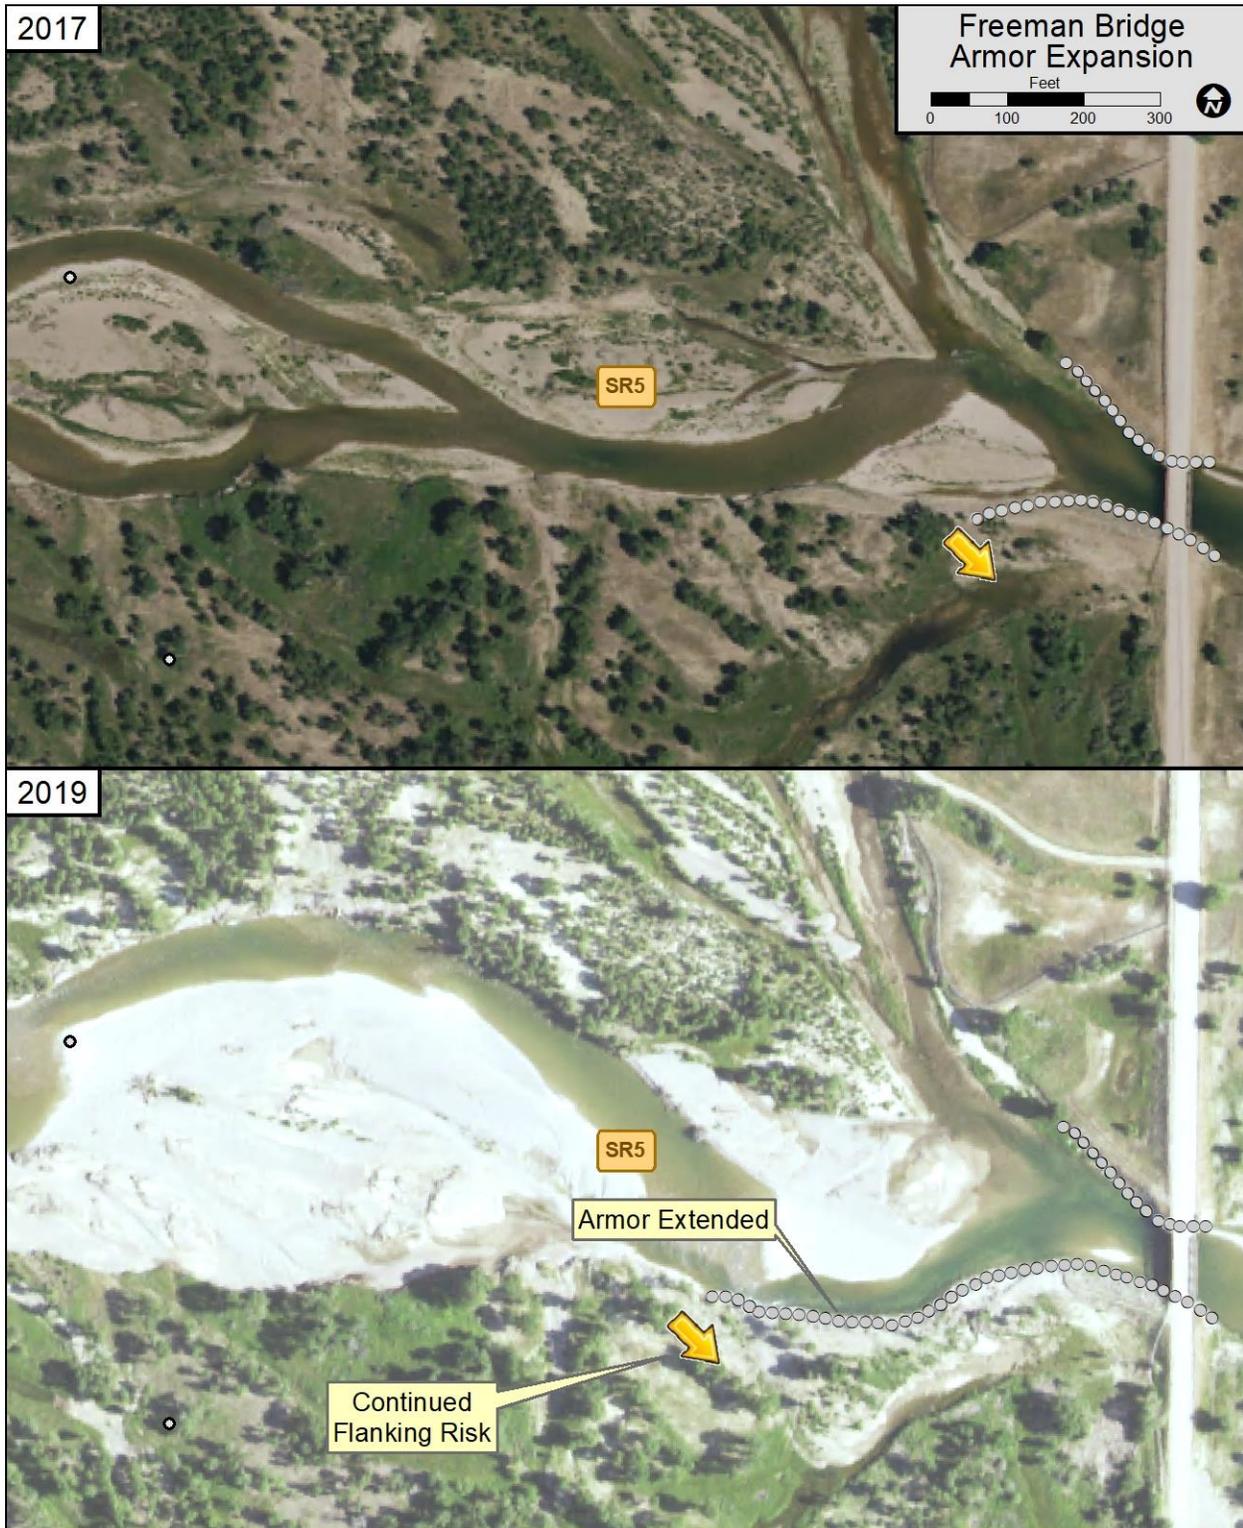
Figure 64. Bank armor expansion above Freeman Bridge between 2017 (top) and 2019 (bottom) showing continued flanking risk south of armor.

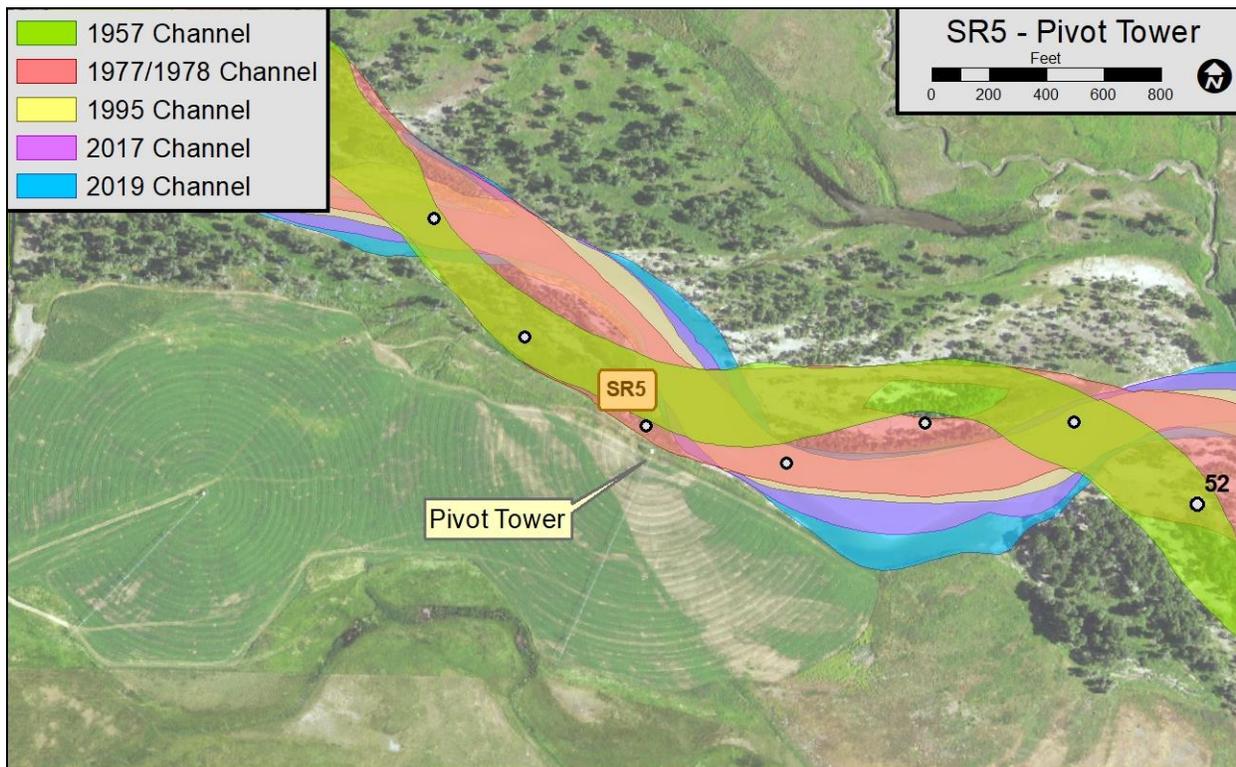
Figure 65. Pivot tower at RM 52.4R at high risk of damage due to channel migration.

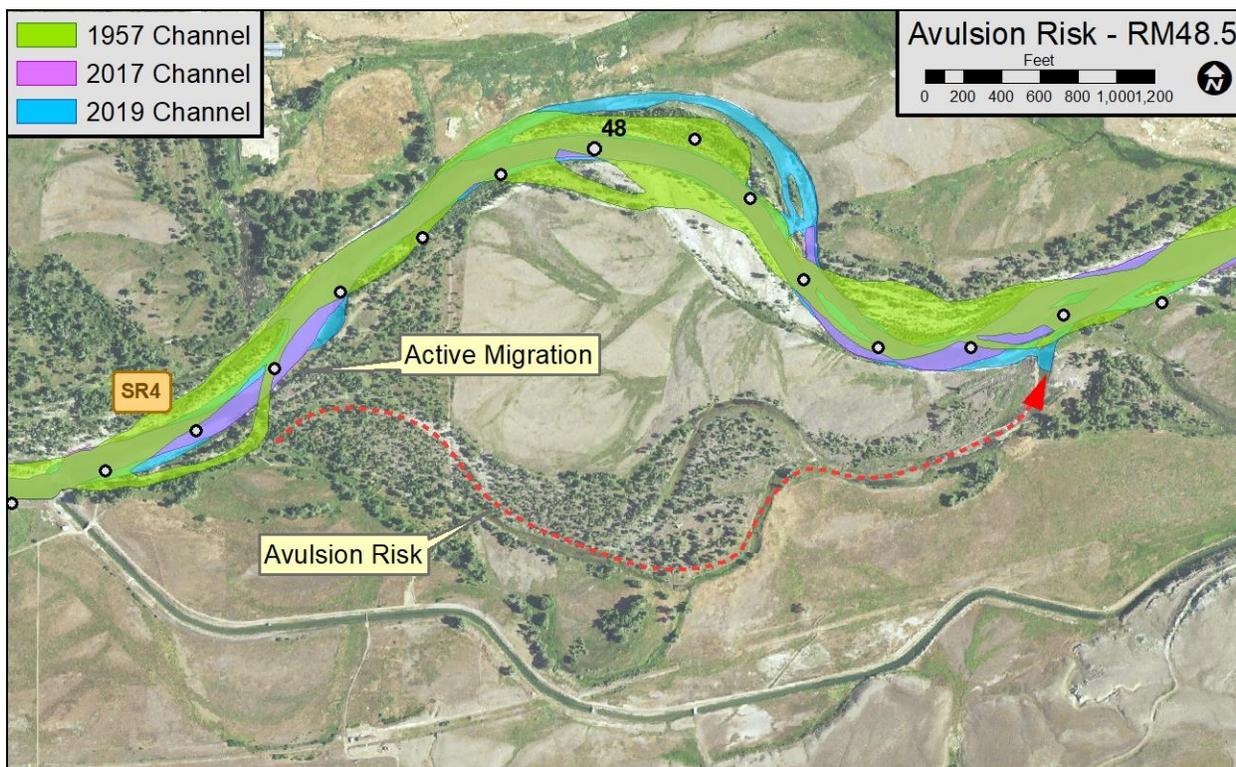
Figure 67. Example avulsion hazard through floodplain swale below Fort Shaw Canal Diversion; note how river has migrated towards upper end of avulsion path in recent years.

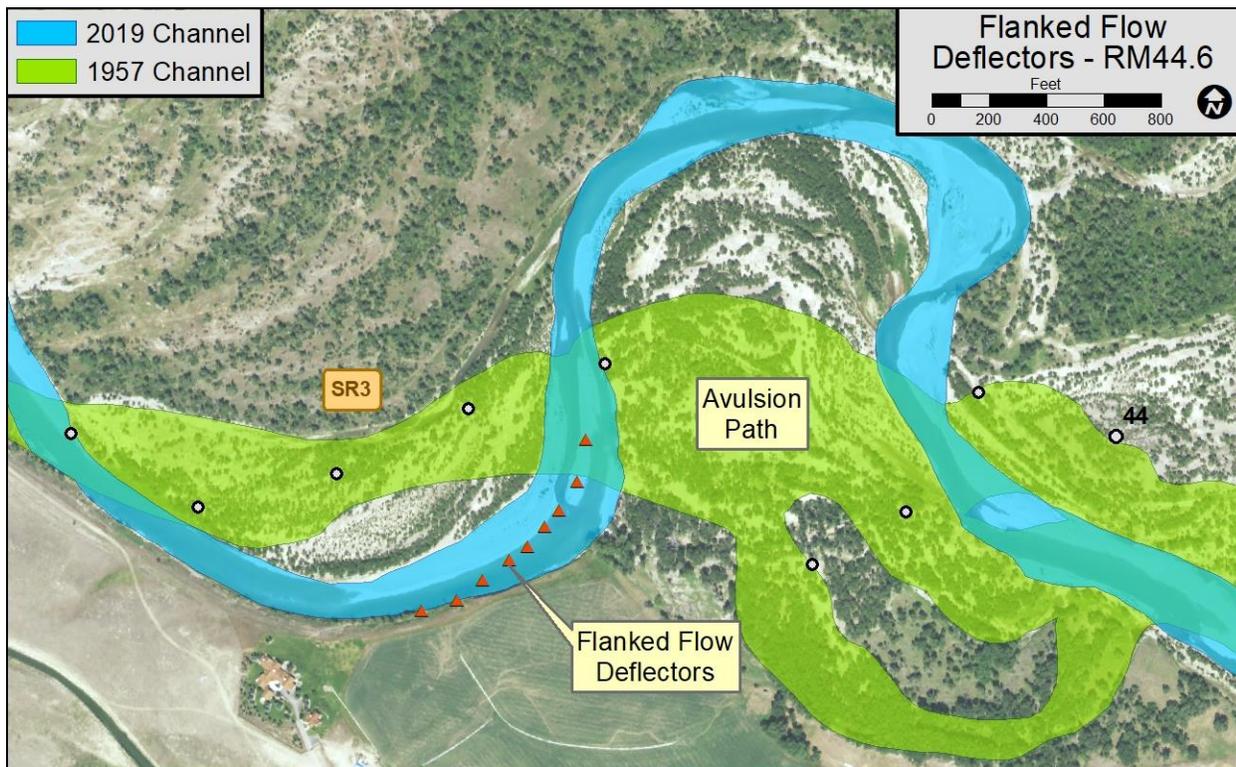
Figure 71. Channel migration at RM 44.7, site of Kellogg (2014) Site SR-3; at least five barbs have been flanked on the right bank; note avulsion path following 1957 channel route just downstream.

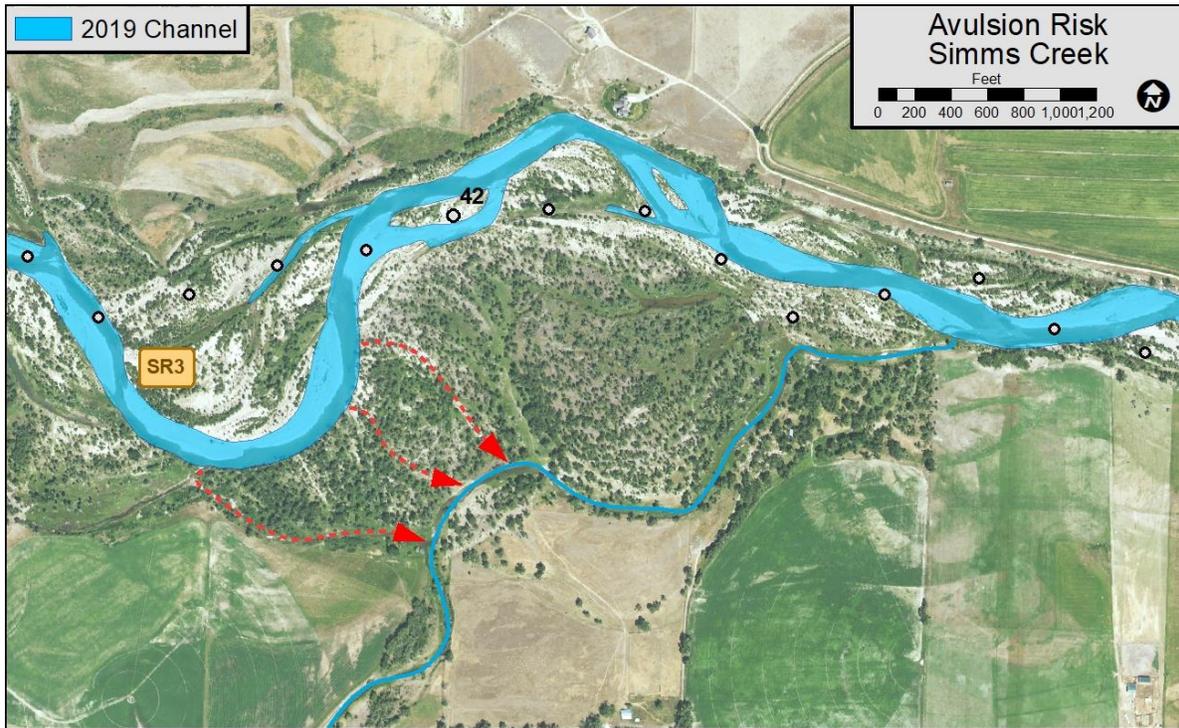
Figure 72. Multiple avulsion paths have developed from an outside bend towards Simms Creek, creating a high avulsion risk in this area.

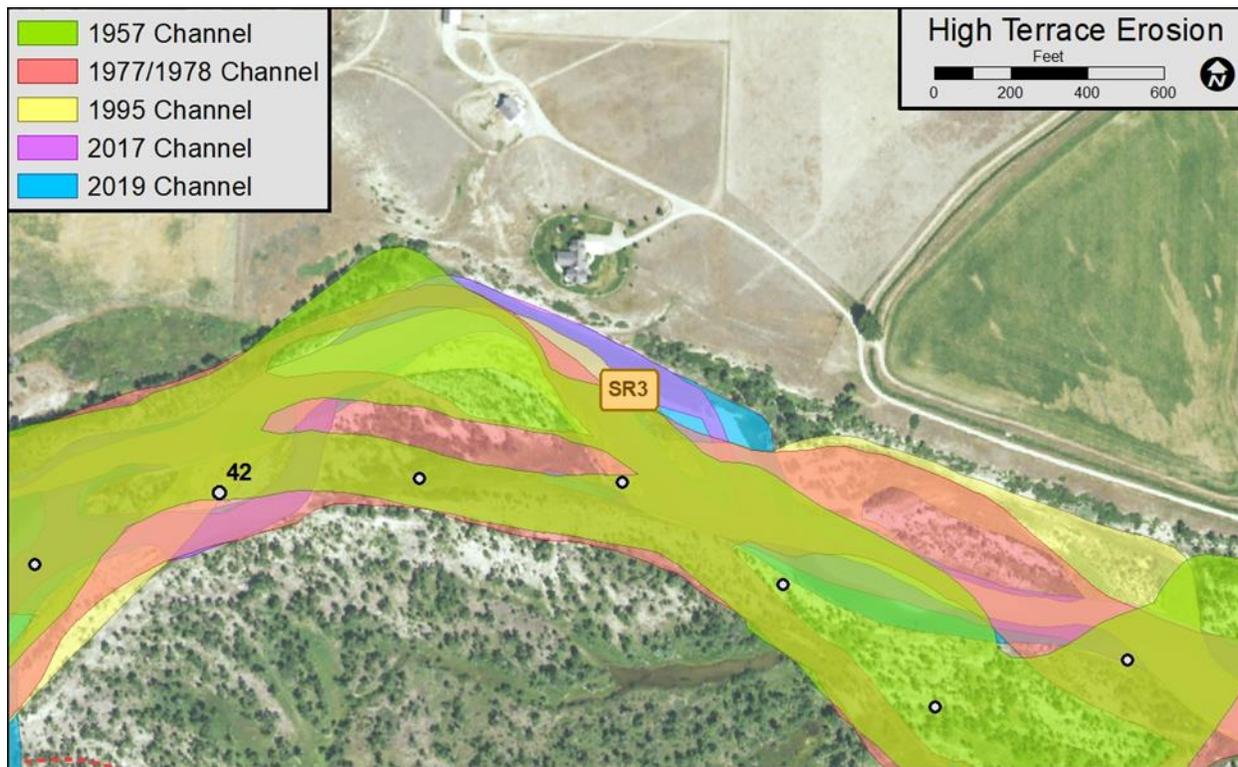
Figure 74. 1957-2019 migration pattern against high terrace at RM 41.8.

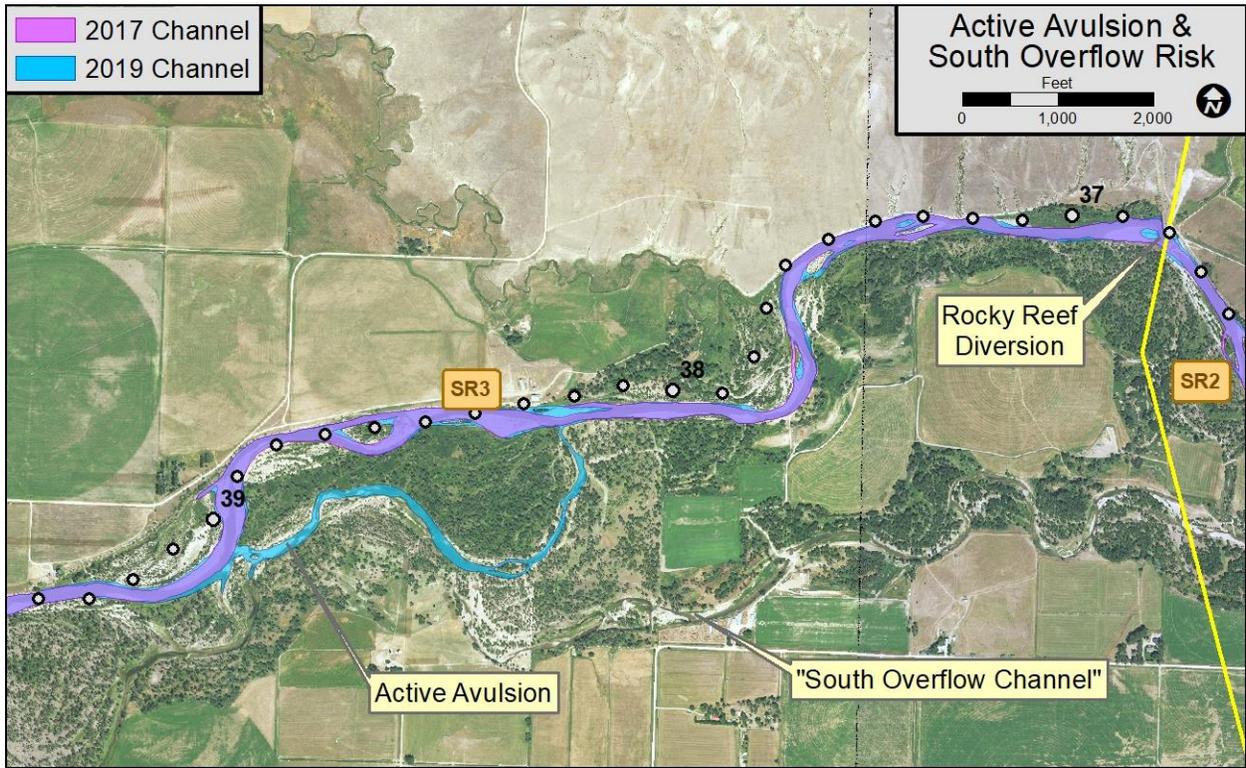
Figure 75. Active avulsion (blue 2019 path) at RM 38.5 showing potential for reactivation of South Overflow Channel that would bypass Rocky Reef Diversion.

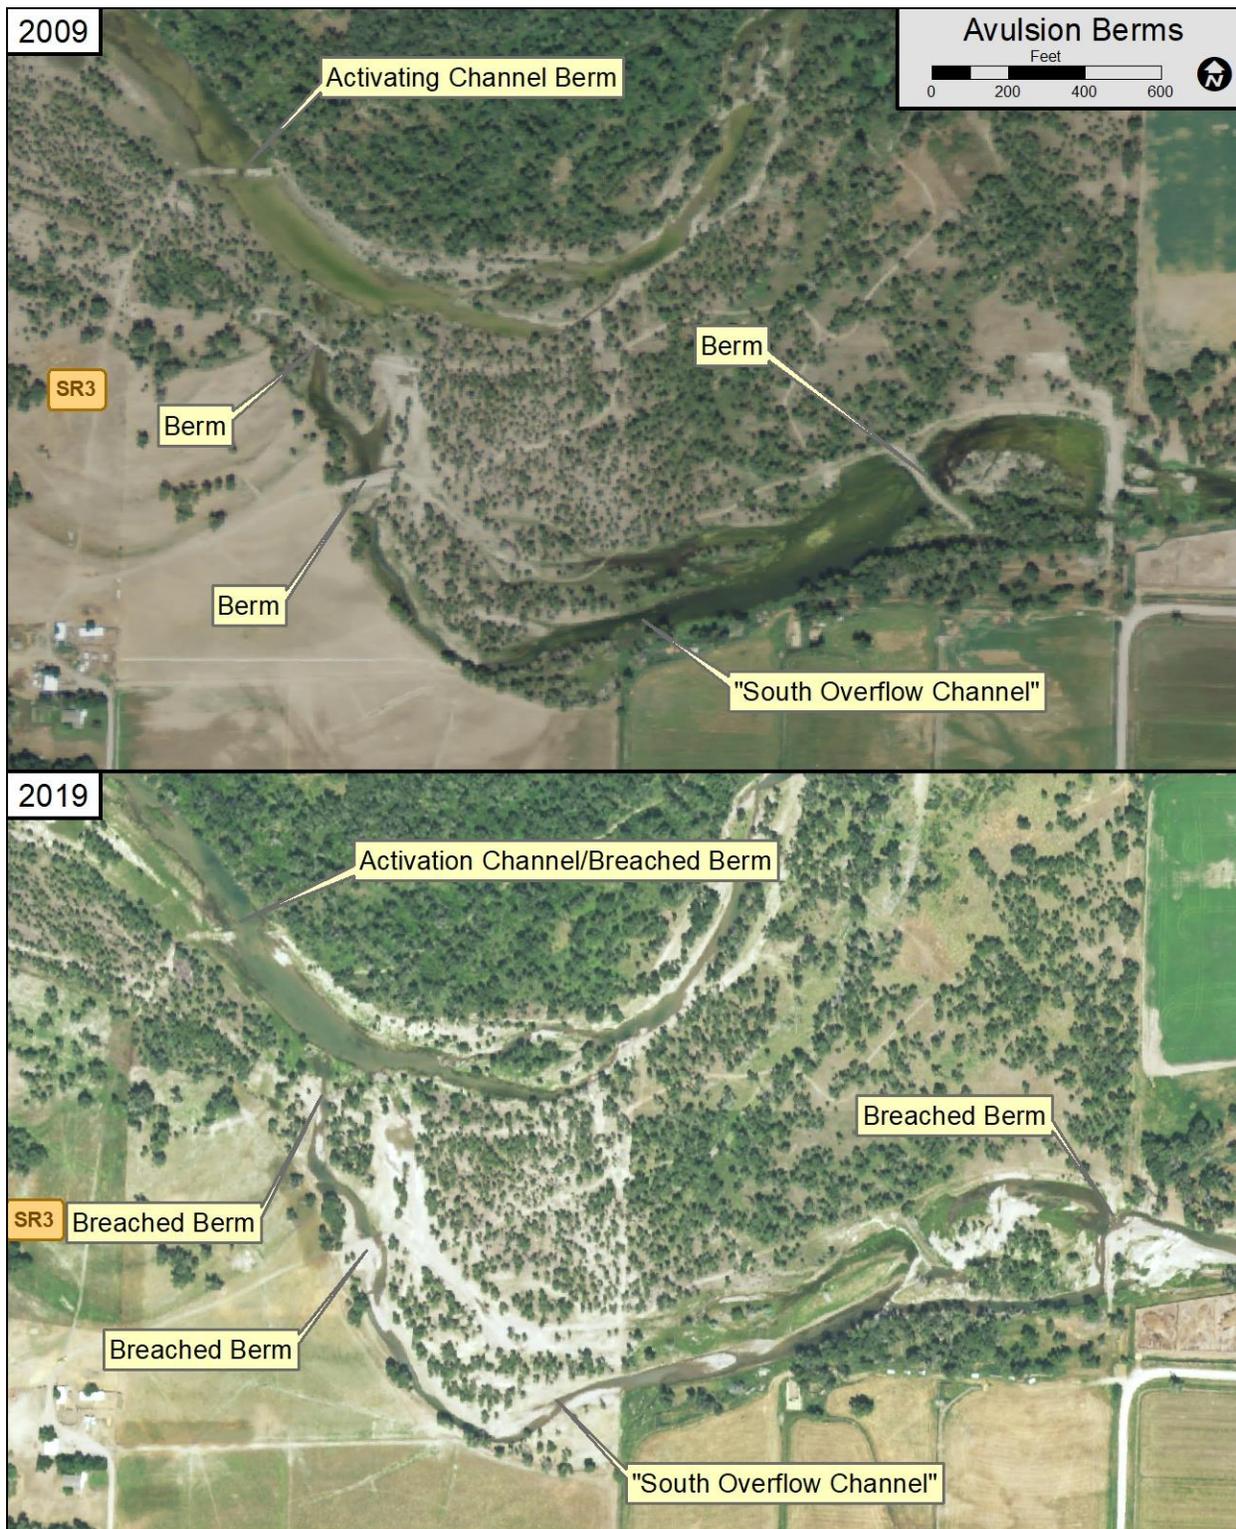
Figure 76. Activating channels on south floodplain about 1.5 miles upstream of Rocky Reef Diversion showing breaching of cross-channel berms between 2009 and 2019.

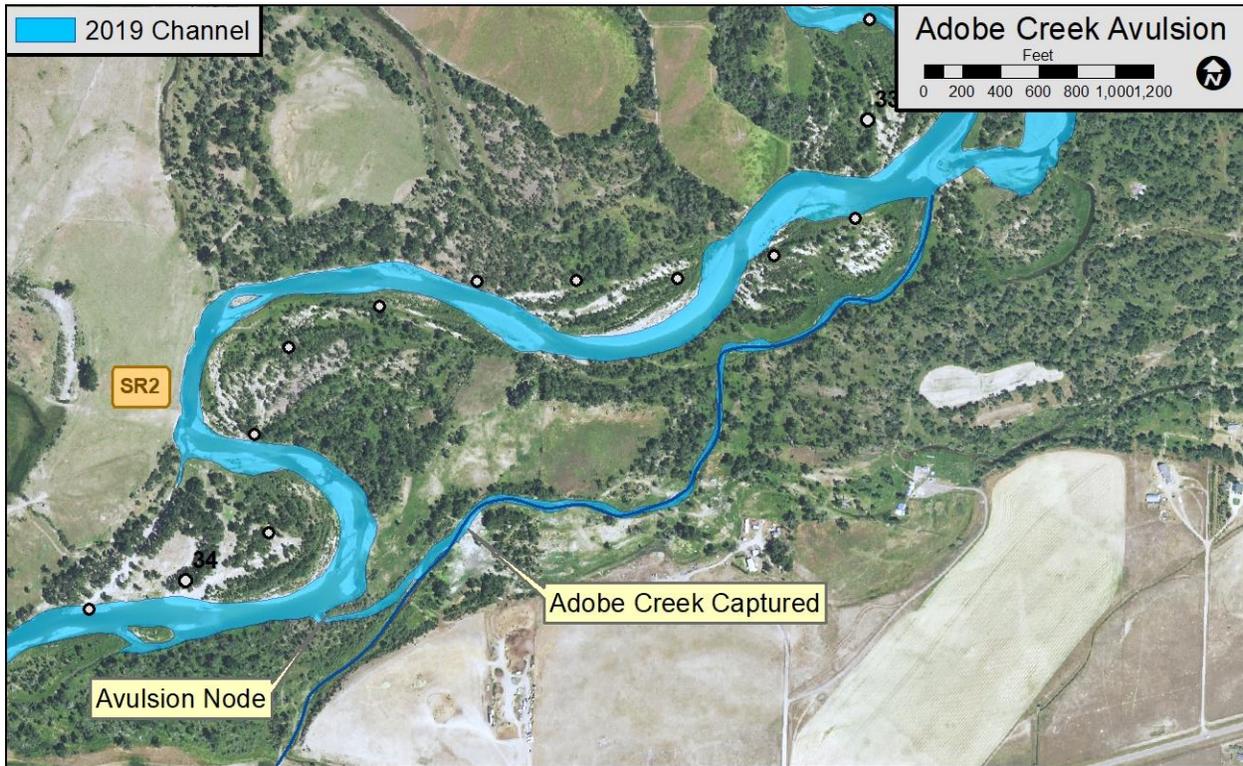
Figure 79. 2019 image showing active avulsion into lower Adobe Creek; avulsion path is about 2,000 feet shorter than the main river.

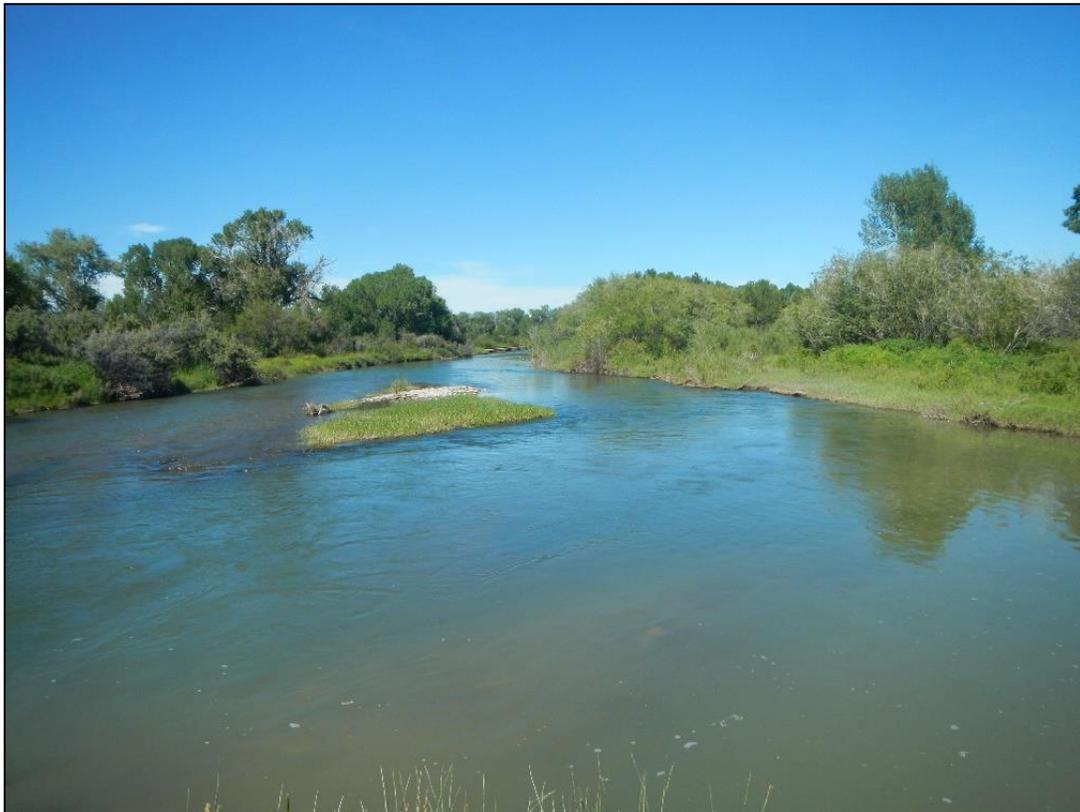
Figure 81. View of Adobe Creek below avulsion point; the Sun River has captured the creek.

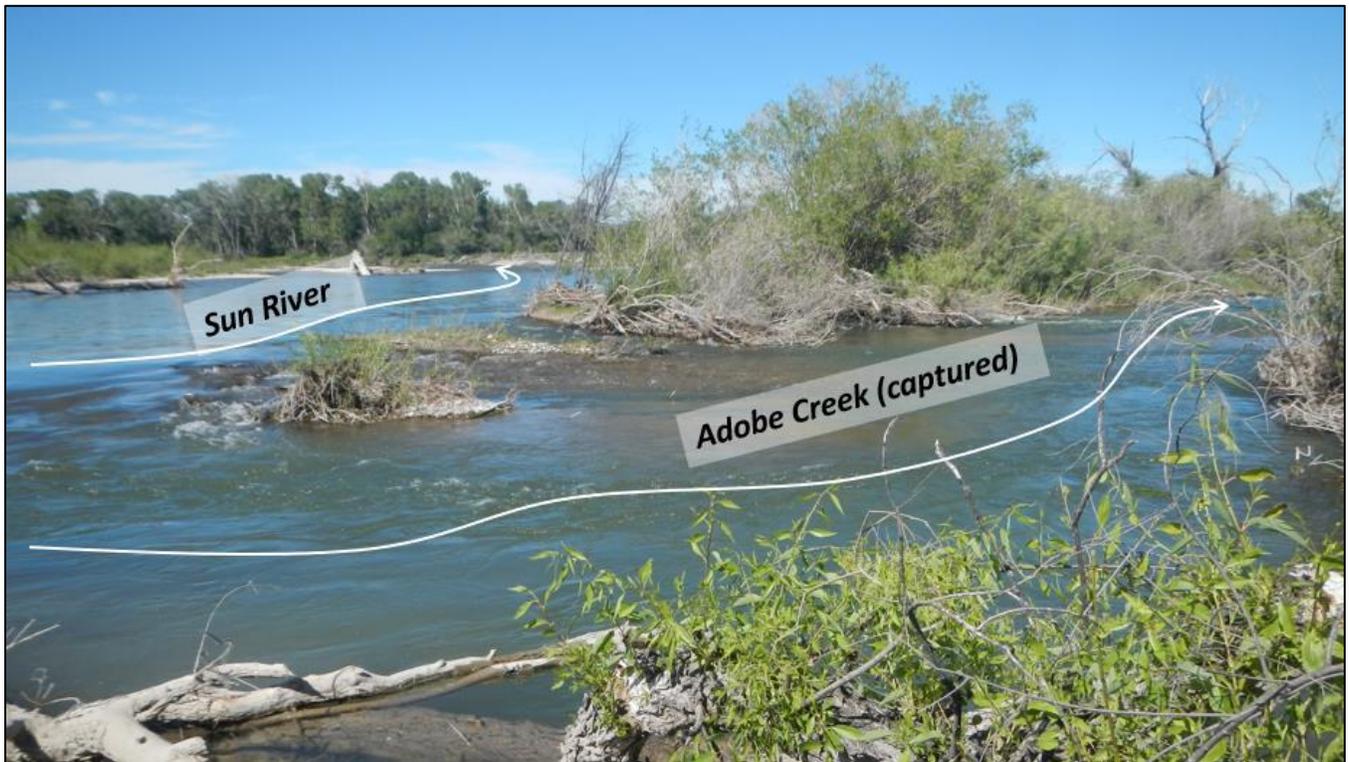
Figure 82. View downstream from avulsion node showing breach in right bank that captured swale feeding Adobe Creek.

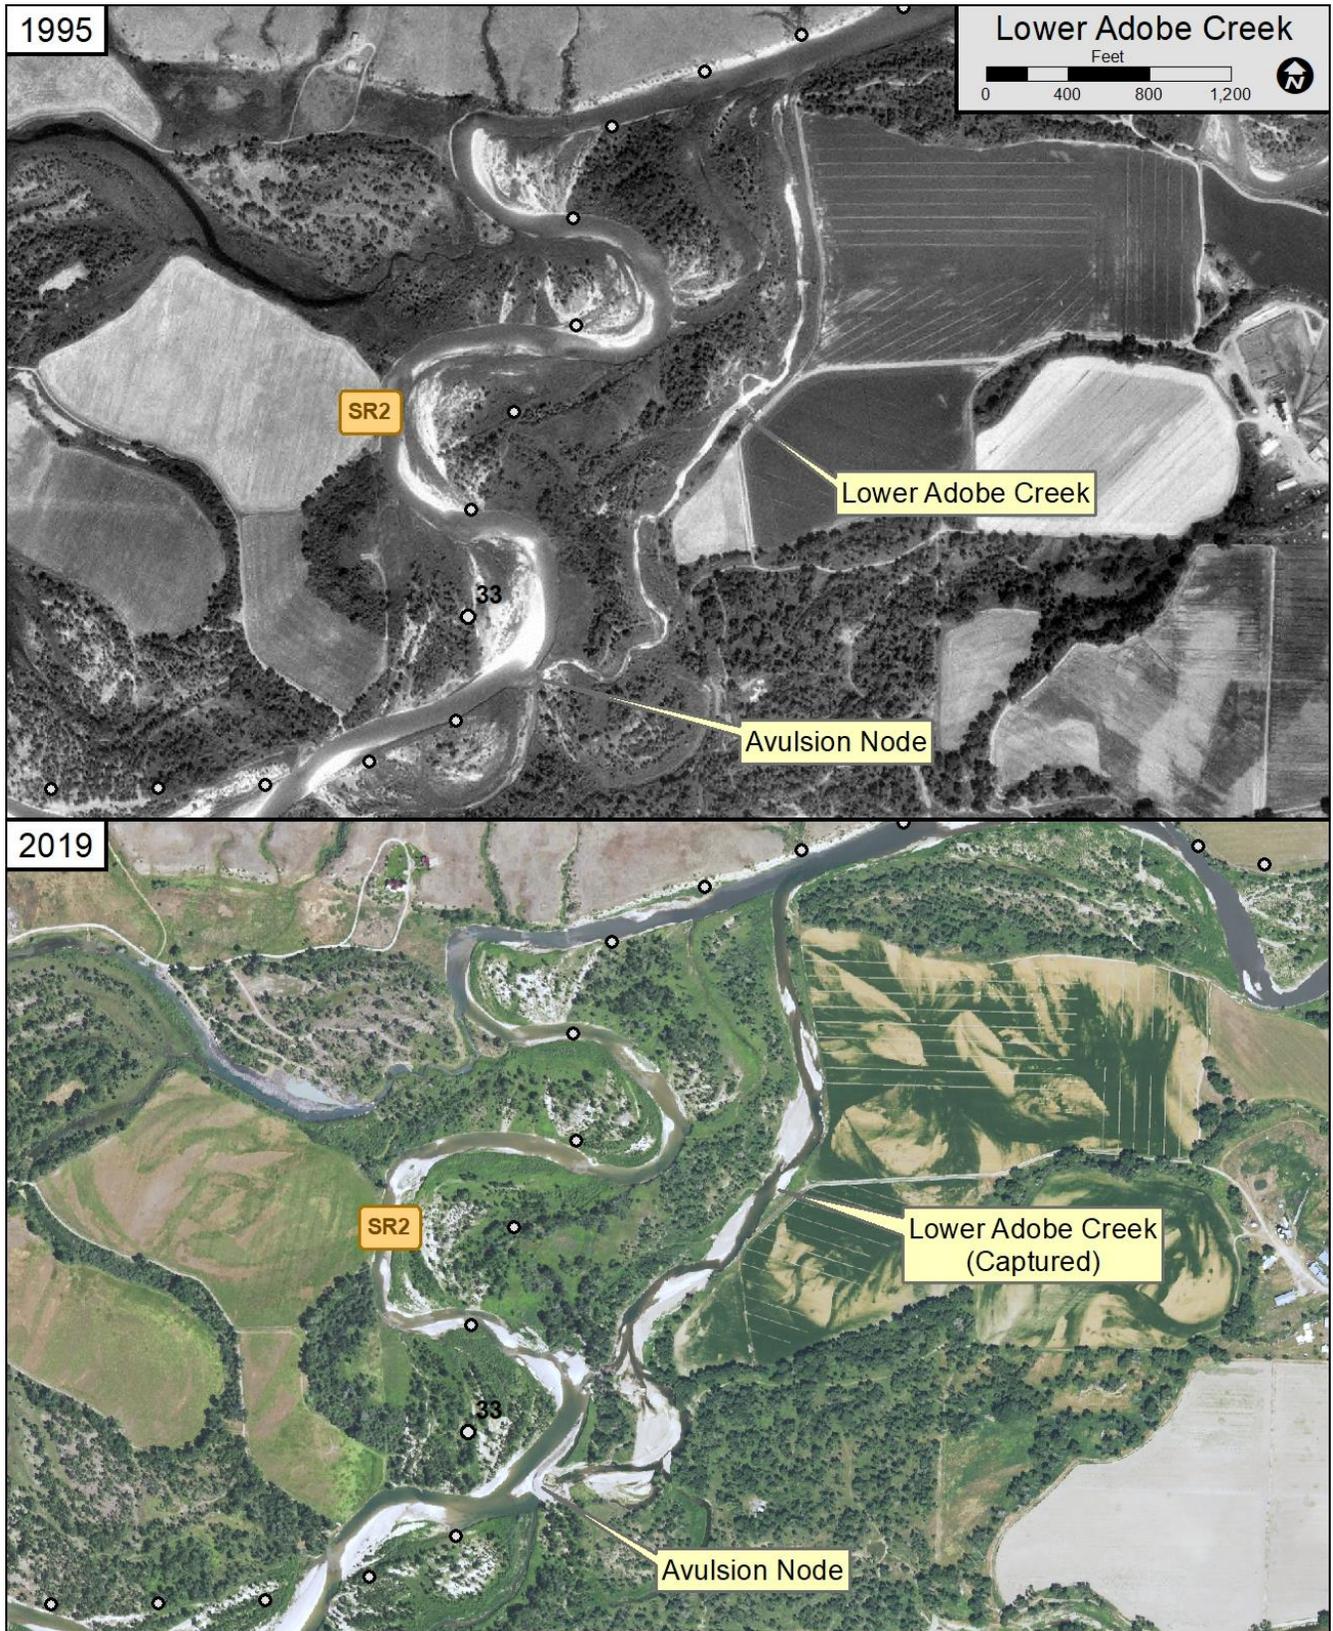
Figure 83. Avulsion into lowermost Adobe Creek between 1995 and 2019 showing tributary capture due to bank erosion at avulsion node into old swale/creek channel.

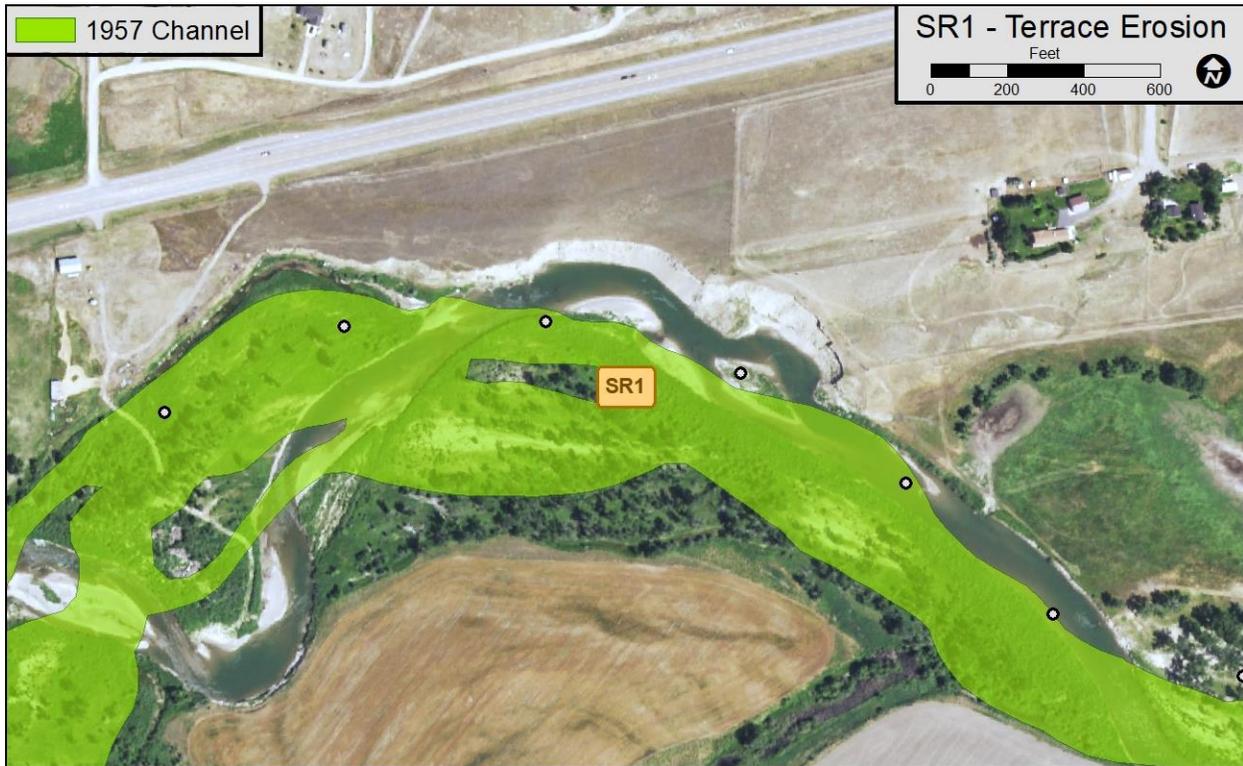
Figure 86. Terrace erosion at RM 20.5; green polygon shows channel location in 1957.

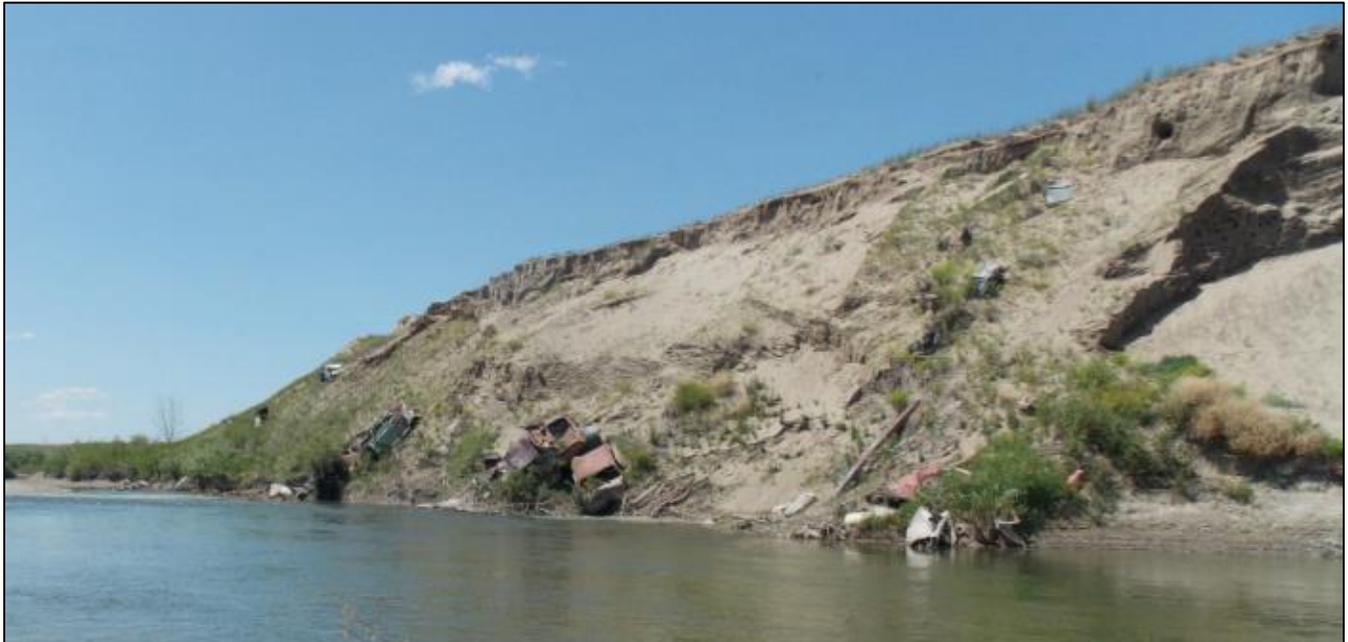
Figure 87. High terrace erosion at RM 20.5 (Kellogg, 2014).

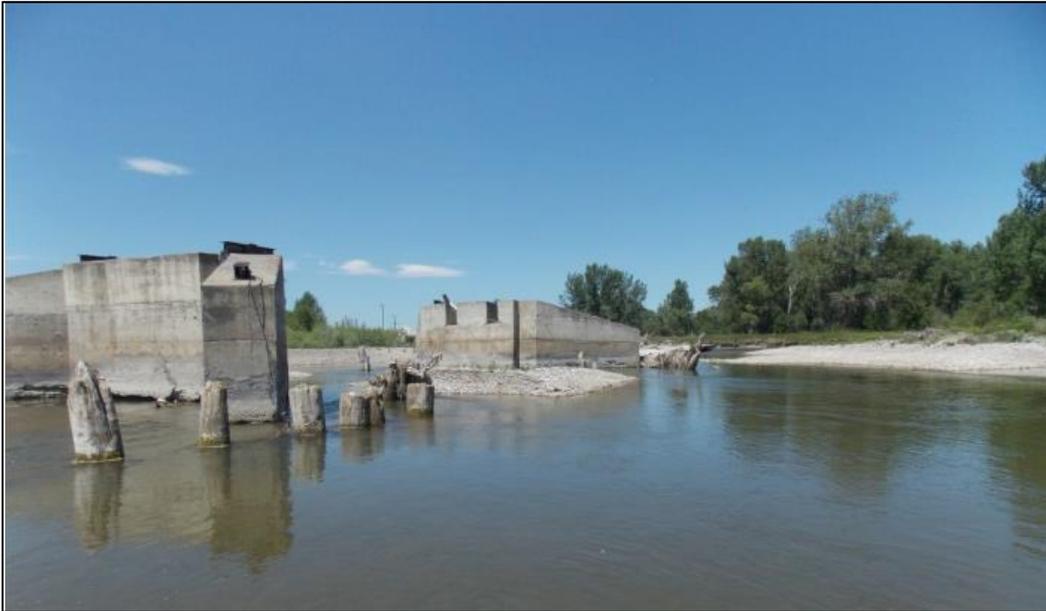
Figure 90. Bridge abutments in channel approximately 1.5 miles downstream from Largent's Bend Fishing Access Site (Kellogg, 2014).
