County	Stillwater	Upstream River Mile	413.7
Classification	PCA: Partially confined anabranching	Downstream River Mile	405.9
General Location	Below Columbus	Length	7.80 mi (12.55 km)

Narrative Summary

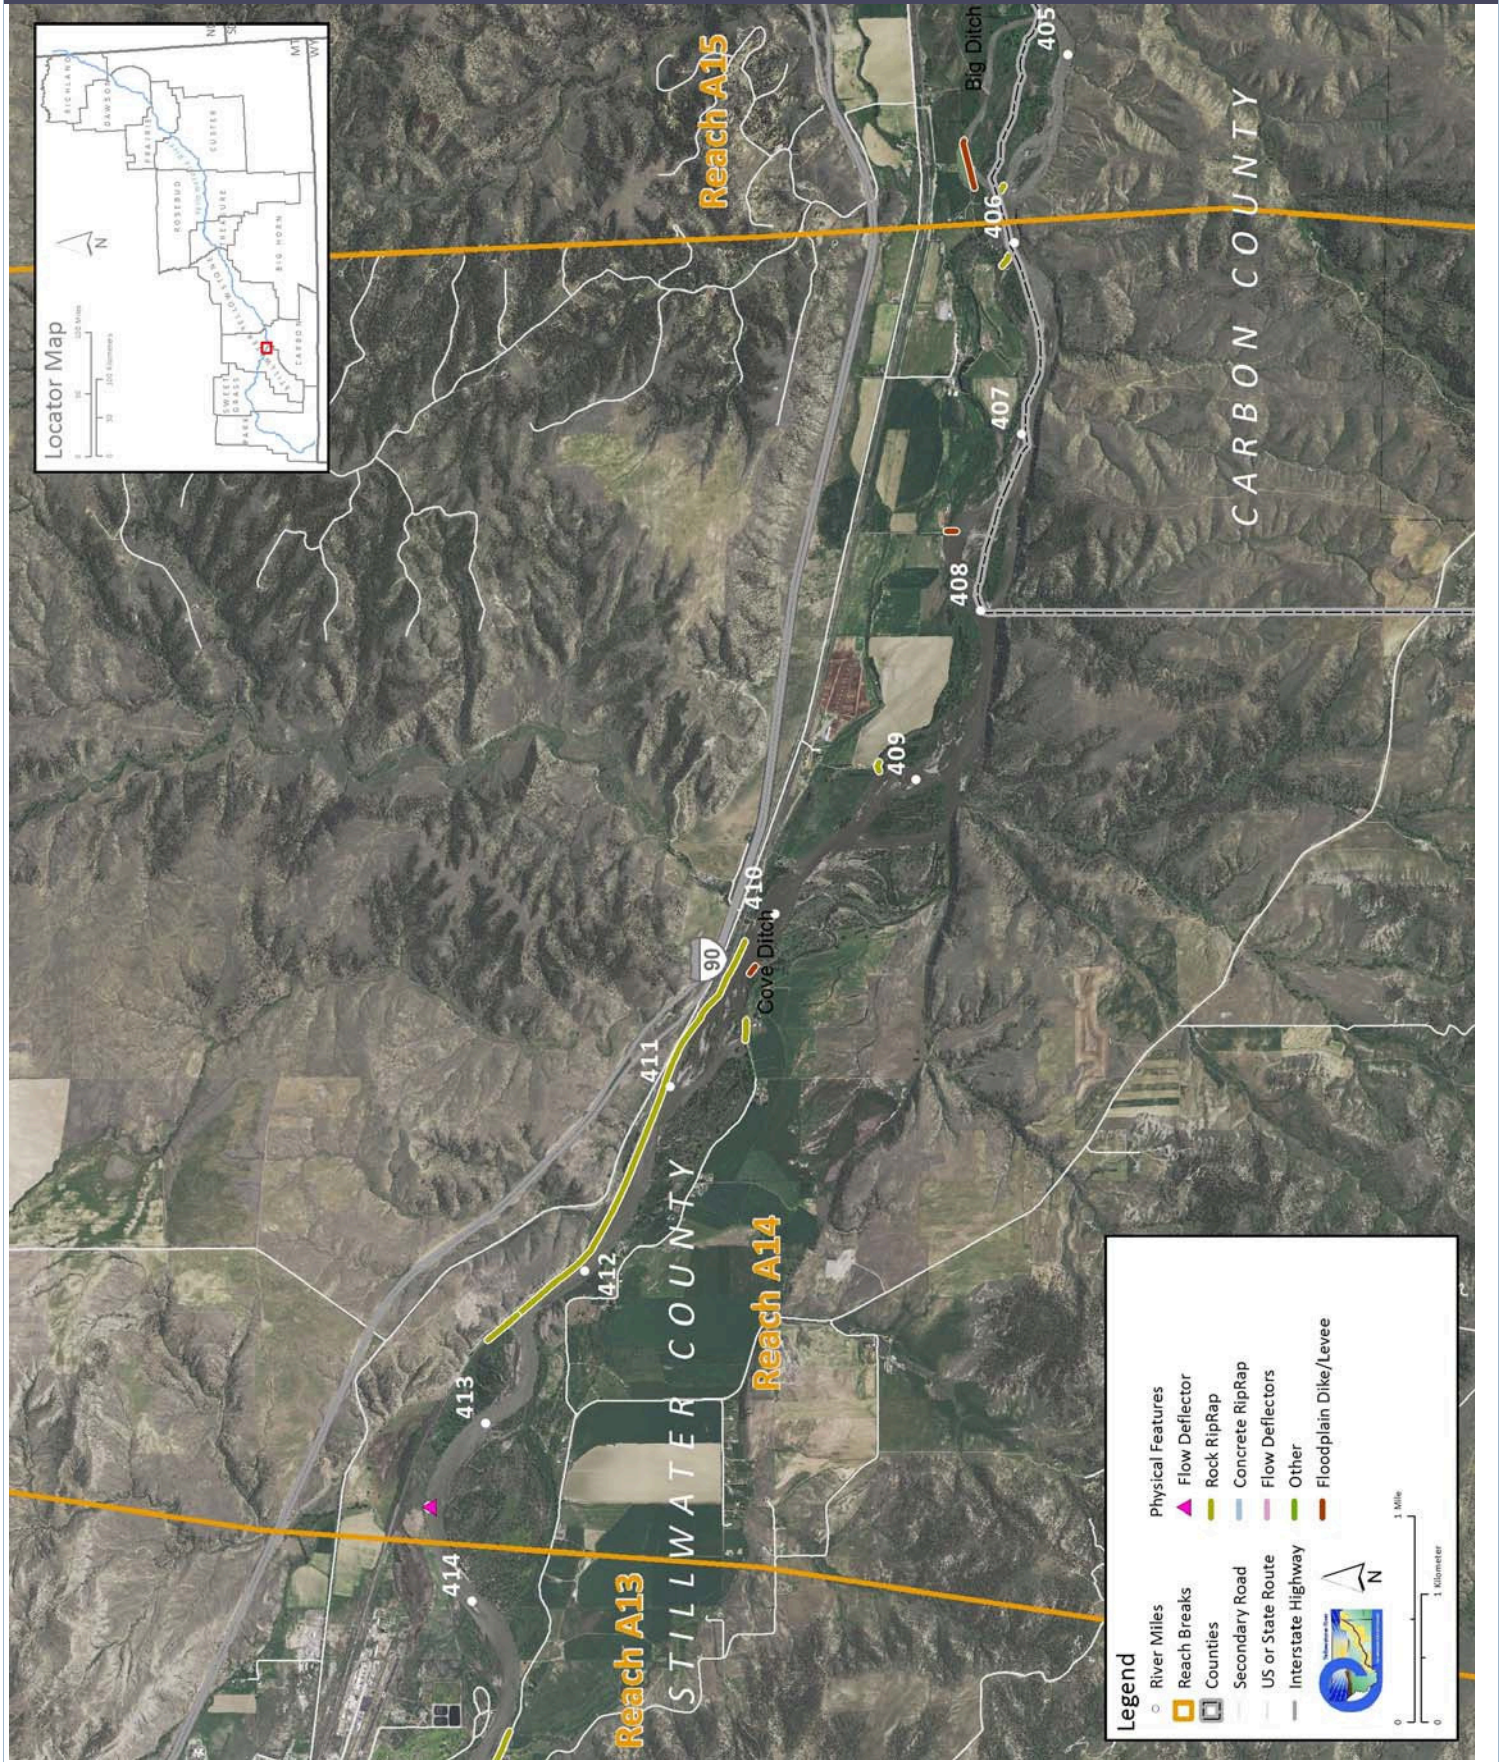
PHYSICAL FEATURES MAP (2011)

Approximately 16 percent of the bankline in Reach A14 is armored, and the armor is almost entirely rock riprap, with a very short section of flow deflectors. The armor is located almost entirely on the northern corridor margin, where transportation infrastructure (mainly railroad) follows the edge of the valley.

Over three miles of side channels have been blocked in Reach A14, with about half of the blockages occurring prior to 1950 and half after. The losses occurred on two distinct channels, one at RM 410 on the south side of the corridor and one at RM 407 on the north side.

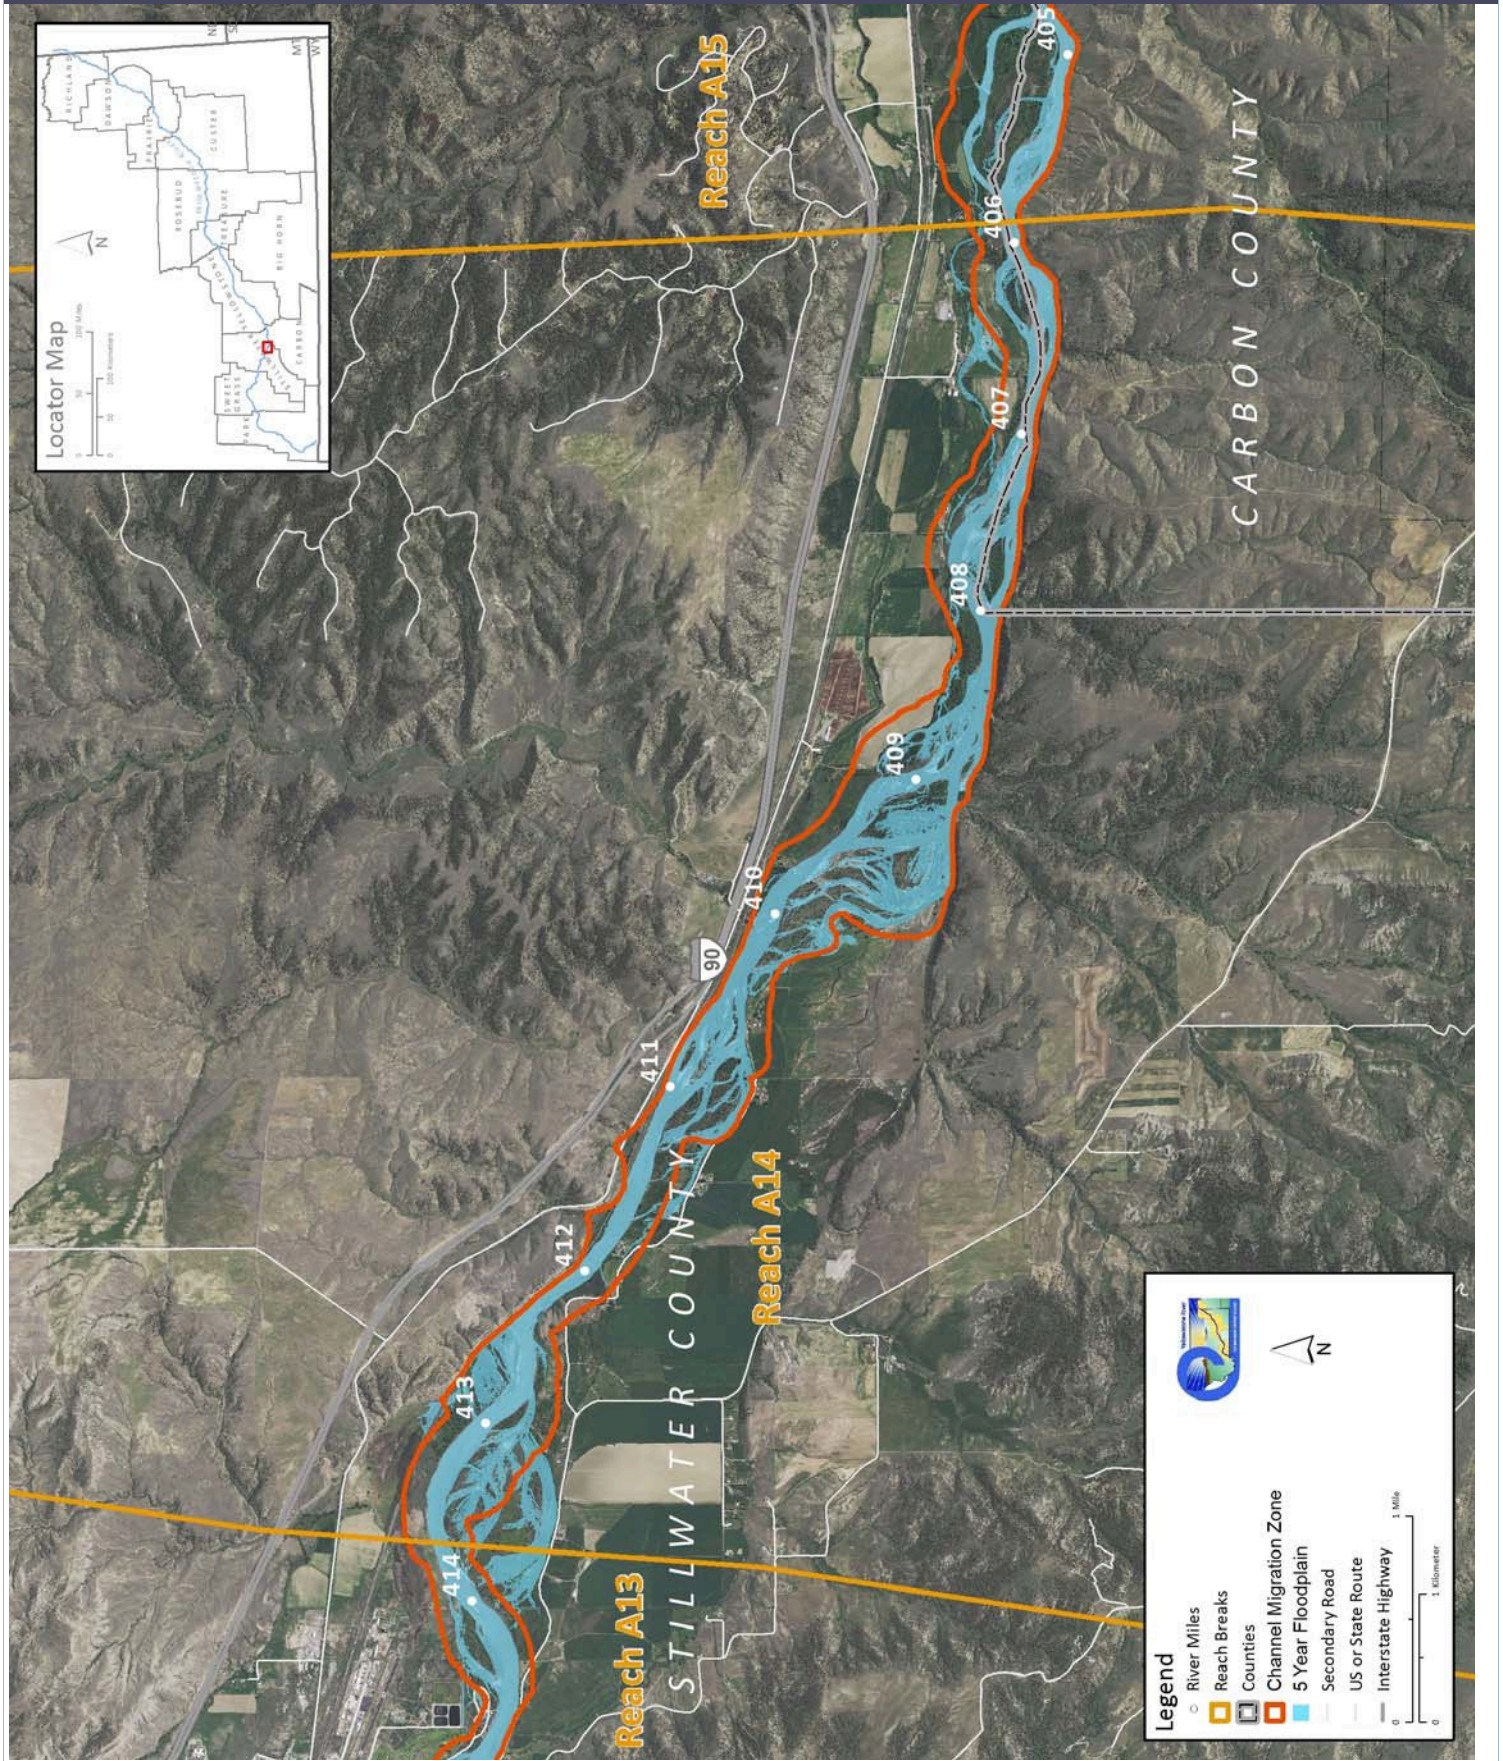
CHANNEL MIGRATION ZONE MAP

Change in Area '50 - '01 (Ac)						
Floodplain Isolation	Acres	% of FP	Floodplain isolation refers to area that historically was flooded, but has become isolated do to flow alterations or physical features such as levees.			
5 Year	40.7	13%				
100 Year	0.0	0%				
Restricted Migration Area	Acres	% of CMZ	Channel Migration Zone restrictions refer to the area and percent of the CMZ that has been isolated by features such as bank armor, dikes, levees, and transportation embankments.
