TECHNICAL MEMORANDUM

To: Peter Nielsen, Missoula County
From: Applied Geomorphology and DTM Consulting, Inc.
Date: December 15, 2009
In Regards To: Clark Fork River CMZ Pilot

This technical memorandum describes the development of a 100-year Channel Migration Zone (CMZ) map for the portion of the Clark Fork River that extends from the Bitterroot River confluence near Missoula downstream to Huson, Montana. The objective of this write-up is to summarize the project methodology and to provide some context regarding results. The CMZ map is provided as a separate .pdf document.

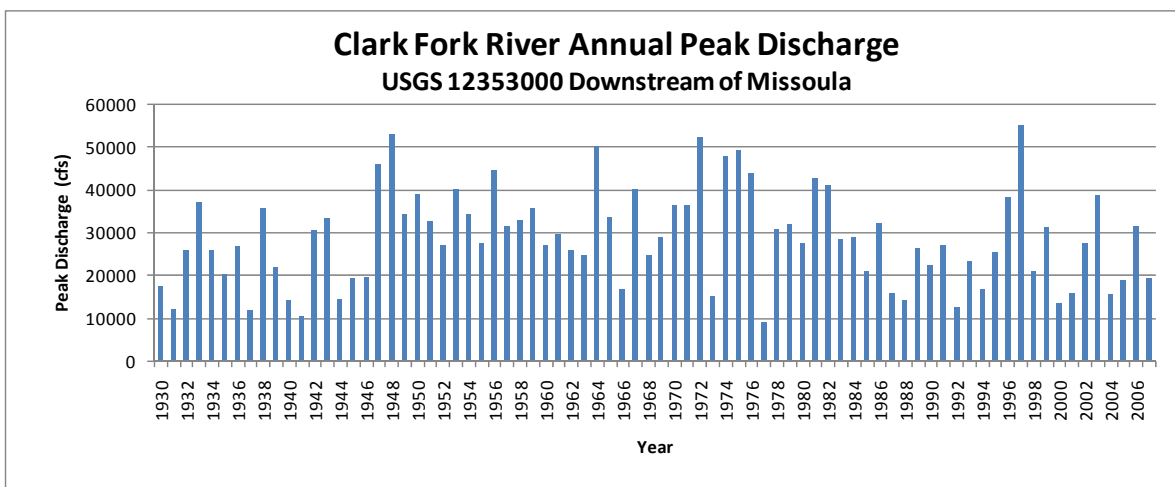
Figure 4. Annual peak discharges, Clark Fork River below Missoula, 1930-2007.

2005, discharges exceeded 50,000 cfs only in 1997 (55,100 cfs). This flood event occurred during a period of relatively low peak flows (typically <25,000 cfs) between the mid-1980's and 2007 (Figure 4).

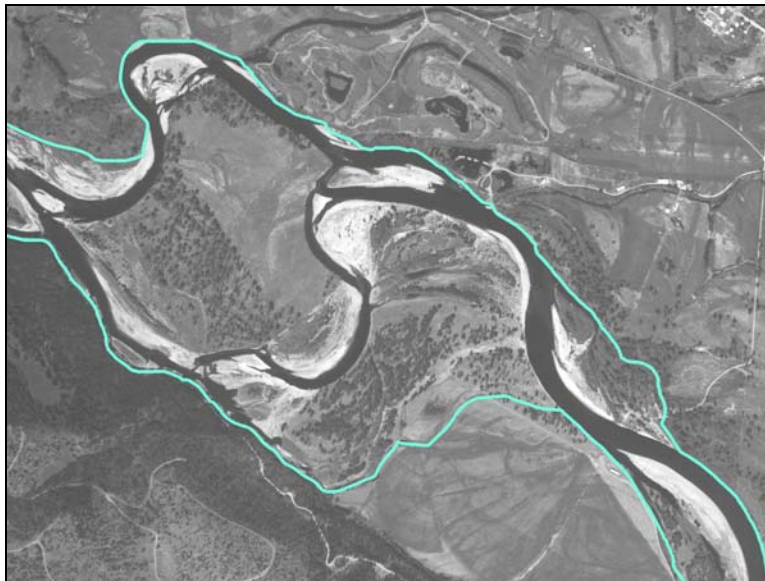
Figure 7. 2005 air photo showing the composite HMZ boundary.

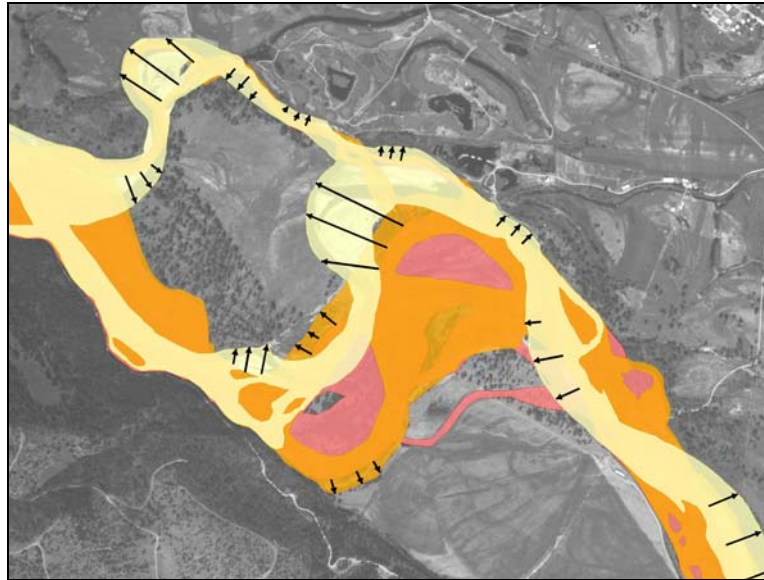
Figure 8. 2005 air photo and digitized bankfull polygons showing migration vectors, Reach 4 near Frenchtown (Pink=1955, Orange = 1972, and Yellow = 2005).

To determine the buffer distance, migration rates from 1955 to 2005 were measured throughout the corridor. A total of 126 measurements were made through the project reach (Figure 8). The rates were then statistically summarized by bendway and reach to approximate anticipated migration

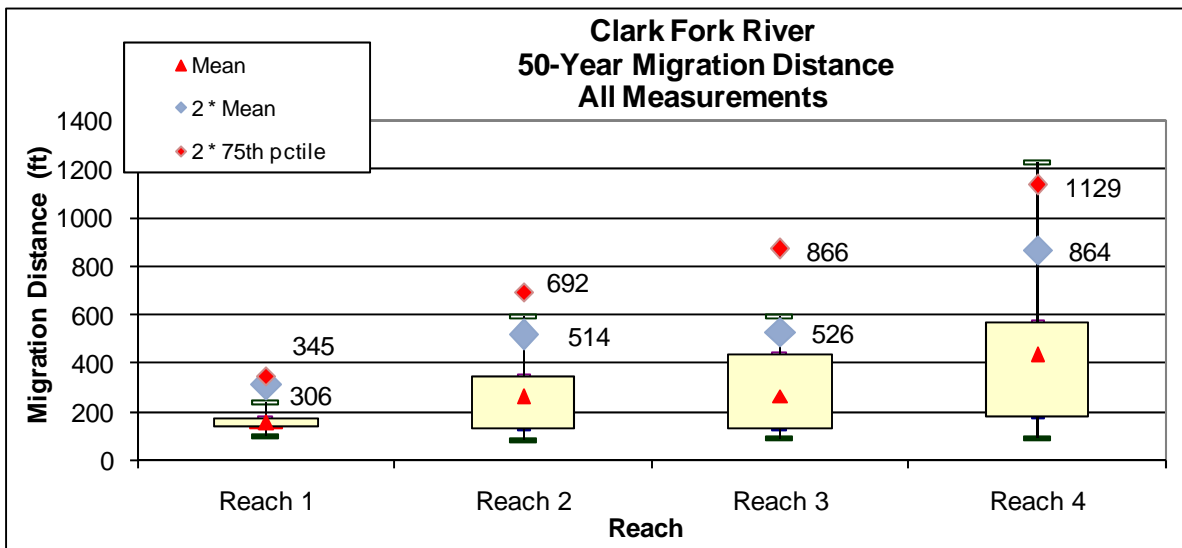
Figure 9. Box and whisker plot showing statistical summary of 50-year migration rate measurements; labeled values include twice the mean 50-year rate, and twice the 75th percentile value.

In order to address migration rate anomalies, a second buffer width has been calculated and applied on the maps. This width represents two times the 75th percentile value for each reach, which is somewhat larger than the 2 times mean value (Figure 9). Both of these buffers have been applied to the 2005 banklines on a reach scale through the project area. The buffers based on the mean measurements range from 306 feet in Reach 1 to 864 feet in Reach 4, and those based on the 75th percentile value range from 345 feet in Reach 1 to 1129 feet in Reach 4 (Table 4). Typically, other CMZ mapping efforts apply a buffer width derived from the mean migration distance. On the Clark Fork River, however, this value is less than the maximum migration distance measured historically. As such, if there is an expressed interest in applying buffers that are more inclusive and likely to capture localized areas of extreme erosion, the 75th percentile could be applied. Alternatively, application of the buffer based on mean migration rates should recognize that localized areas of extremely rapid erosion exist and these areas may locally exceed the limits of the CMZ in a 100-year time frame.

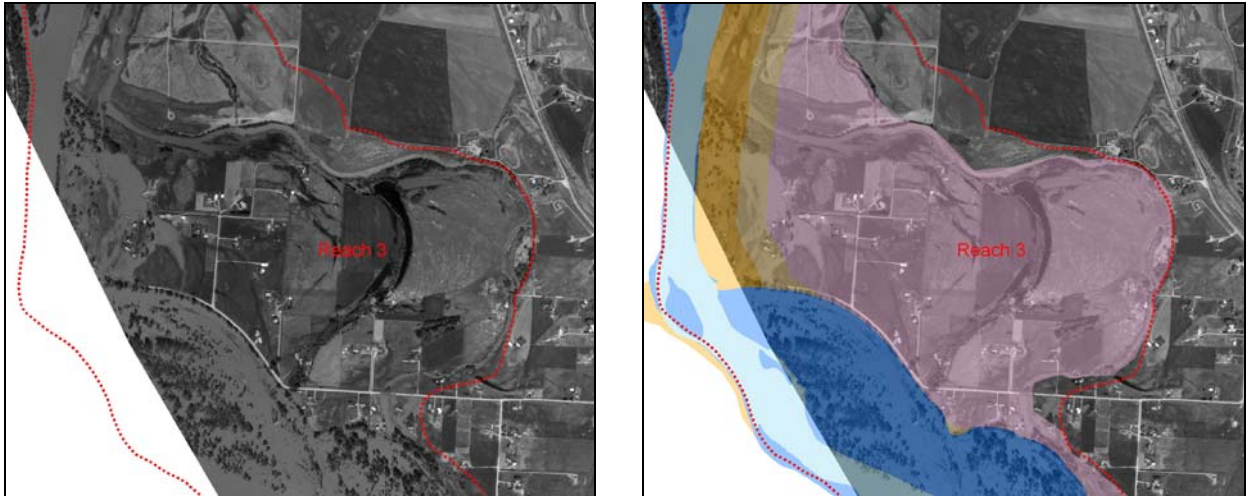
Figure 10. 1997 flood photo of portion of Reach 3 showing FEMA floodplain boundary (red dash) and channelized flow east of main river channel; resulting Avulsion Potential Area is shown on right.

1. Areas beyond the Historic Migration Zone and Erosion Buffer where flow paths captured on the 1997 flood imagery indicate channelized flow conditions and increased potential for channel formation and/or reactivation (Figure 10).
2. Floodplain swales that become proximal to the river in the event that the active channel migrates to the outer edge of the Erosion Buffer.
3. Areas where the floodplain slope will likely be steeper than the current channel slope in the event that the channel migrates to the edge of the Erosion Buffer.

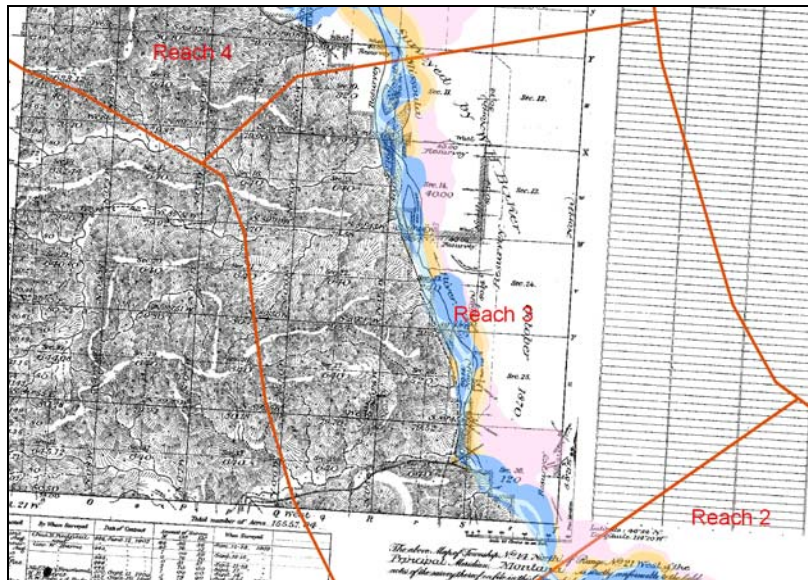
Figure 17. CMZ mapping over 1870 General Land Office Survey maps, Reach 3.

The General Land Office (GLO) Survey maps for the area were brought into the GIS to compare channel locations in the late 1800's to the CMZ boundaries. Results indicate that the CMZ boundaries effectively capture the channel conditions of 140 years ago (Figure 16 through Figure 18).
