December 31, 2017

Clear Creek – Tech Memo Channel Migration Mapping

Prepared for:

Ruby Valley Conservation District
P.O. Box 295
Sheridan, MT 59749

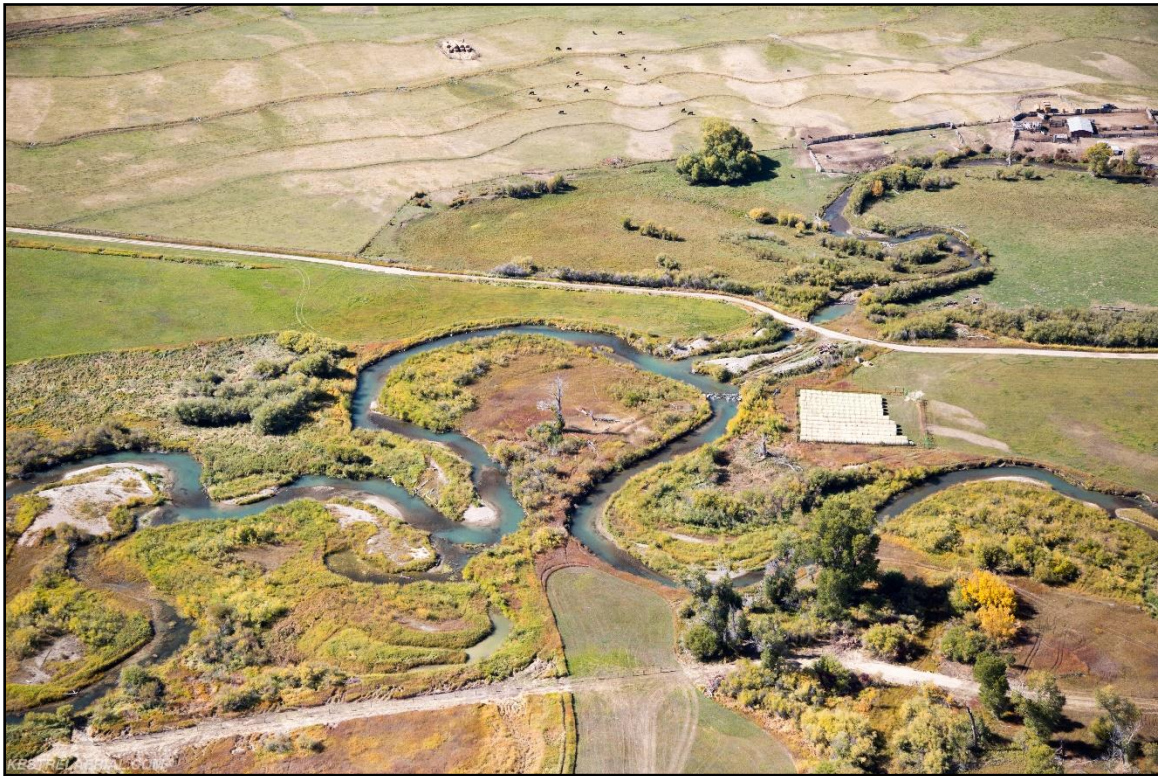
Figure 2. View west across Ruby River showing head of Clear Creek near road crossing at Judy Lane. (Kestrel)

Clear Creek runs parallel to the Ruby River for about 4.6 valley miles from its upstream diversion point above Judy Lane near Alder (Figure 2) to its confluence with the Ruby River due west of Bivens Creek Road. The Channel Migration Zone (CMZ) developed for Clear Creek covers this entire extent, which includes about 11 miles of stream channel.

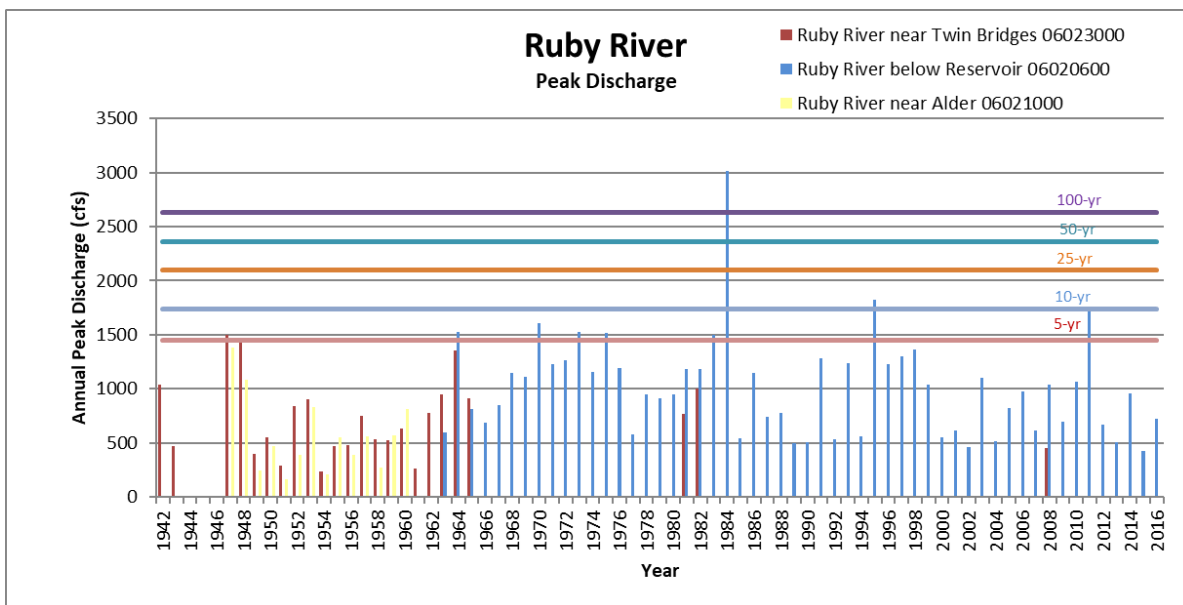
Figure 6. Annual peak discharges, Ruby River; flood frequency values are for the USGS 06020600 gage.

USGS stream gage data for the Ruby River exists at the reservoir outlet (USGS 06020600), near Alder (06021000), and near Twin Bridges (USGS 06023000) (Figure 6). These discontinuous flow records collectively depict the general flood history of the area. The gage at the reservoir has the most complete peak flow record, extending from 1963 to 2016. At this location, the 10-year discharge is 1,740 cfs and the 5-year flood is 1,450 cfs (www.mt.water.usgs.gov). Since 1962, the 100-year event has been exceeded once, on May 16, 1984, when the discharge measured at the gage was 3,010 cfs. This event, which is the flood of record on the Ruby River, exceeded the 200-year discharge of 2,900 cfs (www.mt.water.usgs.gov). This event has been associated with extensive flooding in the Missouri River basin due to intermittent heavy rainstorms that occurred during the months of May and June (NOAA, 2010).

The 10-year flood discharge (1,740 cfs) was exceeded only two times since 1962; the 1984 flood and in 1995, when the river peaked at 1820 cfs. The peak flow record on the Ruby generally shows that there have been few major floods below the reservoir since the mid-20th century.

It is important to note that there has been only one major flood on the Ruby River since the 1940s (Figure 6). The 2011 event peaked at 1,720 cfs, which is just under a 10-year event. The occurrence of 14 avulsions during that flood indicates that, in the event of a major flood on the Ruby River, substantial geomorphic change through both avulsion and bank migration should be expected.

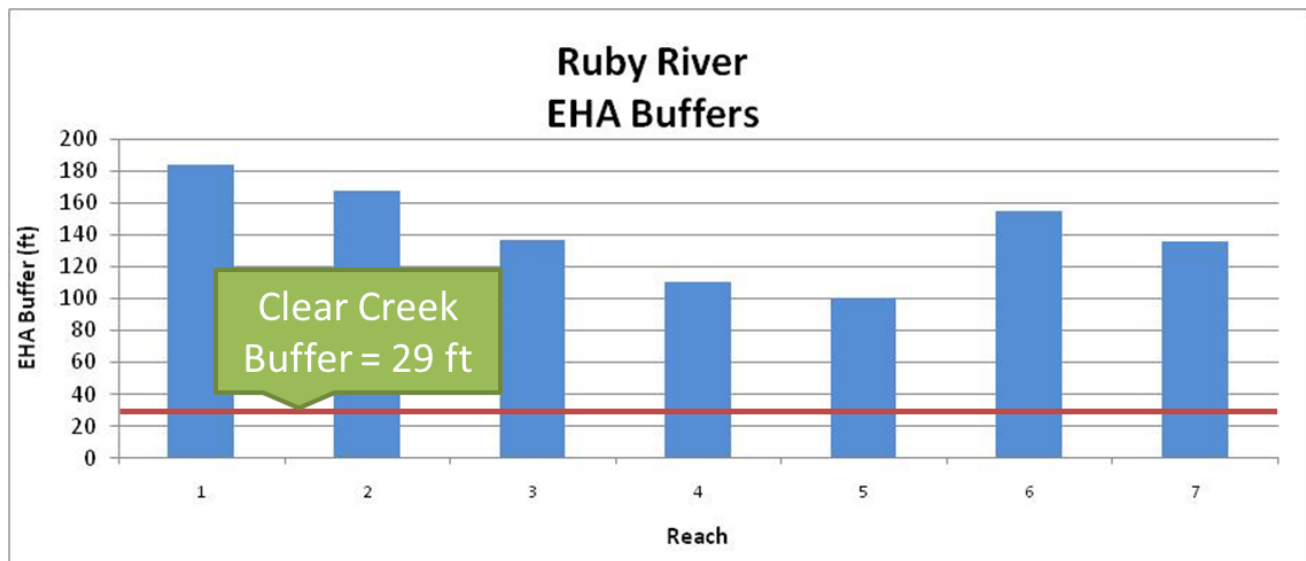
Figure 12. Clear Creek erosion buffer compared to Ruby River buffers.

Once the banklines were digitized, they were evaluated in terms of discernable channel migration since 1955. Where migration was clear, vectors (arrows with orientation and length) were drawn in the GIS to record that change. At each site of bankline migration, measurements were collected approximately every 25 feet (Figure 11). A total of 463 migration vectors were generated for Clear Creek at a scale of 1:1,500. As there were no logical reach breaks for the 11-mile length of Clear Creek, the channel was treated as a single reach. The average migration distance for the 60 years of record was 29 feet. This results in an annual migration rate of 0.48 feet/year, or a 100-year migration buffer of 48 feet, significantly lower than any of the buffers for the Ruby River reaches (Figure 12). This migration buffer was applied to the outside of the 2015 banklines to generate the Erosion Hazard Area (EHA)(Figure 13).

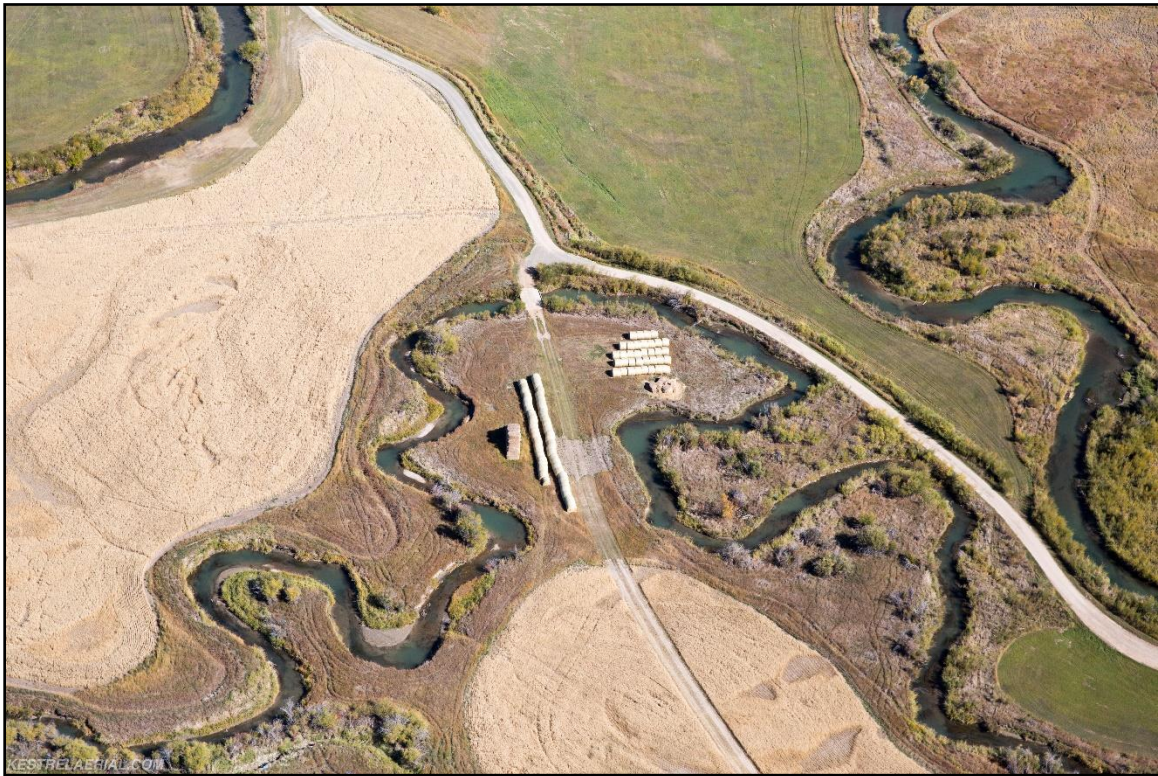
Figure 14. Intermittent bank armor on Clear Creek associated with roads, bridges, and fields. (Kestrel)

In 2012, the Natural Resource Conservation Service (NRCS) performed a detailed inventory of bank armor, channel features, and bank features for the Ruby River from the Ruby Dam, downstream to just above the Silver Spring Road Bridge. This inventory included Clear Creek (Figure 14). This data formed the basis for developing a bank armor data set for the Ruby River and Clear Creek. The NRCS inventory was supplemented below Silver Spring Bridge, and updated throughout the corridor, by reviewing more recent imagery in both GIS and Google Earth. The combined data was used to identify areas that may experience reduced channel migration due to their being behind bank armor. These areas are defined as Restricted Migration Areas (RMA) in the CMZ mapping (Figure 15).
