# Flathead River Channel Migration Zone Mapping

**Final Report**

**November 18, 2010**

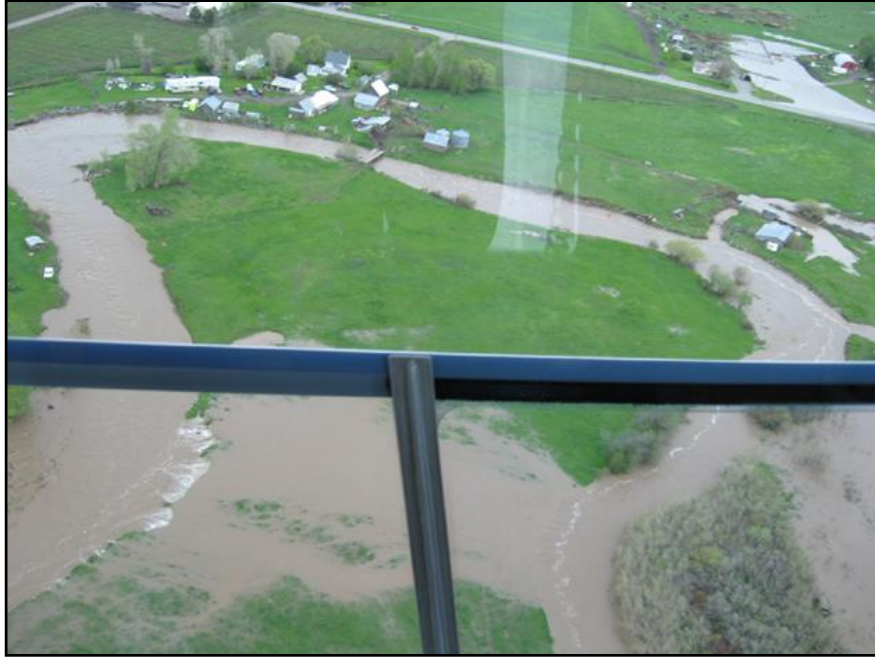
**Figure 7. Example of the avulsion process, East Gallatin River May 2008 (DNRC).**

The process of channel avulsion via development of chute cutoff is shown in Figure 7. This photo was taken from a helicopter by Montana Department of Natural Resources and Conservation (DNRC) staff during the 2008 flood on the East Gallatin River. The photo shows a typical bendway on the East Gallatin River, with floodwaters flowing over the core of the bend. On the downstream end of the bend (left side of photo), the overflows re-enter the main channel over a steep bank edge, creating a headcut. If the flood is large enough or long enough, the headcut will migrate up-valley through the core of the bend and excavate a cutoff channel. On this particular bend, the flood dissipated before cutoff occurred, resulting in a “failed avulsion”.

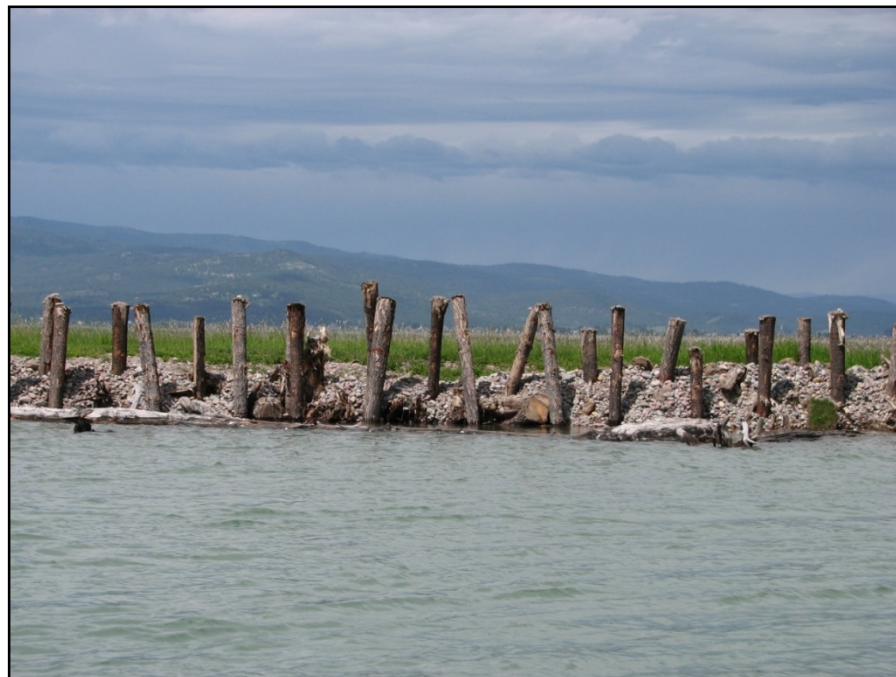
Figure 13. “Bush bundle” project installation near mouth of Flathead River.

Manipulation of water levels at Kerr Dam, on the Flathead River south of Flathead Lake, seasonally increases the lake level relative to its natural outlet elevation, and impounds water in the lowermost section of the project reach. Moore et. al. (1982) mapped a progressive loss of the delta expression through time (Figure 12), and recent erosion rates on the North Shore of Flathead Lake have been attributed to storm-generated waves and estimated at three feet per year (Devlin, 2007). Currently, erosion is a primary concern at the mouth of the river, as evidenced by several implemented erosion control projects including an extensive right bank gravel/wood “bush bundle” project that was designed to trap fine sediment and drive accretion, and enhance riparian vegetation densities on the banks (Figure 13; Devlin, 2007).

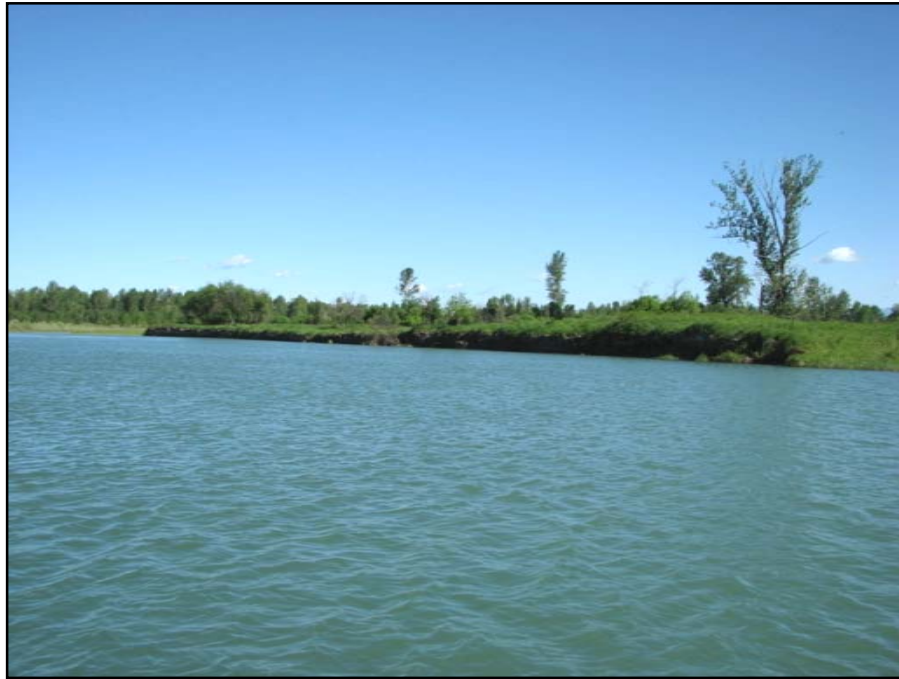
**Figure 14. Relatively long eroding bankline, Flathead River.**

The Flathead River exhibits a complex mosaic of erosion processes due to the overlapping influences of fluvial erosion, saturated bank failure, and wave-induced erosion. In some cases, sites experiencing fluvial erosion are hundreds of feet long (Figure 14). In other situations, severe local erosion in an otherwise stable bank creates discreet scallop-shaped failures (Figure 15). These failures commonly occur along armored banklines, suggesting toe failure of the armor (Figure 16). In some cases these erosion sites correlate to meander scroll features that have been dissected by the modern channel course (Figure 17). Undercutting at the bank toe and topple failure of the upper bank is common (Figure 18).

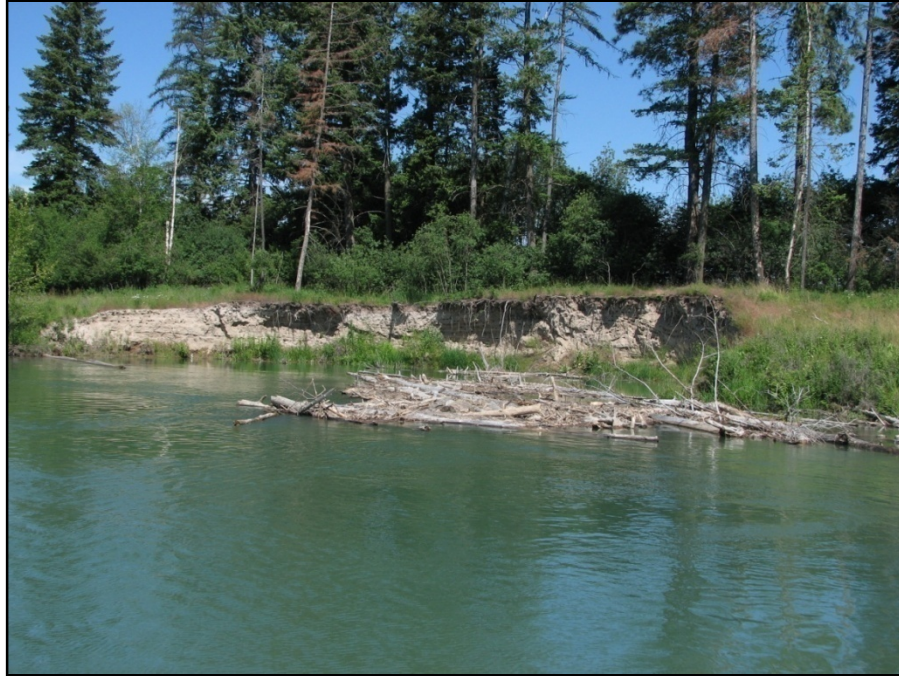
**Figure 15. Localized severe erosion, Flathead River.**

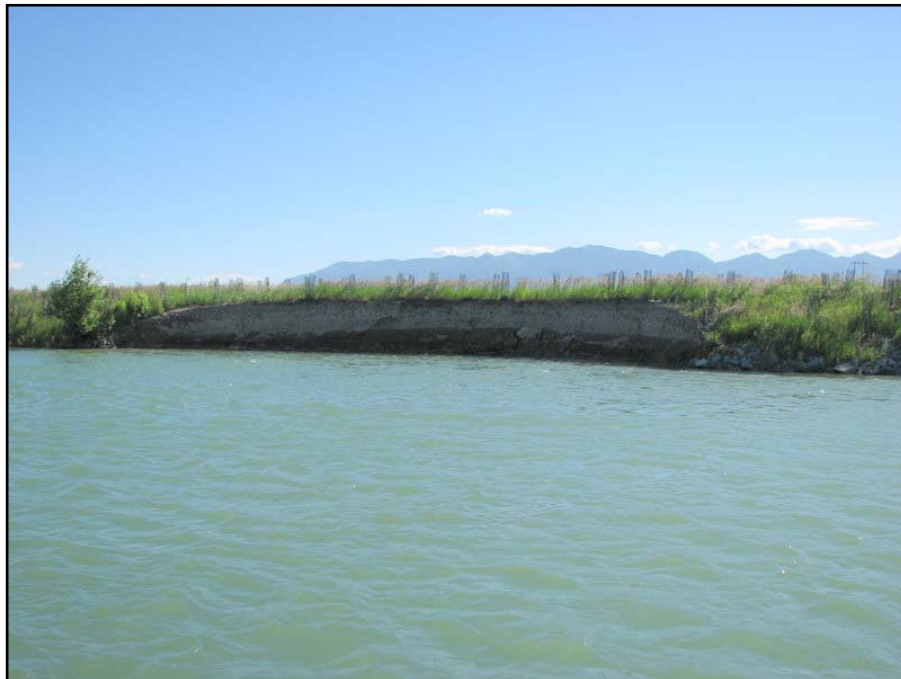
**Figure 16. Severe scallop erosion of previously-armored bank, Flathead River.**

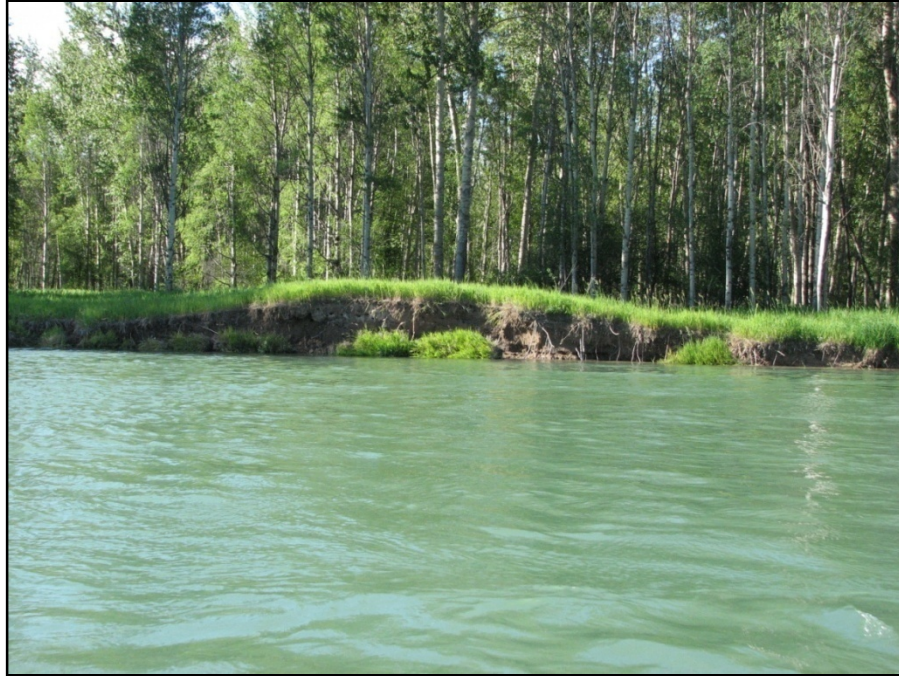
**Figure 17. Cross sectional view of eroding meander scroll deposit.**

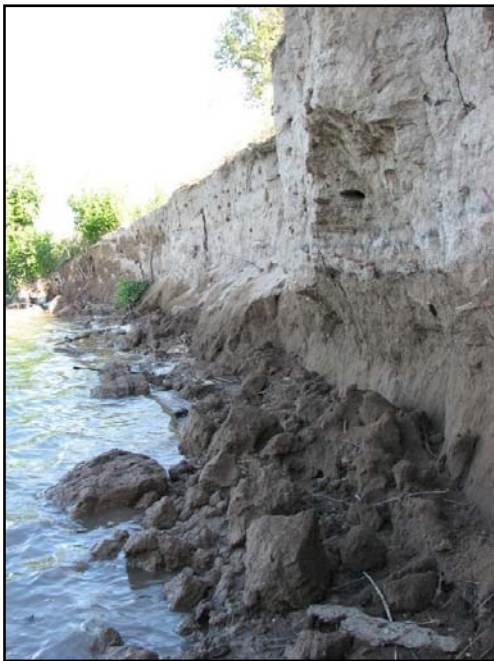
**Figure 18. Lower bank undercutting, Flathead River.**

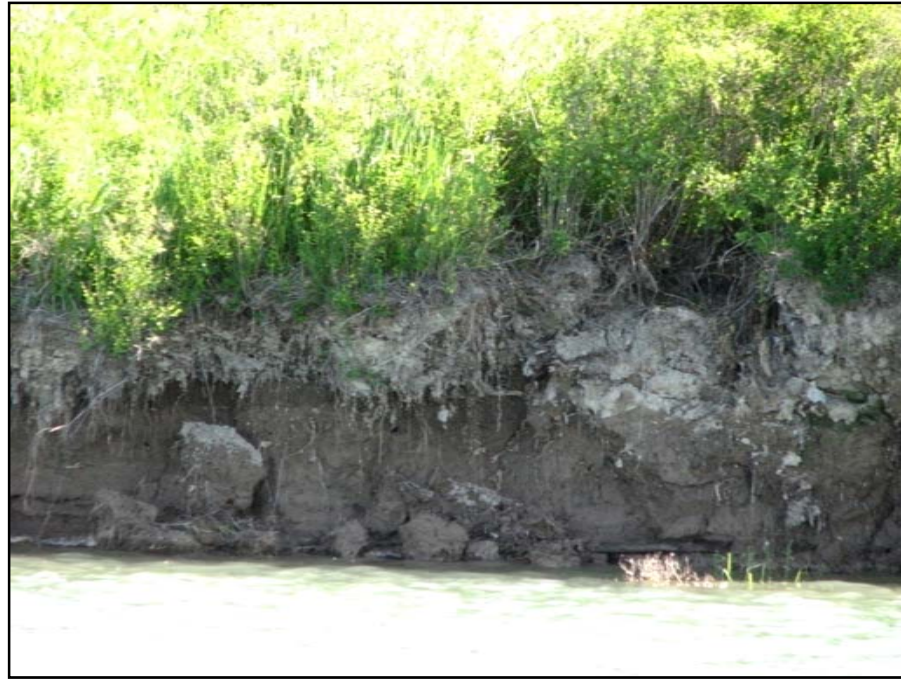
**Figure 19. Saturated bank failure, Flathead River.**

Some bank failures within the project reach appear to be driven by gravitational failure of saturated banks (Figure 19). The exposure of saturated banks could be due to rapid changes in river stage, changes in lake level elevation, or floodplain irrigation.

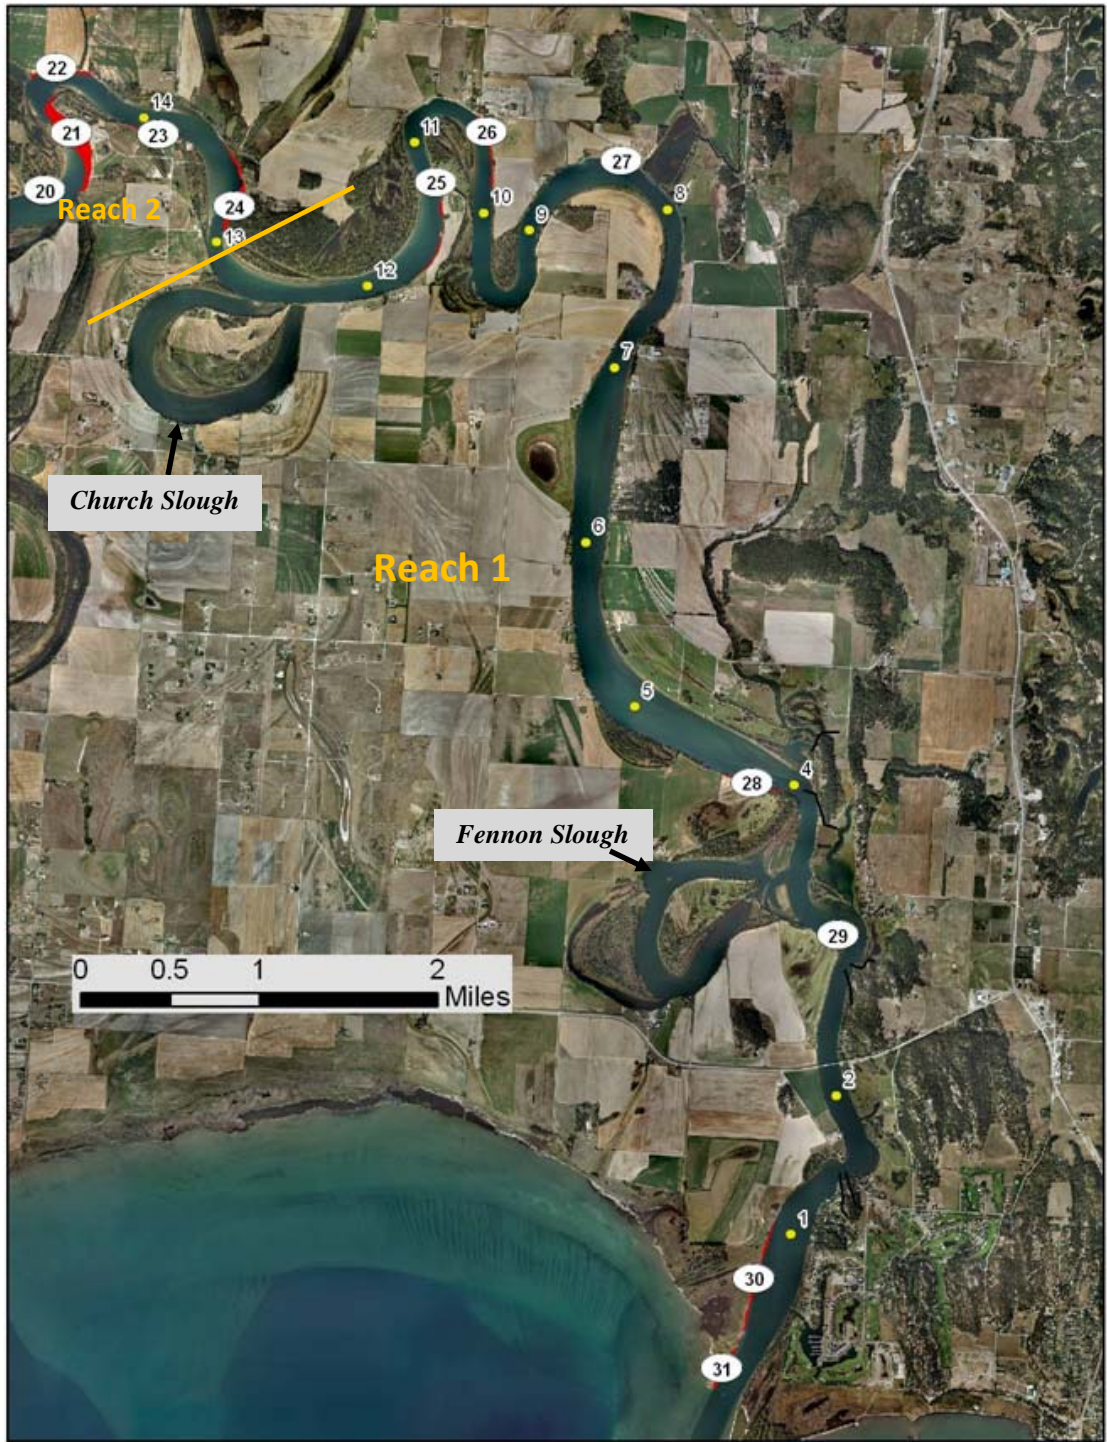
Figure 22. 2009 air photo of Reach 1, showing numbered erosion sites used in CMZ analysis.

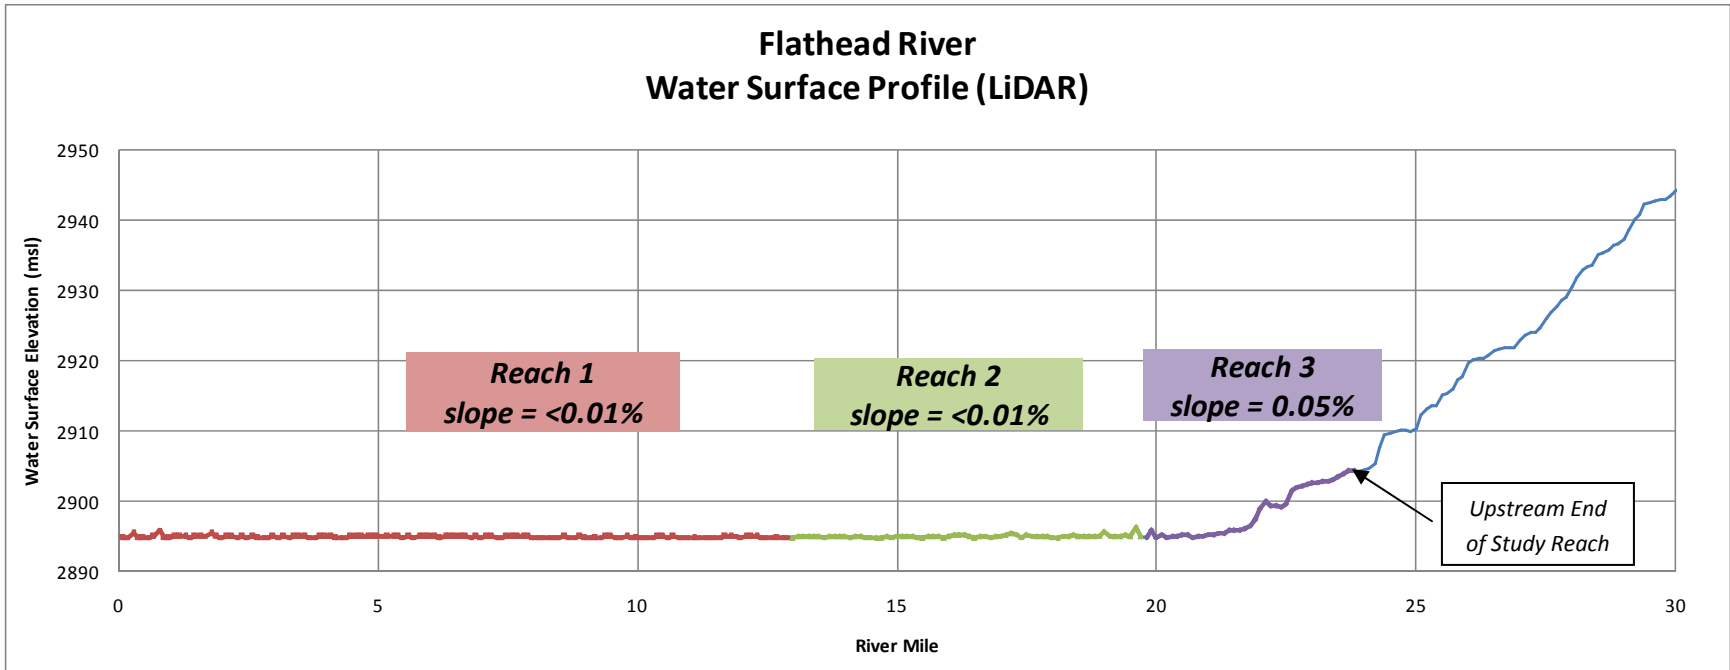
Figure 25. Water surface profile of project reach derived from the resampled 6-foot LiDAR elevation dataset.

The typical high pool elevation in July of 2892.8 feet is lower than the elevation shown at the mouth of the river on the LiDAR-derived profile (2895 ft; Figure 25). This reflects a difference in datums for each data source, so their elevations are not directly comparable.

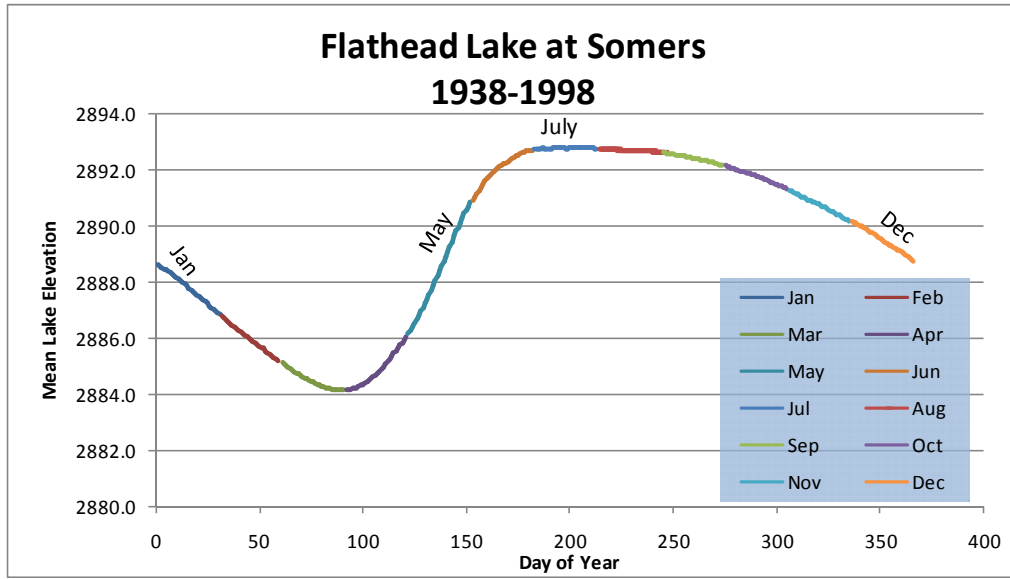
**Figure 28. Mean daily elevation of Flathead Lake as measured at Somers for post-Kerr Dam conditions, 1938-1998.**

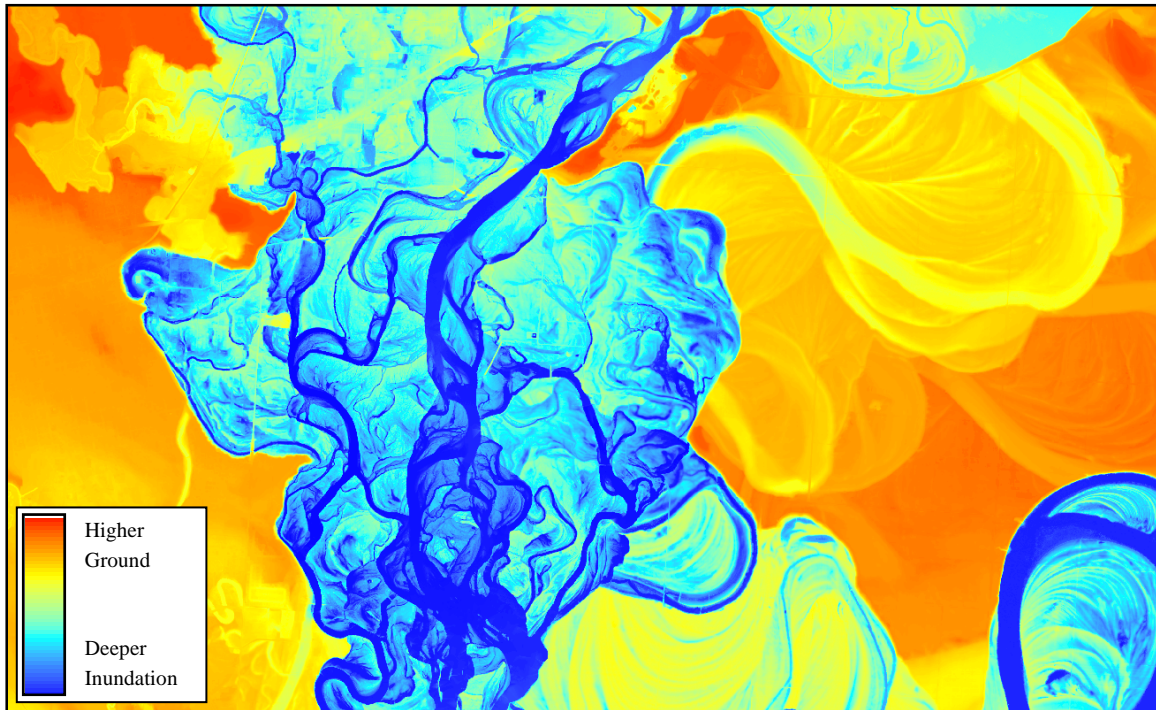
**Figure 36. Inundation modeling output based on LiDAR topographic data, Reach 3.**

represent potential water depth (Figure 36). The use of inundation modeling results in this study is described in more detail in Section 4.4.

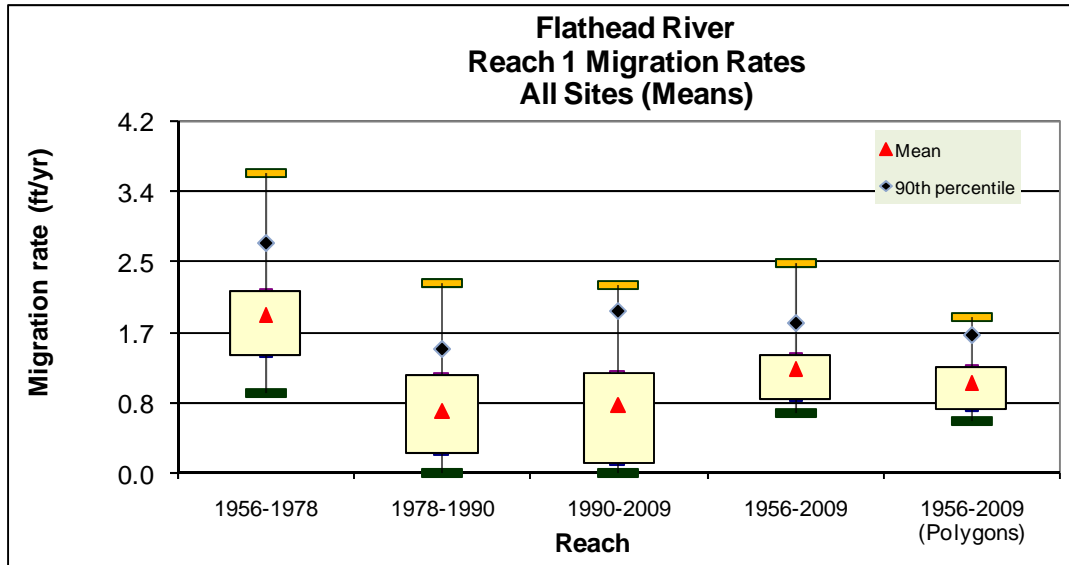
**Figure 39. Reach 1 migration rates by timeframe.**

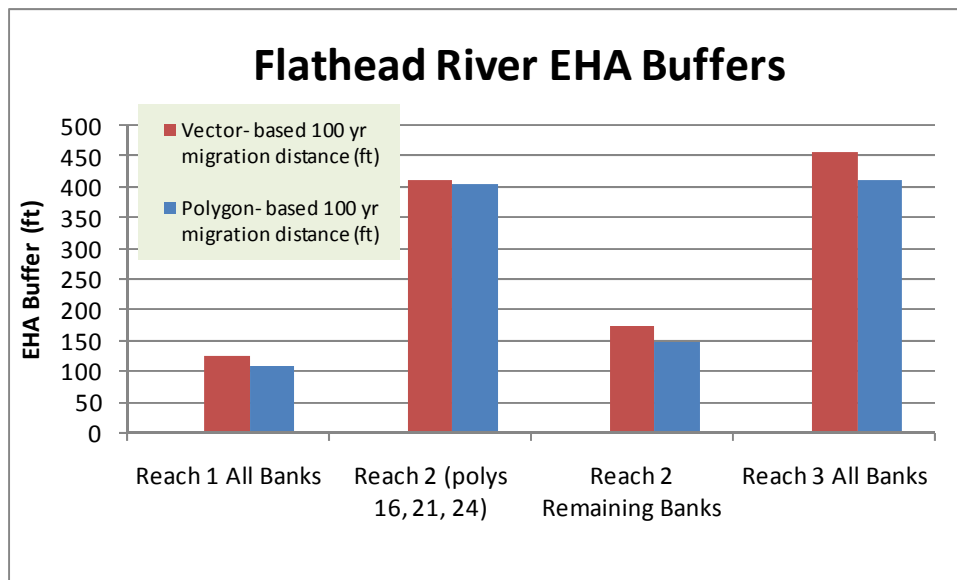
**Figure 46. EHA buffer plot showing differences derived from vector and polygon approach.**

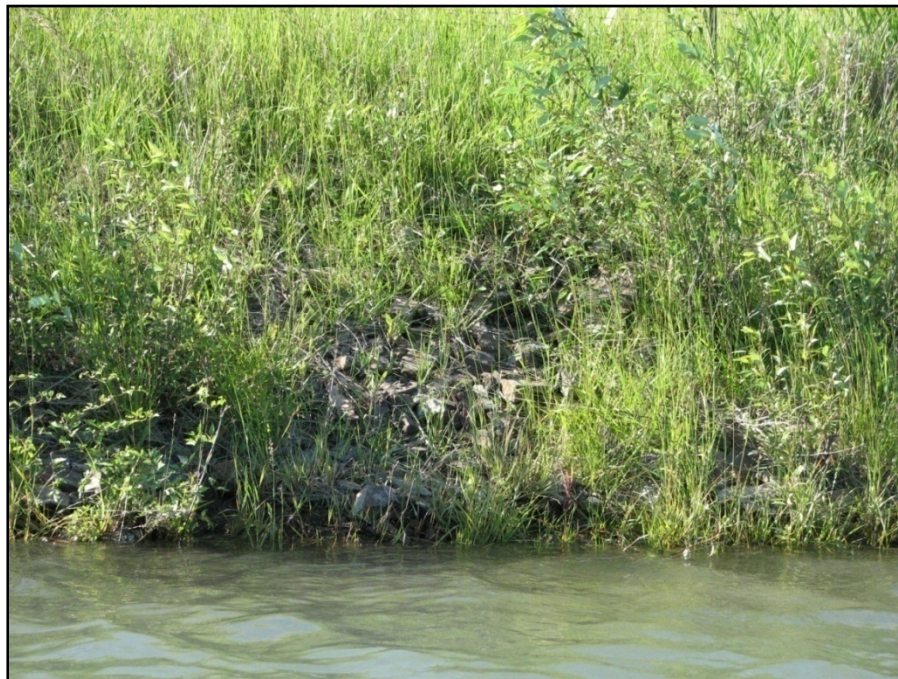
**Figure 48. Quarried rock revetment obscured by vegetation, Flathead River.**

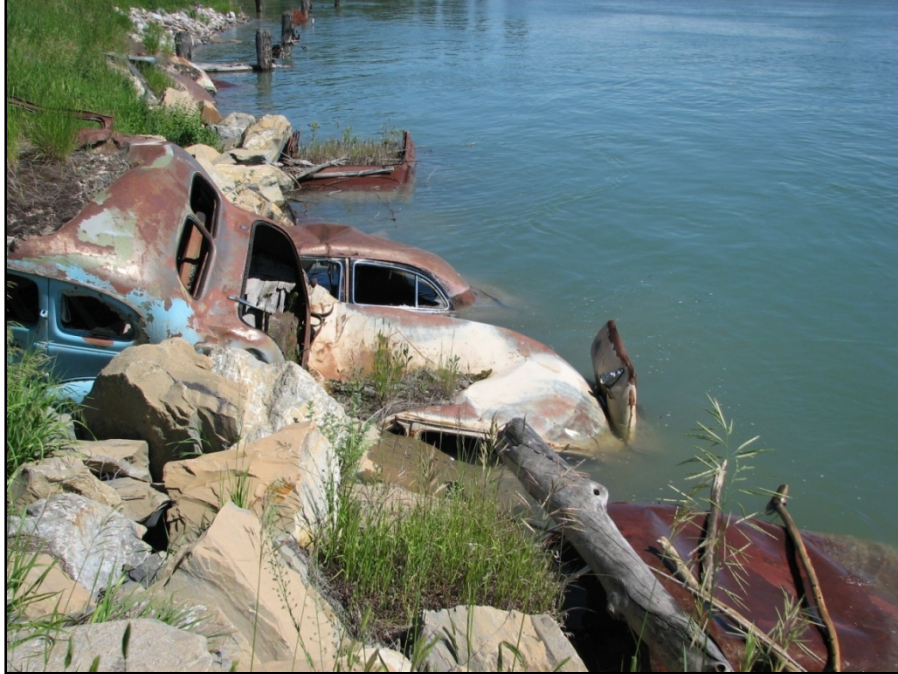
**Figure 49. Typical car revetment, Flathead River; note pilings in background from failed COE wood plank revetment.**

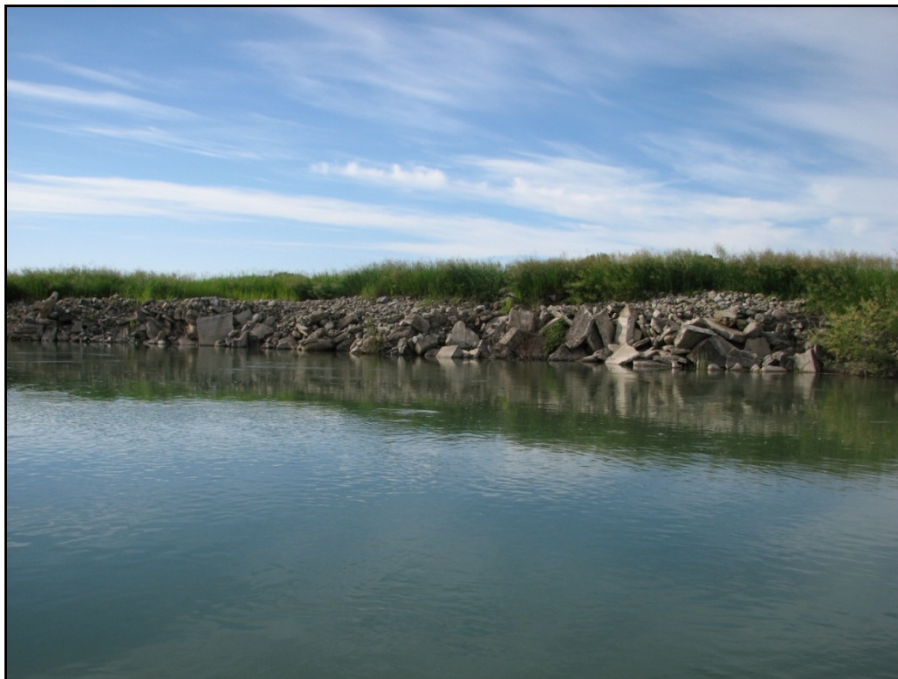
**Figure 50. Typical concrete rubble revetment, Flathead River.**

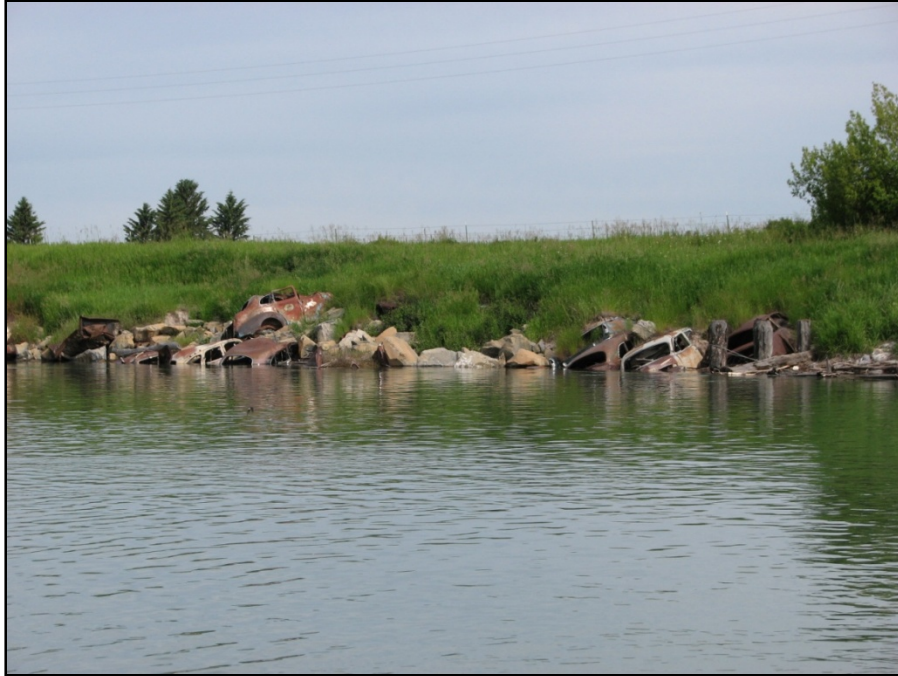
**Figure 51. Rock riprap reinforcement over older car body revetment.**

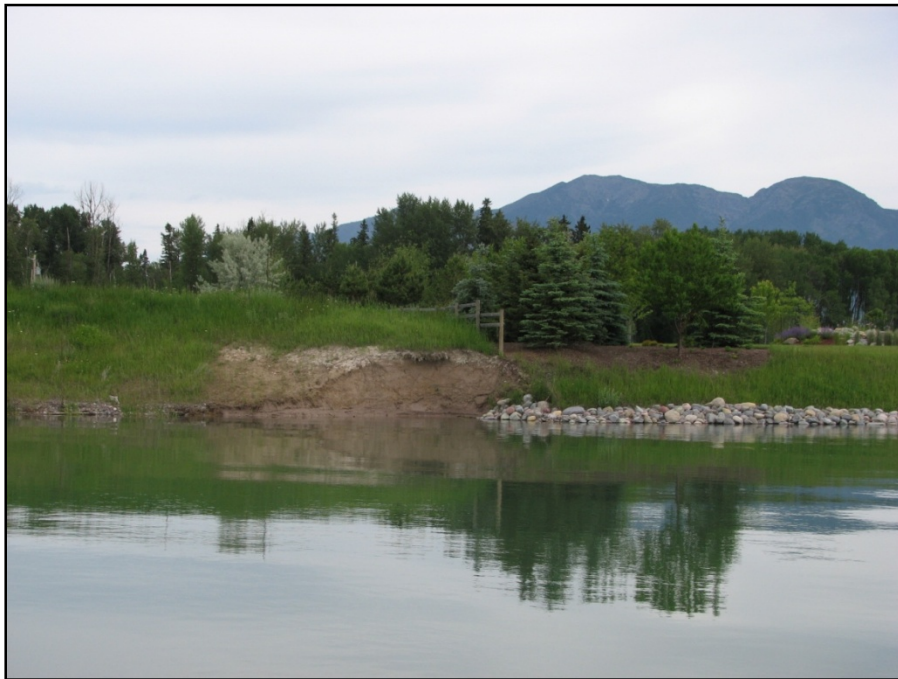
**Figure 52. Boulder armor and local erosion, Flathead River.**

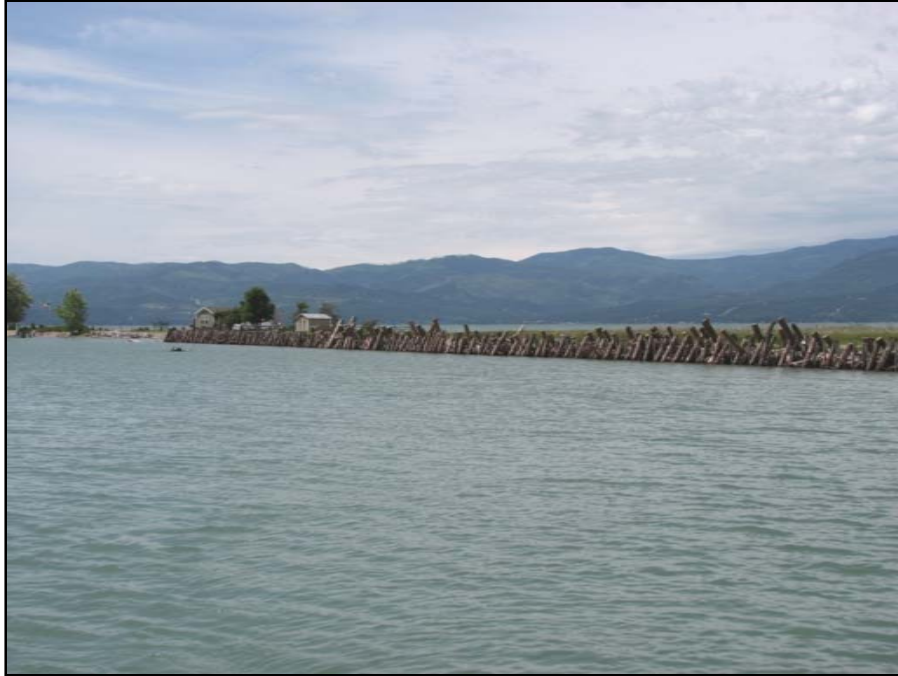
**Figure 53. Bush bundles, Flathead River.**

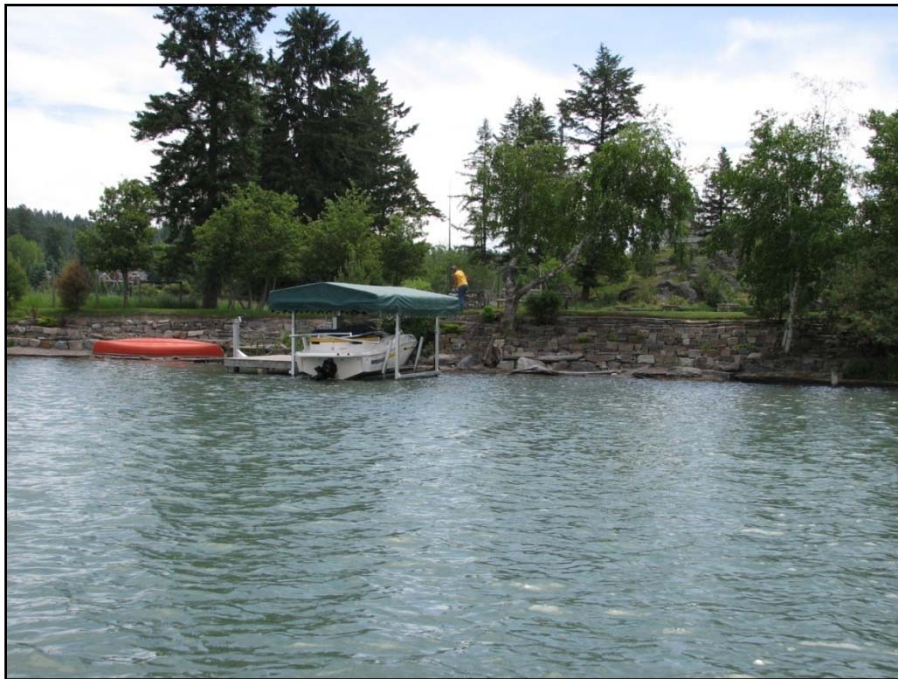
**Figure 54. Stone wall revetment, Flathead River.**

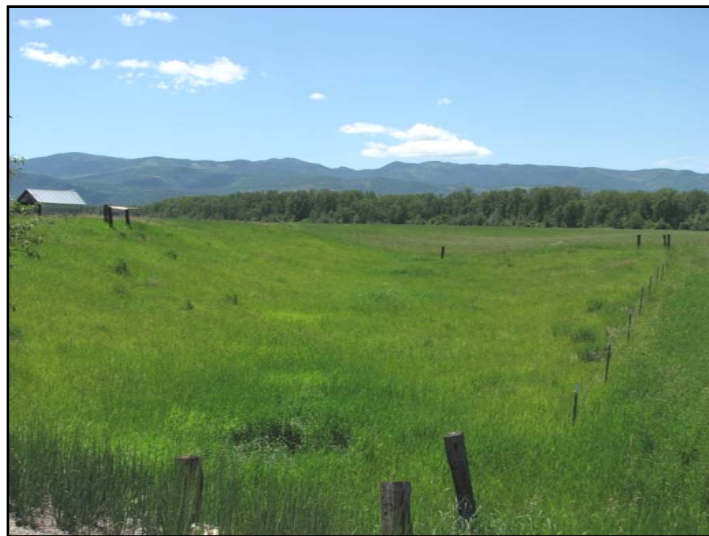
**Figure 56. Floodplain swale, Flathead River.**

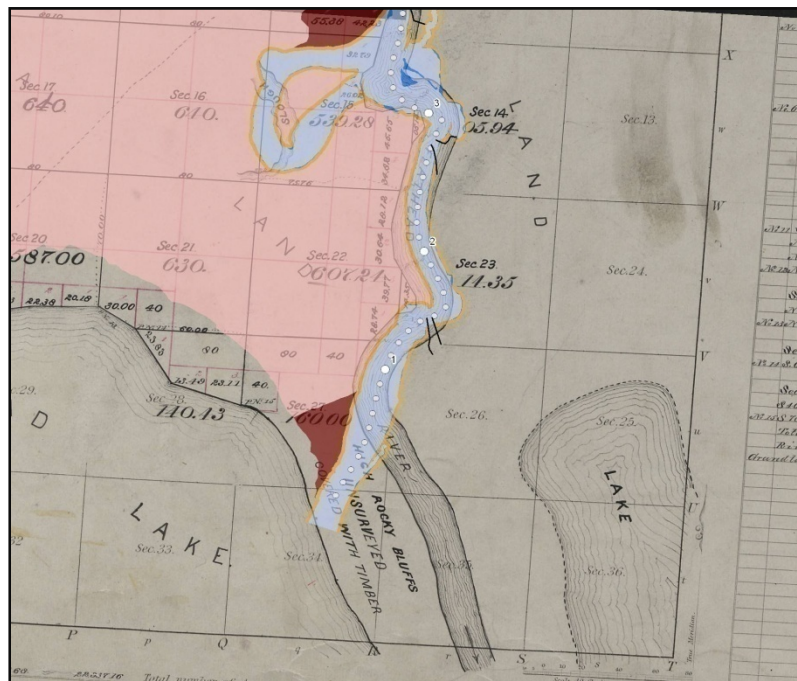
Figure 61. CMZ map overlay on General Land Office Survey Map, lower portion of Reach 1.

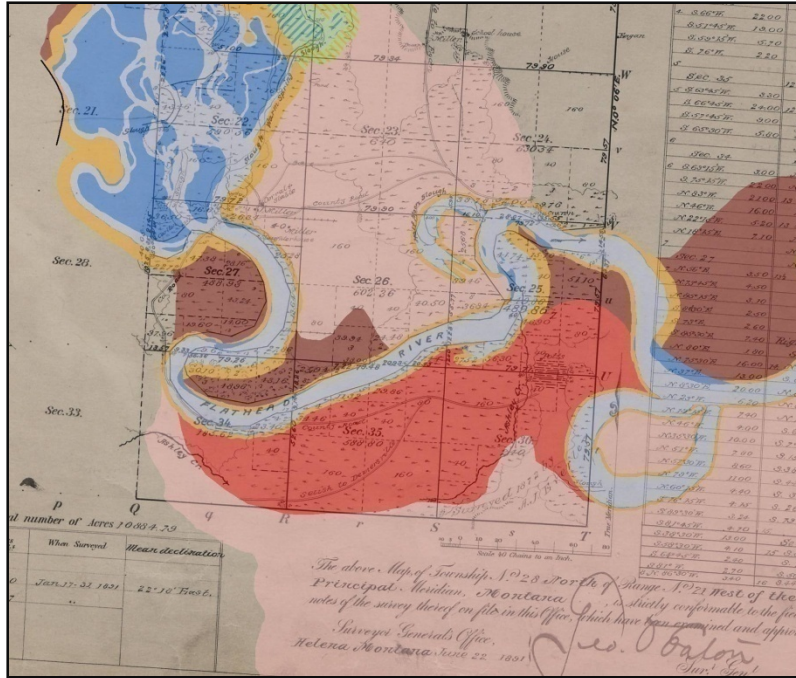
Figure 62. CMZ overlay onto General Land Office Survey Map, Reach 2.

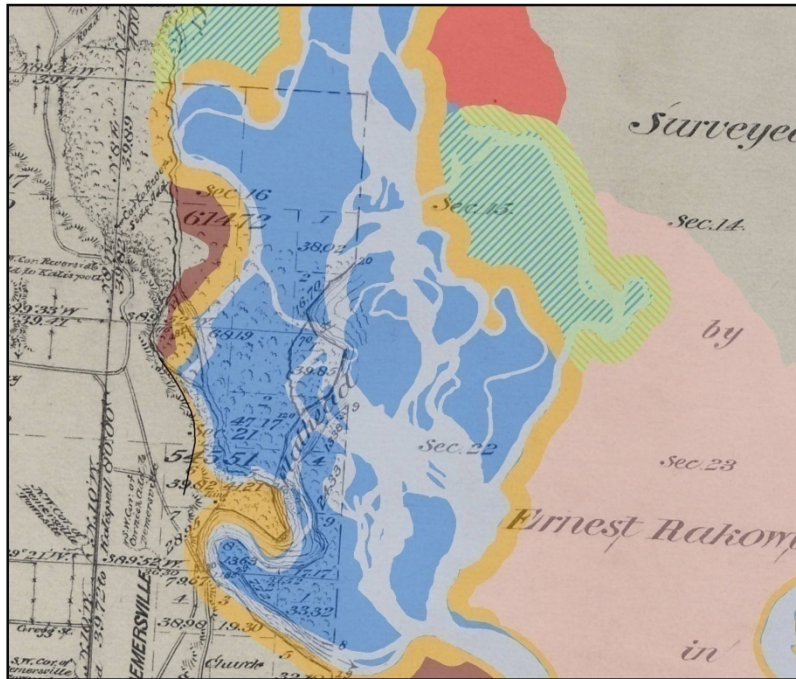
Figure 63. CMZ overlay onto General Land Office Survey Map, Reach 3.
