December 31, 2017

Gallatin River Channel Migration Mapping

Karin Boyd
Applied Geomorphology, Inc.
211 N Grand Ave, Suite C
Bozeman, MT 59715

Tony Thatcher
DTM Consulting, Inc.
211 N Grand Ave, Suite J
Bozeman, MT 59715

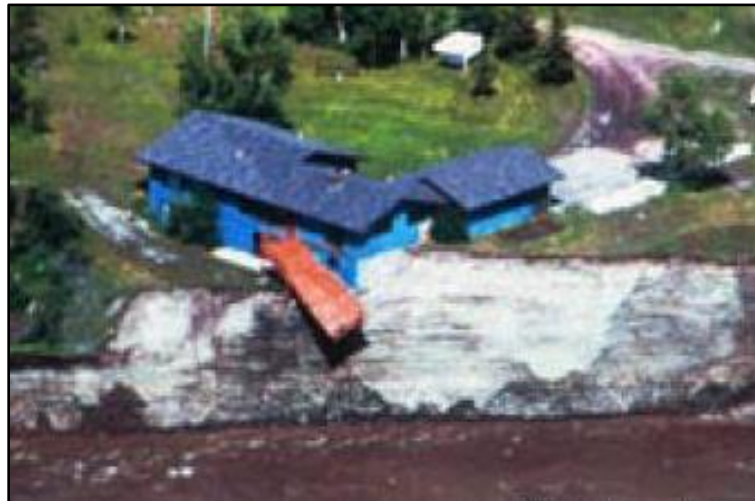
Figure 4. Yellowstone River home on high glacial terrace that was burned down in 1997 to prevent its undermining by the river.

Figure 4 shows a property on the Yellowstone River in Park County that was progressively undermined during the 1996-1997 floods, prompting the owner to burn it down to prevent any liability associated with the structure falling into the river. This has been a chronic problem in river management, as landowners assume that if their home is beyond the mapped floodplain margin, it is removed from all river hazards. After experiencing massive 2005 flood damages in Saint George Utah (Figure 5), several property owners reflected on this issue (www.Utahfloodrelief.com):

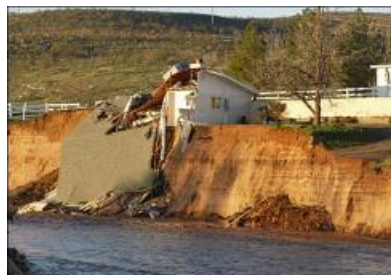
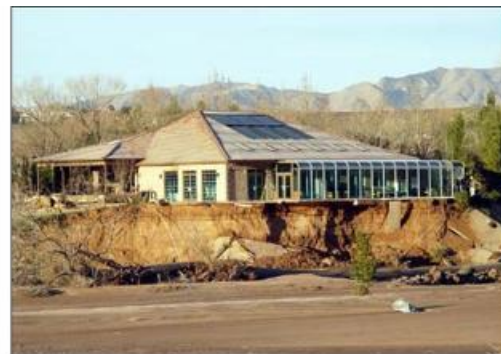
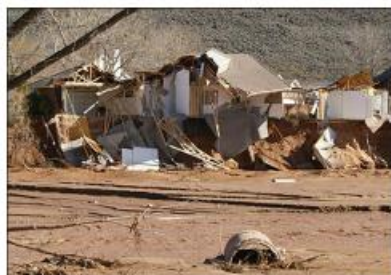
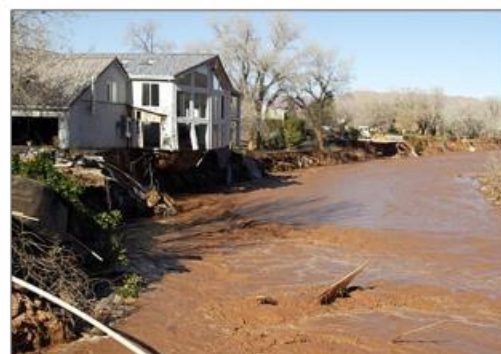
Figure 5. Photos from a 2005 in Saint George Utah, where homes several feet above the mapped floodplain were destroyed by channel migration (www.Utahfloodrelief.com).

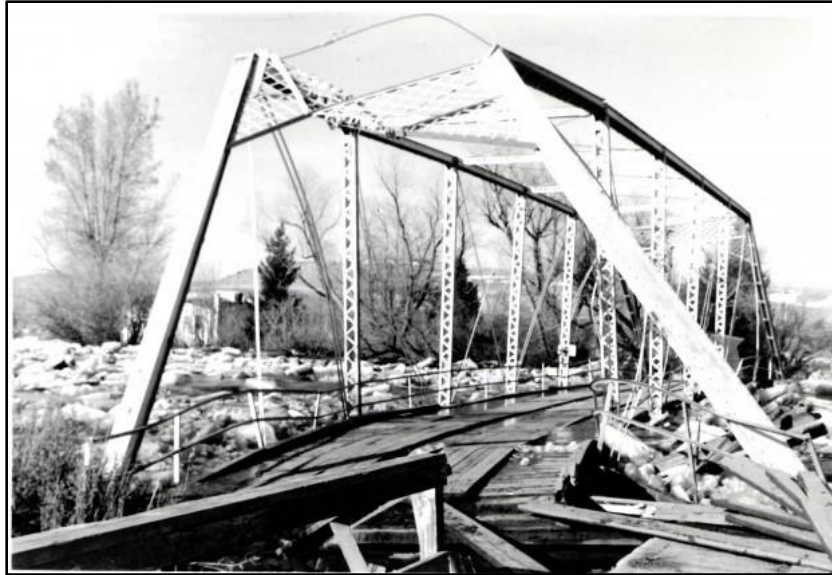
Figure 8. Bridge damage caused by 1963 Ice jam on Gallatin River near Logan (billingsgazette.com).

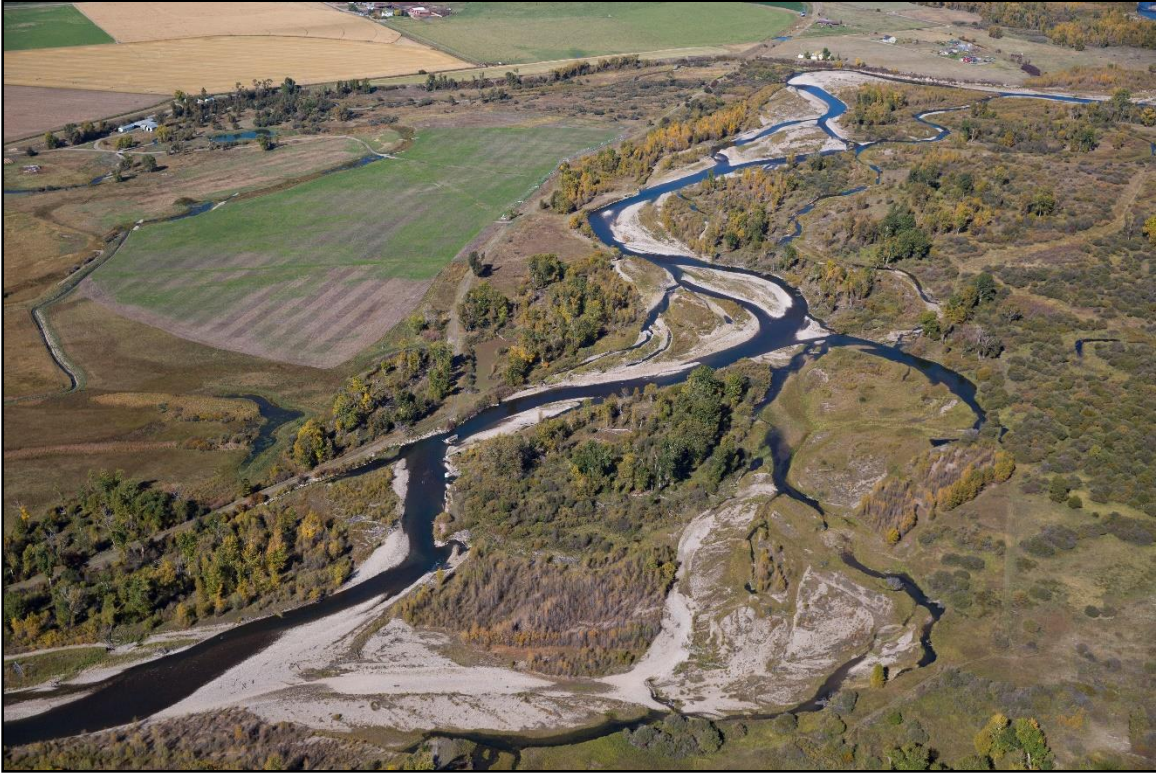
Figure 16. A 0.6-mile dike on left (west) bank of the Gallatin River below West Dry Creek Road. (Kestrel)

example of dikes on the channel margin is shown in (Figure 16). The impact of dikes on the CMZ is described in more detail in Section 4.5.

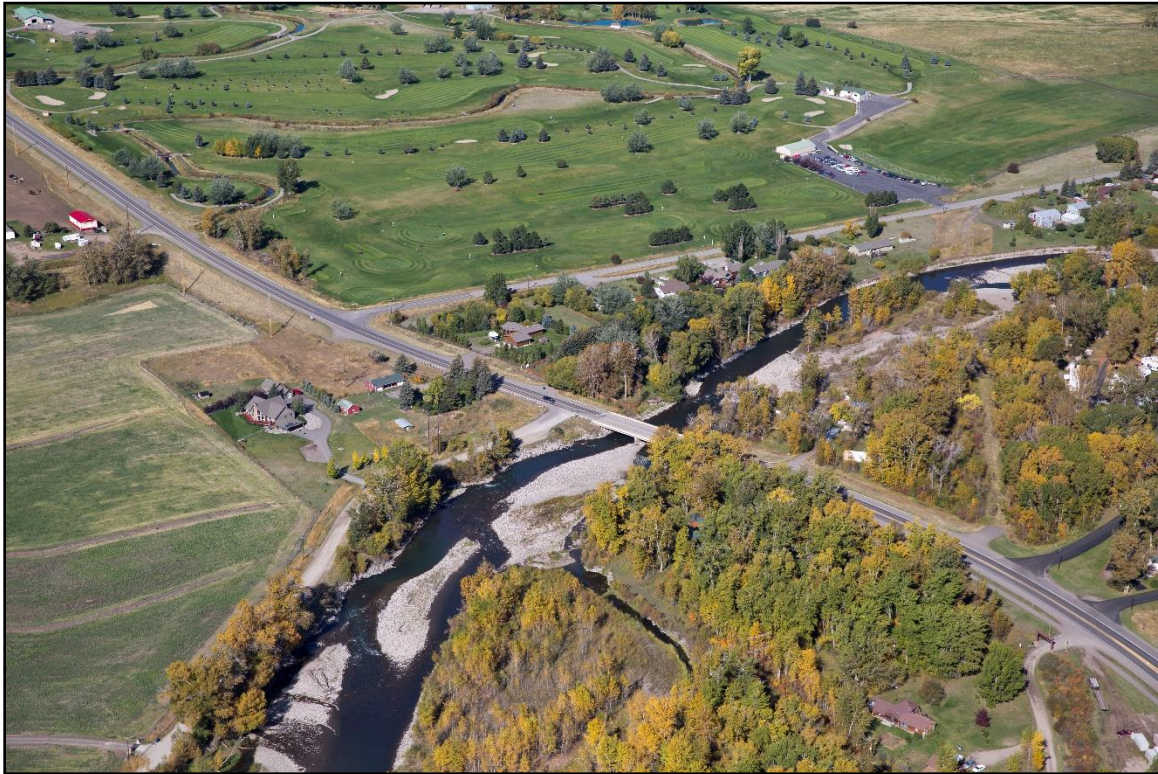
Figure 17. Extensive armor associated with the Norris Road bridge approach. (Kestrel)

Seventeen bridges span the entire primary channel or major side channels within the project area. The bridges are dispersed along the river's length. These bridges and their associated approaches locally constrict the CMZ, and they are commonly armored and/or leveed to manage alignment of the river through the structure (Figure 17).

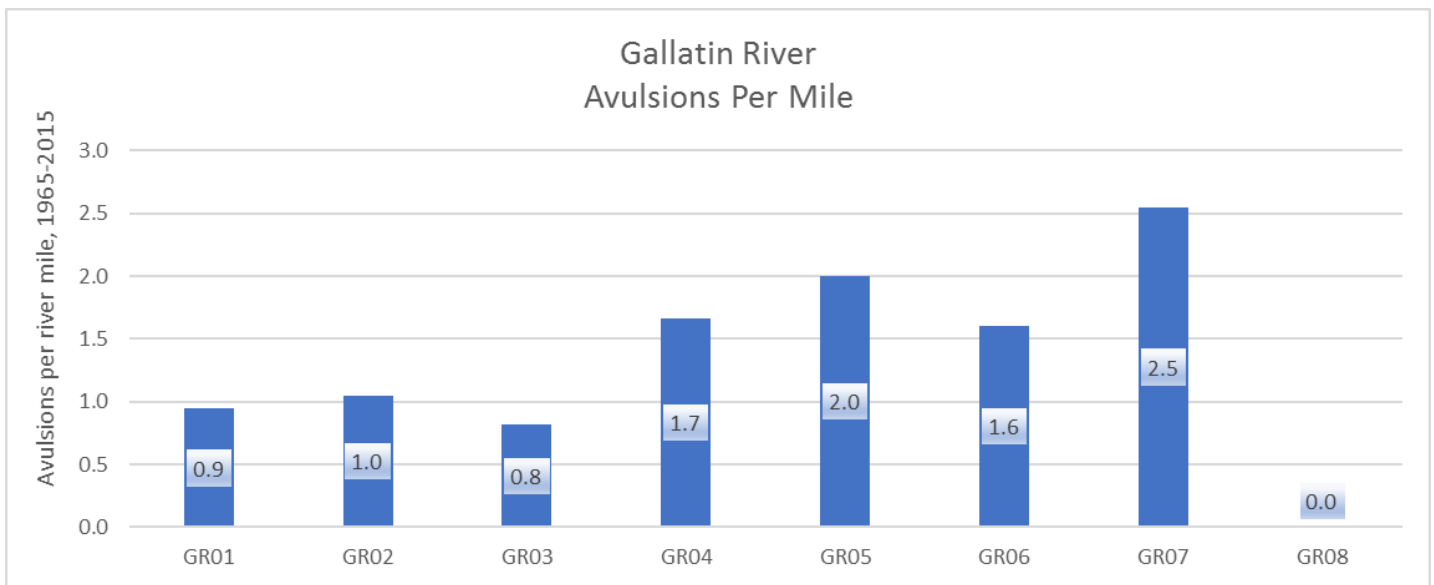
Figure 32. Number of mapped avulsions per river mile by reach.

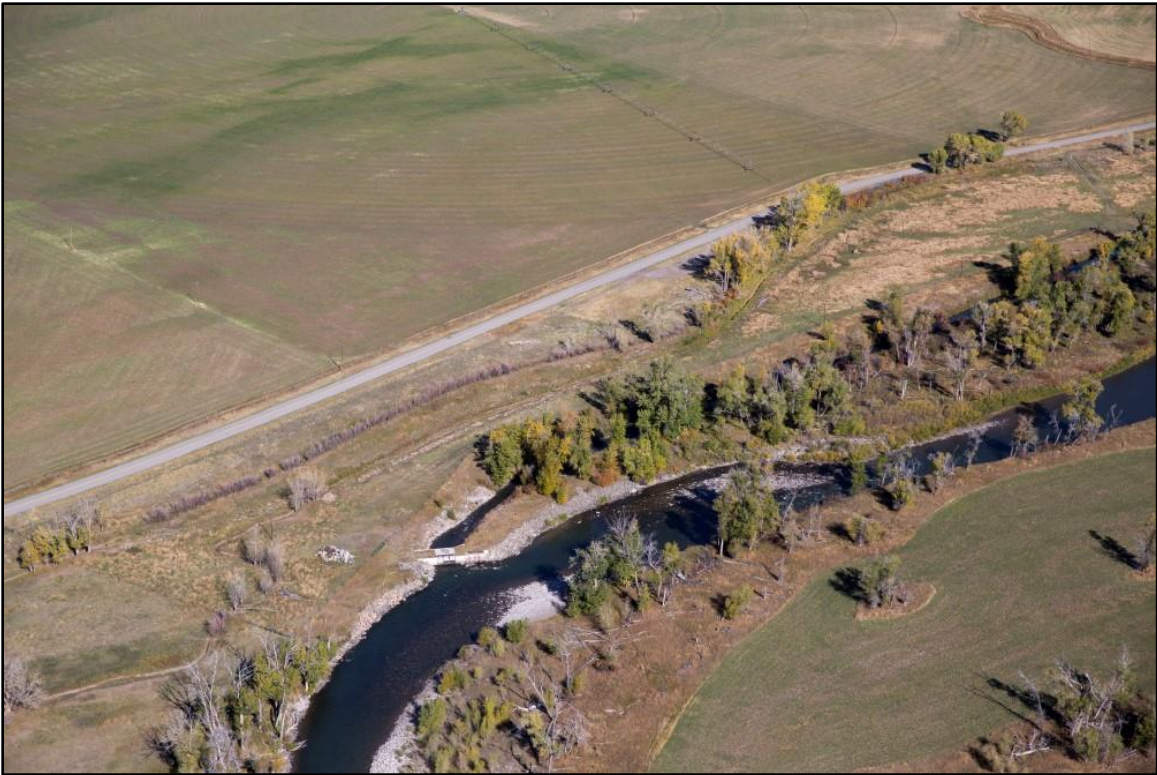
Figure 44. View downstream of diversion structure in area of minimal channel migration, RM 43.2L, Reach GR08 (Kestrel).

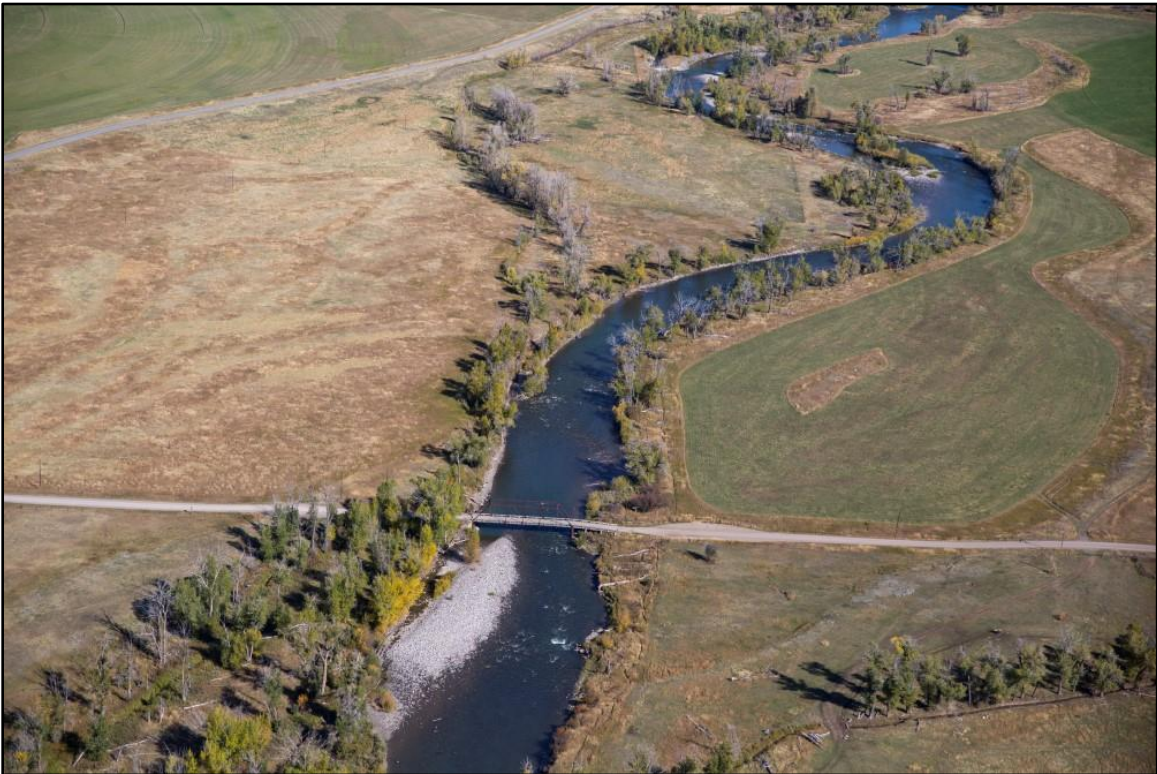
Figure 45. Increasing sediment storage and channel migration near West Williams Road Bridge, Reach GR08 (Kestrel).

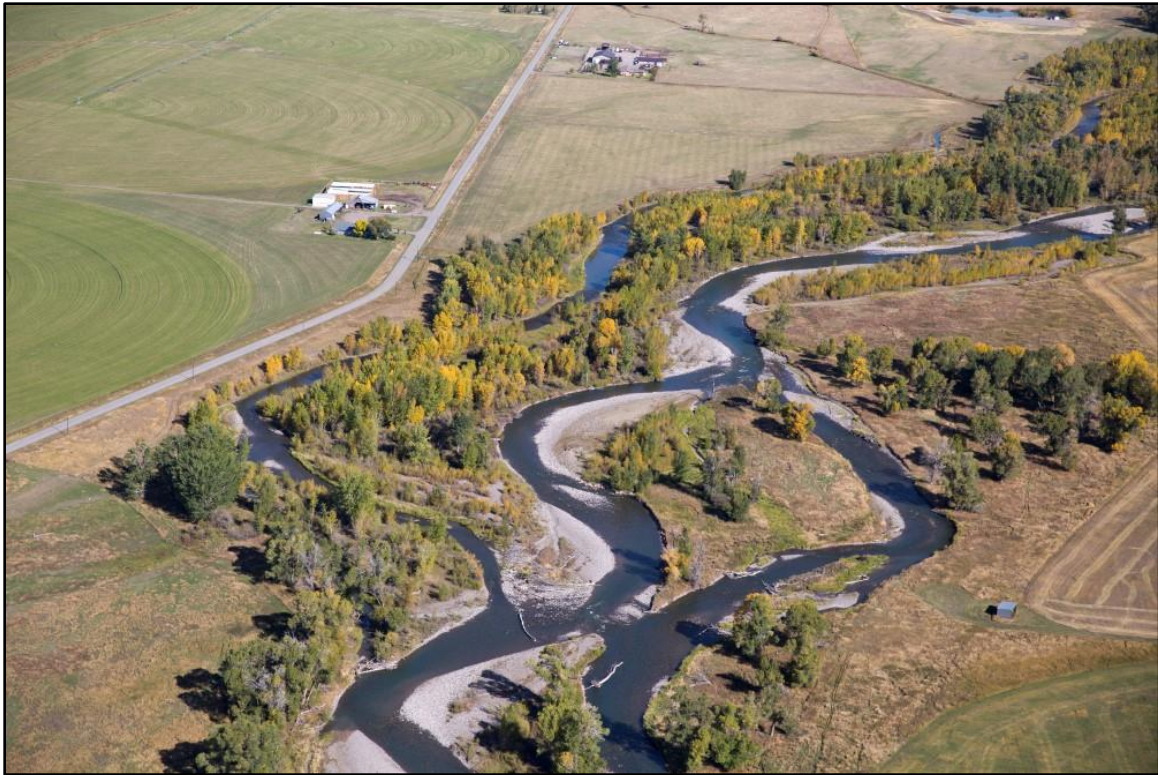
Figure 46. Reach GR07 showing two channels on right formed since 1979, RM 42.2 (Kestrel).

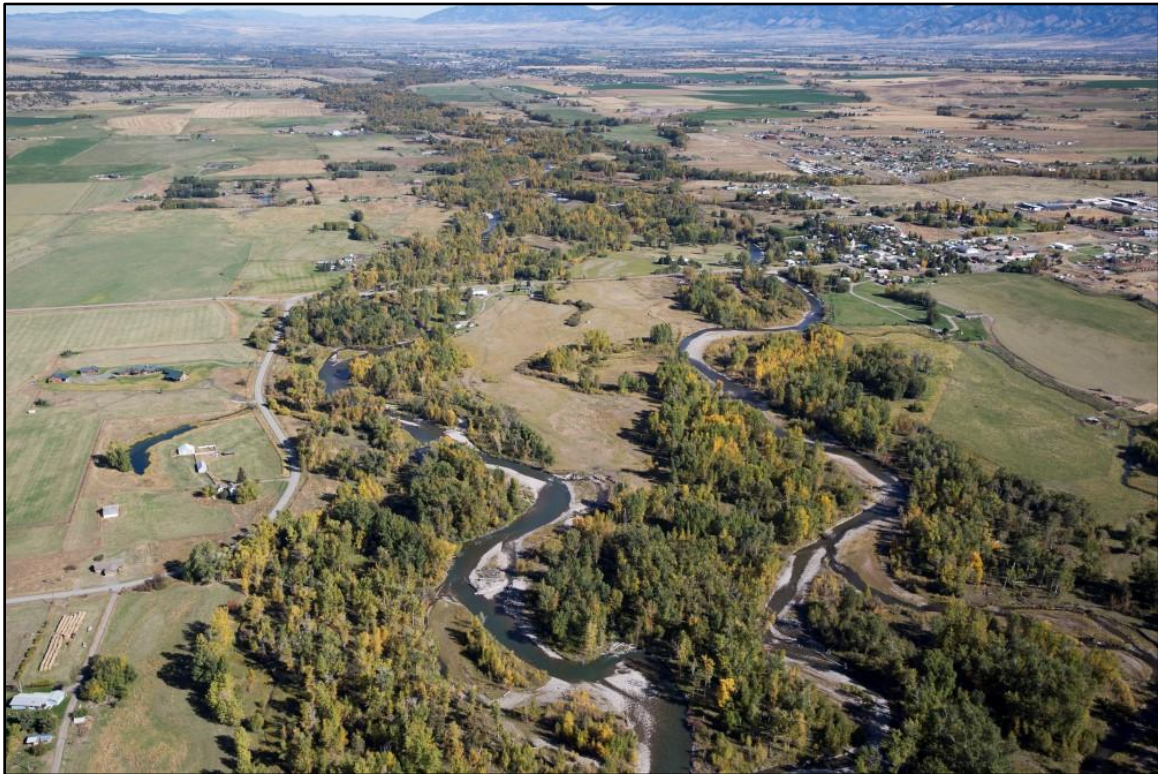
Figure 47. View downstream of Reach GR07 showing split flow approach to Gateway South Road bridge crossings (Kestrel).

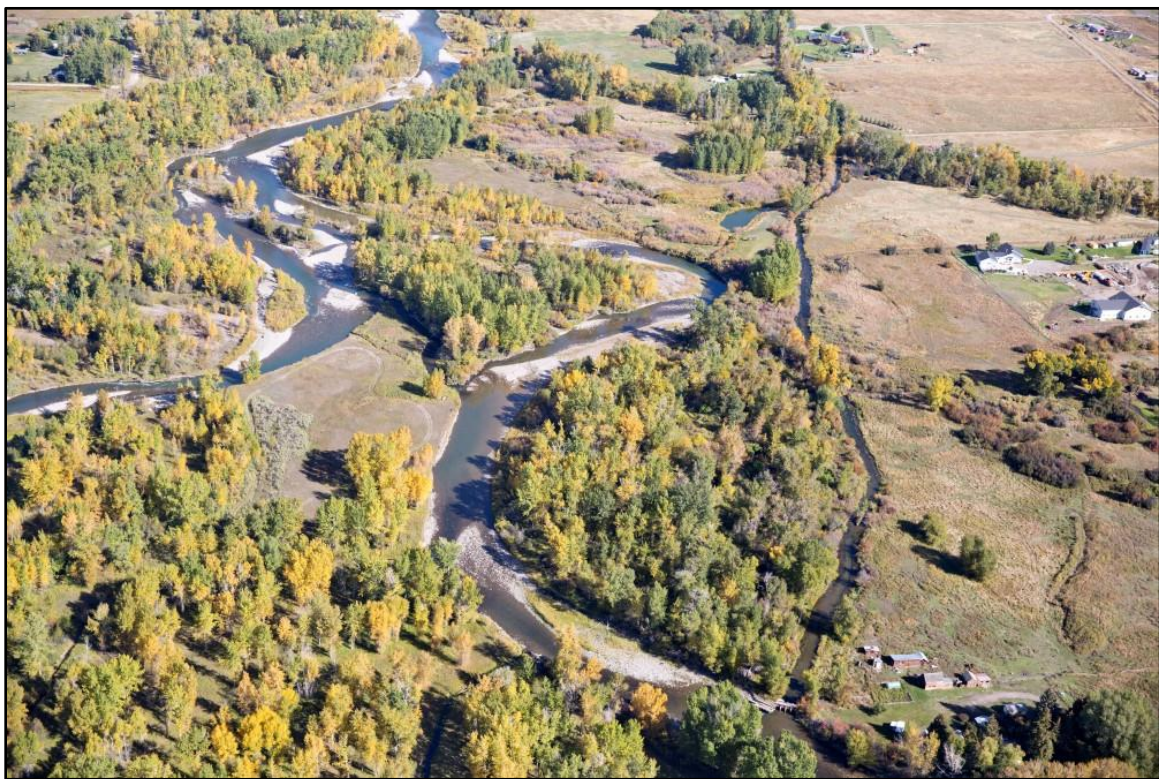
Figure 49. View downstream of Reach GR07 active meander migration towards a ditch at RM38.7R (Kestrel).

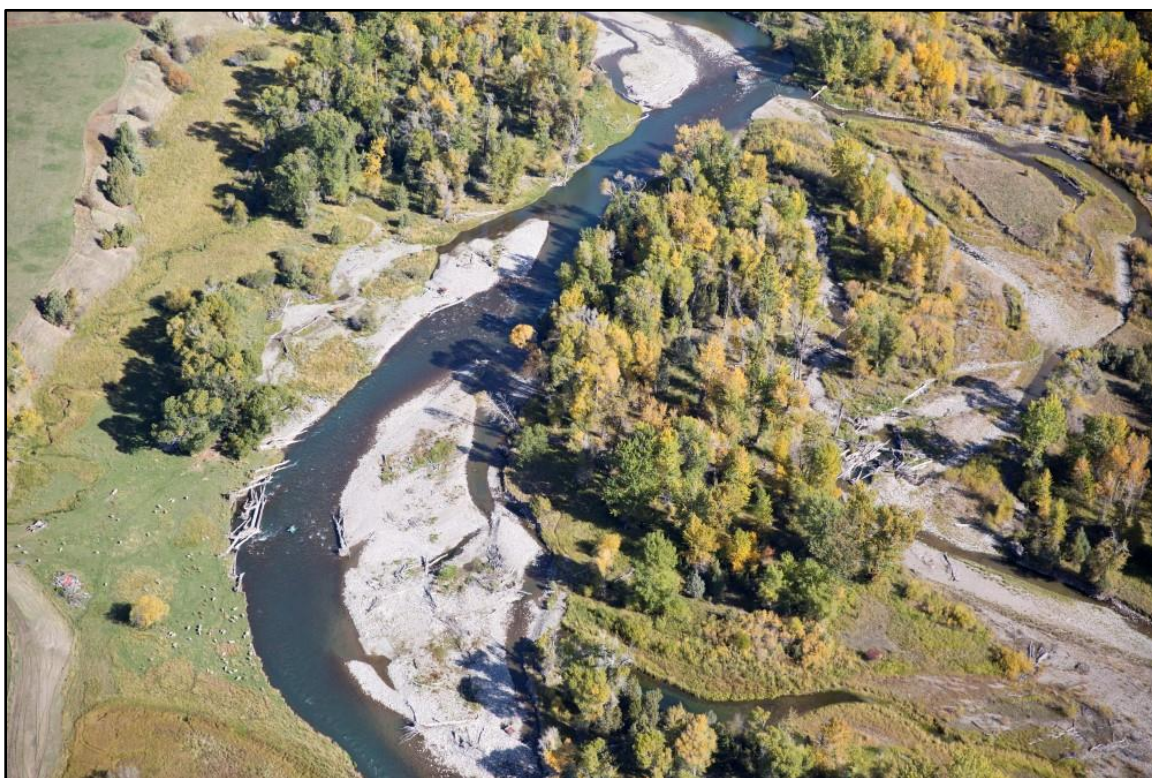
Figure 51. View downstream at RM 36.1 showing area with frequent avulsions; channel in foreground avulsed since 1995 (Kestrel).

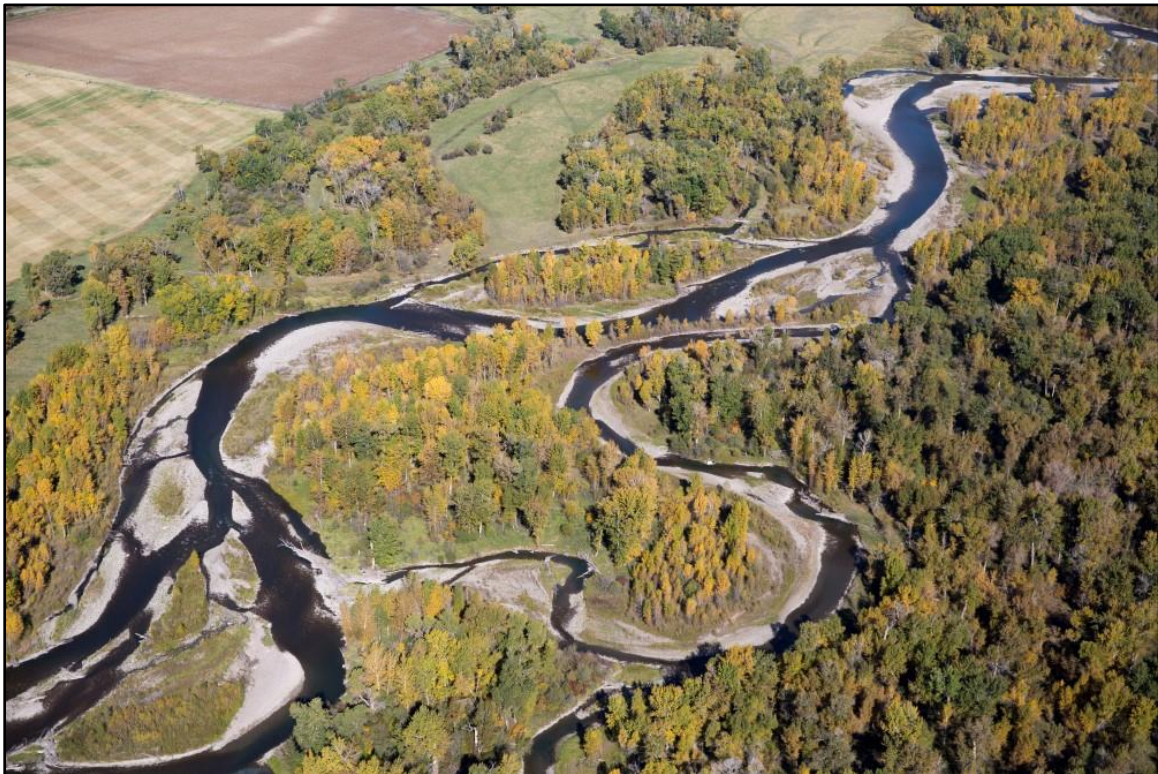
Figure 53. Reach GR05 channel complexity at RM 31; bendway in left foreground has migrated 392 feet since 1965 (Kestrel).

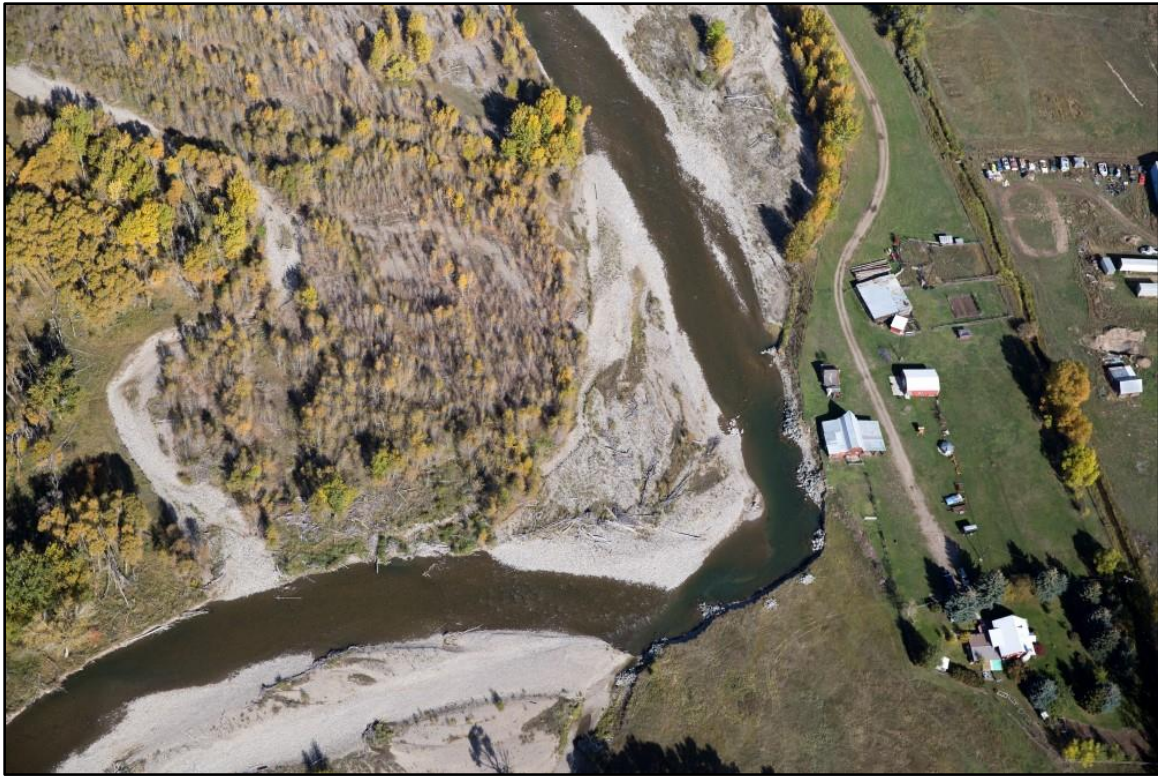
Figure 59. Barn on right bank where river has migrated 216 feet since 1965, RM 23.2 (Kestrel).

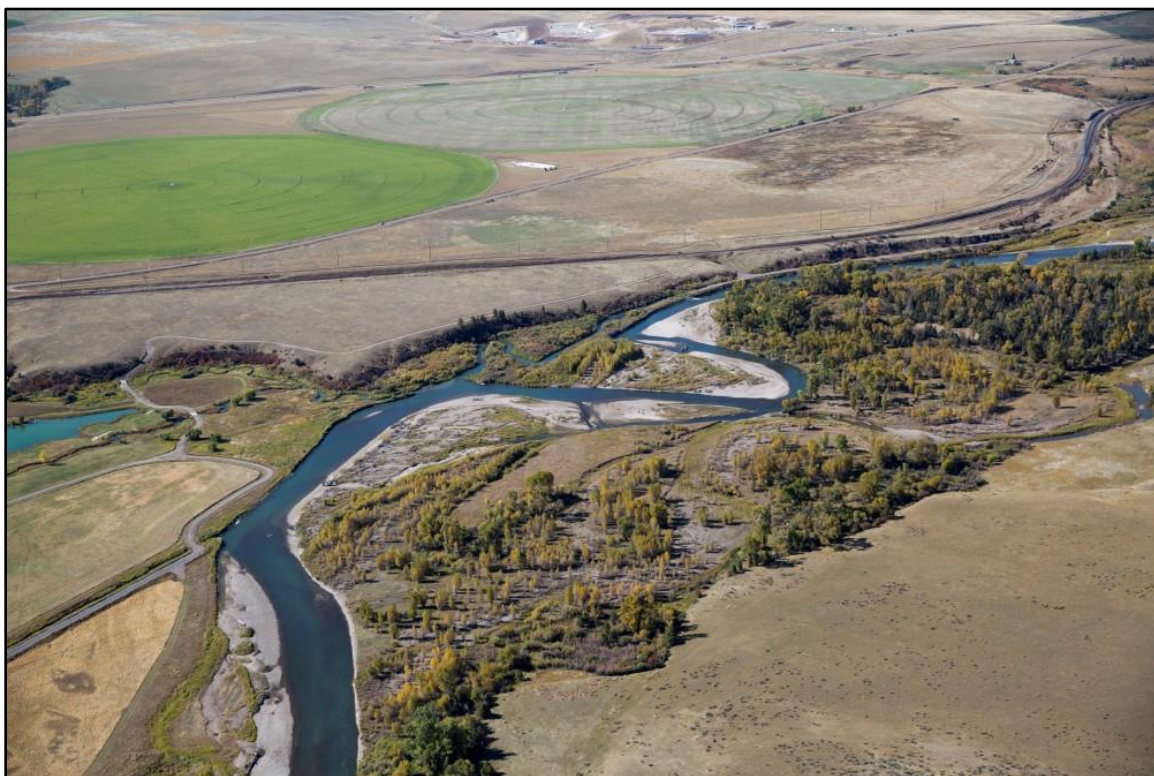
Figure 68. View downstream breached railroad grade and relocated road, Reach GR02 (Kestrel).

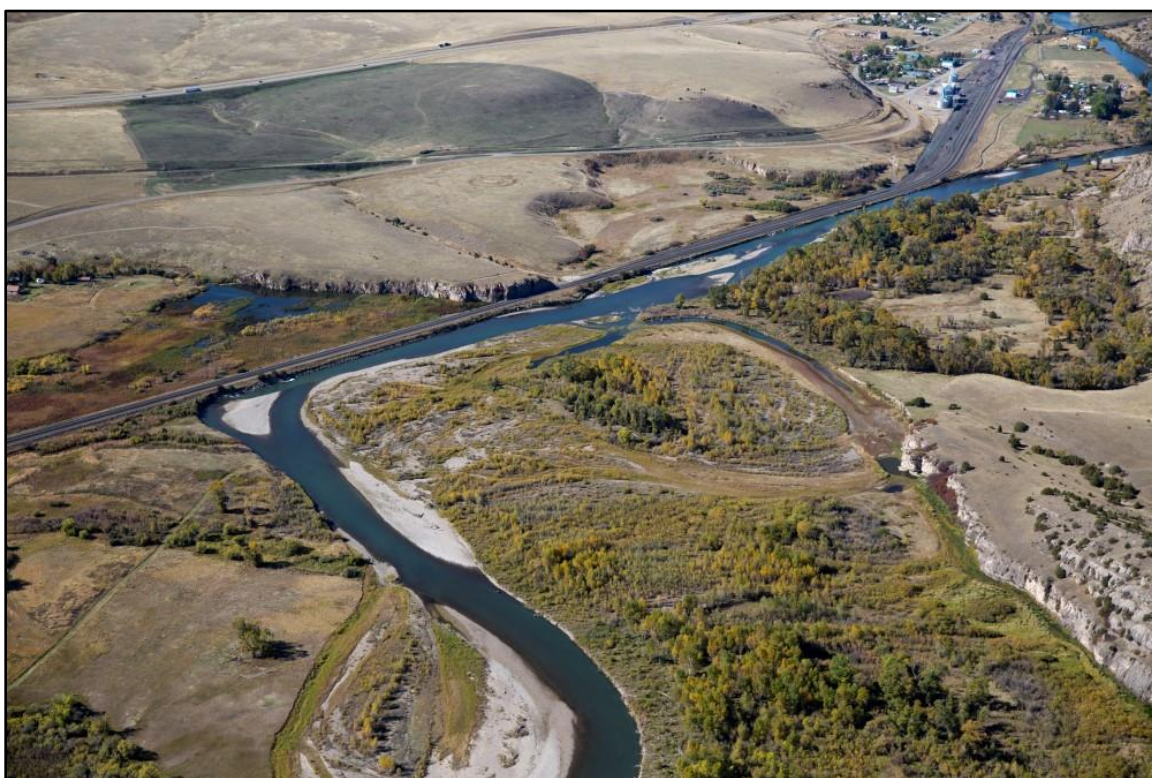
Figure 70. View downstream showing avulsion site and rail line isolation of historic floodplain, Reach GRO2 (Kestrel).

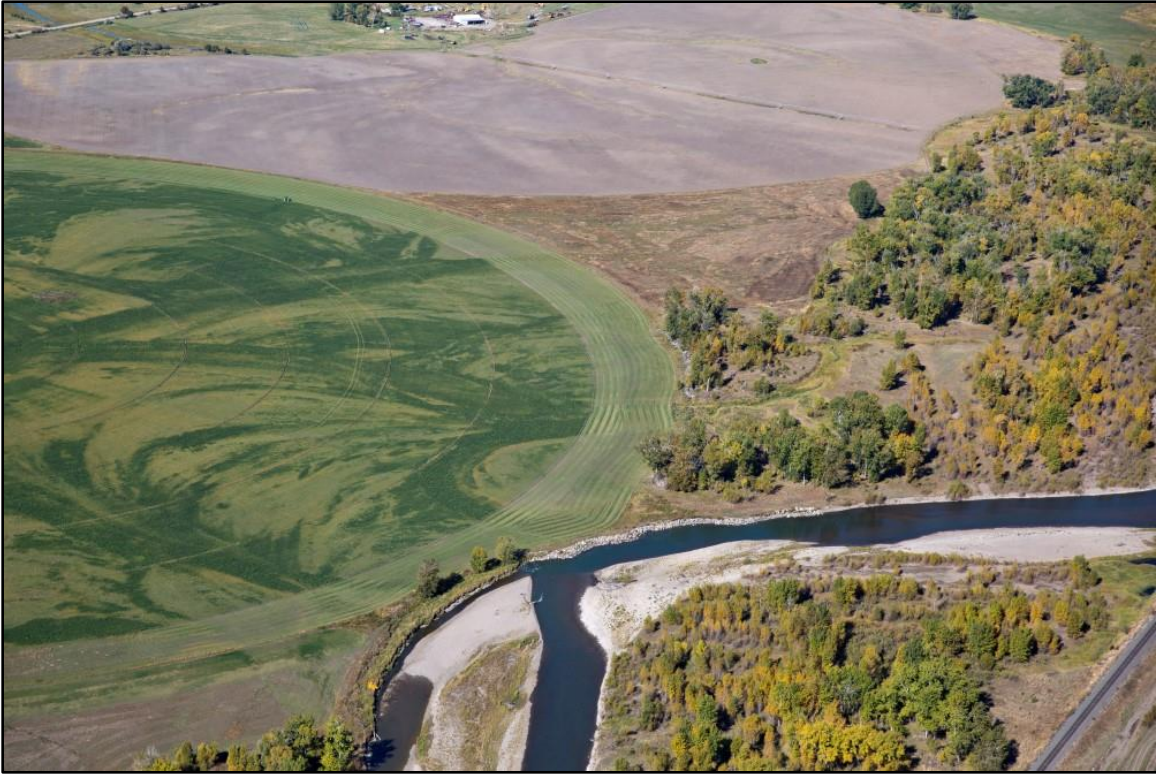
Figure 72. View downstream showing stream corridor narrowing between armored pivot field (left) and rail line (right) (Kestrel).

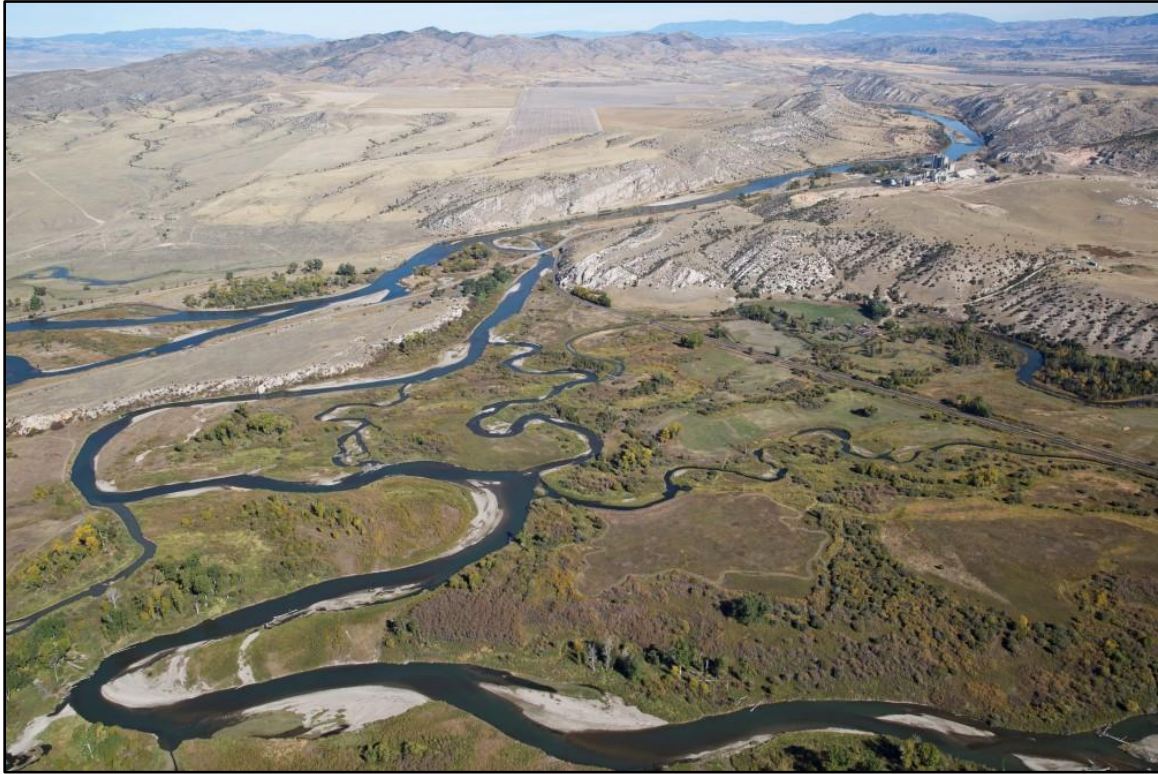
Figure 74. View downstream showing wide floodplain and active avulsions, Reach GR01 (Kestrel).
