Jefferson River Channel Migration Mapping

Prepared for:

Karin Boyd
Applied Geomorphology, Inc.
211 N Grand Ave, Suite C
Bozeman, MT 59715

Abstract

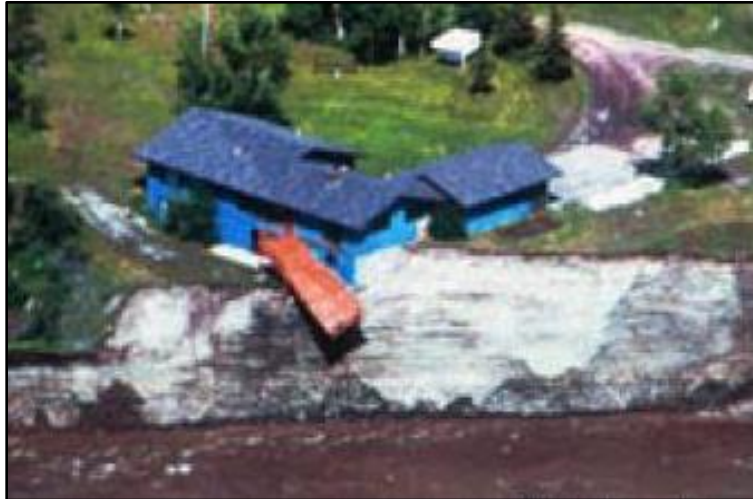
Figure 4. Yellowstone River home on high glacial terrace that was burned down in 1997 to prevent its undermining by the river.

Figure 4 shows a property on the Yellowstone River in Park County that was progressively undermined during the 1996-1997 floods, prompting the owner to burn it down to prevent any liability associated with the structure falling into the river. This has been a chronic problem in river management, as landowners assume that if their home is beyond the mapped floodplain margin, it is removed from all river hazards. After experiencing massive 2005 flood damages in Saint George Utah (Figure 5), several property owners reflected on this issue (www.Utahfloodrelief.com):

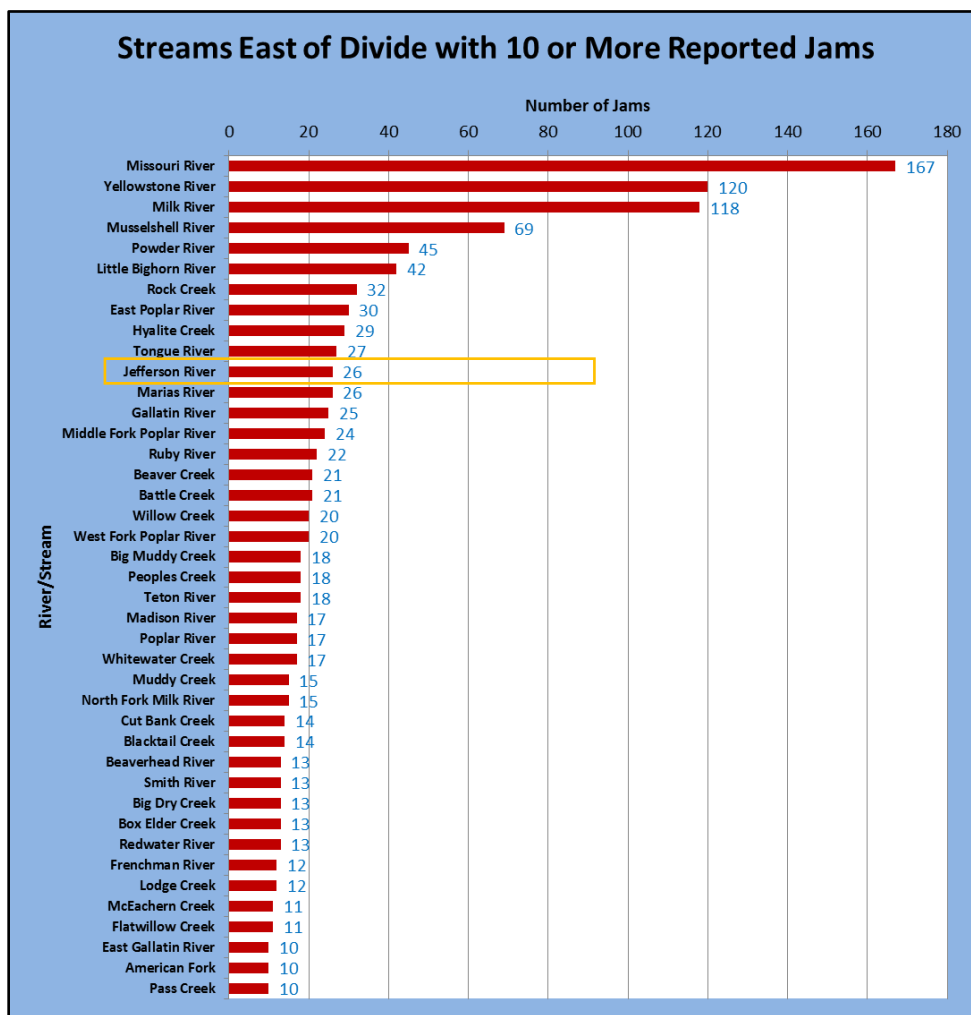
Figure 6. Montana rivers east of the continental divide with 10 or more reported ice jams.

Another serious river hazard, especially in Montana, is ice jamming. Over 1,470 ice jams have been recorded in Montana, which is the most of any of the lower 48 states (<http://dphhs.mt.gov/>). The ice jams are most common in February and March. The National Weather Service has identified the Jefferson River as having 26 reported ice jams (Figure 6).

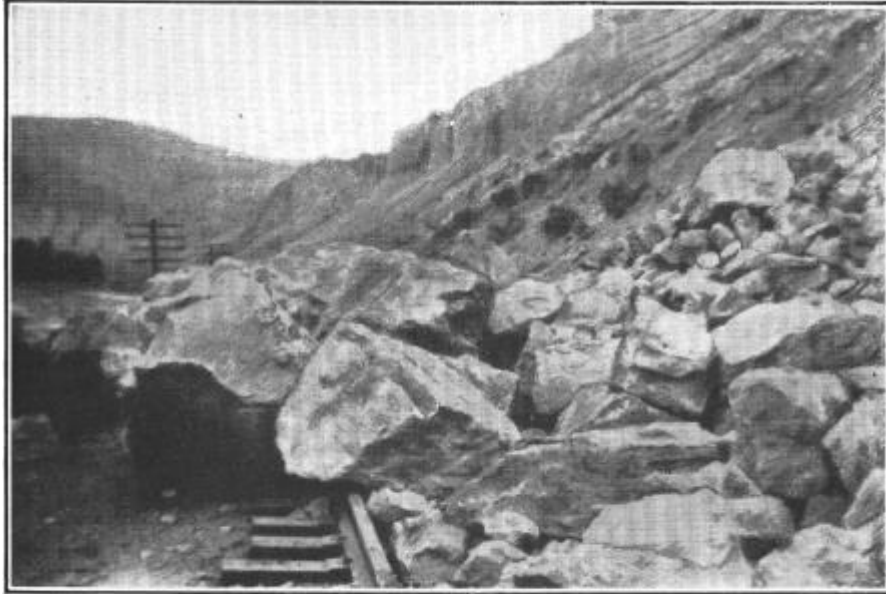
B. ROCKS ON RAILROAD TRACK NEAR LOMBARD, MONT.

Figure 8. Rock slide near Lombard caused by the 1925 earthquake (Pardee, 1926.)

There are no mapped landslides on the valley walls of the Jefferson River in the project area. During the 1925 earthquake, however, rockslides (Figure 8) were reported on the bluffs on the Jefferson River above Willow Creek (Pardee, 1926). The 6.6 magnitude quake was epicentered in Clarkston Valley, causing extensive damage at Manhattan, Three Forks, Logan, and Lombard (USGS). The dust that the rockslides generated appeared from a distance like smoke and led to a report that the town was on fire (Pardee, 1926). The earthquake also reportedly generated several new springs in the river valley, and several existing springs went dry.

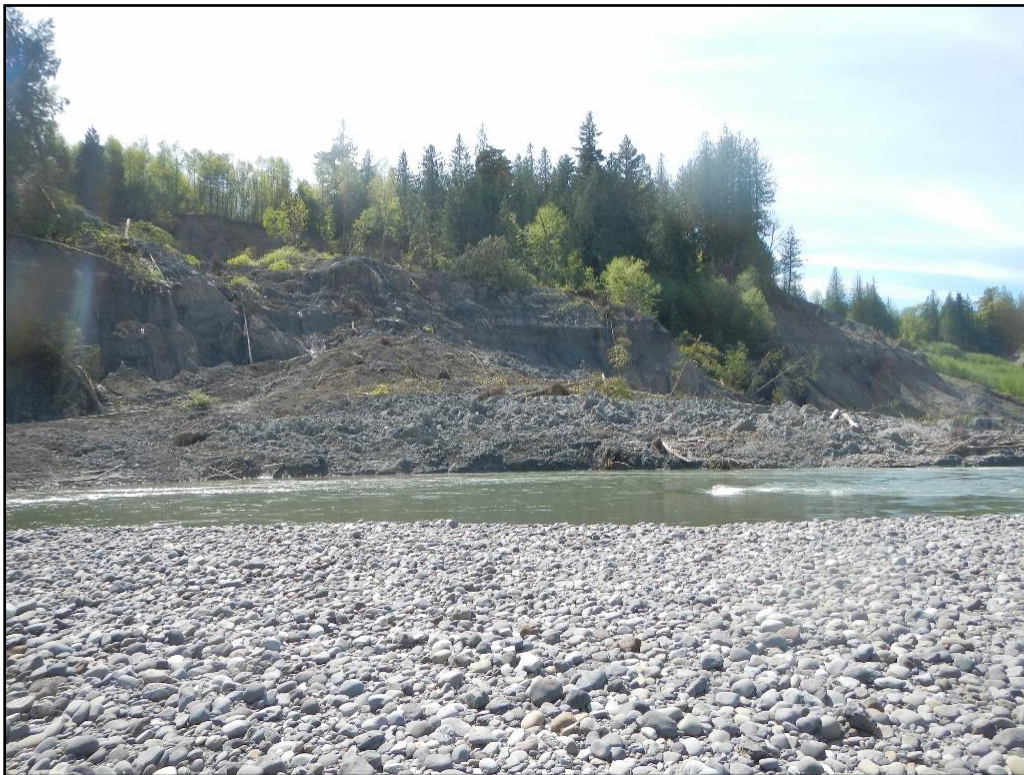
Figure 9. Hillslope failure on Nooksack River near Bellingham Washington on February 21, 2014 (K. Boyd).

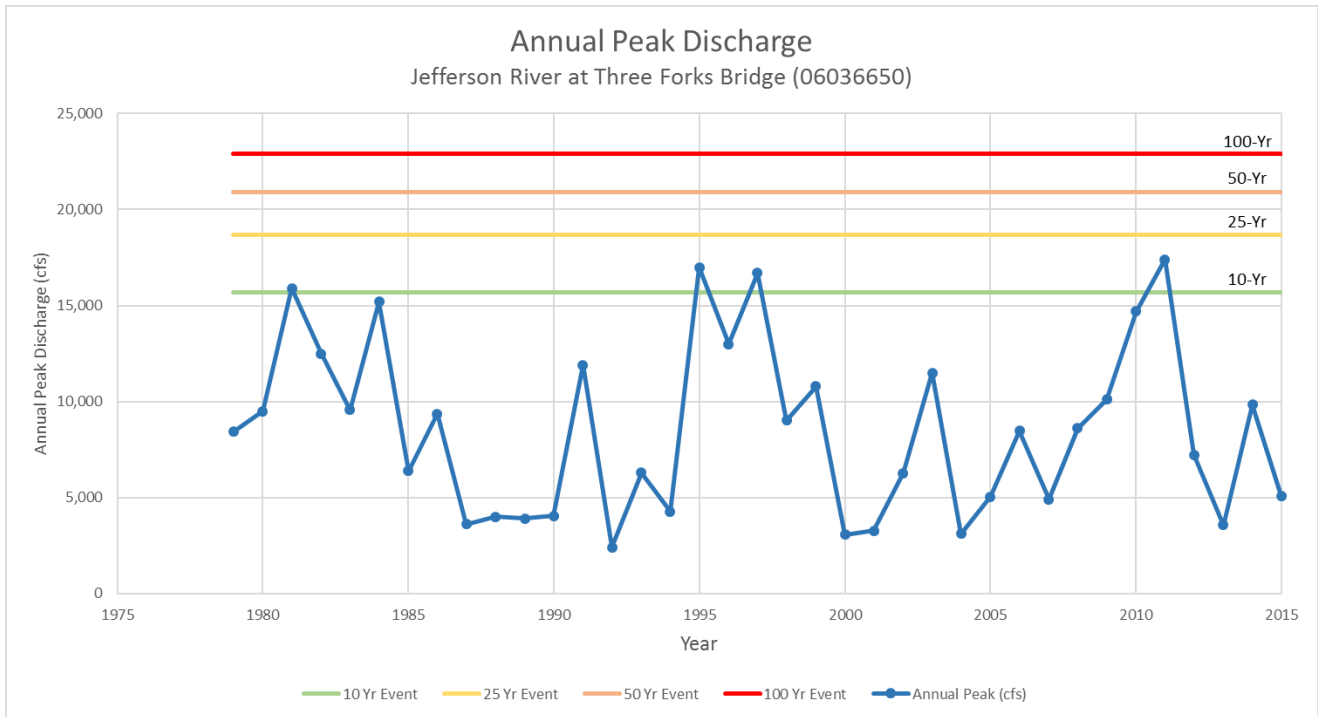
Figure 13. Annual peak flow record for Jefferson River below at Three Forks.

exceeding a 10-year event and none exceeding a 25-year event (Figure 13). The largest flood recorded on the Jefferson at Three Forks peaked at 17,400 cfs on June 12, 2011. Figure 14 shows that floods on the Big Hole River have a much larger influence on Jefferson River flooding than the Beaverhead River does, even though the Beaverhead has a larger drainage area. 1984 for example, the Beaverhead River experienced a major flood that exceeded a 100-year event, which was less than a 10-year event on the Jefferson at Three Forks.

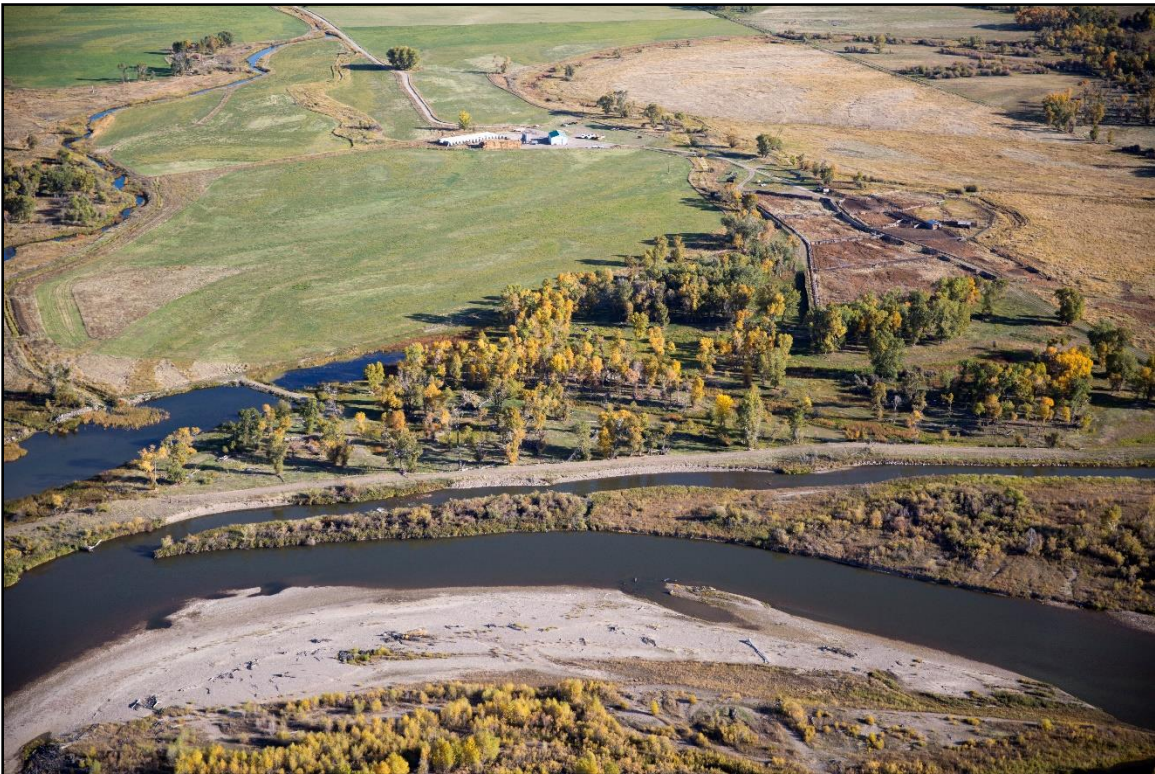
Figure 15. A 0.8-mile levee on the Lower Jefferson River. (Kestrel)

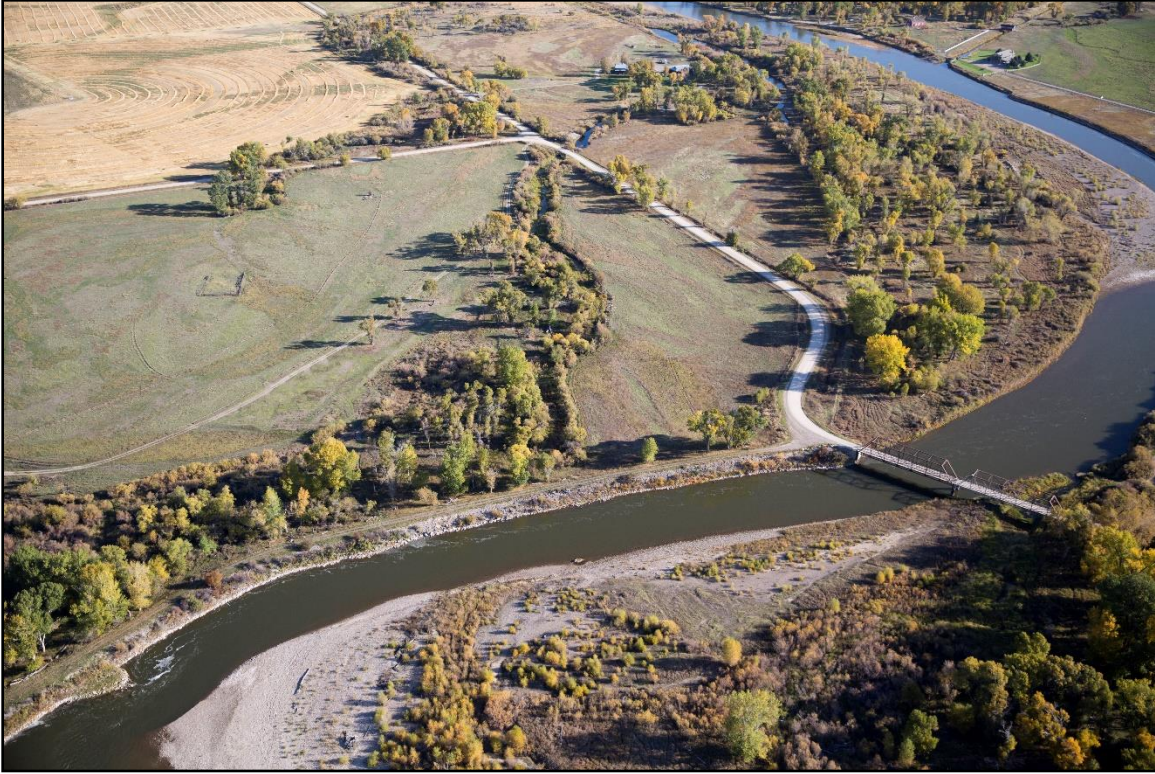
Figure 16. View (looking downstream) of the Meridian Bridge approach near Willow Creek showing a left bank levee. (Kestrel)

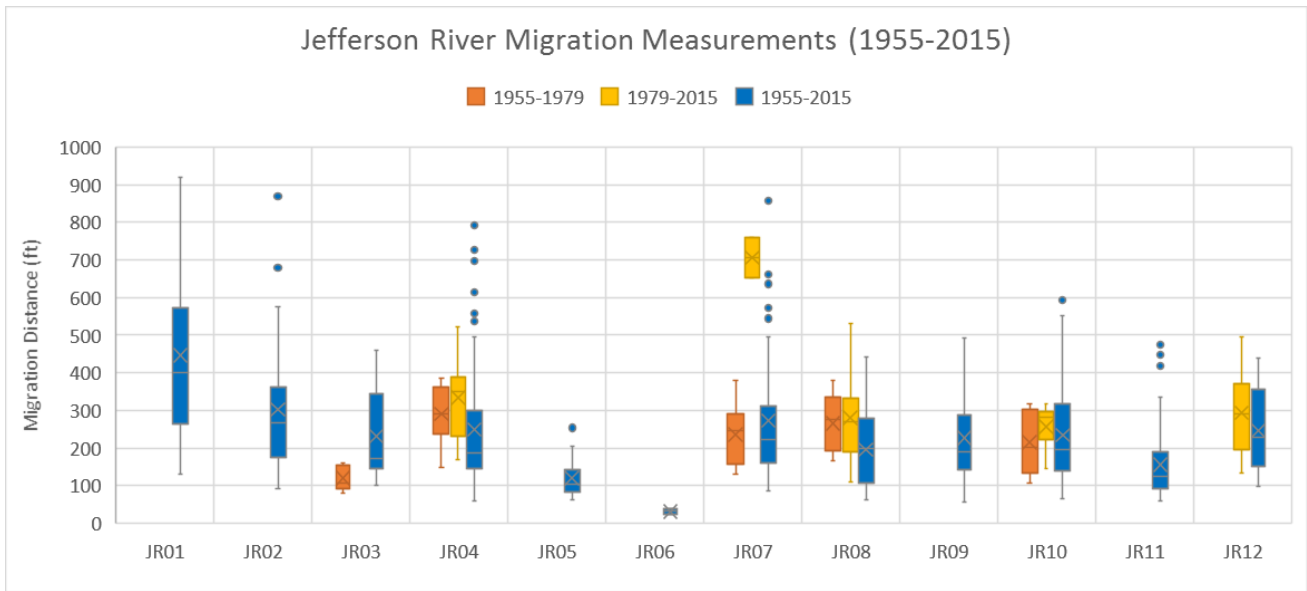
Figure 26. Box and whisker plot showing migration distance measurements for three timeframes.

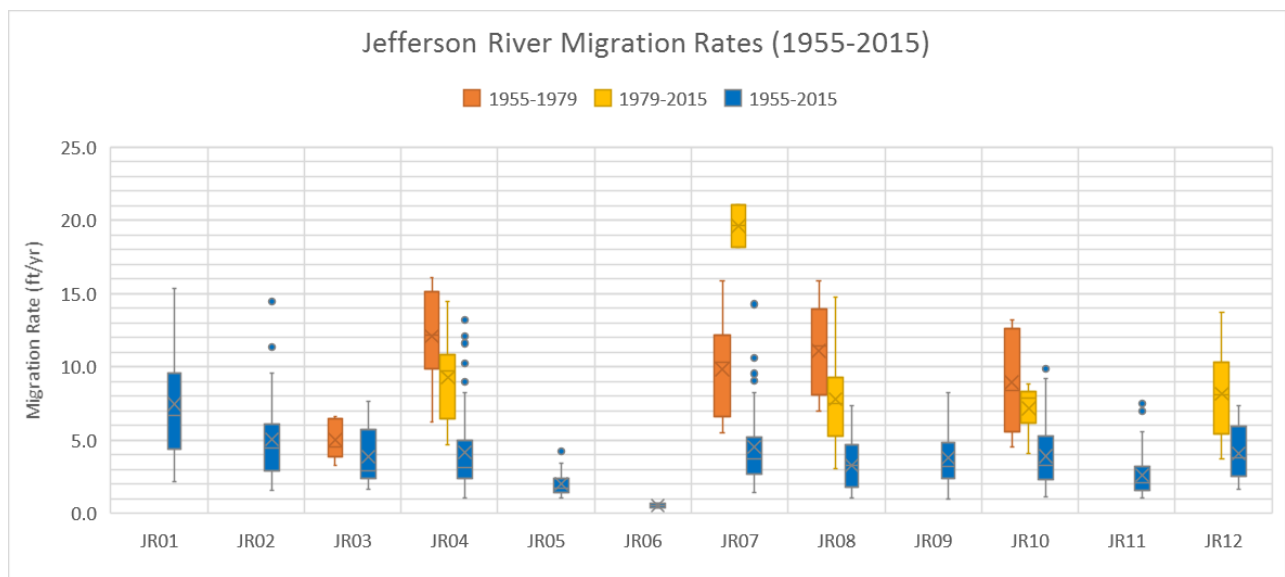
Figure 27. Box and whisker plot showing migration rate measurements for different timeframes.

term rates are higher than long-term rates. In Reach JR07 for example, which is below Kountz Road, notably rapid migration occurred between 1979 and 2015 (Figure 27). However, these shorter-term rates represent a relatively small proportion of the total number of measurements, so short-term migration does not disproportionately influence mean migration rates. In Reach JR07 for example, the rapid 1979-2015 rates reflects only two of 74 total measurements (Figure 28). The resulting mean migration rates and EHA buffer widths are shown in Table 3 and Figure 30. The buffer width is calculated as that distance the river would move over a century's time at the mean annual rate.

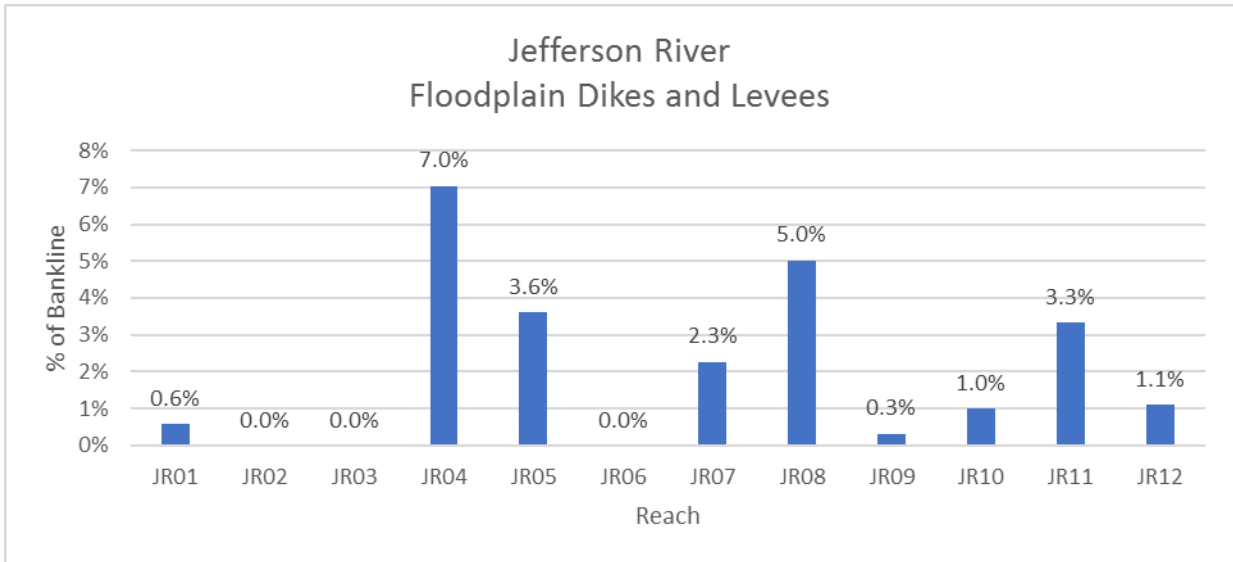
Figure 36. Percentage of bankline protected by berms or levees by reach.

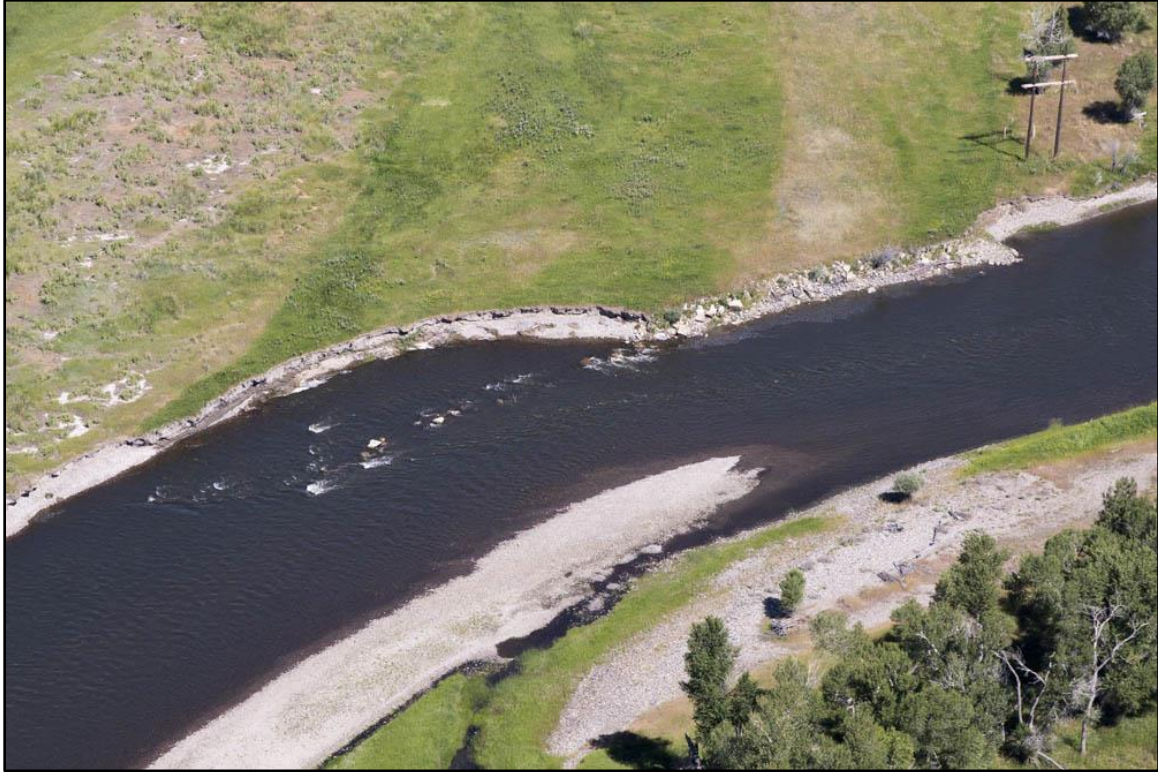
Figure 44. Flanked left bank riprap in channel, RM 71.8L. (Kestrel)

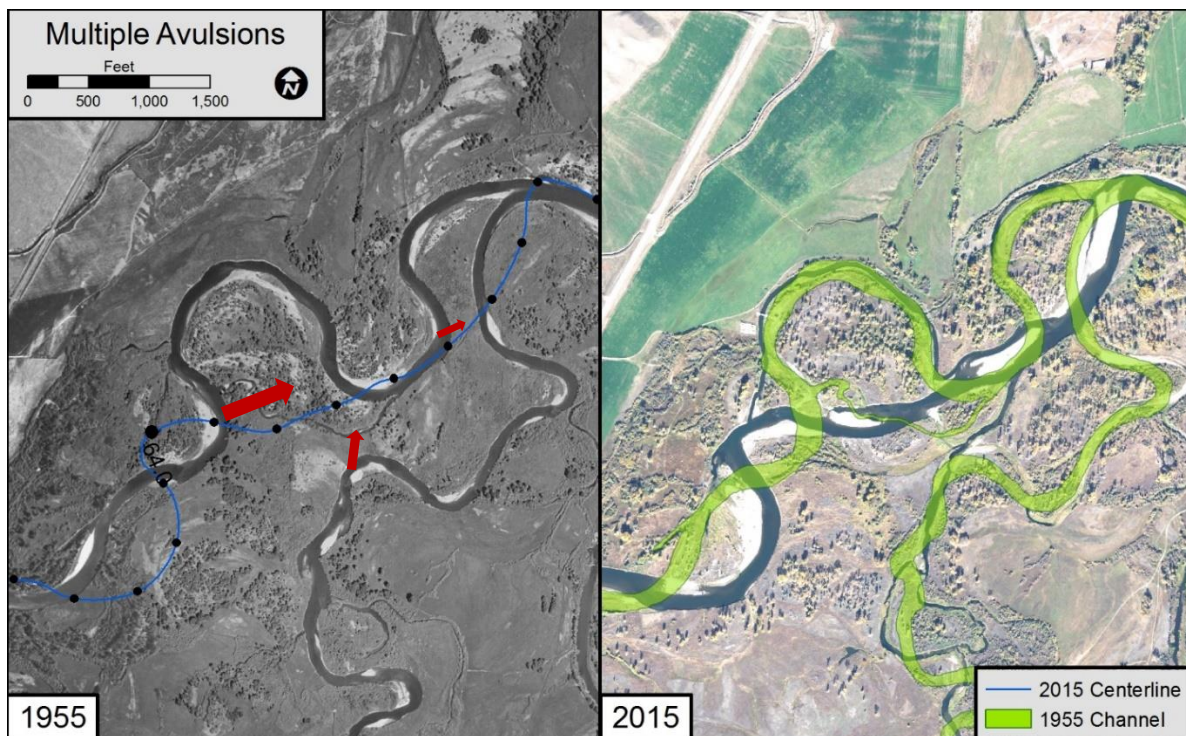
Figure 48. Imagery from 1955 (left) and 2015 (right) showing three avulsions and resulting channel straightening below Silver Star.

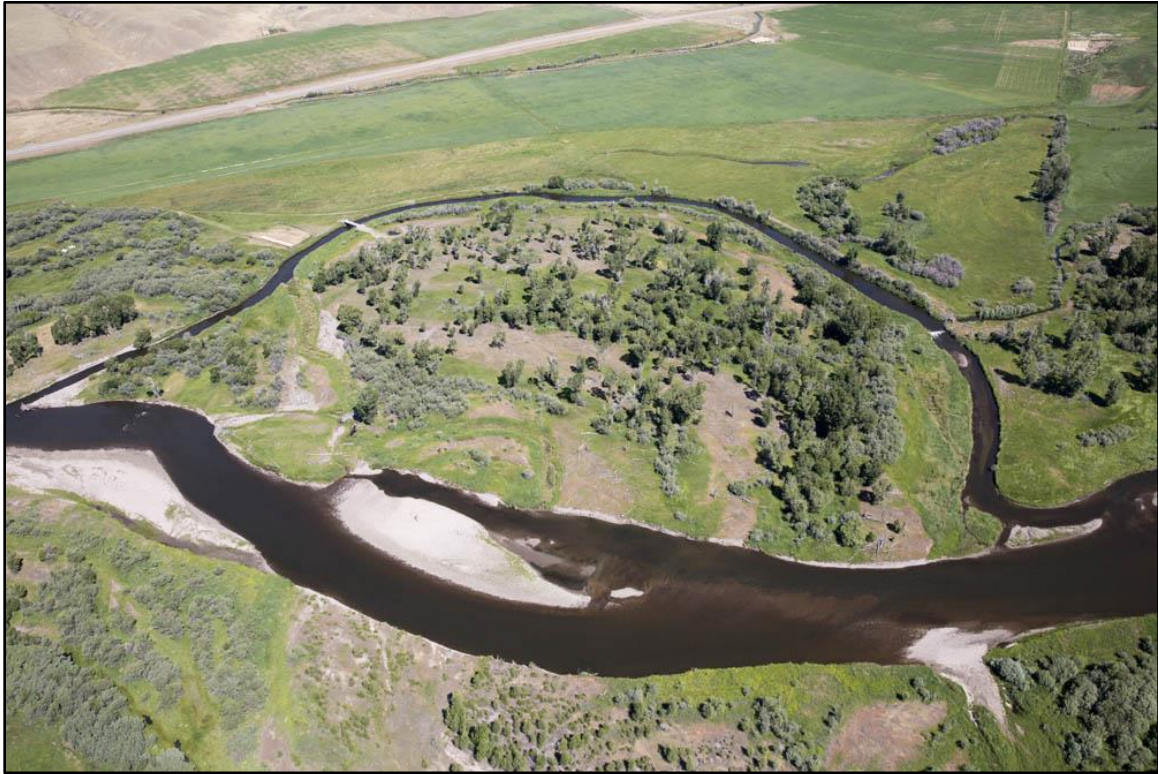
Figure 49. Post-avulsion channel widening, RM64. (Kestrel)

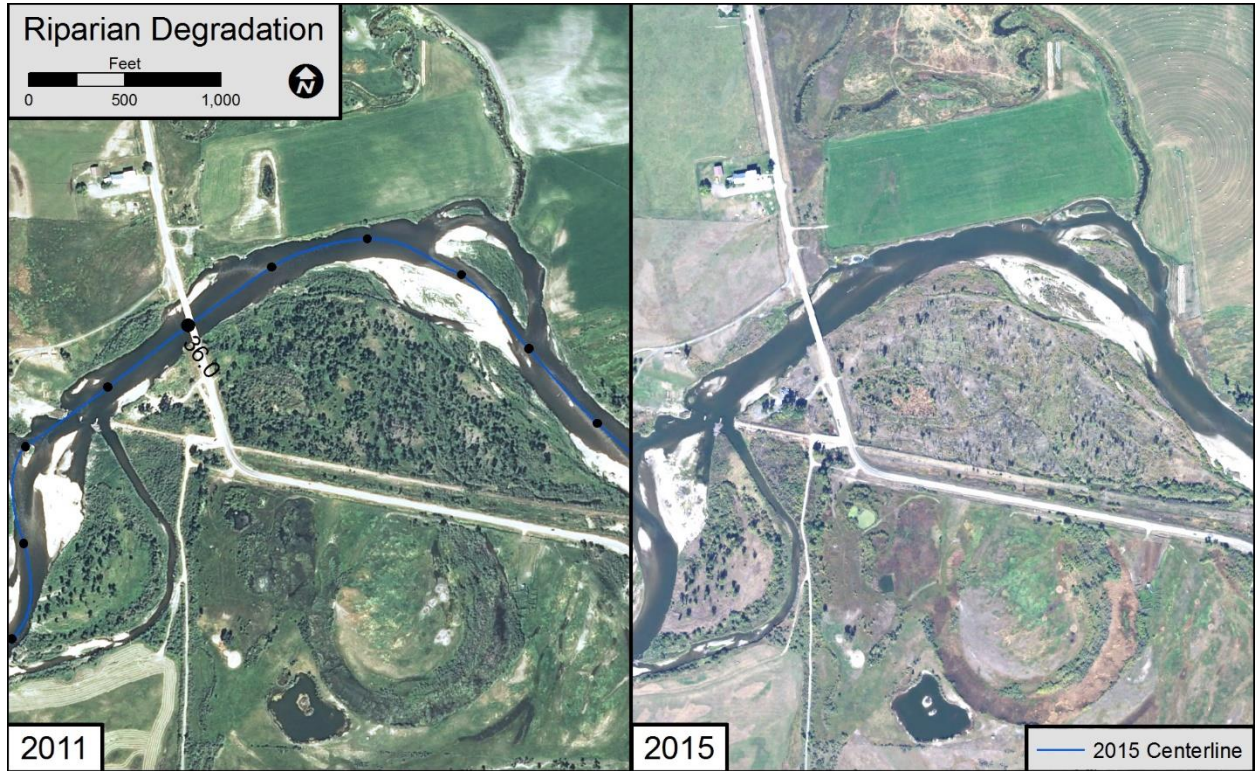
Figure 62. Riparian decay downstream of Cardwell Bridge between 2011 (left) and 2015 (right).

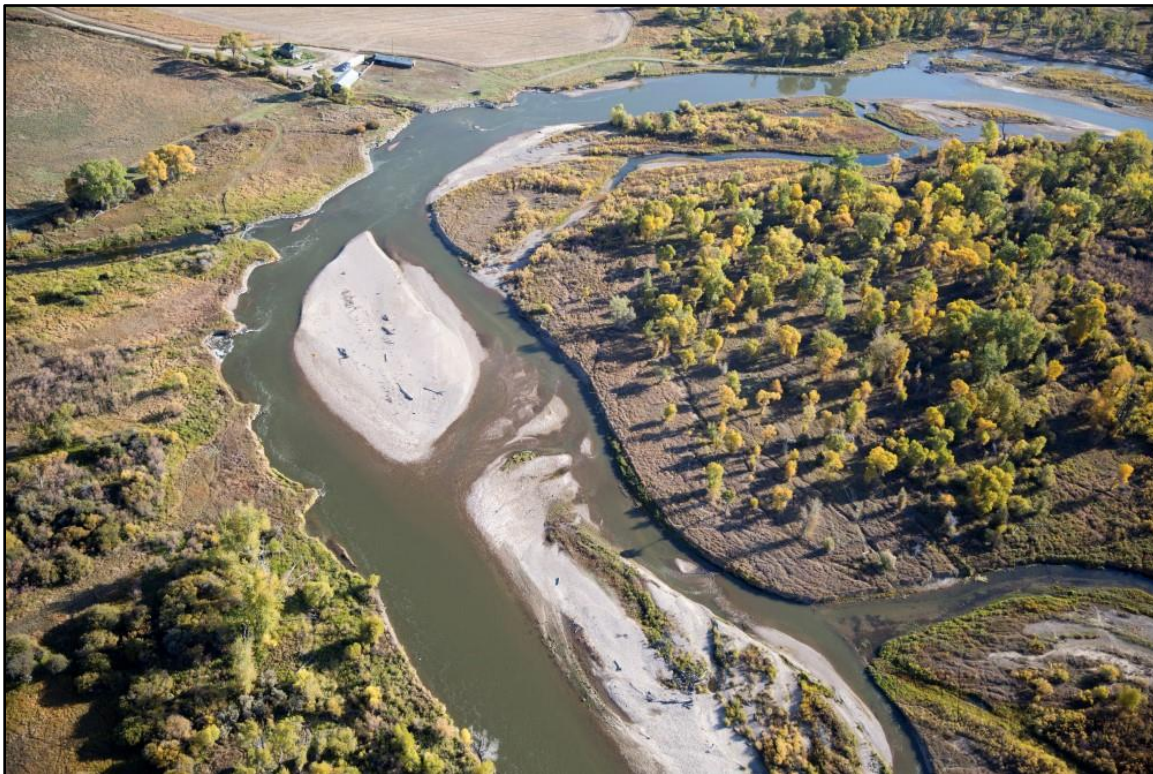
Figure 65. View downstream Reach JR04 showing left bank barbs with erosion between structures. (Kestrel)
