TECHNICAL MEMORANDUM

In Regards To: Musselshell River CMZ Pilot

This technical memorandum describes the development of a draft Channel Migration Zone (CMZ) map for the portion of the Musselshell River through Roundup, MT, extending from above Naderman Diversion to near Kilby Butte, a distance of 34.4 river miles. The work was authorized under FWP Contract P17035.

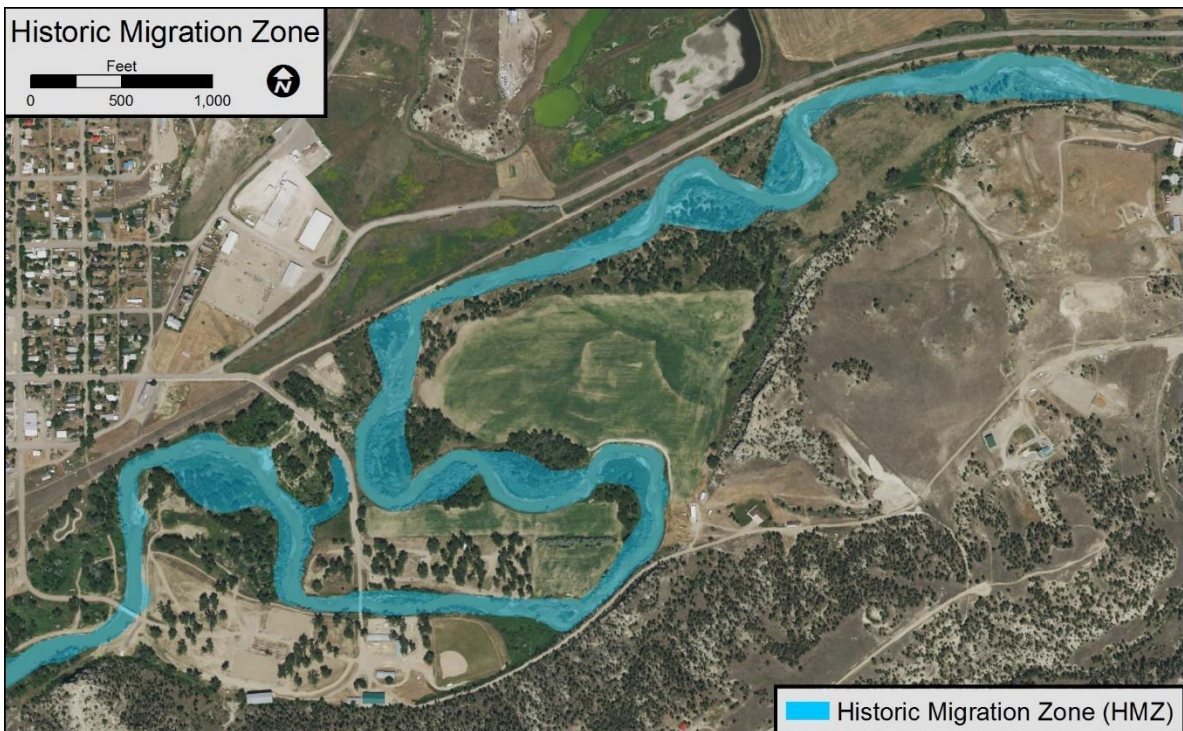
Figure 10. Historic Migration Zone.

For this study, the Historic Migration Zone is comprised of the total area occupied by Musselshell River channel locations in 1953, 1979, 1996, 2011 and 2015 (Figure 9). The resulting area reflects 62 years of channel occupation for the Roundup study area of the Musselshell River (Figure 10).

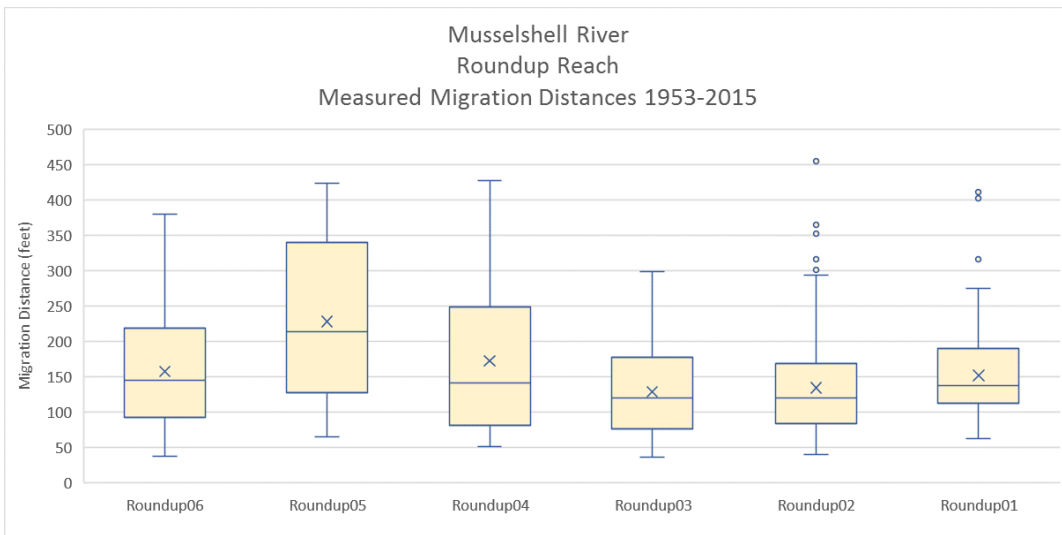
Figure 11. Measured migration distances by reach.

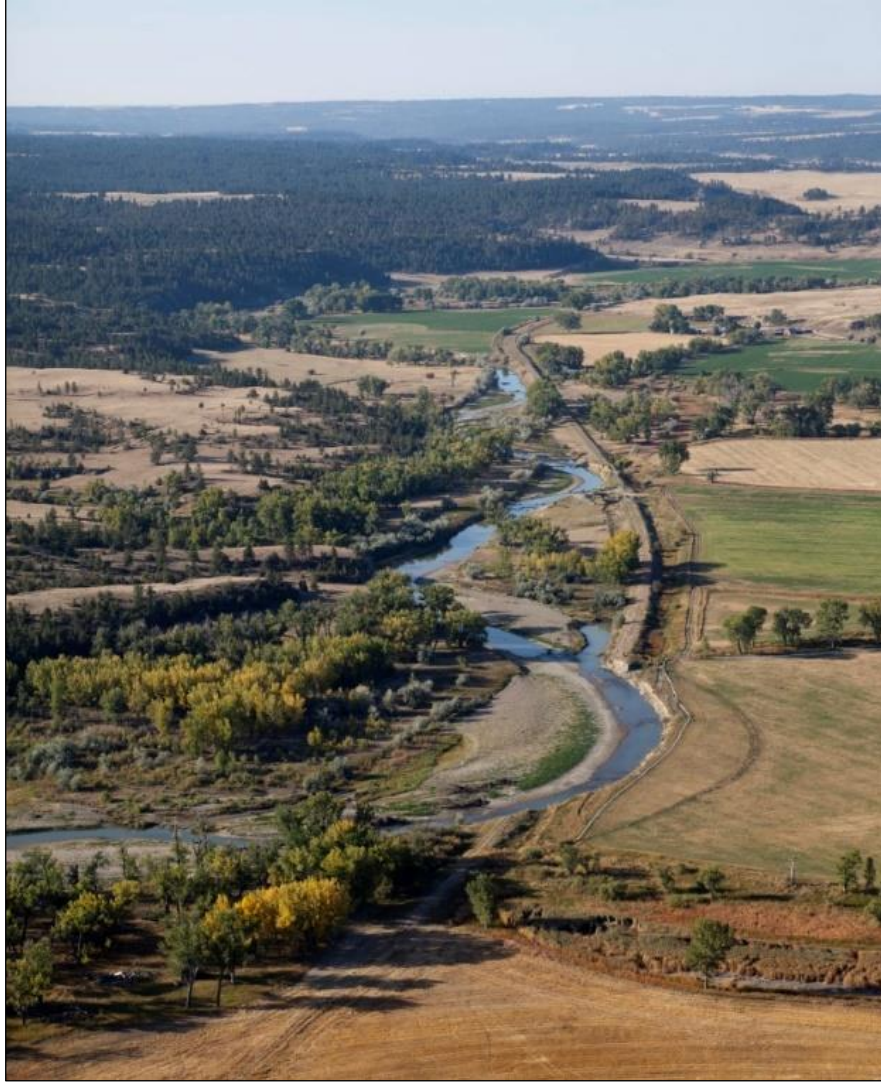
Figure 19. View upstream of northward migration through Milwaukee Road, RM 194.8. Photo taken on Sept 20, 1012 (Kestrel).

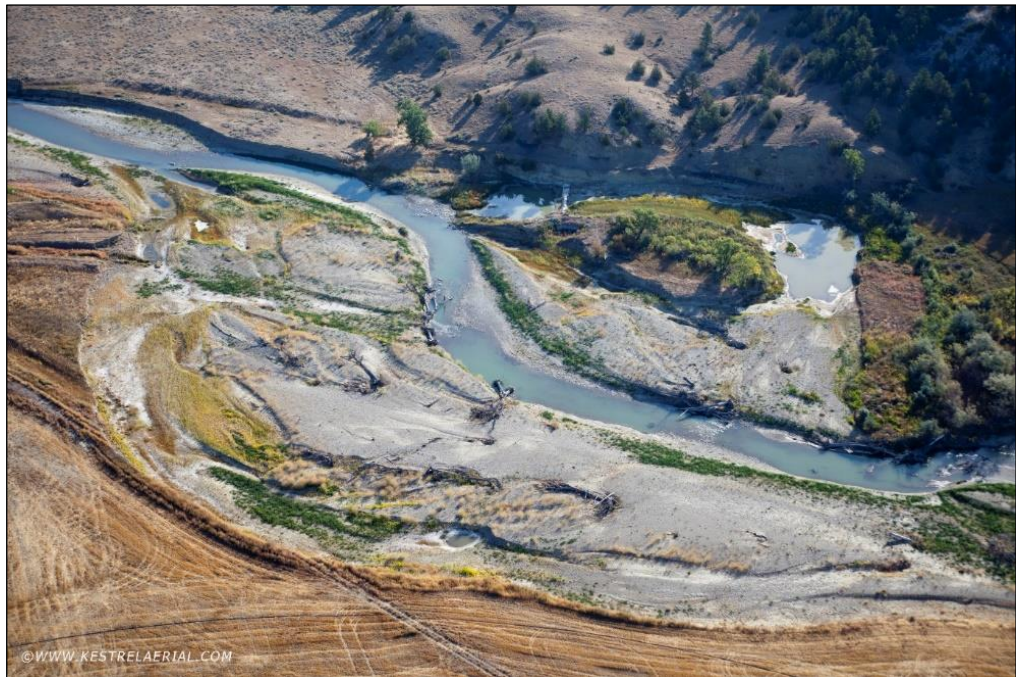
Figure 21. Naderman Dam 2011 avulsion, RM 194.2 (Sept 20, 2012—Kestrel).

Two avulsions were mapped in the Reach 6, one of which flanked and abandoned the Naderman Diversion Dam (Figure 21). There are two bendways in the upper part of Reach 6 that appear prone to cutoff in coming decades.

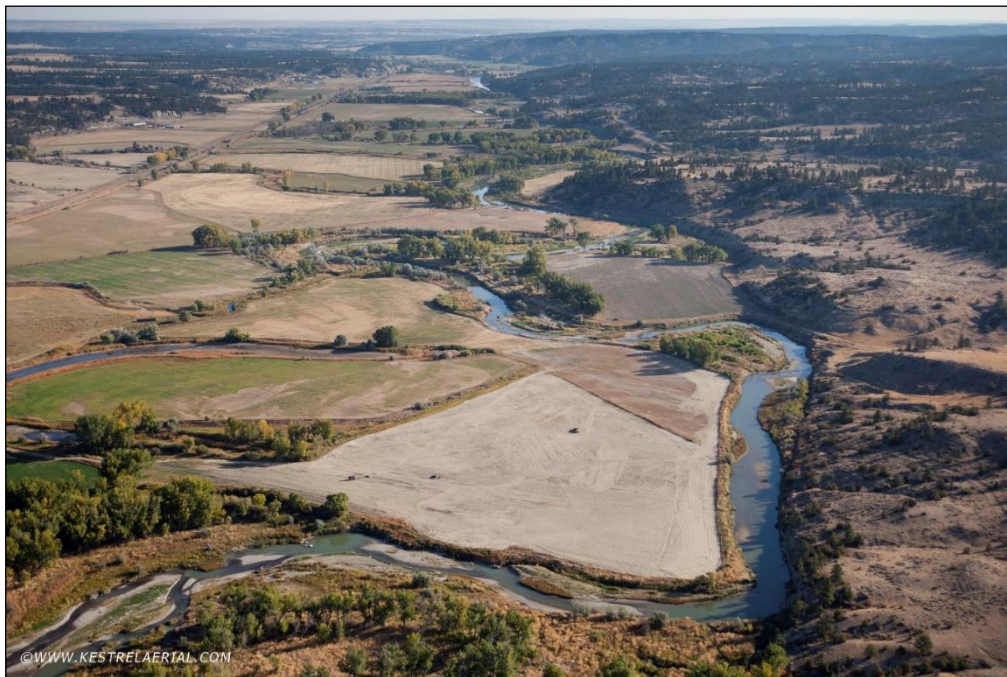
Figure 22. View downstream showing Musselshell River following south valley wall (Sept 20, 2012—Kestrel).

Reach 5 is much less confined than Reach 6 upstream, mainly because the rail line and highway both cross the river valley and expand the corridor (Figure 22). Reach 5 has the highest mean migration rate in the project reach, and the 368 foot-wide erosion hazard buffer is the largest as a result.

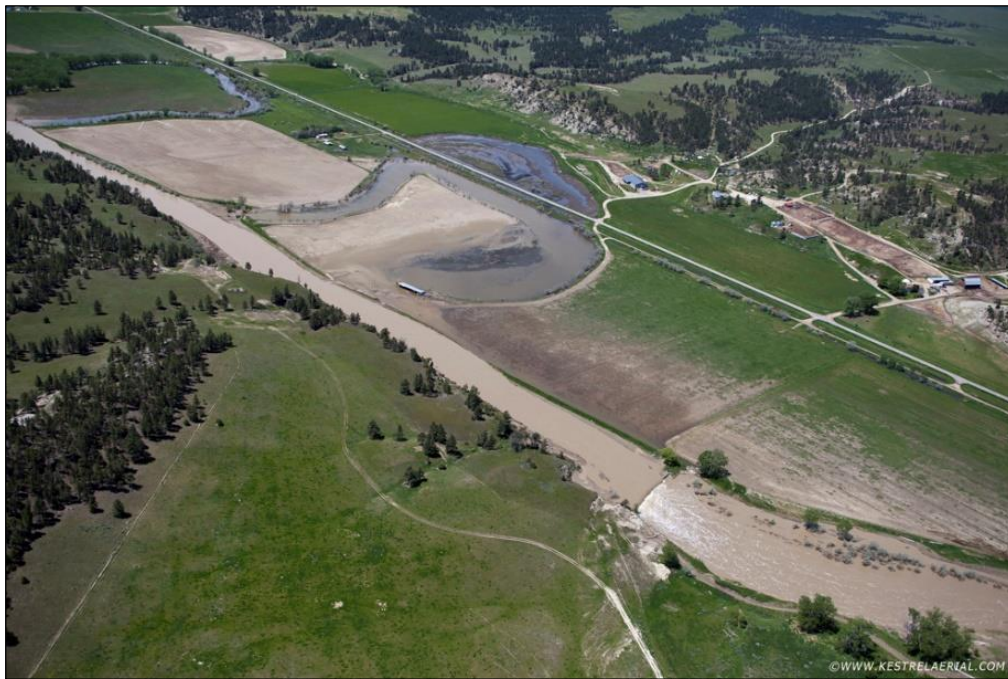
Figure 23. View upstream of Eliason Diversion Dam on June 16, 2011 showing historic channel remnants both within active corridor and beyond highway (Kestrel).

Reach 4 is the straightest reach in the project area, with a sinuosity of 1.2 (the channel length is 1.2 times the straight valley distance). Numerous floodplain meander scars record a much longer channel length, on both sides of the highway/rail line (Figure 23).

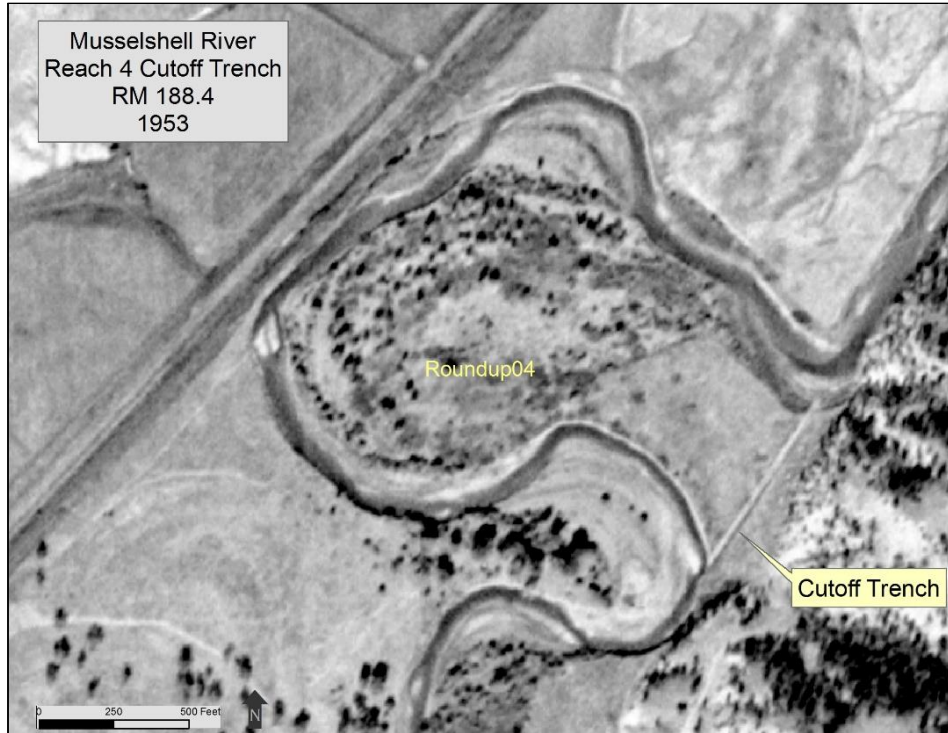
Figure 24. 1953 image at RM 188.4 showing cutoff trench excavated through meander core.

At RM 188.4 there is a good example of a deliberate bendway cutoff between 1953 and 1979 that was achieved by excavating a pilot trench through the bendway core that eventually captured the main river channel (Figure 24 and Figure 25). This resulted in the loss of almost a mile of channel length. The bankline upstream of this man-made cutoff is now intensively armored (Figure 26).

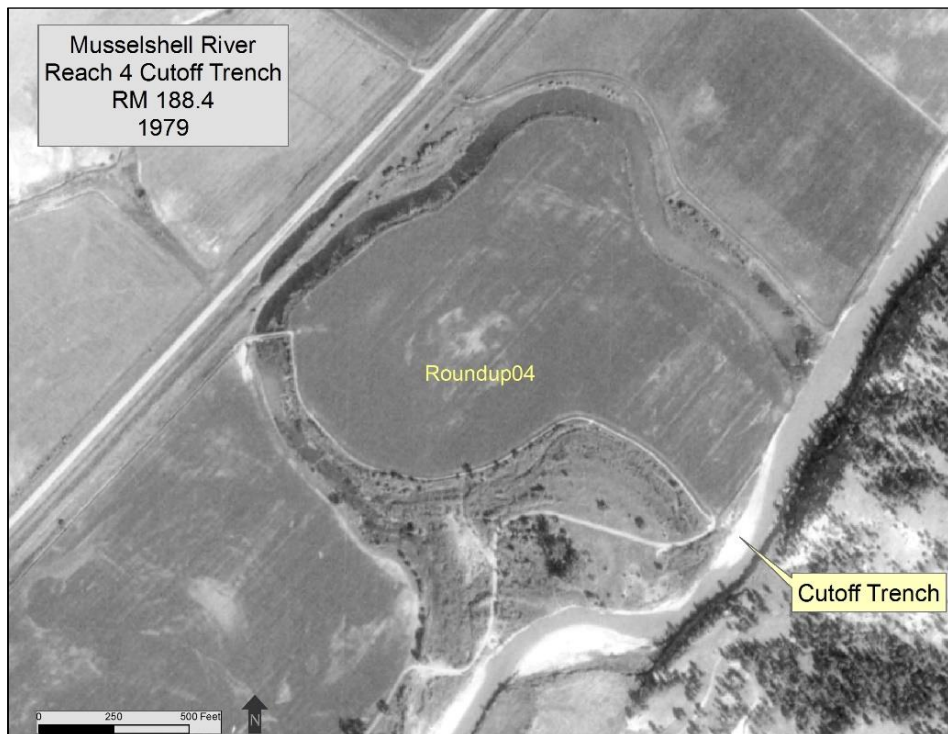
Figure 25. 1979 image at RM 188.4 showing trench capture of main river channel.

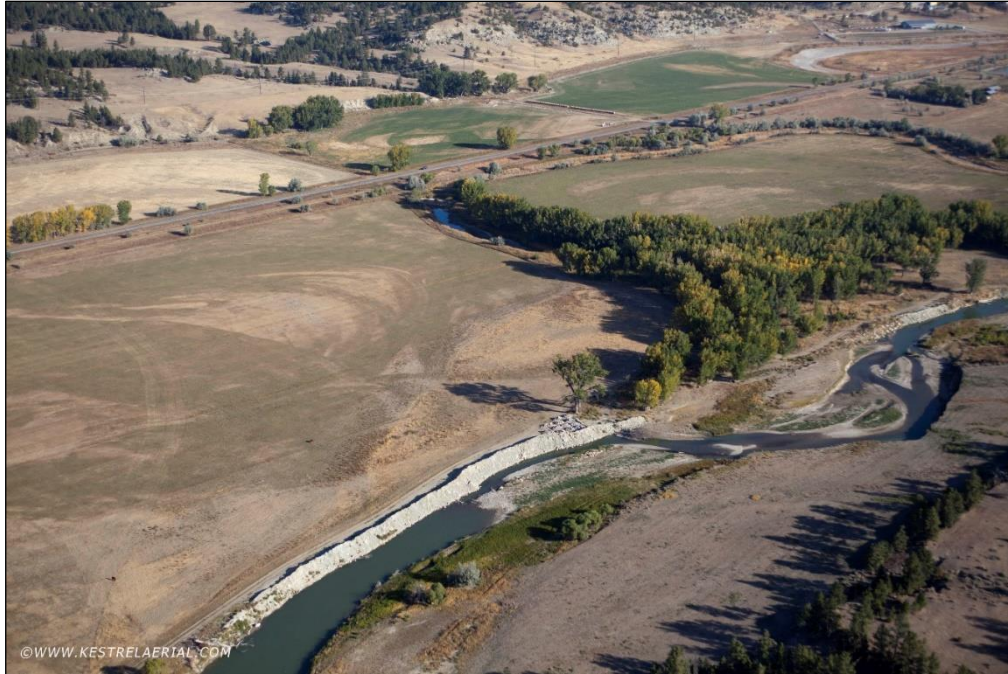
Figure 26. View downstream showing left bank armoring just below Goulding Creek Road Bridge (Sept 20, 2012, Kestrel).

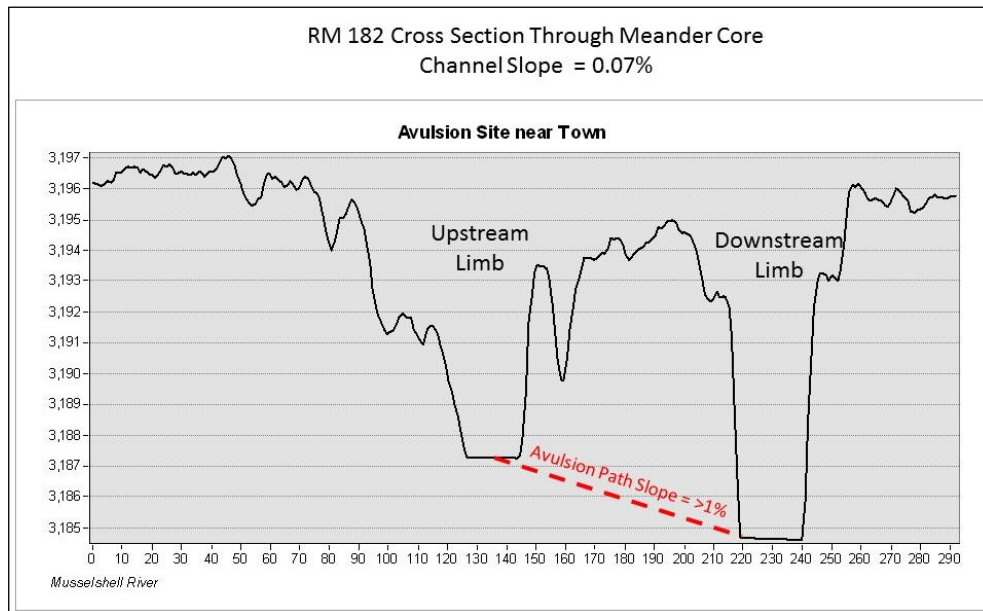
Figure 28. Cross section through avulsion path showing avulsion route slope is about 14 times that of channel slope.

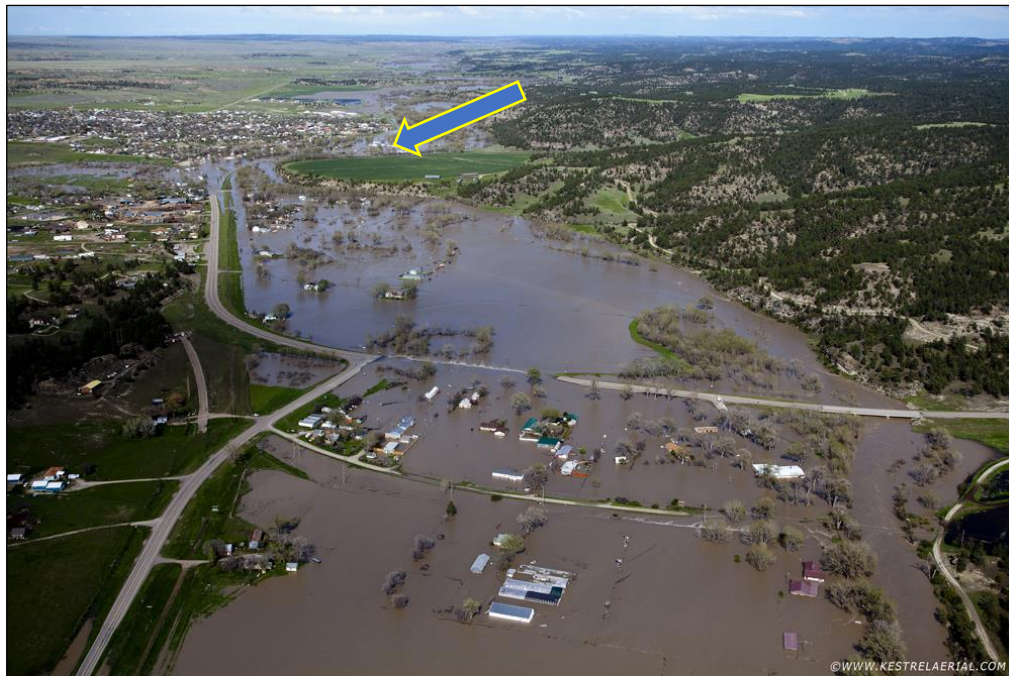
Figure 32. View downstream of bedrock constriction (arrow) at Roundup during 2011 flood (May 26, 2011—Kestrel).

Also notable in Reach 3 are two constrictions formed by bedrock and transportation infrastructure, one of which is just upstream of Roundup, where a high bedrock shelf juts into the stream corridor. Historically, the river flowed north of this bedrock in an area now isolated by development (Figure 32 and Figure 33). The second constriction is located downstream just above Number Four Road.

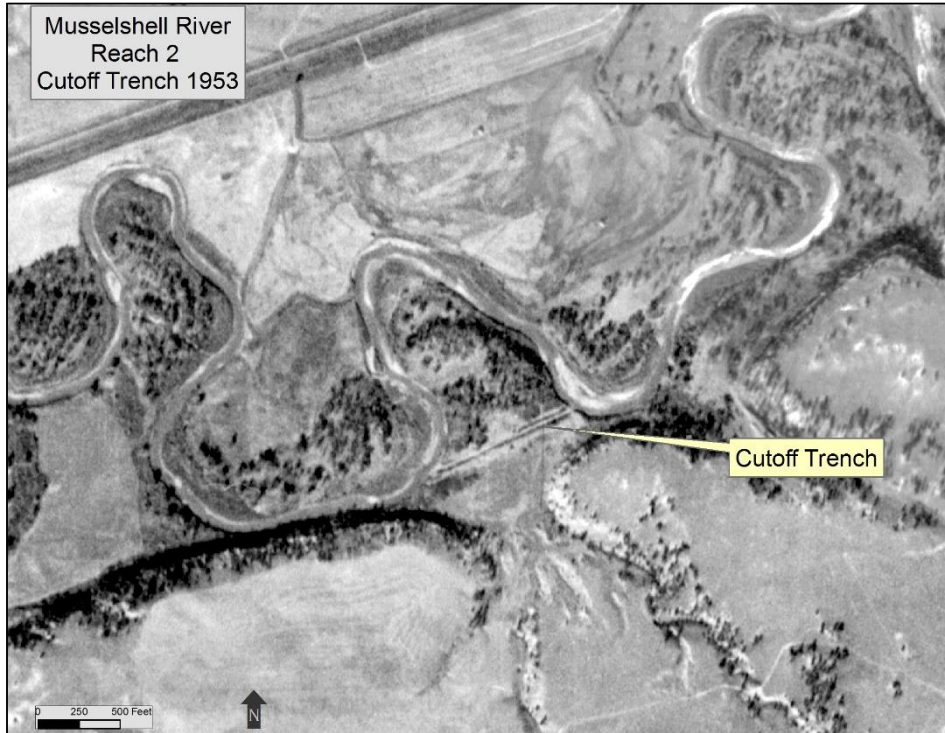
Figure 34. 1953 image of Reach 2 meander cutoff trench.

Although there have been two major cutoffs in the reach since 1953, neither of those avulsions occurred during the 2011 flood. One of those cutoffs was precipitated by the excavation of a cutoff trench through a meander core sometime prior to 1953 (Figure 34 and Figure 35). It is interesting to note that both this cutoff and another immediately downstream were blocked by dikes by 1979, limiting high water flow into the oxbows (Figure 36). With regard to natural storage of spring runoff, removal of these blockages could provide restoration opportunity.

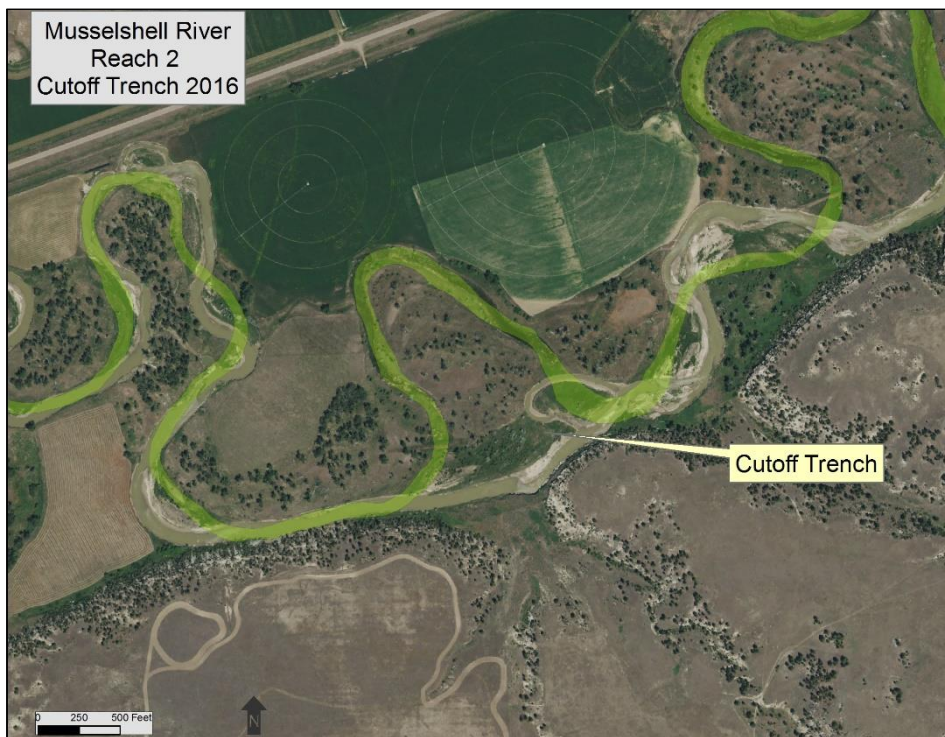
Figure 35. 2015 image of Reach 2 meander cutoff through trench.

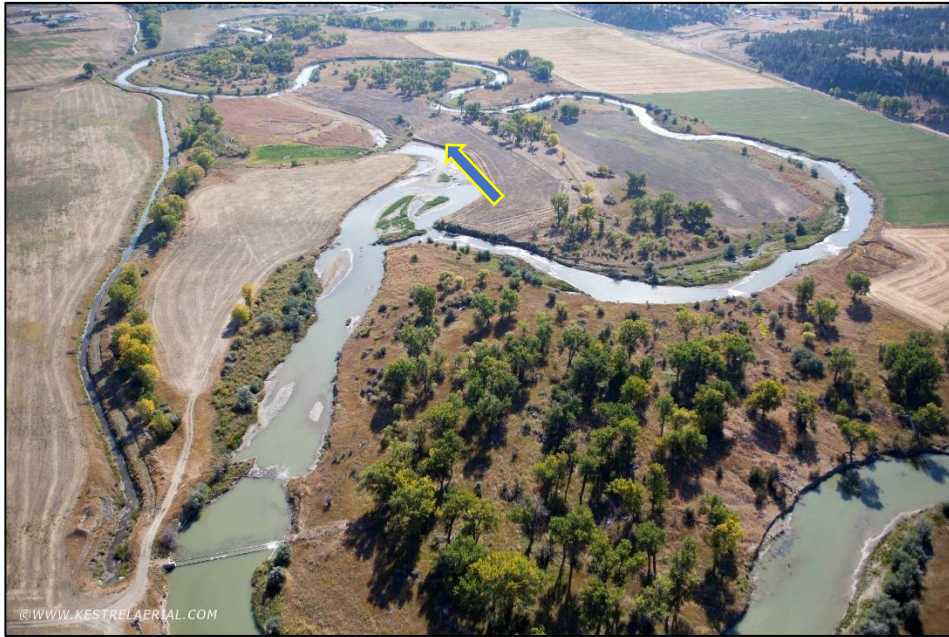
Figure 37. View downstream showing Kilby Butte avulsion (arrow) and Goffena Diversion in foreground - Sept 20, 2012, Kestrel.

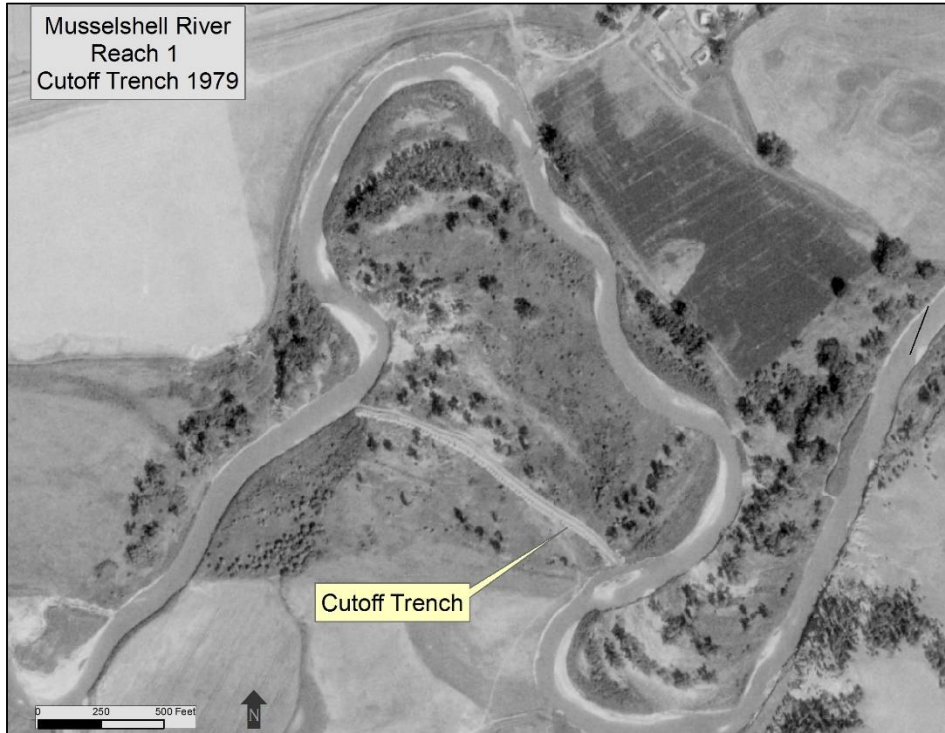
Figure 38. 1979 image showing newly excavated cutoff trench at RM 163.4.

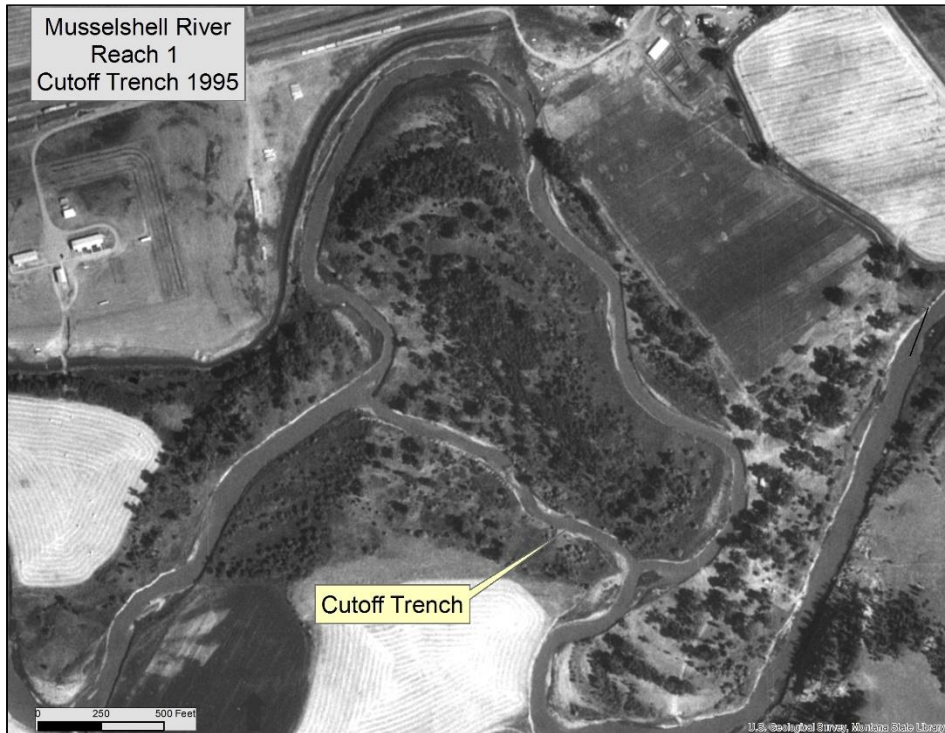
Figure 39. 1995 image showing captured cutoff trench at RM 163.4.

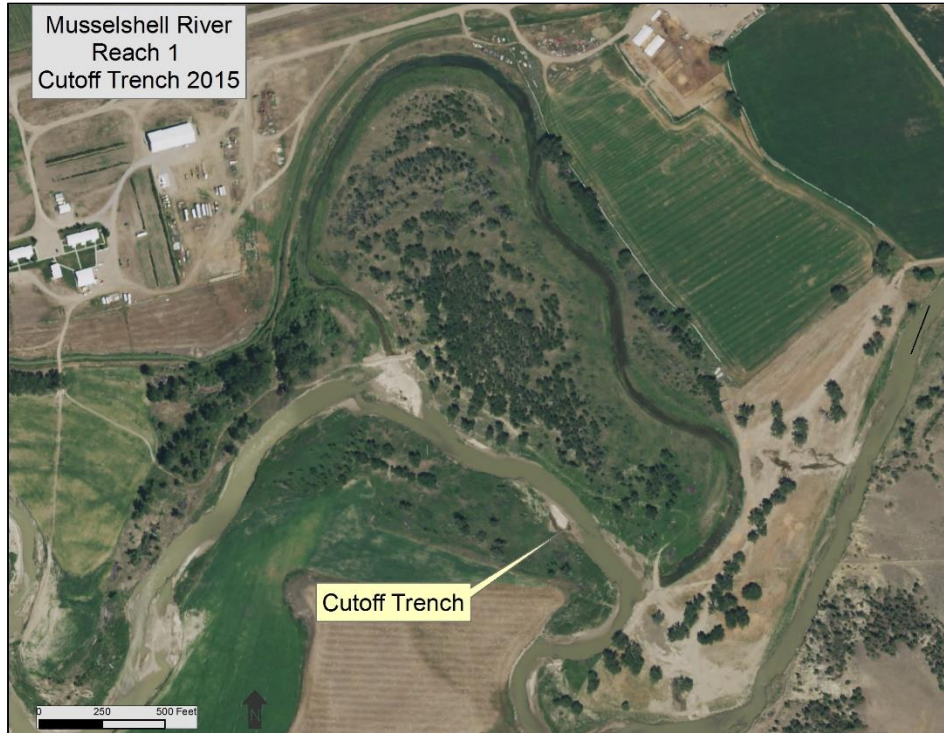
Figure 40. 1979 image showing cutoff through trench and oxbow blockages at RM 163.4.
