# Final Report

November 17, 2008

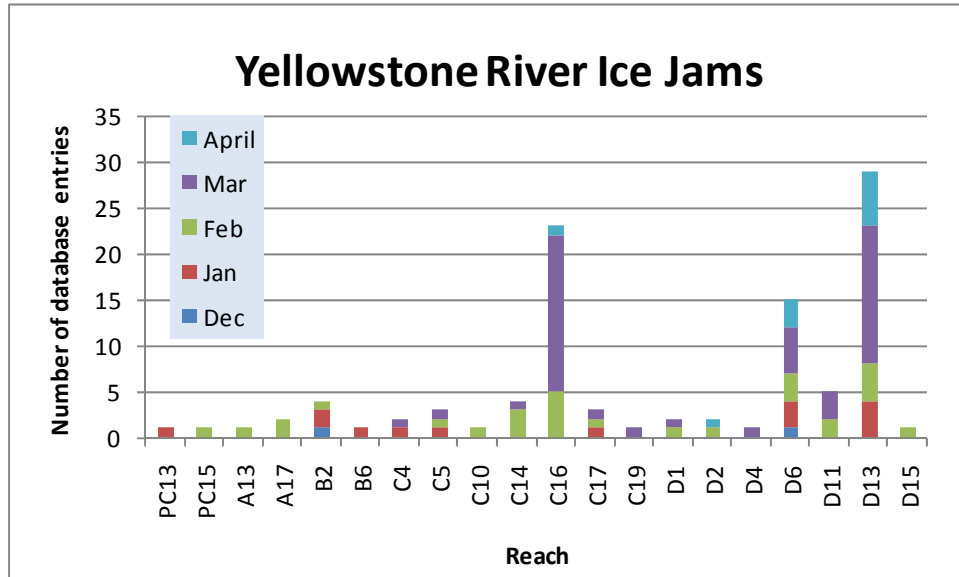
**Figure 3-3. Number of ice jam database entries for reaches of the Yellowstone River (multiple entries may exist for a single event).**
