County	Sweet Grass	Upstream River Mile	459.7
Classification	UB: Unconfined braided	Downstream River Mile	456.4
General Location	Big Timber Creek	Length	3.30 mi (5.31 km)

Narrative Summary

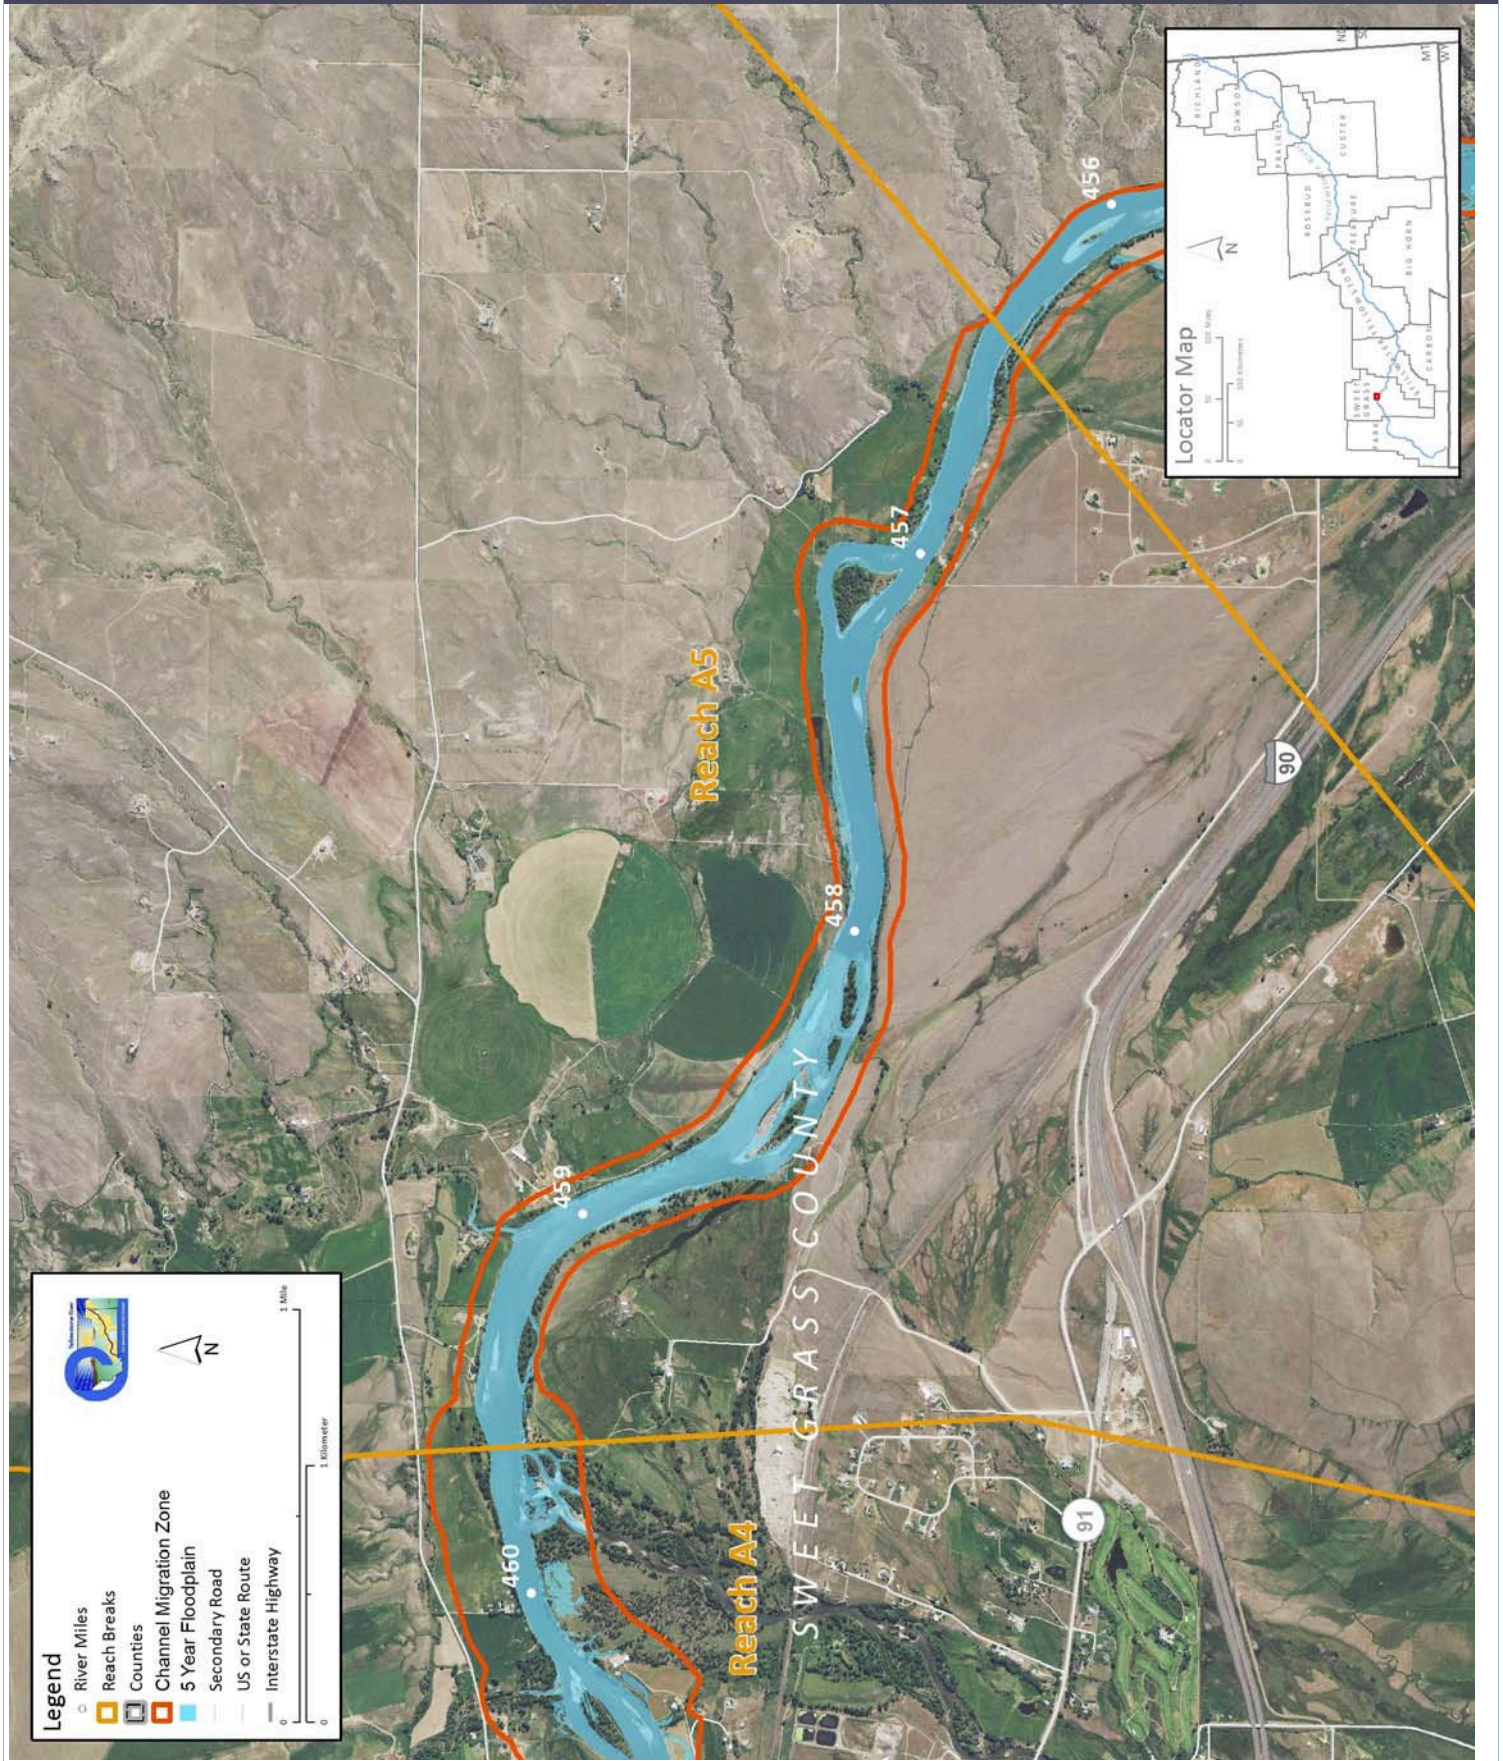
CHANNEL MIGRATION ZONE MAP

Reach A5 is approximately 3.3 miles long, and is located just below Big Timber near the Otter Creek Fishing Access Site starting just below the mouth of the Boulder River. Reach A5 shows low migration rates and has a relatively narrow CMZ as a result. Similar to other reaches in Region A, the channel footprint has enlarged since 1950; in this reach the channel shows continual expansion from 1950 to 2001 of about 24 acres. This has been accompanied by a loss of 16 acres of riparian area in the main river corridor.

Reach A5 has substantial irrigated land in the Channel Migration Zone. Land use mapping for 2011 conditions show 62 acres of flood, 2 acres of sprinkler, and 9 acres of pivot irrigated land within the CMZ boundary.
