County	Custer	Upstream River Mile	166.2
Classification	CS: Confined straight	Downstream River Mile	158.7
General Location	Shirley	Length	7.50 mi (12.07 km)

Reach C20 is 7.5 miles long and is located in lowermost Custer County at Shirley. The Bonfield Fishing Access Site is located at RM 161 on the left bank. It is a Confined Straight reach type, as the river flows through the confining geology of the Fort Union Formation sandstones. Small tributaries that enter Reach C20 include Hay Creek (RM 165), Harris Creek (RM 164), Cabin and Cottonwood Creeks (RM 162) and Saugus Creek (RM 160.2). Bank migration rates are very low in the reach, and as a result the Channel Migration Zone (CMZ) is unusually narrow.

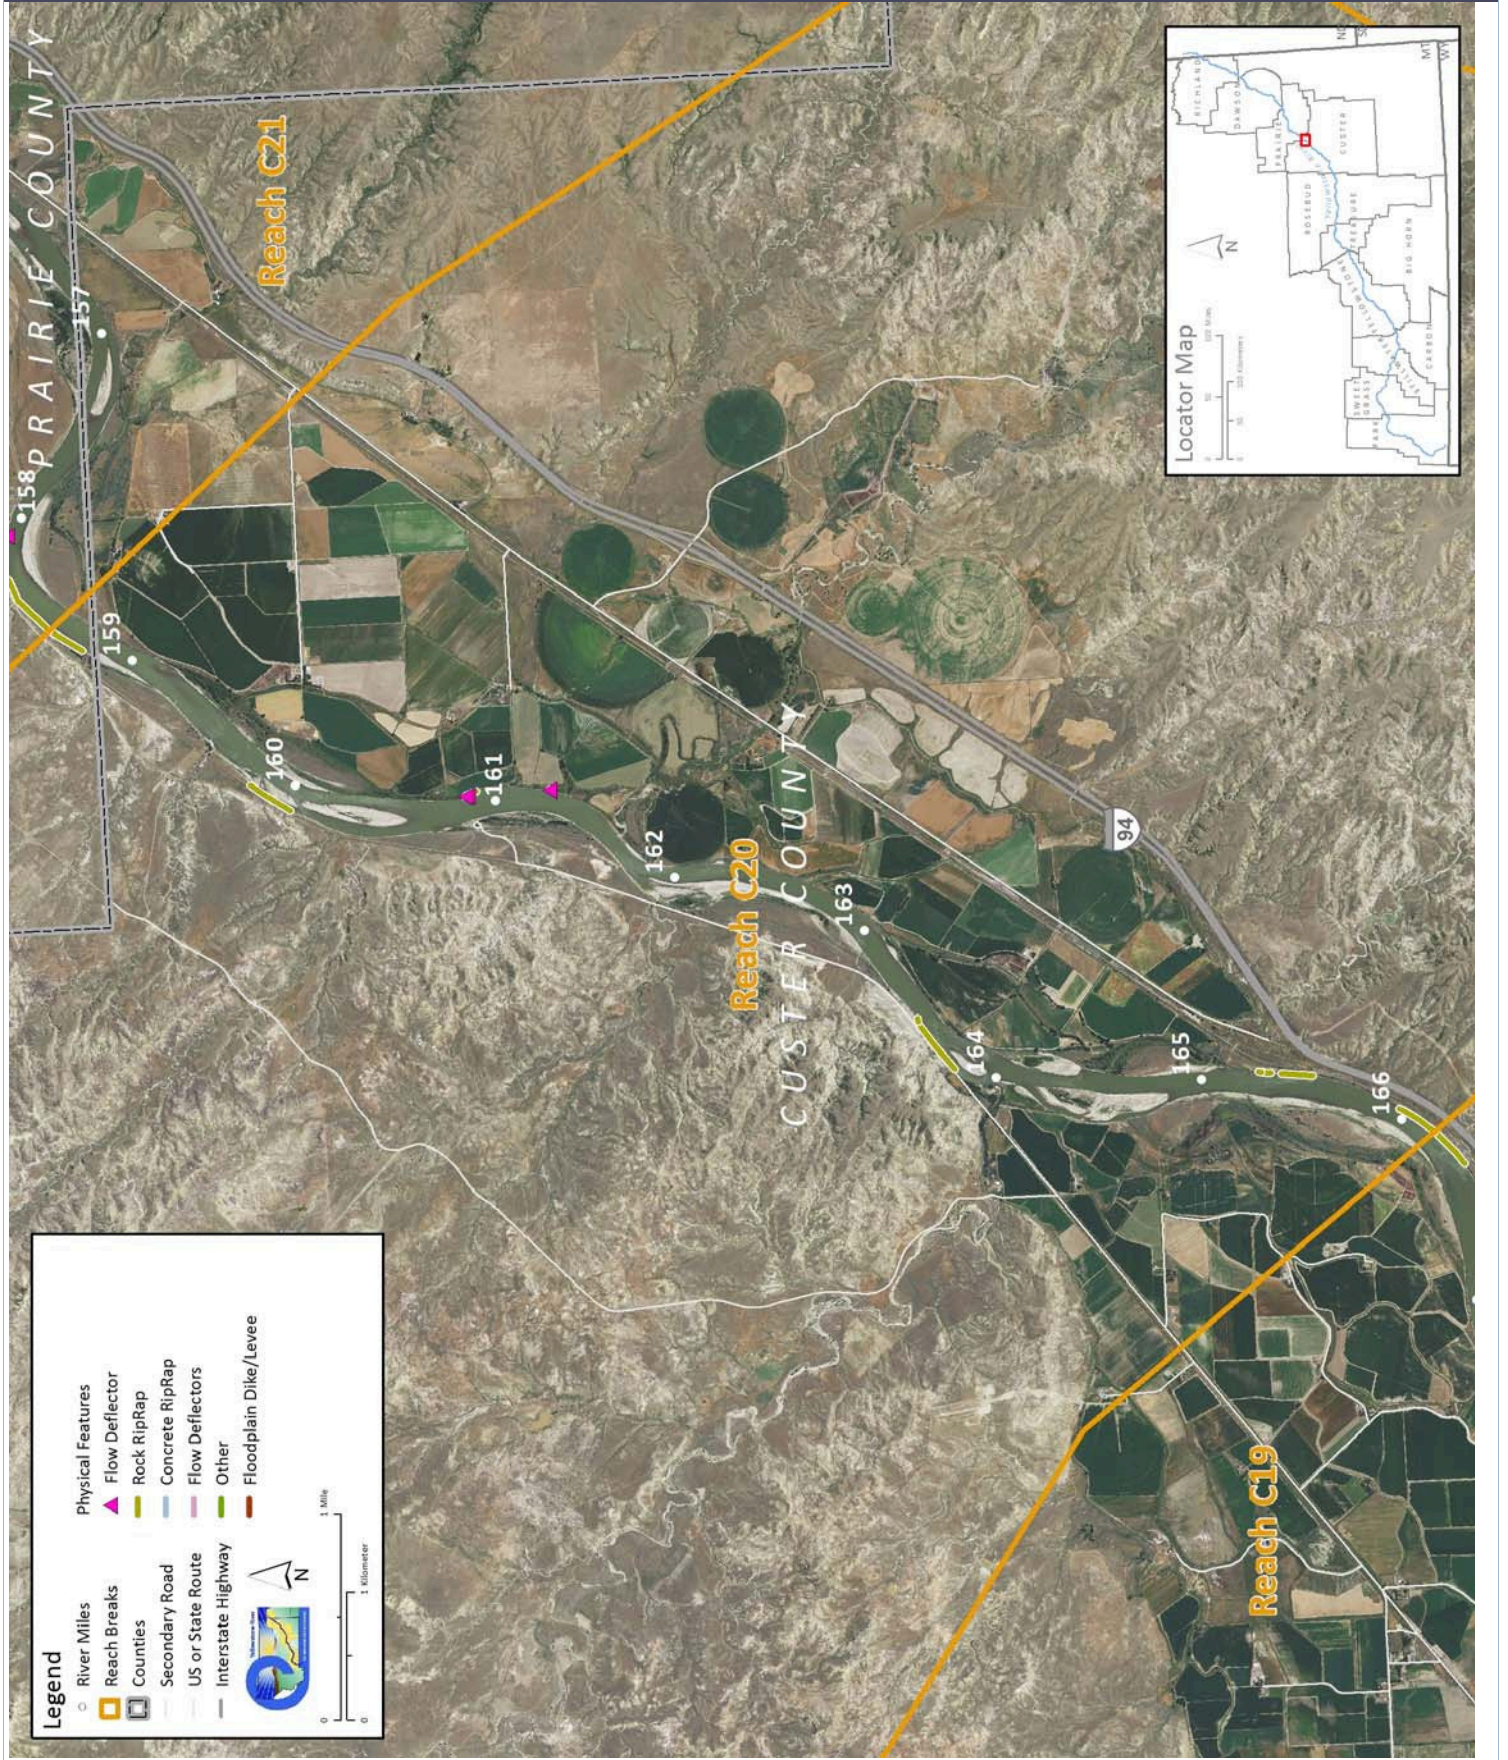
PHYSICAL FEATURES MAP (2011)

There is just over a mile of bank armor in the reach that covers about 8 percent of the total bankline. As of 2011 there was 6,059 feet of rock riprap in reach C20, and 1,650 feet of that armor was built between 2001 and 2011. Most of the rock riprap is protecting the abandoned Milwaukee Rail line on the north side of the river where it runs in the edge of the bluff line. The new armor is protecting the Shirley Pump Station at RM 165.3R. There are also 131 feet of flow deflectors across the river from the Bonfield Fishing Access Site.
