<b>County</b>	Park	<b>Upstream River Mile</b>	506.7
<b>Classification</b>	PCB: Partially confined braided	<b>Downstream River Mile</b>	505
<b>General Location</b>	Through canyon upstream of Livingston	<b>Length</b>	1.70 mi (2.74 km)

## Narrative Summary

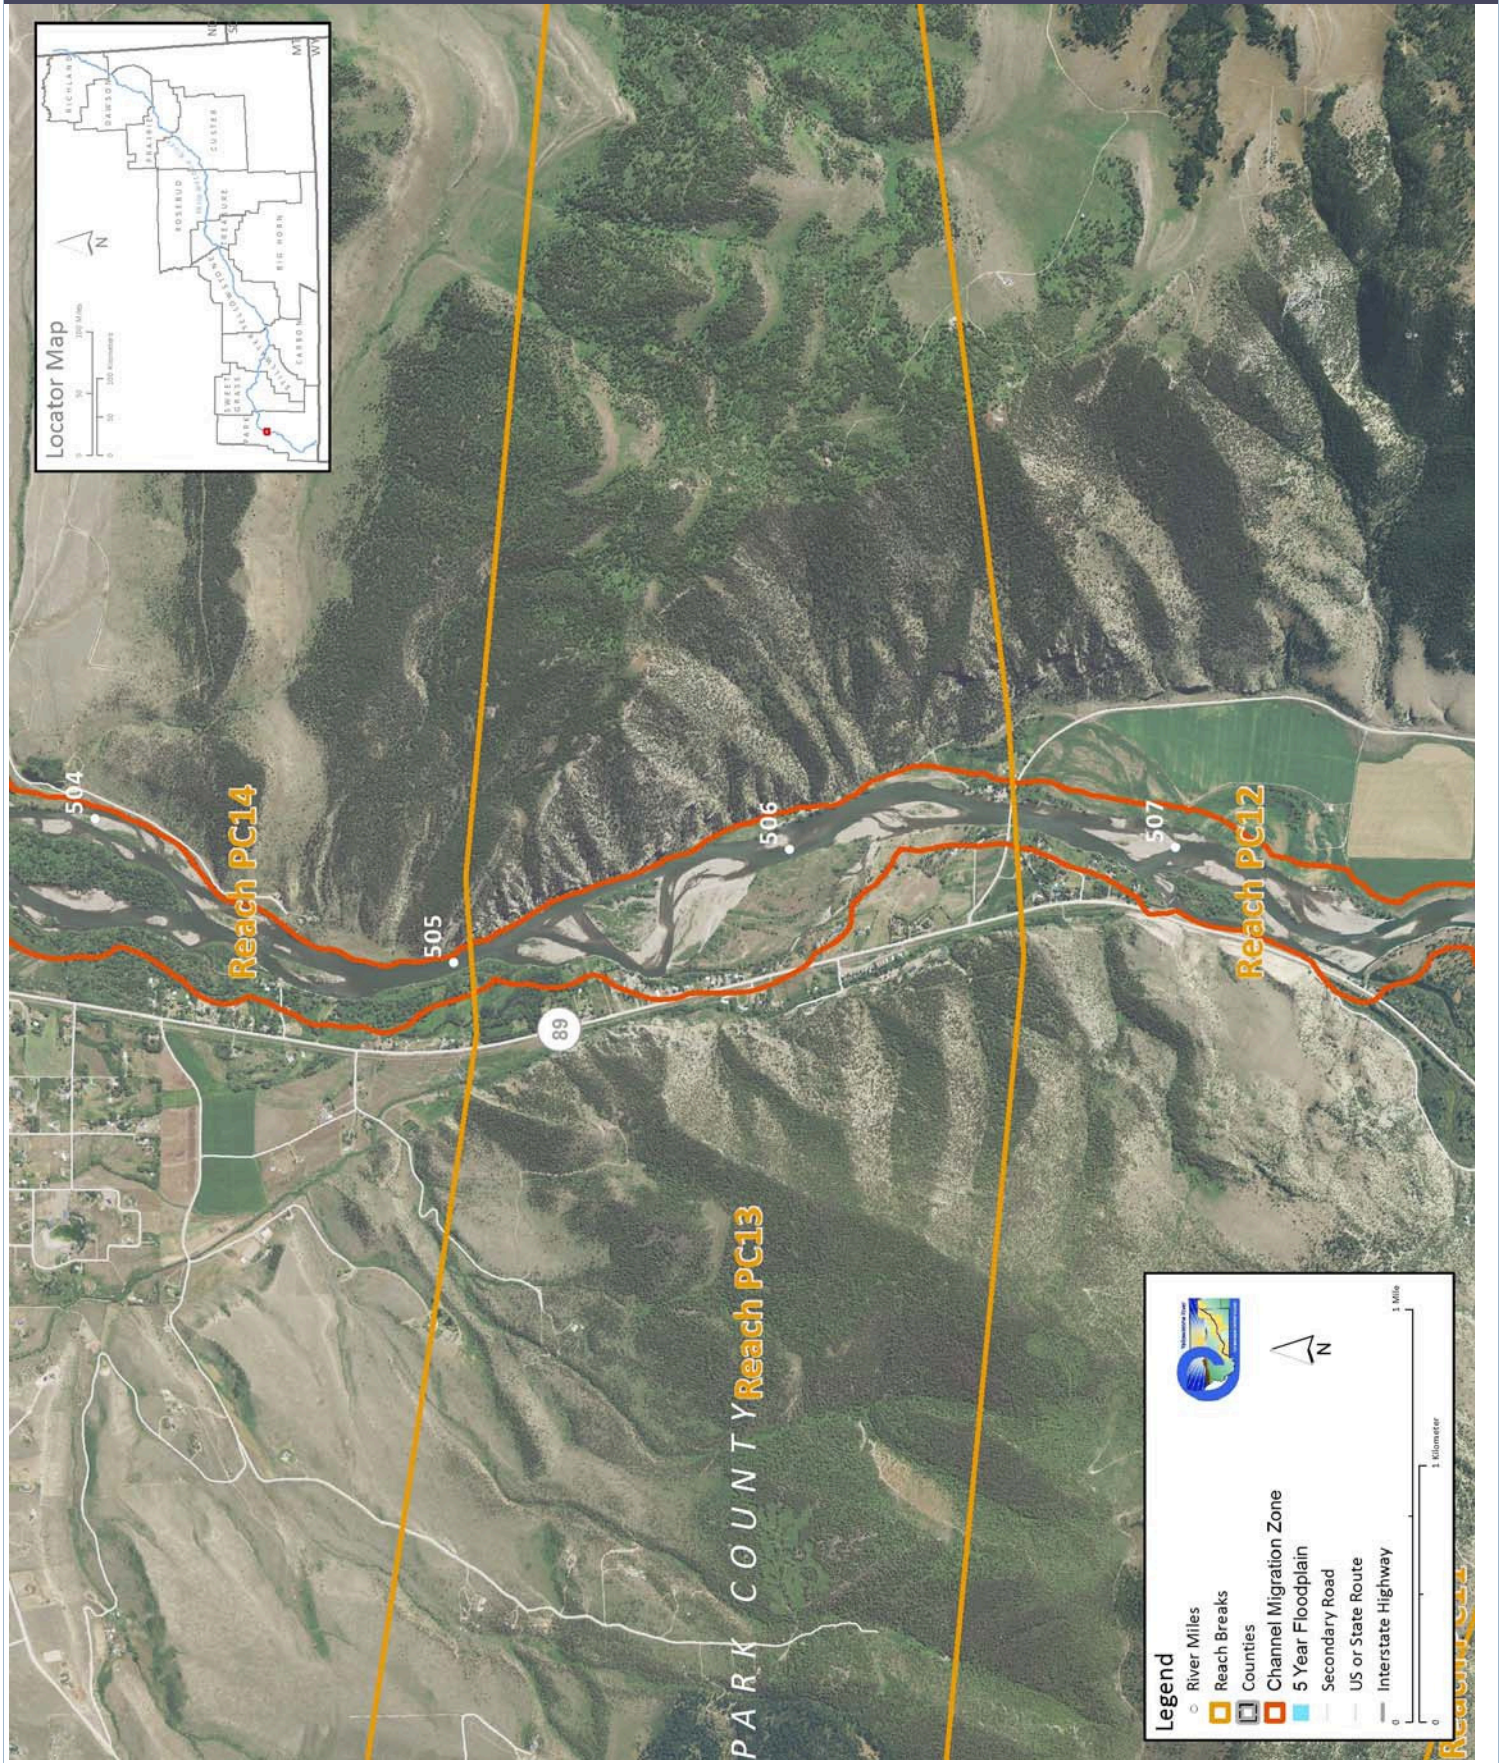
## CHANNEL MIGRATION ZONE MAP

Numerous structures and a portion of the Highway 89 embankment are located within the CMZ in Reach PC13. A total of 8 percent of the CMZ has been restricted by physical features.

- CMZ Management due to development pressure in confined reach
