Yellowstone River Conservation District Council
**Yellowstone River Pipeline Risk Assessment
and Floodplain Reclamation Planning Project**
FINAL Report

September 21, 2012

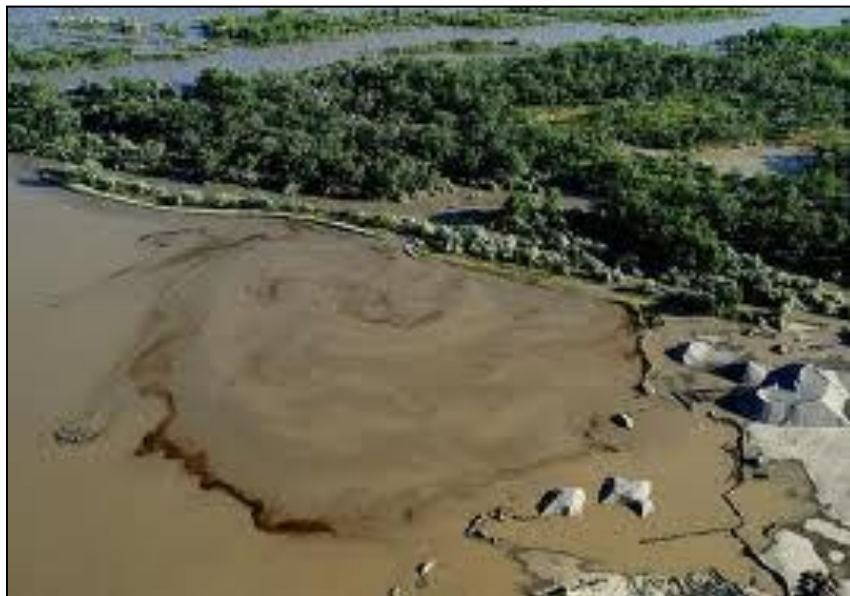
Figure 1. 2011 Oil spill, Yellowstone River (Billings Gazette).

The flooding and erosion associated with the seasonal high water of 2011 resulted in significant damage along the Yellowstone River mainstem and tributaries. Floodwaters on the Yellowstone near Billings peaked July 2, 2011 at 70,600 cfs, which is an estimated 25-50-year event. Damages sustained to critical infrastructure include ExxonMobil's Silvertip Pipeline, a 12-inch diameter crude oil pipeline that, until its rupture, crossed under the Yellowstone River near Laurel. Originally installed approximately 5-7 feet beneath the riverbed, hydraulic forces had since scoured away the overlying gravel such that on July 1, 2011, the pipeline ruptured, spilling an estimated 50,000 gallons of oil into the Yellowstone River. As the river receded, oil was detected miles downstream of the rupture and millions of dollars were spent in the clean-up effort. This environmental accident has heightened public awareness both locally and nationally. The Yellowstone River is the longest free-flowing river in the lower 48 states and is home to threatened and endangered (T&E) species including the Pallid Sturgeon. In addition, numerous communities along the river tap the Yellowstone for their public water supply systems.

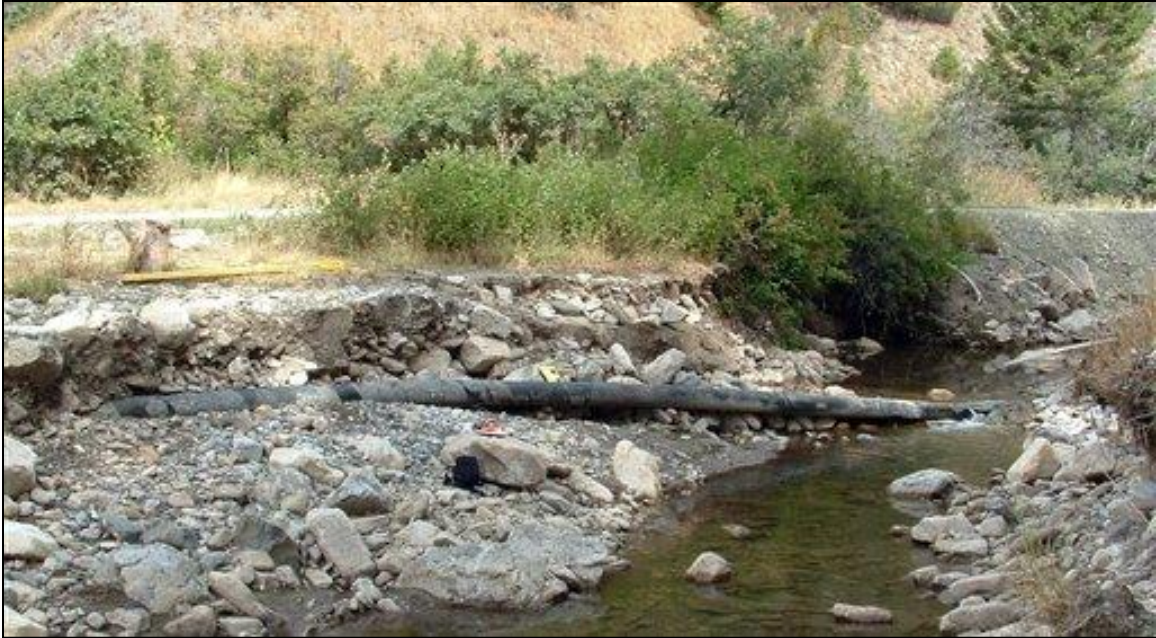
Figure 3. Exposed section of ConocoPhillips gasoline pipeline on Beaver Creek near York, Montana showing exposure from both lateral movement and vertical downcutting. (<http://ravallirepublic.com>)

1. Lateral migration of the river with eventual intersection of a pipeline route that is parallel to the river (Figure 3),
2. Lateral migration of the river at a pipeline crossing, where shallow margins of the crossing are exposed,
3. Reach-scale, systemic channel degradation (lowering of the channel bottom) due to natural or man-caused channel changes (Figure 4 and Figure 5),
4. Short term scour during flood events; this can be difficult to identify as it is typically not visible during low flows.

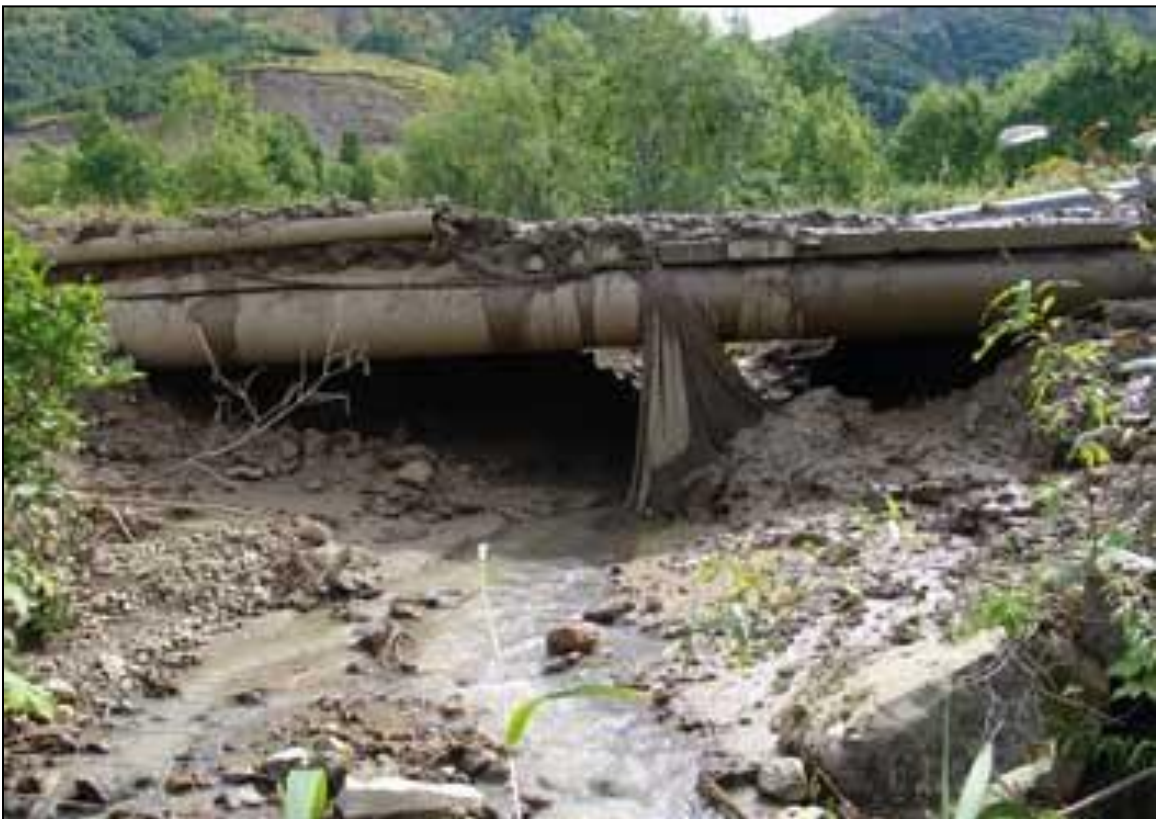
Figure 4. Pipeline exposed from vertical bed degradation, Travyanaya River, Russia. (<http://www.sakhalin.evinronment.ru>)

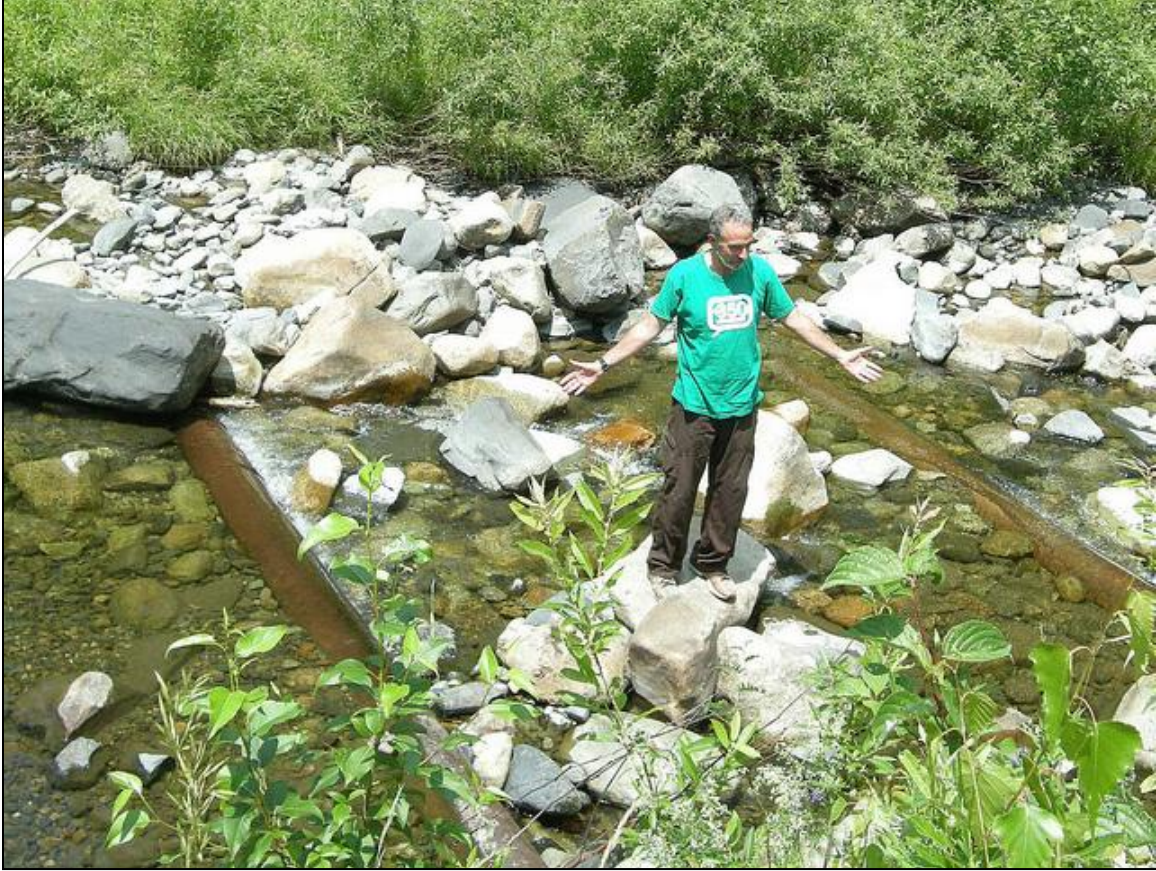
Figure 5. Exposure of two pipelines on small creek in Vermont. (<http://world.350.org>)

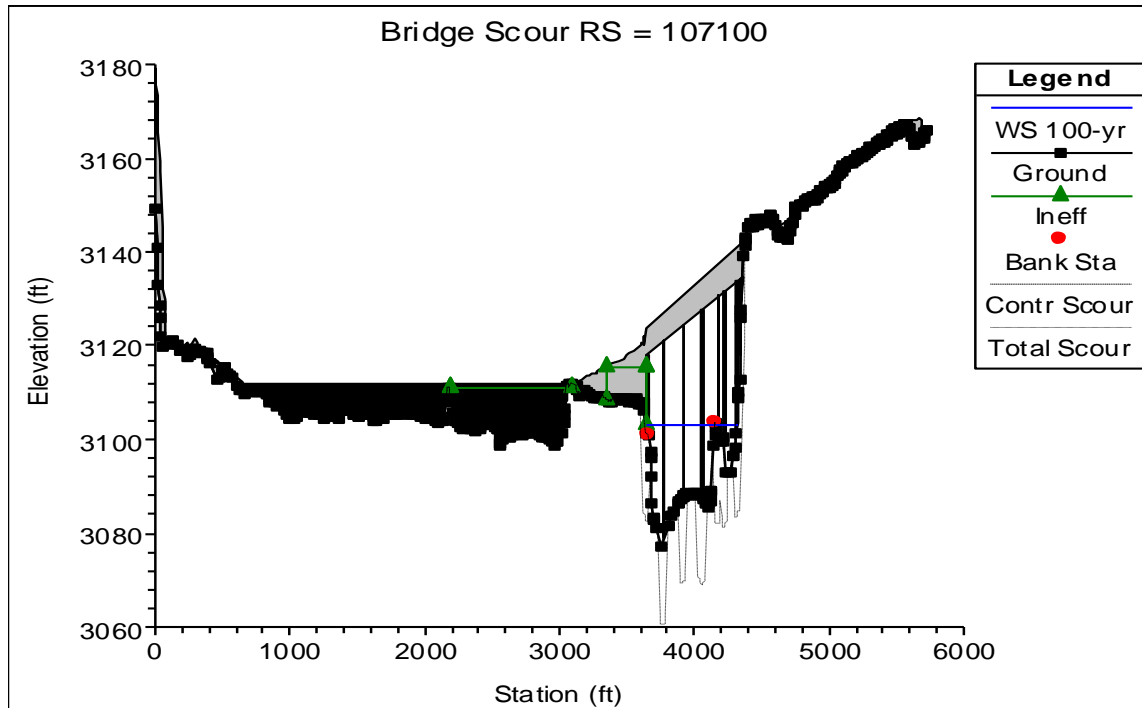
Figure 26 presents a schematic of computed scour for the Interstate 90 bridges. Levees upstream of the bridges reduce the rapid contraction of flows. Therefore, computed abutment scour is significantly less than that found for the downstream railroad bridge shown in **Figure 25**.

Interstate 90 Bridge Scour Analysis (RM 365): Contraction = 0 feet, Pier = 19 feet, Abutment = 8.9 feet

Figure 24. Site 9, RM 365 Bridge Scour Schematic, Interstate 90 bridges (upstream bridge).

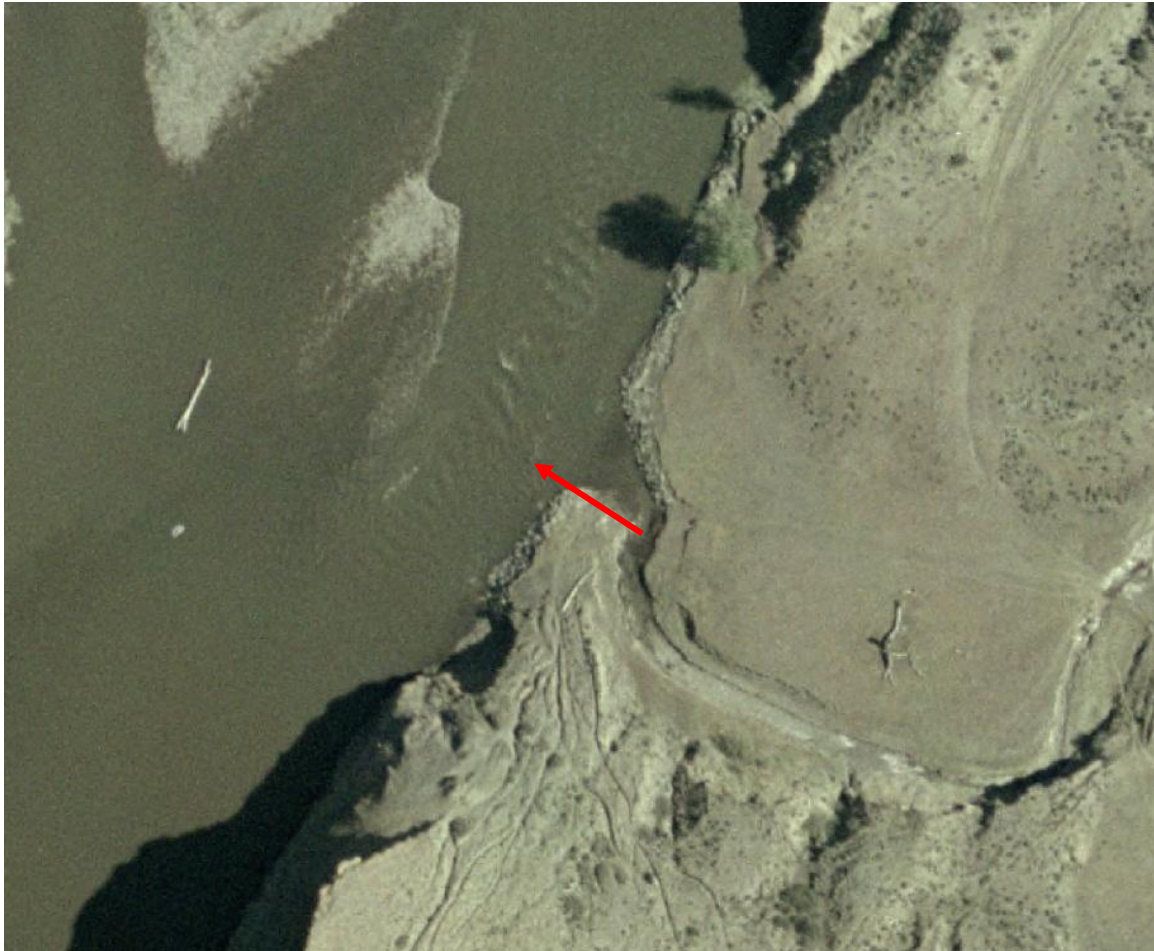
Since 1950, the right bank has migrated ~180 feet into the mouth of Birch Creek, where the pipelines cross the right bank of the river. The erosion was into deposits at the mouth of Birch Creek. This bank has been armored with concrete since 1950. The upstream end of this armor appears to be flanking and should be carefully monitored (Figure 27).

Figure 25. Mouth of Birch Creek at Site 10 (RM 367) showing flanking on upstream end of riprap.

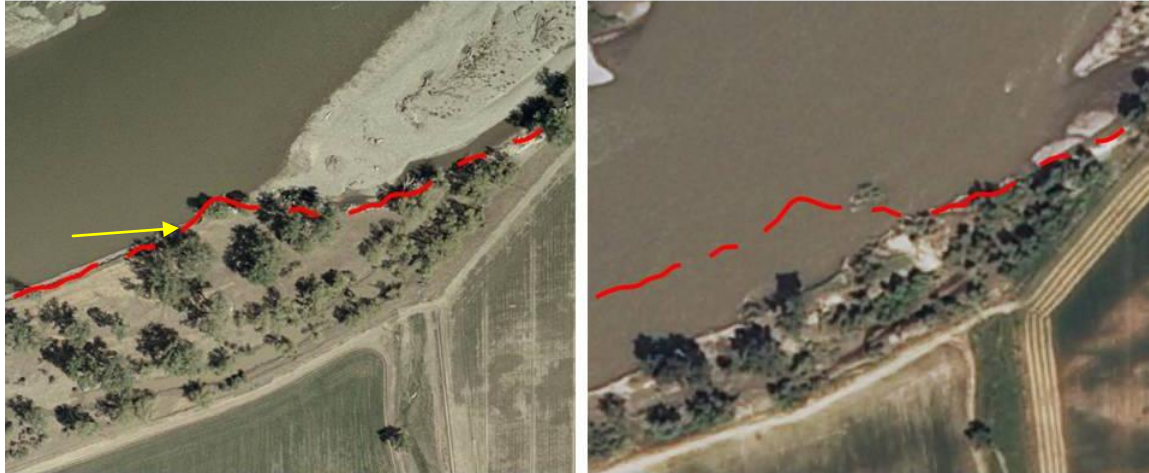
In 1950, the riverbank was 260 feet from the pipeline alignment shown in the NPMS geodatabase. A portion of this bank was armored sometime prior to 1976. By 2011, the river had migrated to within approximately 130 feet of the pipeline, flanking the upper end of this armor.

Figure 29. Site 14 bankline showing 2004 (left) and 2011 (right) conditions; red line is 2004 bankline and yellow is upstream end of armor in 2004. Pipeline runs parallel to field road on lower portion of image.

Site 14 Risk Potential: High due to armor failure and rapid right bank migration on an outside bend.

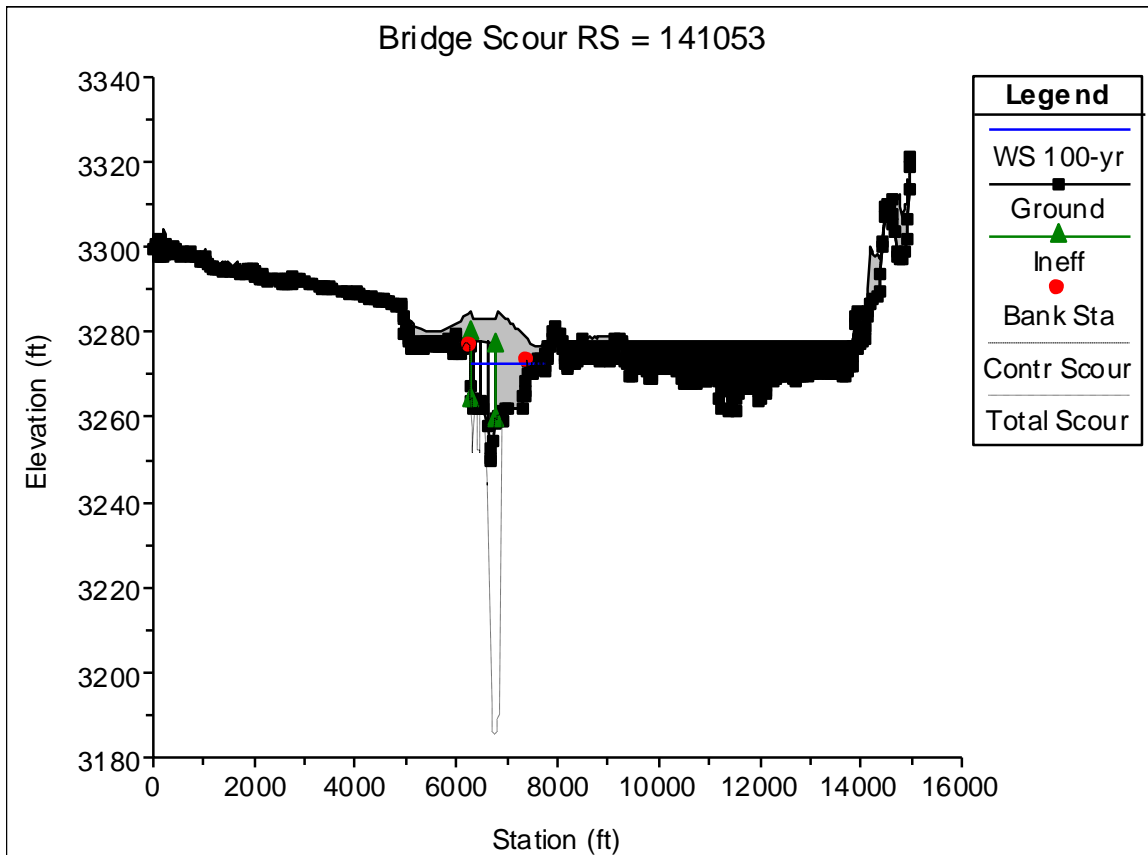
Bridge Scour Analysis (RM 385): Contraction = 0 feet, Pier = 15 feet, Abutment = 74 feet.

Figure 30. Site 16 Scour Analysis Schematic (RM385), Laurel Bridge.

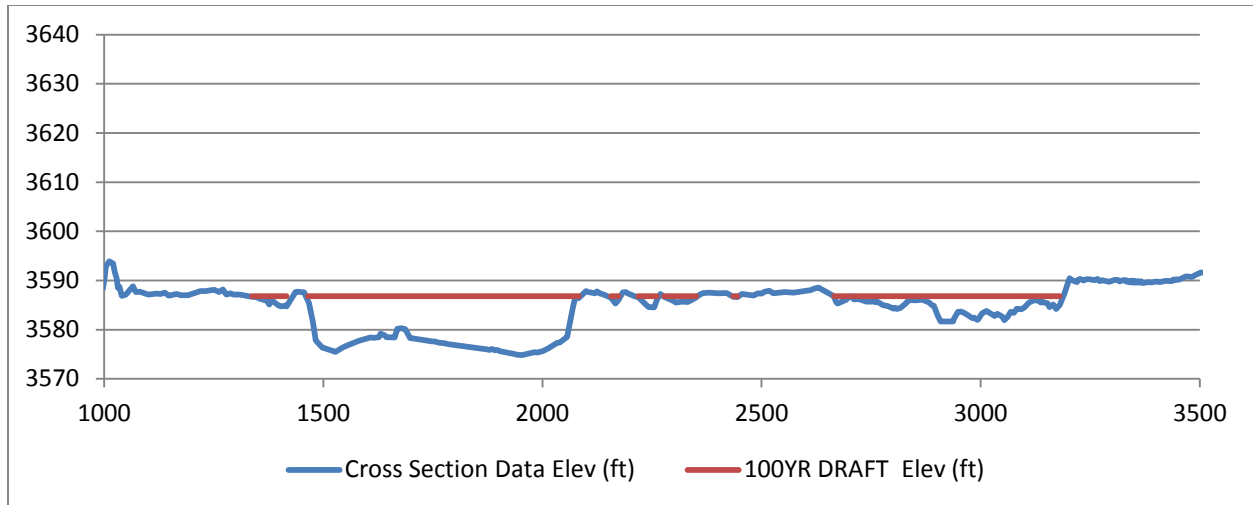
Figure 34. Cross Section at RM 417, 120 feet upstream of Site 18, showing 100-year water surface elevation. Note Yellowstone channel to left and perched (Stillwater River) channel on right.
