September 12, 2024

Yellowstone River Channel Migration Zone Mapping Park County Update

Executive Summary

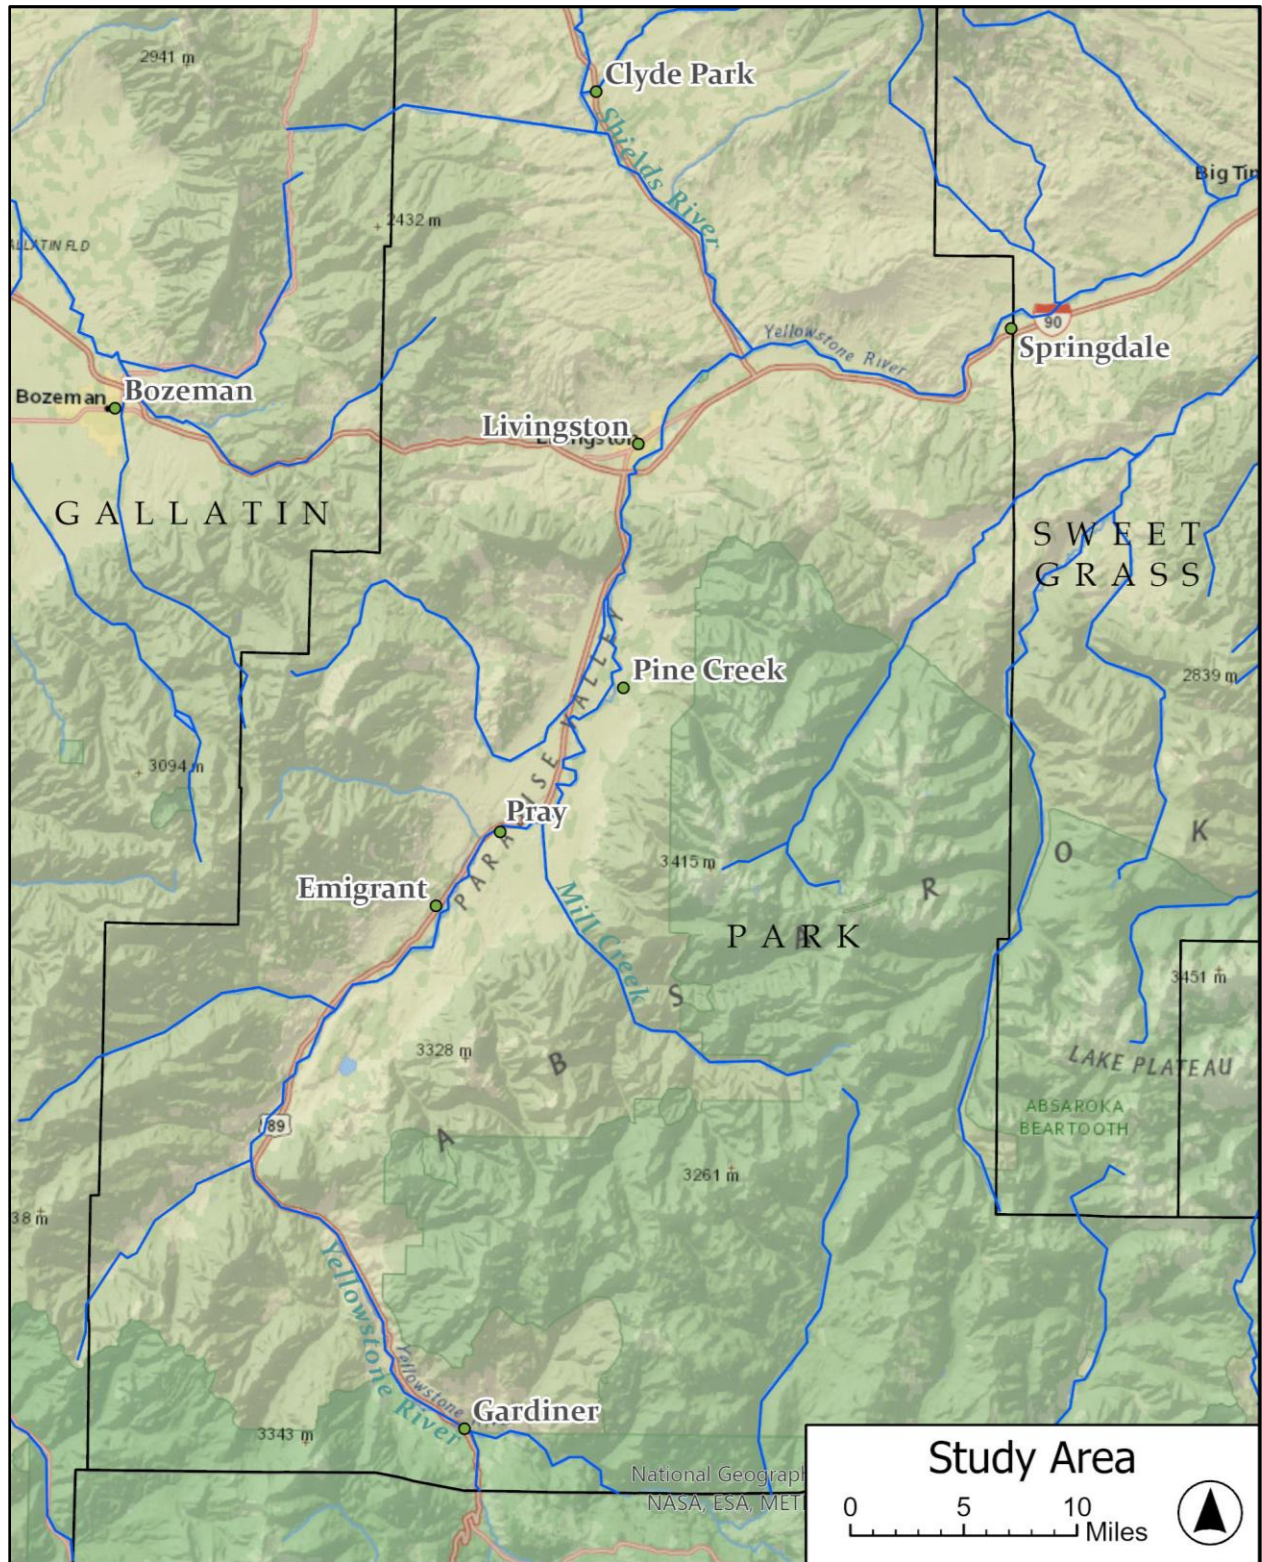
Figure 2. CMZ Mapping extent on the Yellowstone River.

The 86 miles of river in Park County (Figure 2) drains an area of 4,716 square miles with the only major tributary being the Shields River, which enters the Yellowstone River below the City of Livingston. There are several major irrigation diversions, including the Park Branch Canal and Livingston Ditch. With no dams on the river or major tributaries and only a few significant diversions, it behaves as a snow melt system with a natural hydrograph that tends to peak during late spring and early summer months.

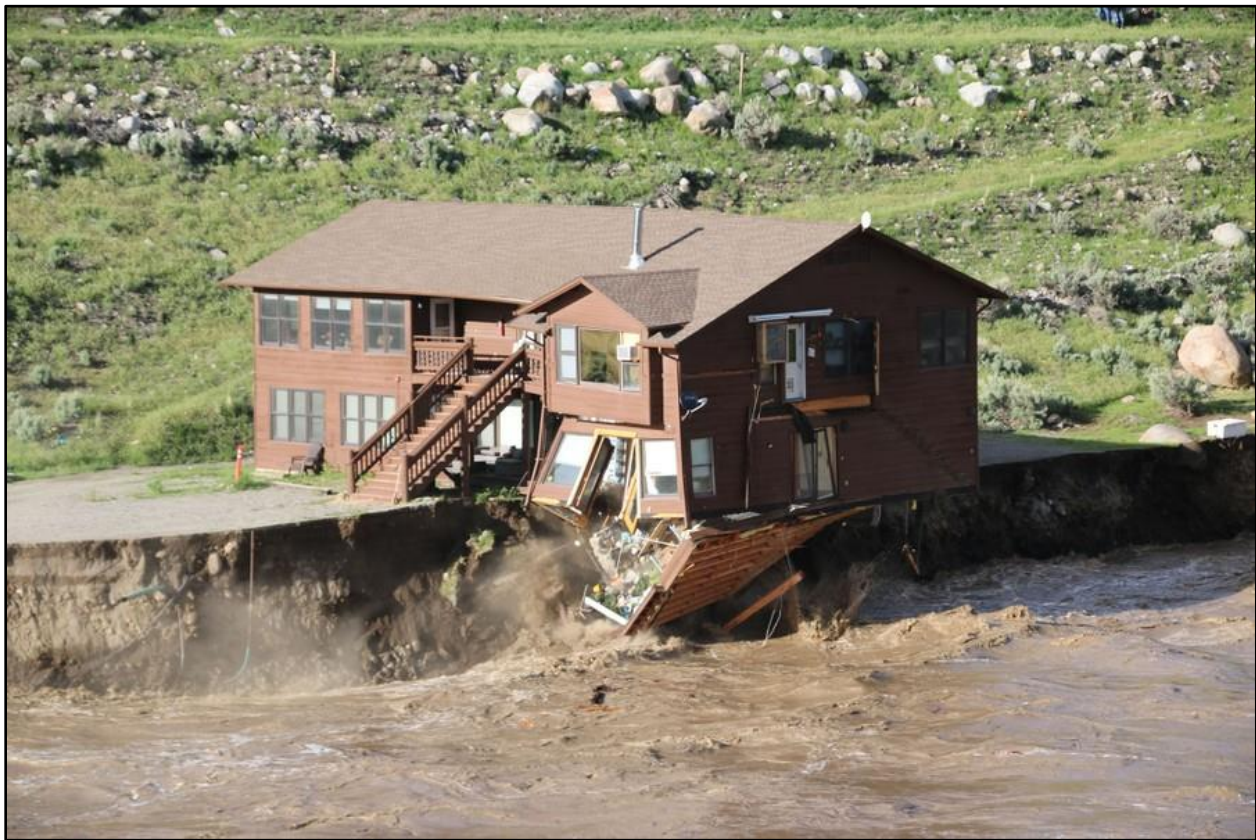
Figure 6. A National Park Service housing structure in Livingston, MT shown moments before falling into the Yellowstone River on June 13, 2022 (Gina Riquier / NPS).

Figure 6 and Figure 7 show a National Park Service housing structure on the Yellowstone River in Gardiner, Montana that was undermined during the 2022 flood. This has been a chronic problem in river management, as landowners assume that if their home is beyond the mapped floodplain margin, it is safe from all river hazards. In 2005, after experiencing massive flood damages in St. George, Utah (Figure 8), several property owners reflected on this issue (www.Utahfloodrelief.com):

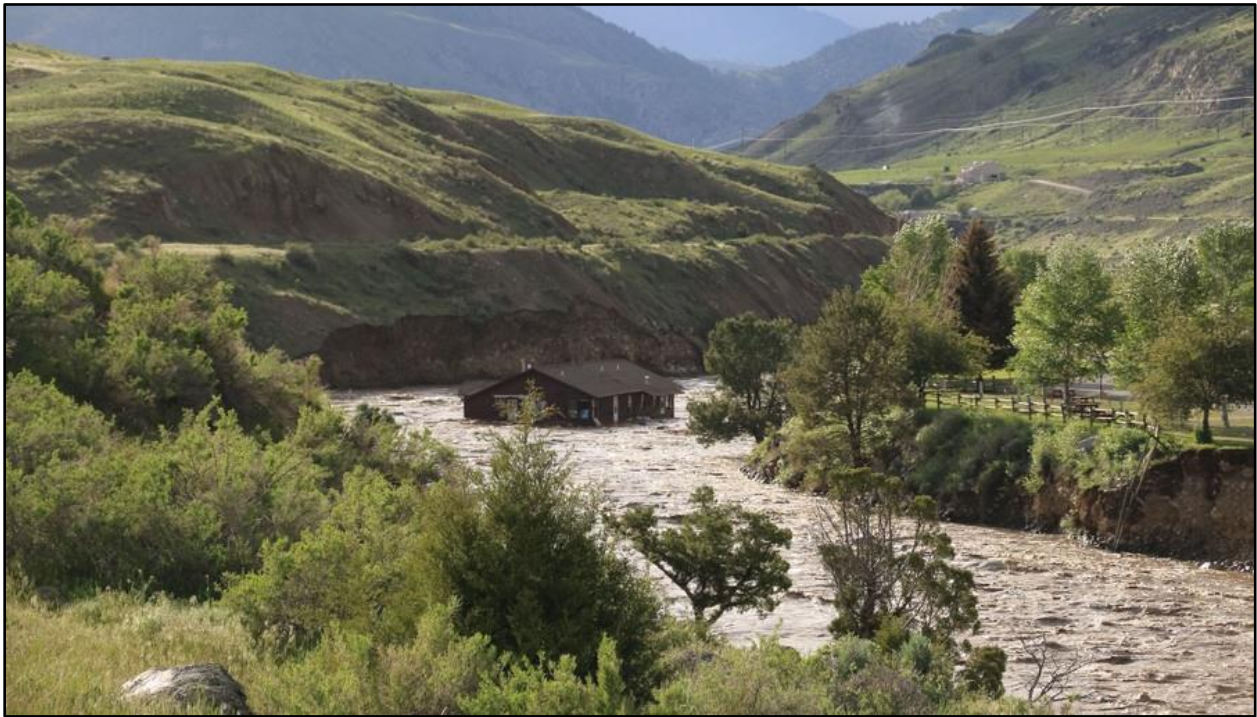
Figure 7. The same structure is shown floating downstream before eventually breaking up and depositing significant piles of debris on downstream properties (Gina Riquier / NPS).

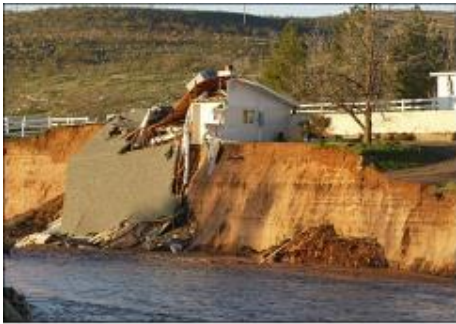
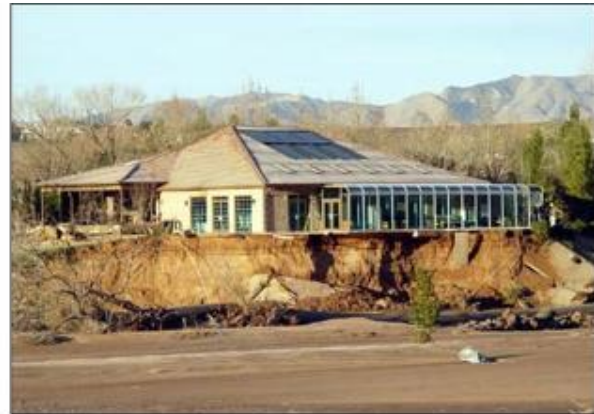
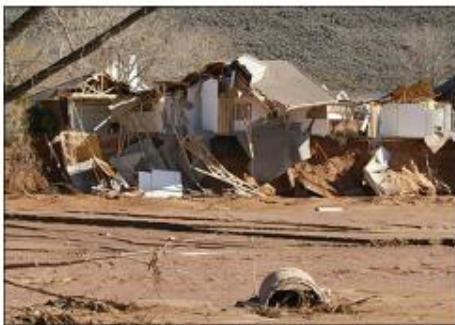
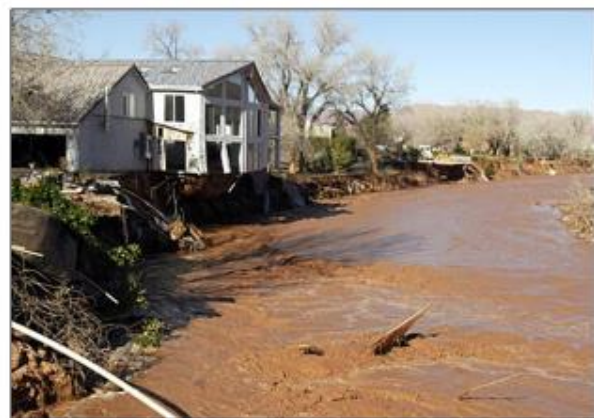
Figure 8. Photos from a 2005 flood event in Saint George Utah, where homes several feet above the mapped floodplain were destroyed by channel migration (originally sourced from Utahfloodrelief.com).

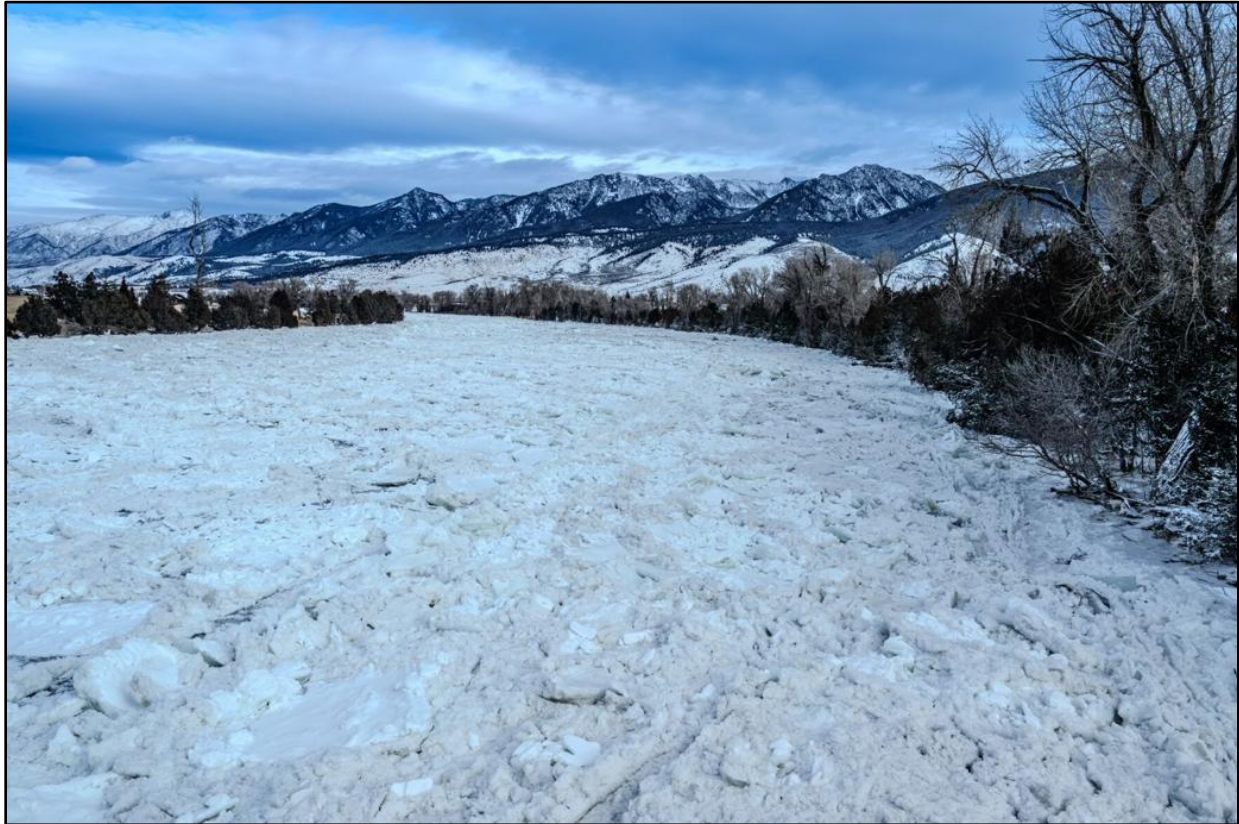
Figure 10. Yellowstone River ice jam near Mill Creek, January 2024 (Livingston Enterprise).

Another serious river hazard, especially in Montana, is ice jamming. Over 4,559 ice jams have been recorded in Montana since 1894, which is the most in the United States (CRREL Ice Jam Database), with 219 jams located on the Yellowstone River. Although ice jams are most common in Montana during February and March, ice jam flooding has happened on the Yellowstone River as early as November and as late as May. Ice dams can cause flooding upstream due to backwatering, and downstream of the jam, ice chunks mobilized by breakups can cause damage. Breakups can occur rapidly, and it generally takes water that is almost two to three times the thickness of the ice to mobilize the jammed ice. Ice jams can also cause avulsions by entirely blocking channels and forcing flows onto the floodplain.

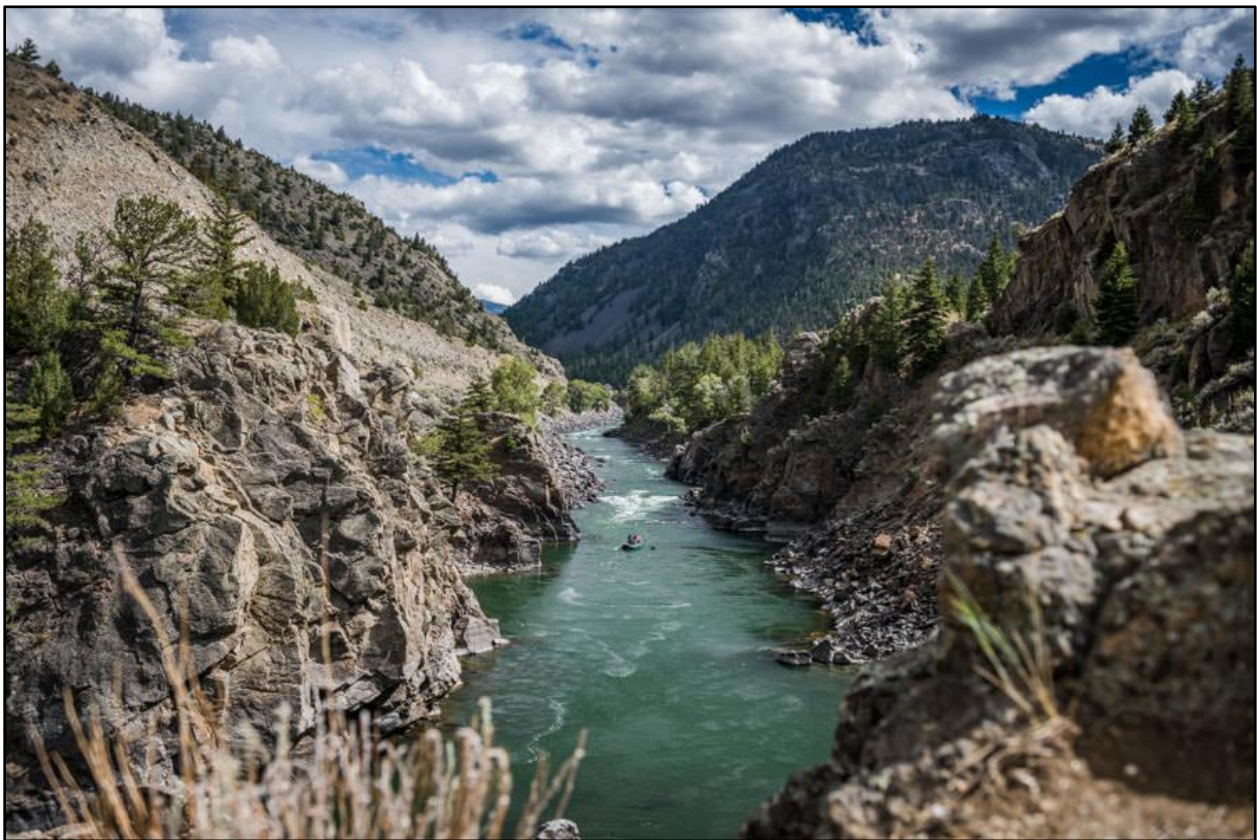
Figure 15. View upstream of bedrock geology of Yankee Jim Canyon (Montana Angler).

The character of the Yellowstone River and its host valley is strongly controlled by local geology. In the uppermost project area near Gardiner, glacial deposits form high terraces adjacent to the river that underlie much of the town of Gardiner (Figure 13 and Figure 14). About 14 miles downstream, Yankee Jim Canyon forms a tight constriction through Archean-age gneissic rocks that create a steep channel with rapids that are a popular recreational float (Figure 15).

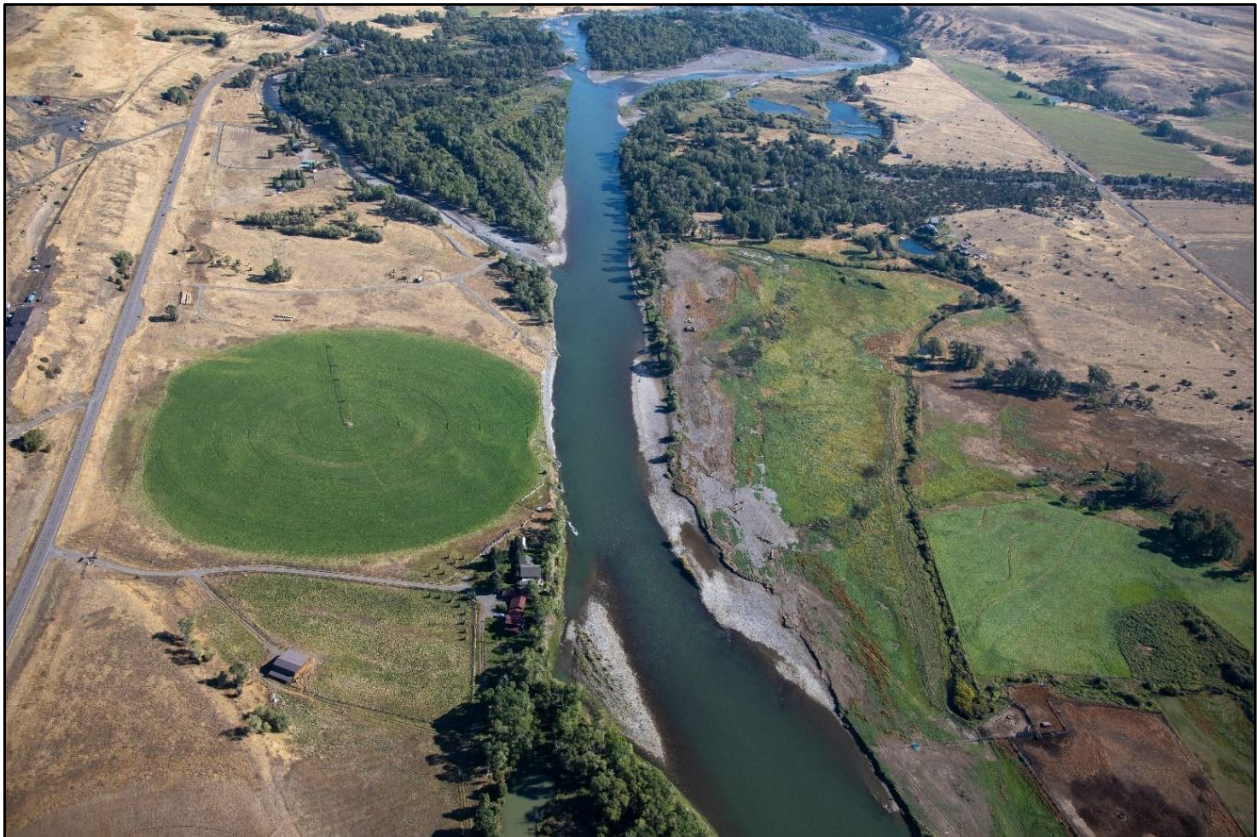
Figure 17. View downstream from 2 miles upstream of Emigrant Bridge showing active narrow corridor in foreground widening out to an approximate 1/2 mile wide riparian corridor; note low adjacent floodplain surfaces; Sixmile Creek is on right of photo (Kestral Aerial Services).

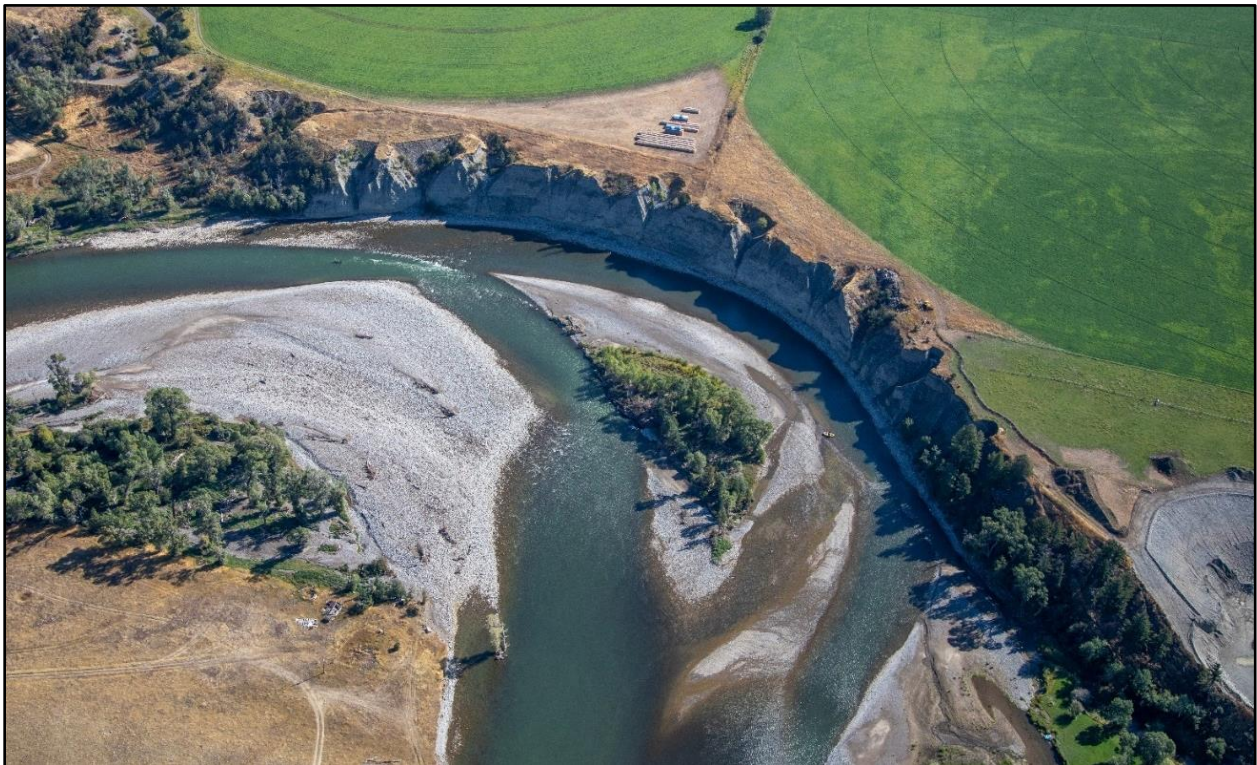
Figure 18. High eroding outwash terrace against river at the Weeping Wall below Pine Creek (Kestral Aerial Services),

channel in places like the Weeping Wall and Mallard's Rest, contributing large quantities of gravel to the river that contribute to point bar formation and channel migration (Figure 18).

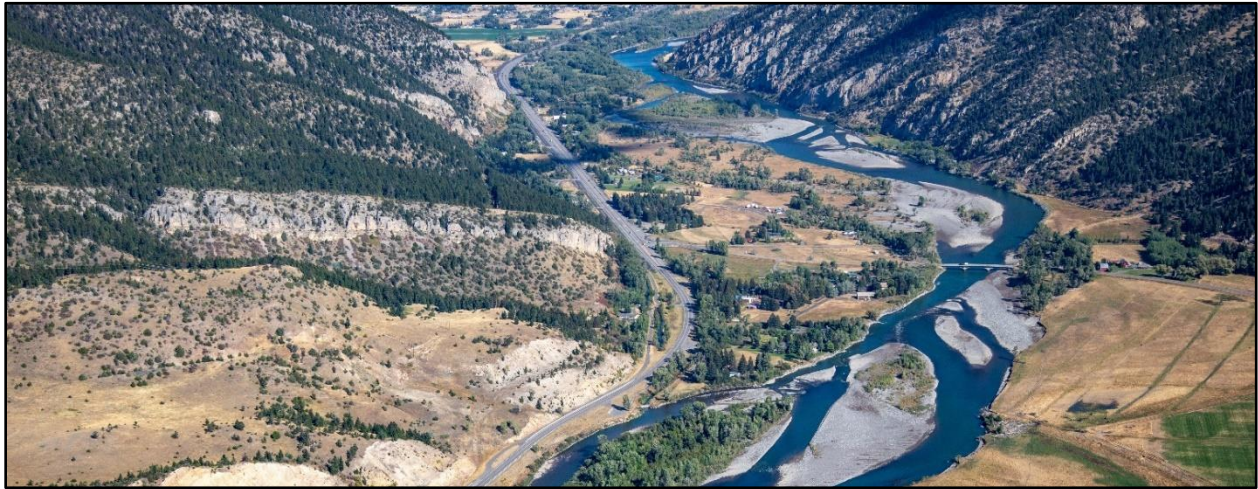
Figure 19. View downstream showing Allenspur Gap bedrock constriction near Carter’s Bridge - photo center (Kestral Aerial Services).

The Paradise Valley rapidly tapers near Carter’s Bridge where bedrock exposures of limestone and other sedimentary rocks form a valley bottom constriction (Figure 19). This is known as Allenspur Gap, which is a notch carved through a limestone and sandstone ridge that runs perpendicular to the river. Within this notch, the river bottom is 1,000 to 1,800 feet wide, so that the river is not entirely confined. In the early 1970’s, a dam was proposed for Allenspur Canyon but was ultimately defeated largely due to local resistance. Allenspur Dam was proposed as a 380-foot tall dam with a 250,000 watt power plant that would have inundated the Paradise Valley up to 30 miles upstream.

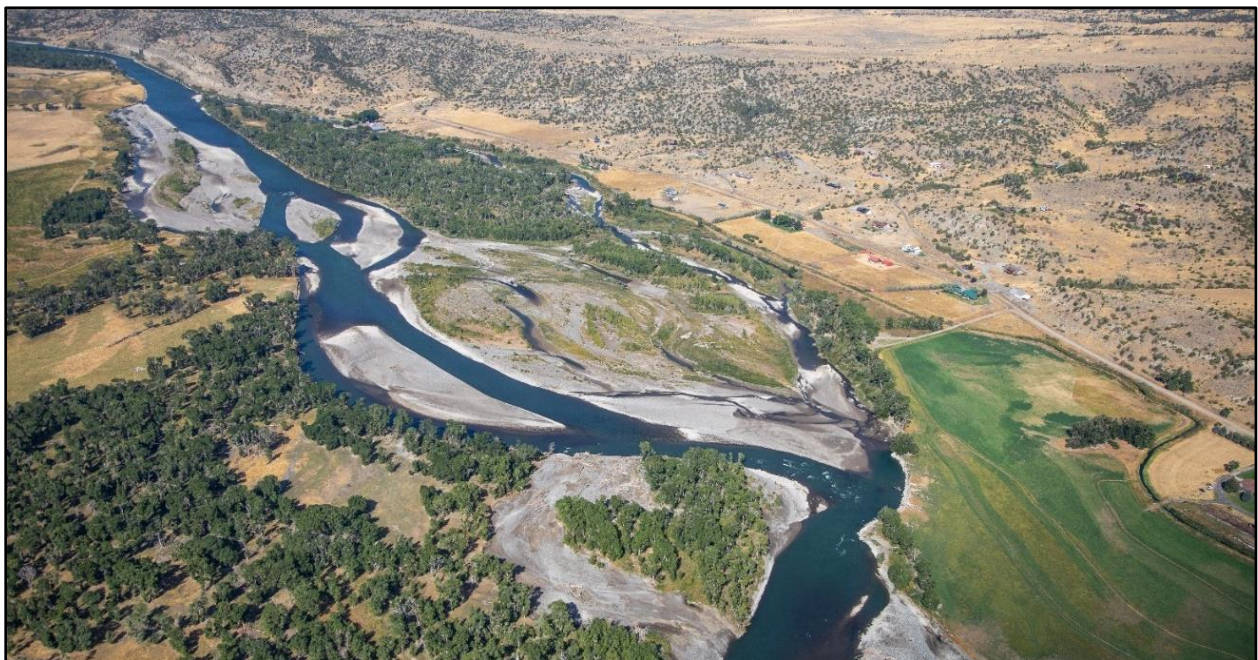
Figure 20. Wide active stream corridor below Shields River confluence (Kestral Aerial Services).

From Allenspur Gap to the mouth of the Shields River, the town of Livingston has expanded on both sides of the river resulting in a highly developed river segment. Bank armor is extensive. Below the Shields River the stream corridor widens with long multi-thread channel segments supporting broad riparian forests (Figure 20).

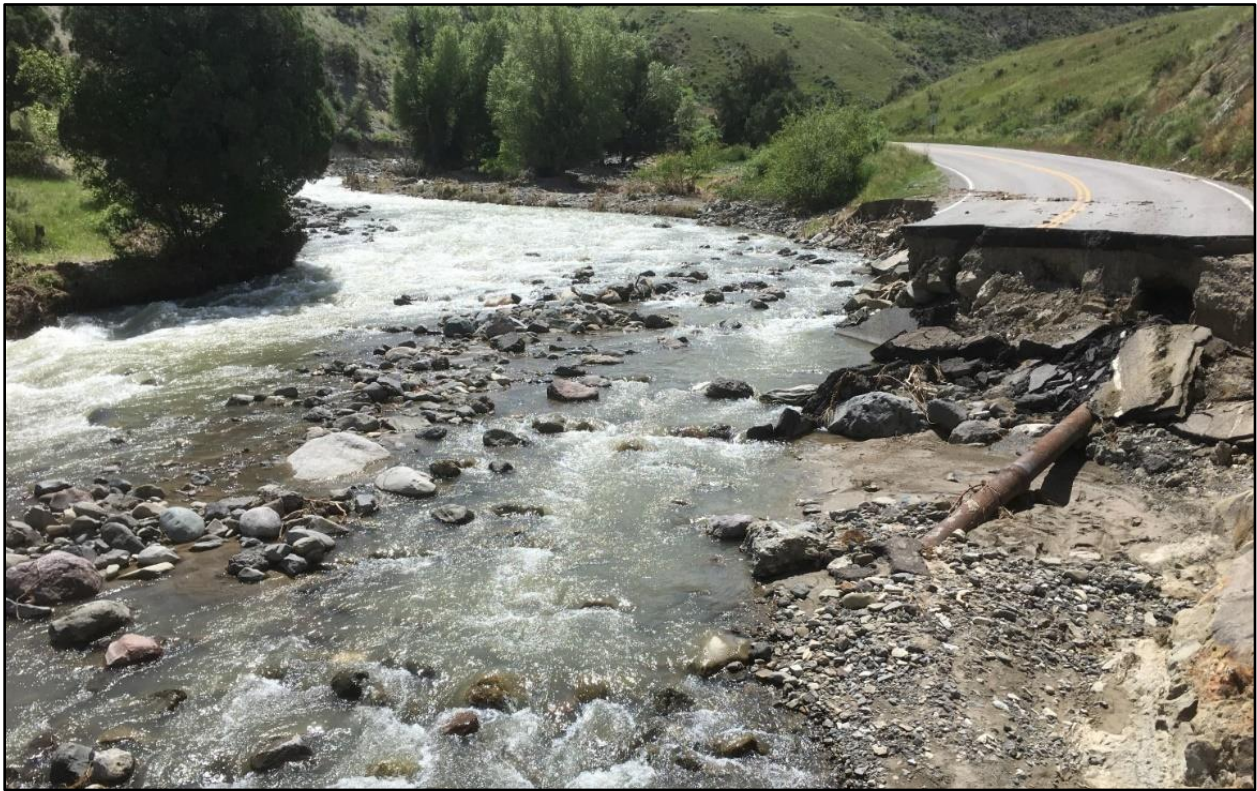
Figure 22. 2022 flood destruction of the Highway 89 North Entrance Road to Yellowstone National Park on the Gardner River, which joins the Yellowstone River at Gardiner.

The flooding was extensive. Yellowstone National Park was closed on June 13 and over 10,000 visitors were evacuated due to safety concerns (Figure 22).

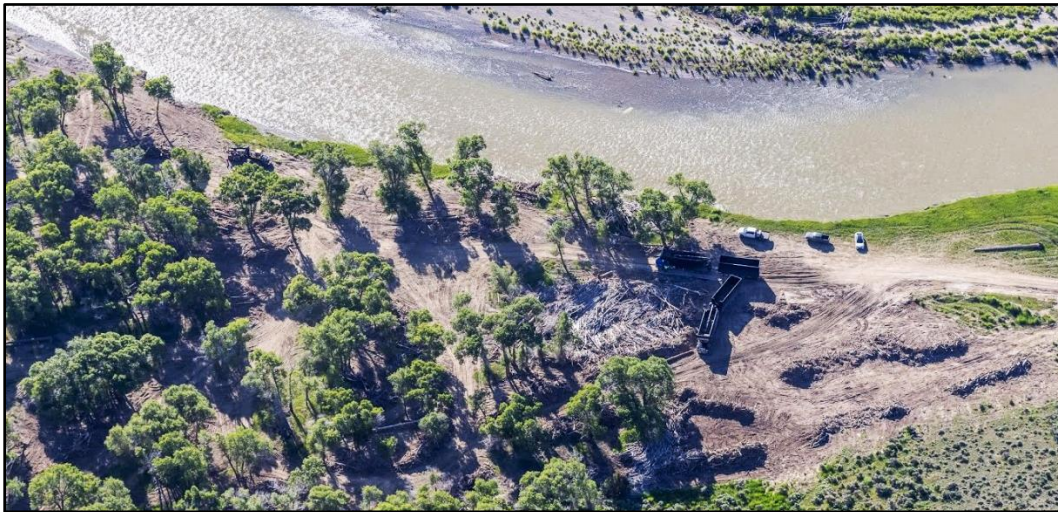
Figure 25. Woody debris removal from Yellowstone River floodplain following 2022 flood (Kestrel Aerial Services).

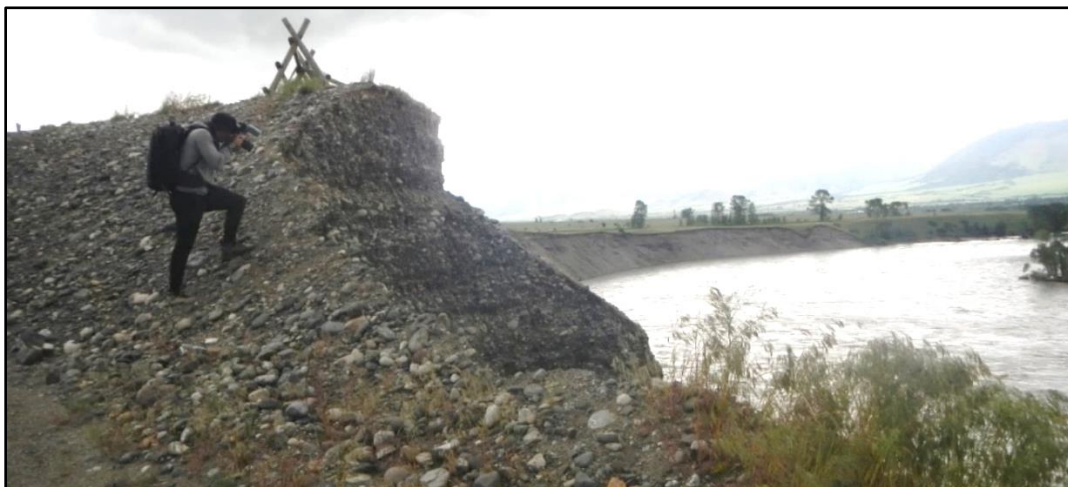
Figure 26. High terrace erosion at Mallards Rest that threatened the access road behind the photographer and resulted in closure.

Although the short duration 2022 flood did not completely alter the form of the river system-wide, the very high peak caused different processes to occur, creating major changes in certain areas. One of the most striking changes was where the river is deeply entrenched in coarse outwash material upstream of Yankee Jim Canyon. In these sections, coarse boulders accumulated from the high banks had been naturally protecting the bank toes, forming a natural riprap that helped stabilize the channel during previous floods. Although the 2022 event was relatively short, its extreme magnitude caused that material to mobilize, destabilizing those banks which resulted in extensive erosion, channel widening, and downstream sediment delivery. Figure 26 shows one area near Gardiner where the river almost doubled in width from 120 to 220 feet.

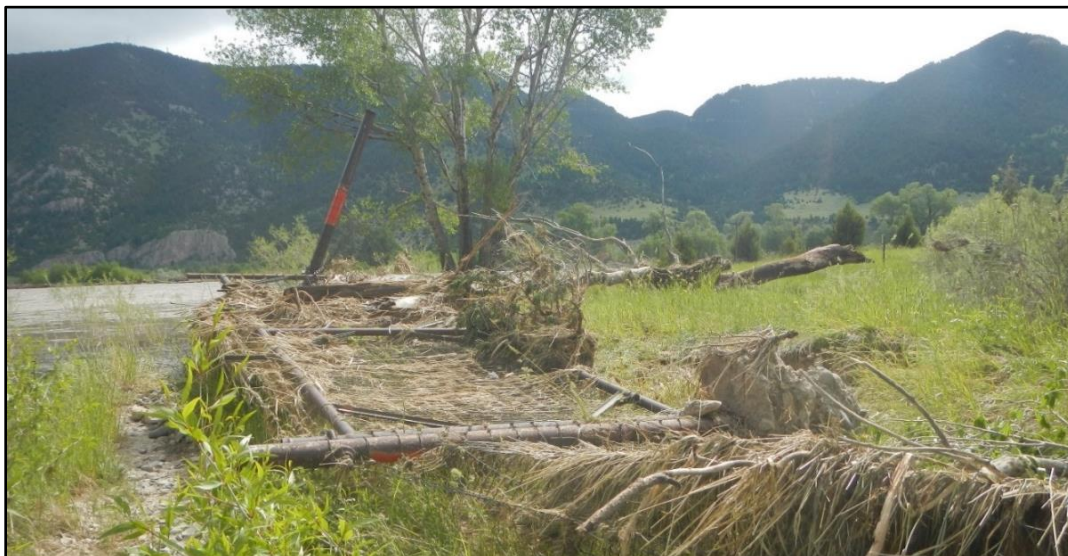
Figure 27. Miles of fencing were destroyed during the 2022 flood.

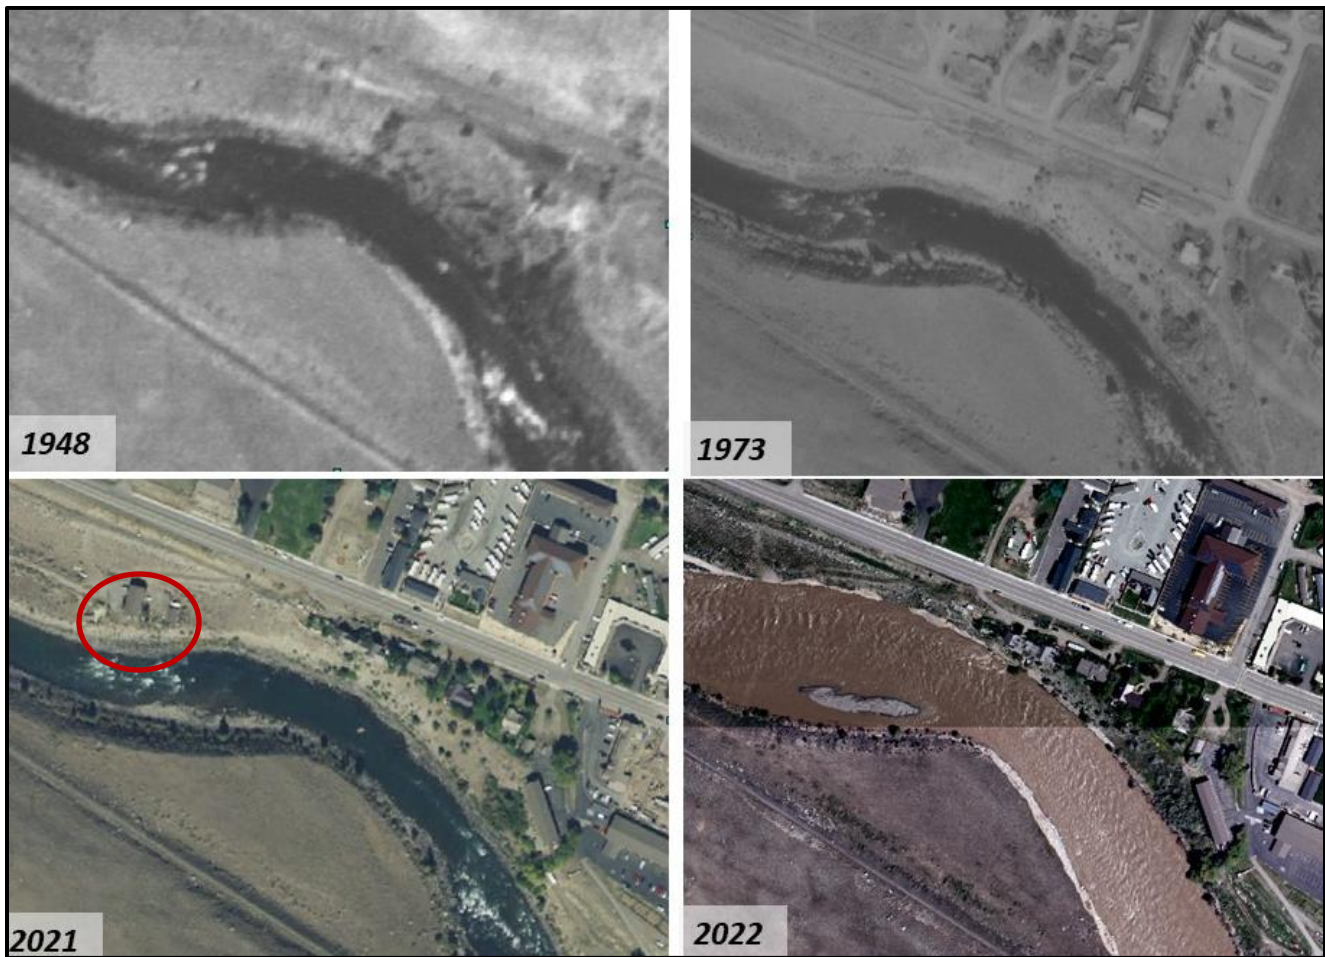
Figure 28. Time series of channel segment near Gardiner showing relatively stable channel form from 1948-1973 followed by about 100 feet of widening during the 2022 flood; the house circled in the 2021 image was lost during the flood.

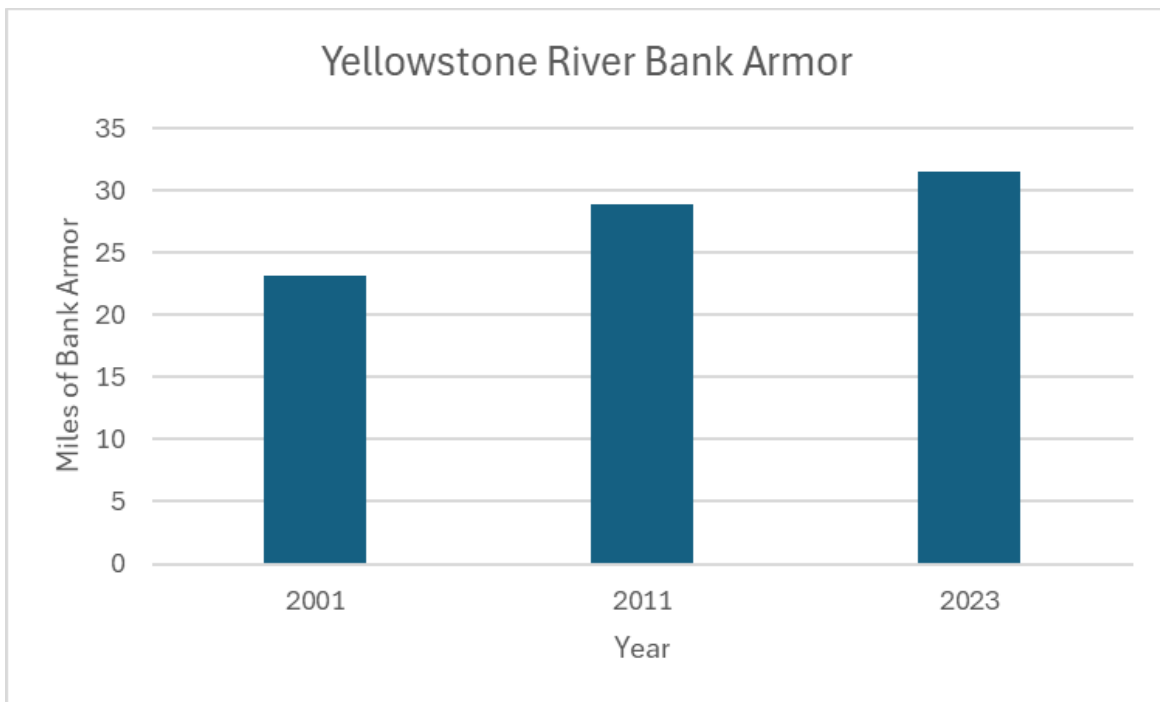
Figure 29. Growth in mapped bank armor in Park County, 2001-2023.

Based on the 2015 Cumulative Effects Assessment (USACE, 2015), there were approximately 23.1 miles of armor on the Yellowstone River in Park County in 2001. This armor inventory was updated for this study to include 2011 and 2023 conditions, noting both new and lost armor at each time period. By 2011, the amount of armor had increased to 28.9 miles and by 2023 there were 31.5 miles of armor. Another way to look at this is in terms of the percent of bankline that is armored, not including levees. From 2001 to 2023 the percentage of armored bankline has increased from 13% to 18%. Some reaches are upwards of 25% armored (USACE, 2015).

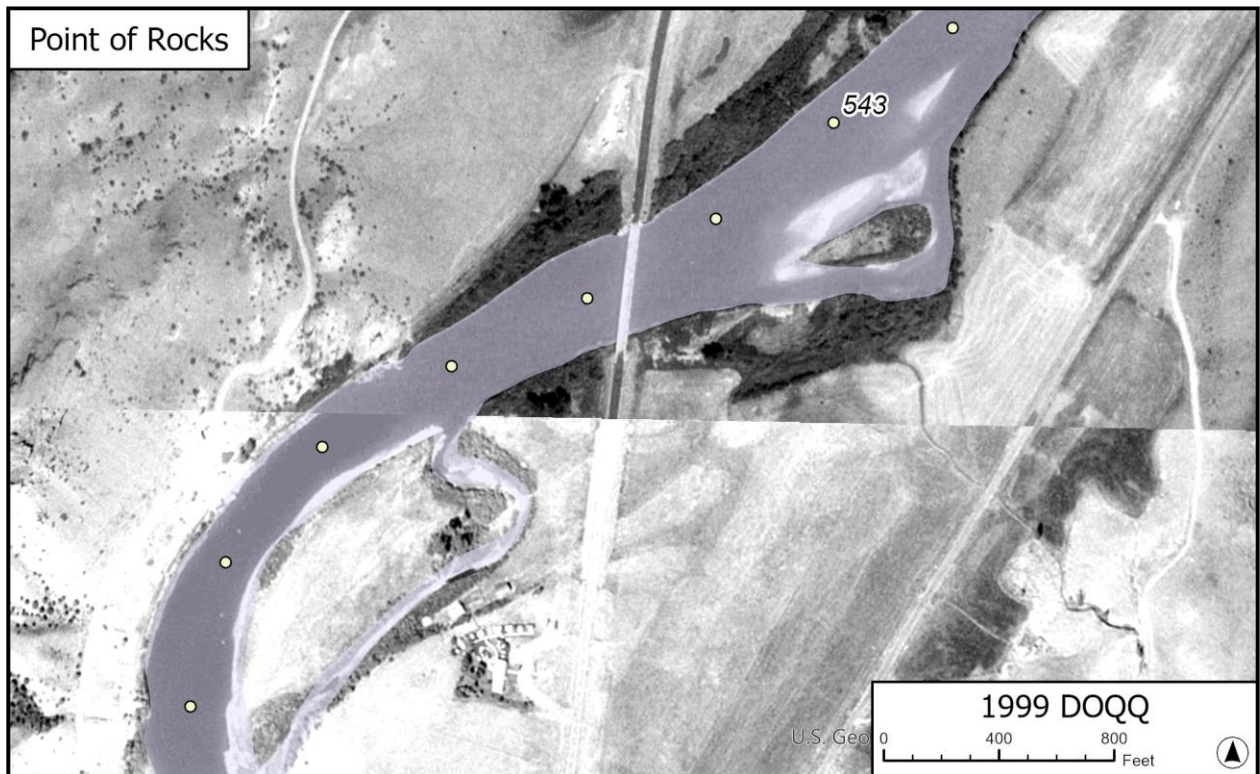
Figure 33. Example of 1999 DOQQ imagery at Point of Rocks.

Figure 32 to Figure 37 provide imagery examples at the same location along with the associated digitized bankfull channel boundaries.

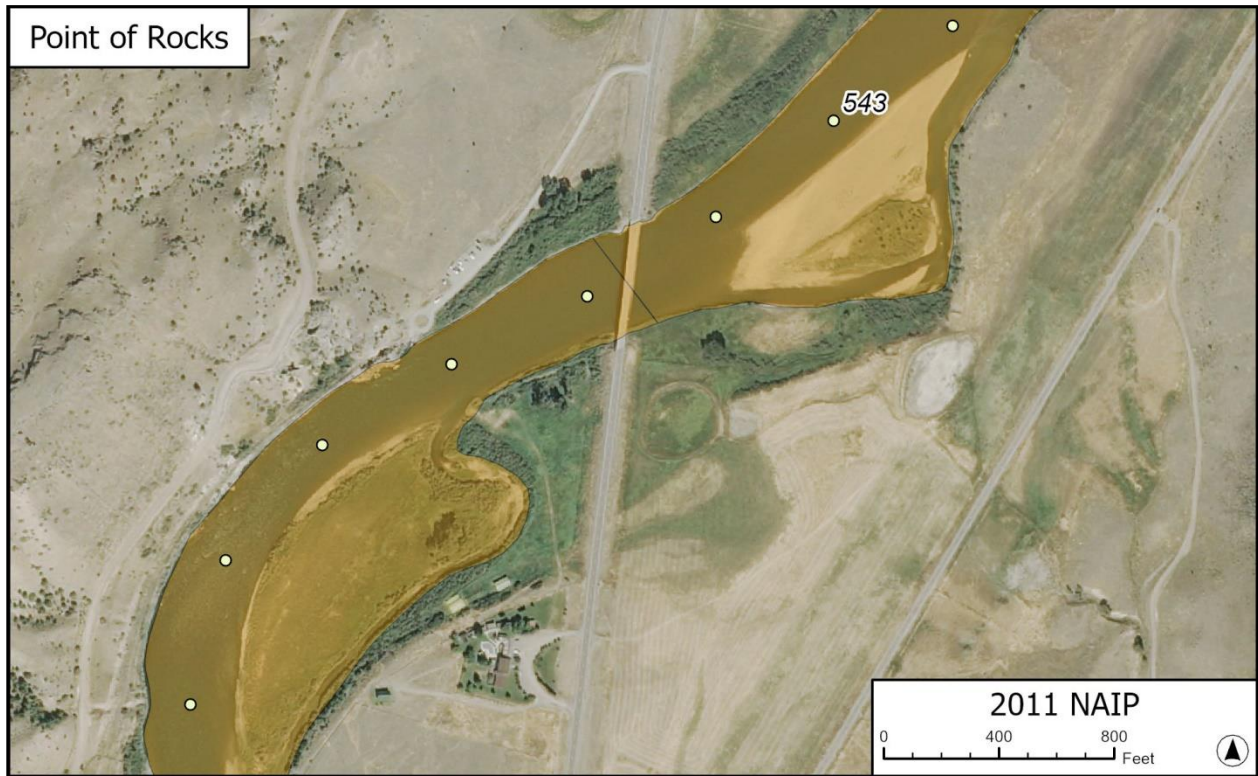
Figure 34. Example of 2011 NAIP imagery at Point of Rocks.

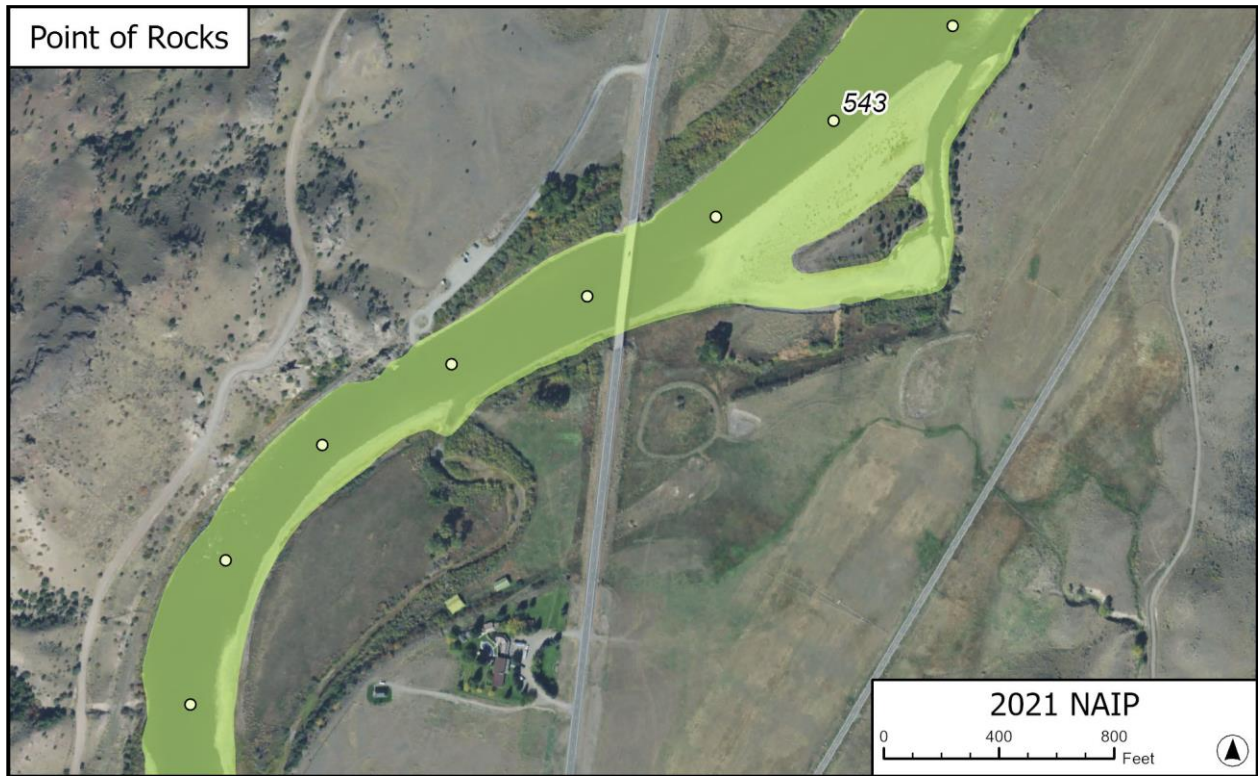
Figure 36. Example of 2021 NAIP imagery at Point of Rocks.

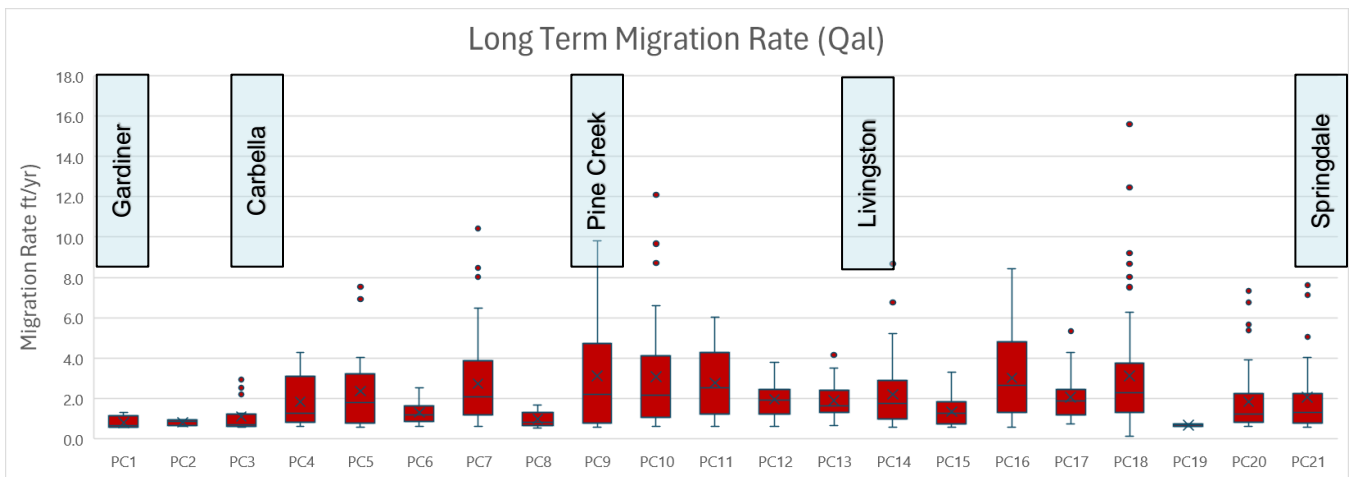
Figure 39. Annual migration rate box and whisker plots.

Error! Reference source not found. shows the distribution of measurements for each reach. On these plots, the “box” is defined by the 25th and 75th percentile values. The median value is a horizontal line in the box and the average is denoted by an “X”. Statistical outliers are shown as individual dots above the boxes. The results show that 10 of the 21 reaches have individual areas of markedly high migration rates that show up as outliers on the plot.

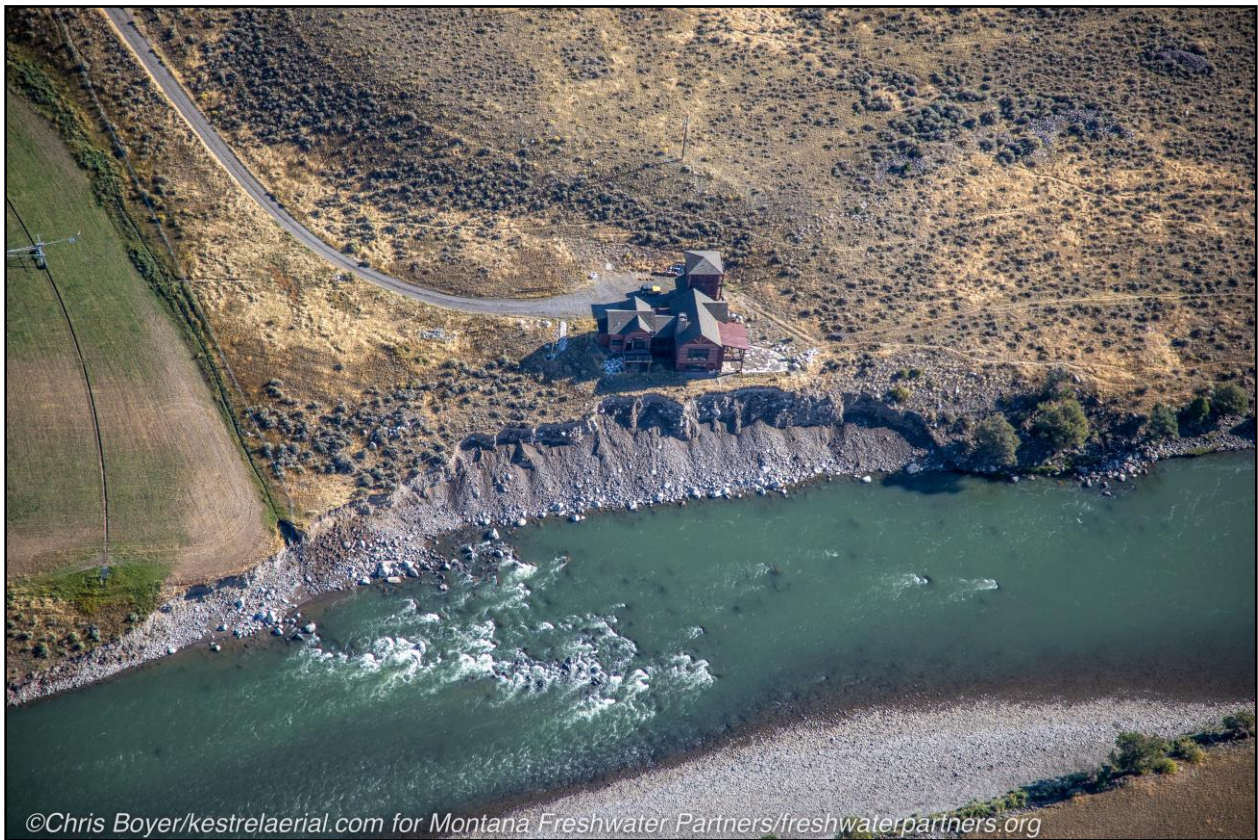
Figure 44. A bankline with a vertical scarp associated with 2022 bankline erosion.

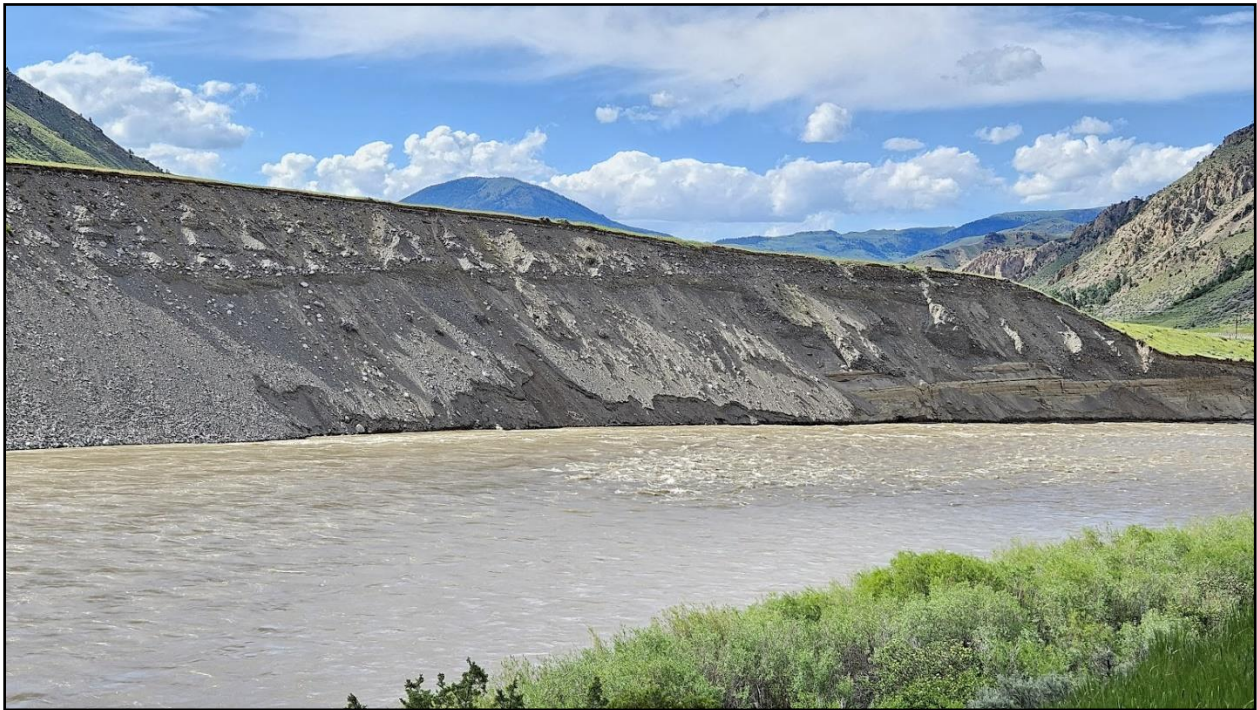
Figure 47. Bankline below La Duke Picnic Area showing actively eroding banklines where the river moved up to 50 feet. Photo is at peak runoff on June 10, 2024.

Continued adjustments of the channel are visible in several locations (Figure 47), though currently they are not placing infrastructure at immediate risk.
