September 12, 2024

Yellowstone River Channel Migration Zone Mapping Park County Update

Executive Summary

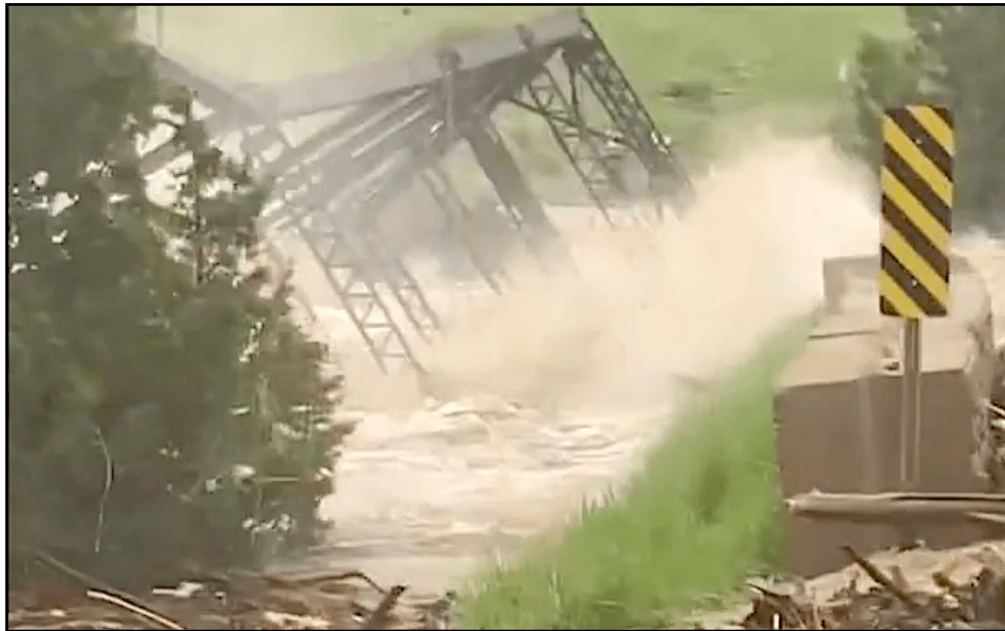
Figure 49. The Carbella Bridge seen as it collapsed into the river (source unknown).

The Carbella Bridge at RM 547.4 was completely destroyed as floodwaters overtopped the decking and washed the historic structure downstream. The crossing provides the primary access to homes, ranches and recreation in the Tom Miner Basin. The Old Yellowstone Trail Road has been providing access during the reconstruction of the bridge. Note that the bridge failure was not due to channel migration, but rather an undersized bridge restricting floodwater passage.

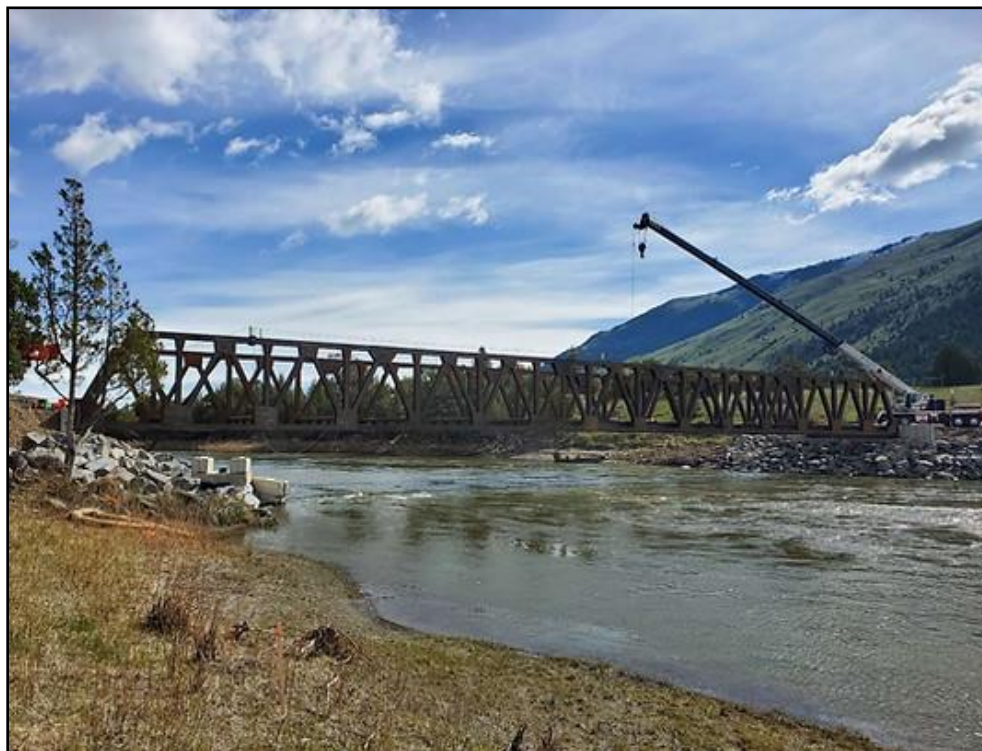
Figure 50. Reconstruction of the Carbella Bridge following the flood (Stahly Engineering).

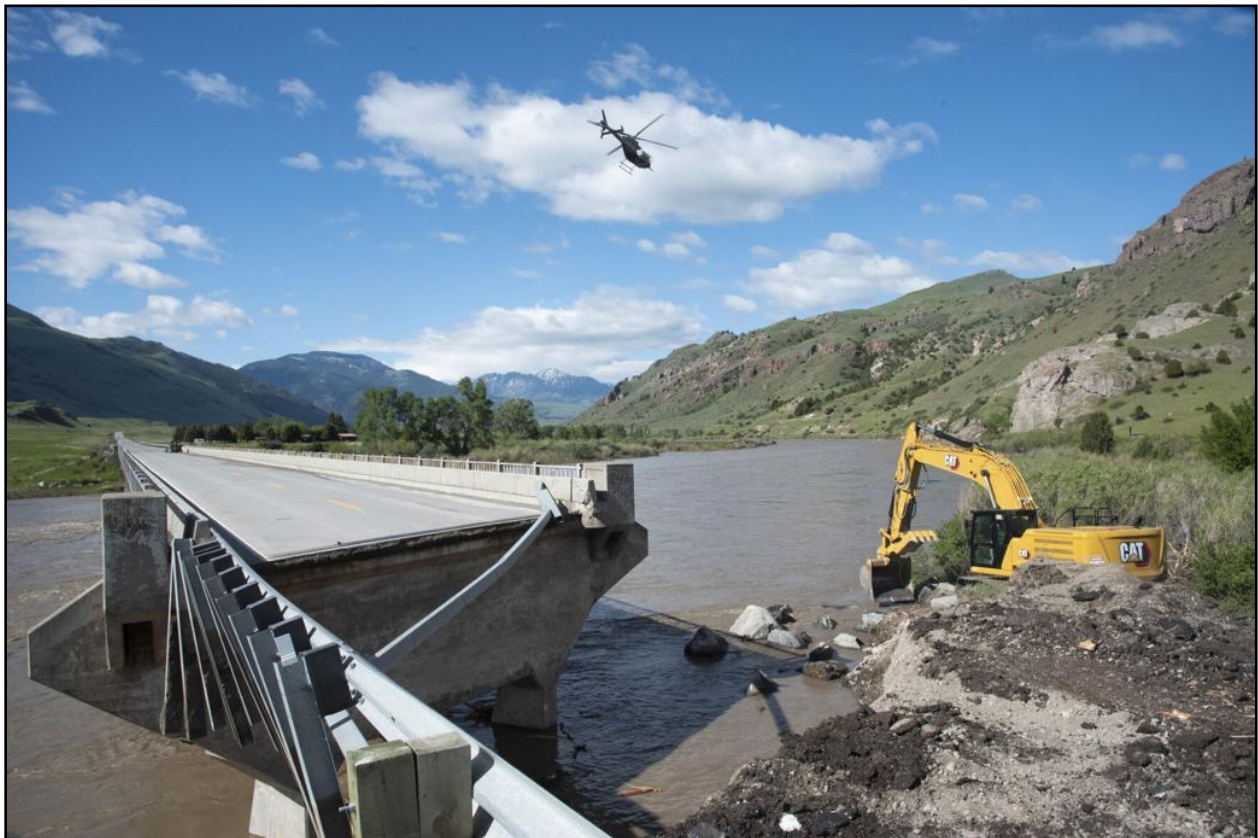
Figure 52. Point of Rocks Bridge showing where the northern approach was flanked during the flood. (Samuel Wilson/Chronicle/Report for America).

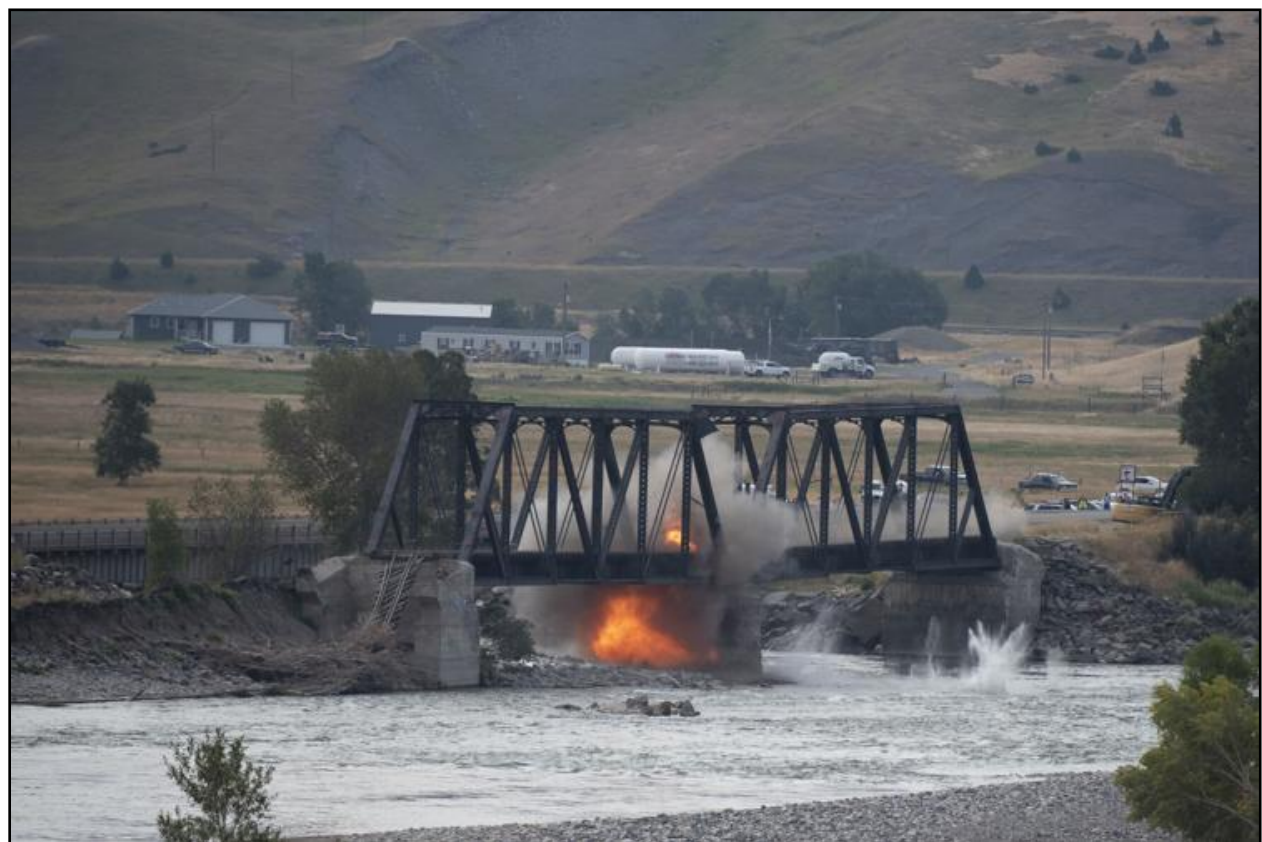
Figure 61. Implosion of the Northern Pacific Railway Bridge on August 24, 2022 (Bozeman Chronicle).

At RM 495 the Hwy 89 Bridge site presents one of the most challenging maintenance issues in the corridor. The non-active North Pacific Railway Bridge which was constructed in 1897 was located immediately upstream of the highway bridge (Figure 60). When the rail bridge was constructed, it was built perpendicular to the flow of the river. The Hwy 89 Bridge was co-located in the same location many years later. Over time, the river has shifted to the north and created a pair of 90 degree turns for the river to pass under. For many years northern approach to the railroad bridge acted as protection for the bridge just downstream. After the 2022 flood, the railroad bridge began to sag, resulting in a closure of the Hwy 89 Bridge until the rail bridge could be removed. On August 24, 2022 the railroad bridge was demolished with explosives (Figure 61), resulting in minor damage to the adjacent Hwy 89 Bridge. The damage has been repaired and the highway bridge is open. Given that the northern bridge approach on the left bank and the right bank immediately upstream continue to bear the full force of the river and is forced to make two dogleg turns, one can expect continued challenges in maintaining this bridge, especially during flood events when complex hydraulics through the turn can amplify scour potential. Of note is that the river used to be located to the south as seen in the 1873 and 1888 GLO maps (Figure 60). The former channel is still on the right floodplain and is mapped as an avulsion risk. Should this avulsion occur, proper alignment under the bridge would be restored.

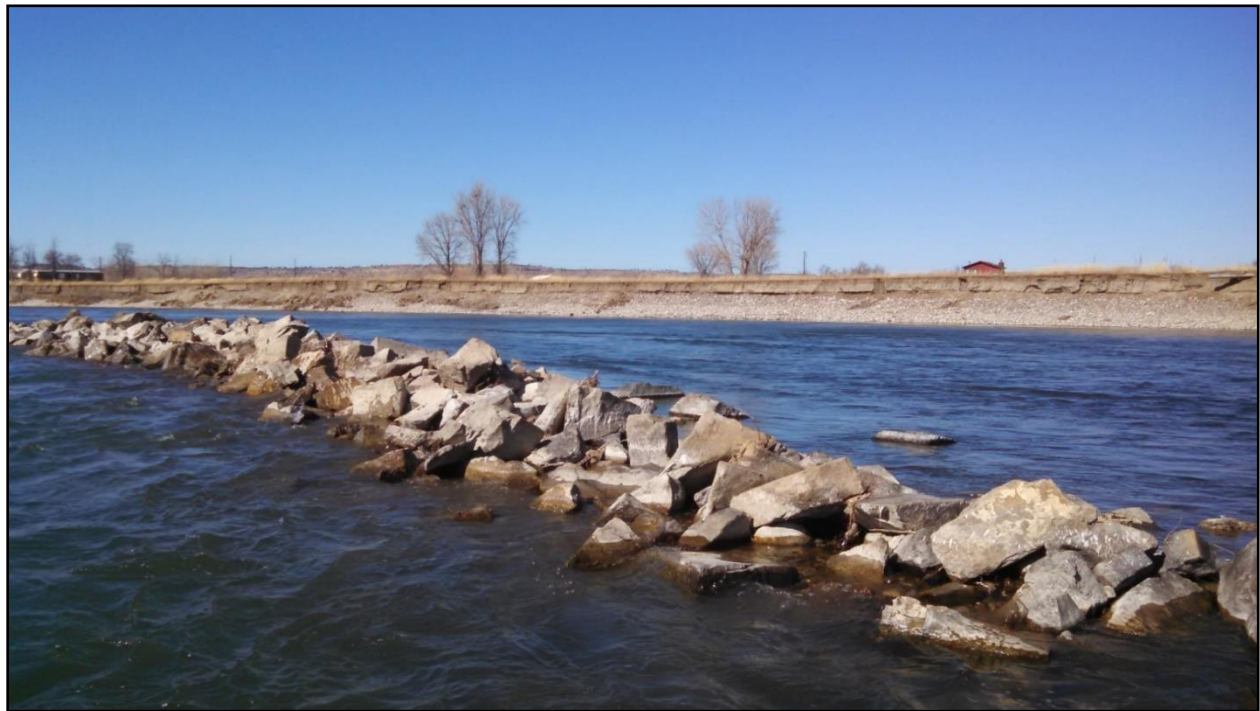
Figure 65. Failed bank armor (2011) in the middle of the Yellowstone River near Park City, MT where the bankline has rapidly eroded back towards the home in the background.

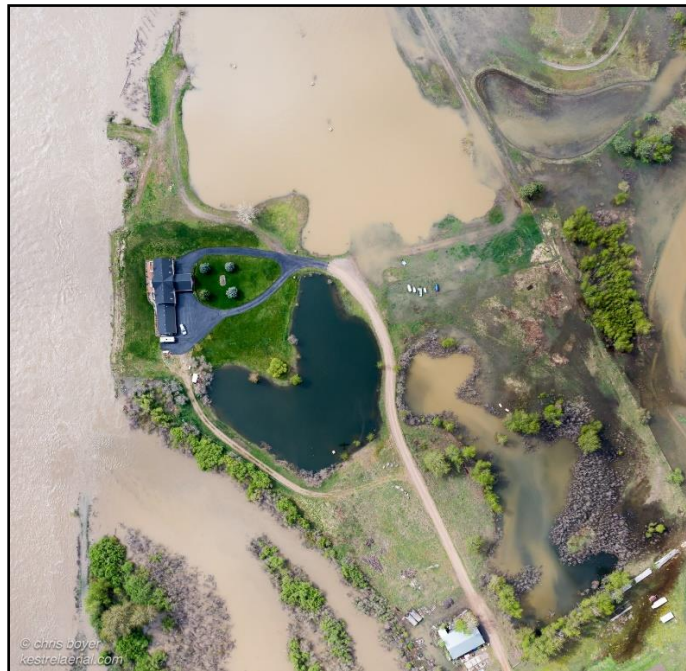
Figure 74. Residential development within EHA of Clark Fork River during the 2018 flood near Frenchtown (May 10, 2018).

In developing CMZ maps across Montana, it is always striking to see how many structures are at risk of damage due to bank erosion. In CMZ related public outreach meetings that we have held across the state for other projects, we have heard numerous testimonies in which landowners have described their anxiety over river movement and financial stresses of property protection. Bank armoring typically costs on the order of \$90-\$120 per linear foot of bank, so protection of structures on these rivers can easily cost over \$100,000. Yet structures are still constructed close to actively migrating channels. We sincerely hope that this analysis will help landowners make cost-effective decisions in siting homes or irrigation structures. On the Big Hole River, for example, one landowner moved his house site 100 feet back from the top of a terrace edge based on the mapping; subsequent erosion of that terrace has proven that decision to be a major cost saving move.
