March 3, 2021

Clark Fork and Bitterroot Rivers Channel Migration Mapping Missoula County

Karin Boyd
Applied Geomorphology, Inc.
211 N Grand Ave, Suite C
Bozeman, MT 59715

Tony Thatcher
DTM Consulting, Inc.
211 N Grand Ave, Suite D2
Bozeman, MT 59715

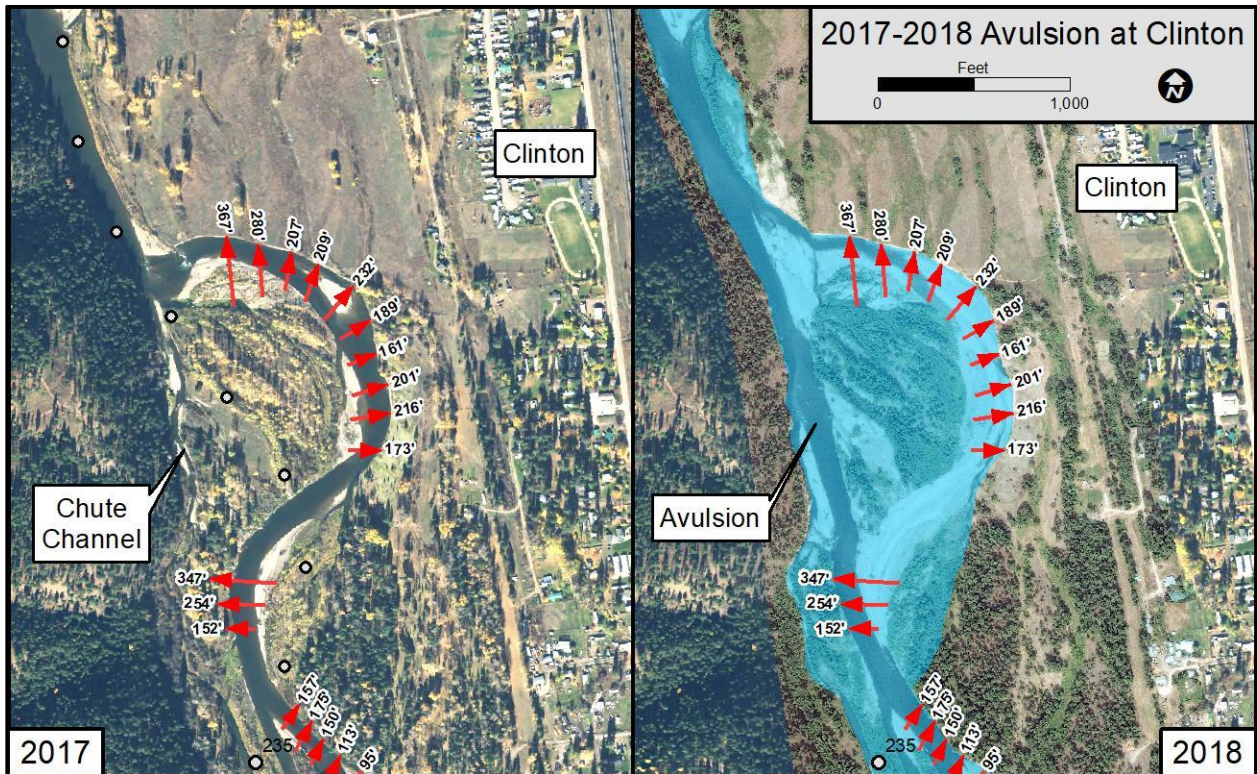
Figure 52. 2017 (left) and 2018 (right) images showing meander cutoff/avulsion through established chute channel at Clinton.

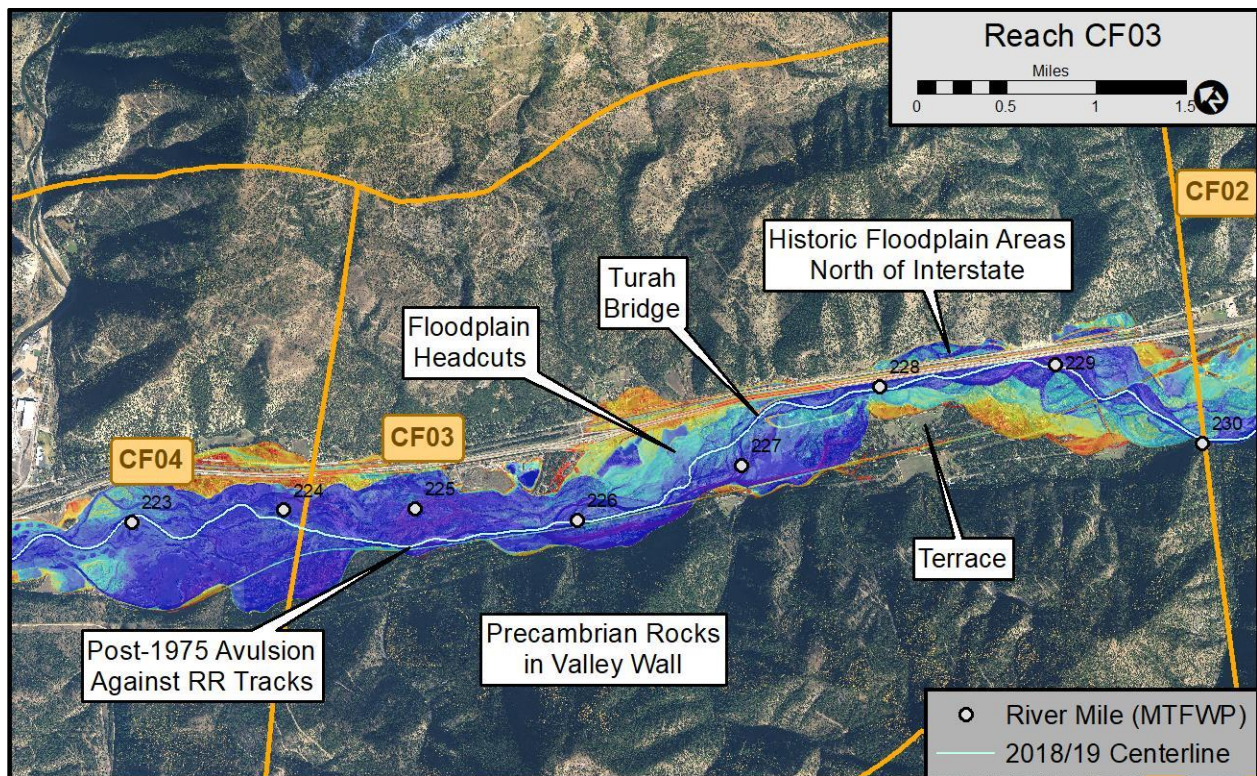
The Clark Fork River is relatively straight in Reach CF03. Figure 54 shows the Relative Elevation (REM) modeling results for the reach, with the river flowing straight along transportation infrastructure upstream of Turah Bridge. Below the bridge, the river crosses over to the left side of the valley and then closely follows the abandoned Milwaukee Line Railroad embankment. Most of the channel movement in this reach has been concentrated in that crossover area just below Turah Bridge at RM 227.7 (Figure 55). This crossover area is currently developing an avulsion and active headcuts are evident on flood photos (Figure 56). These headcuts will migrate upstream and progressively create a new floodplain channel that has the potential to become increasingly active with time. One other avulsion mapped at RM 225 was characterized by a rapid relocation of about a half mile of river towards the toe of the railroad embankment, which it currently follows closely.

Figure 54. Relative Elevation Model results for Reach CF03; blue colors highlight active and abandoned channels.

Just upstream of Turah Bridge, the Clark Fork River is tightly confined between the Interstate and exurban development. Just upstream of here, about a mile of the Clark Fork River channel was relocated when the Interstate was built (RM 228-229, Figure 54). Much of the Interstate in this area was built on top of 1955 Clark Fork River channel. The Relative Elevation Model (Figure 54) shows the low elevation thread in this area to be very narrow along the channel, with most development (homes, barns, etc.) occurring on low terraces. The historic impacts in this area due to Interstate 90 encroachment into the stream suggests that this section of river may have downcut due to artificial straightening, perching the floodplain slightly and allowing for more development. Unfortunately, however, the channelized river has begun to regain length in this area, and the asymmetry caused by bar deposition is driving bank erosion in the reach. At the specific area of concern, the river has migrated about 50 feet towards a large barn since 2011 (Figure 58). The large open point bar, in combination with a broad sweeping bendway (high radius of curvature) both indicate that continued erosion should be expected, such that the barn will be threatened by both active bank movement on the main channel, as well as enlargement of a side channel that flows right by the barn. Numerous structures in this developed area above Turah Bridge are well within the mapped CMZ boundaries, and some, but not all, are also within the mapped floodplain boundary.

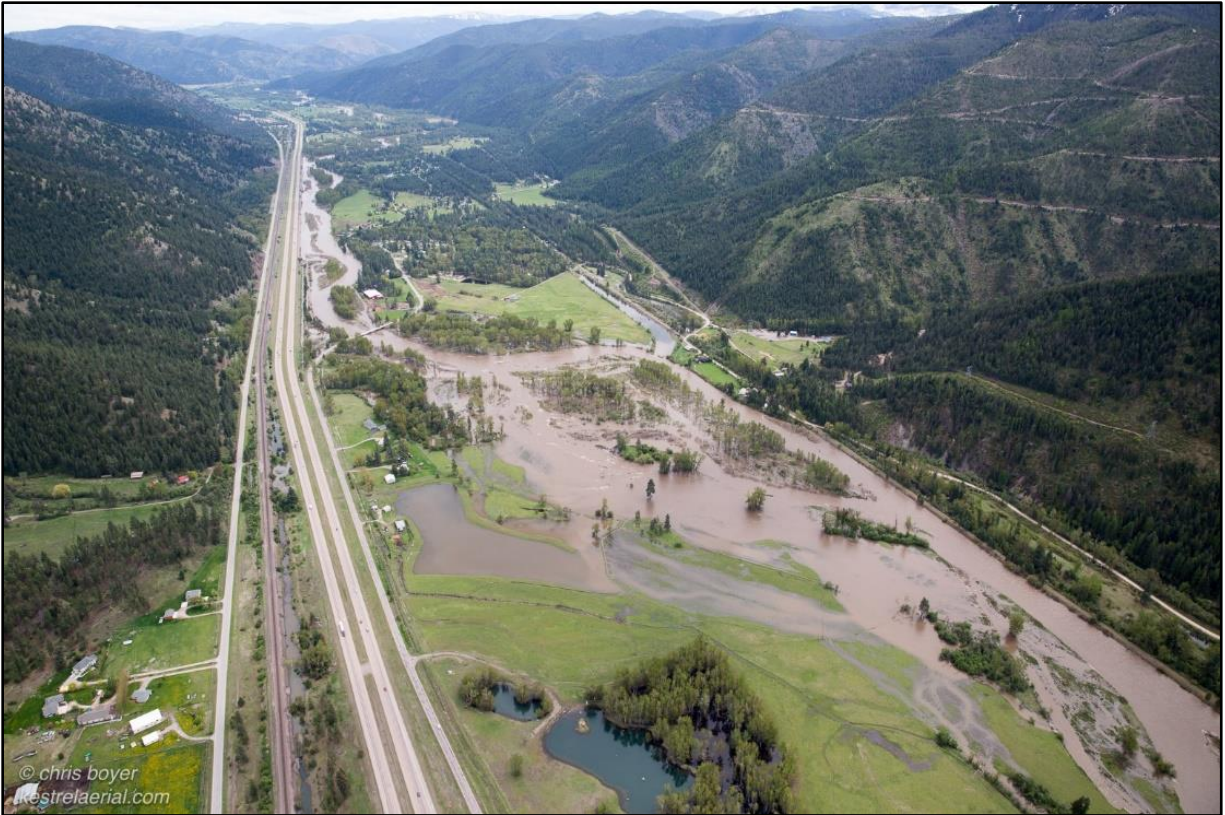
Figure 55. View upstream showing river cross from its path closely following the interstate (background) to closely following the rail line (right foreground), RM 227 (May 10, 2018).

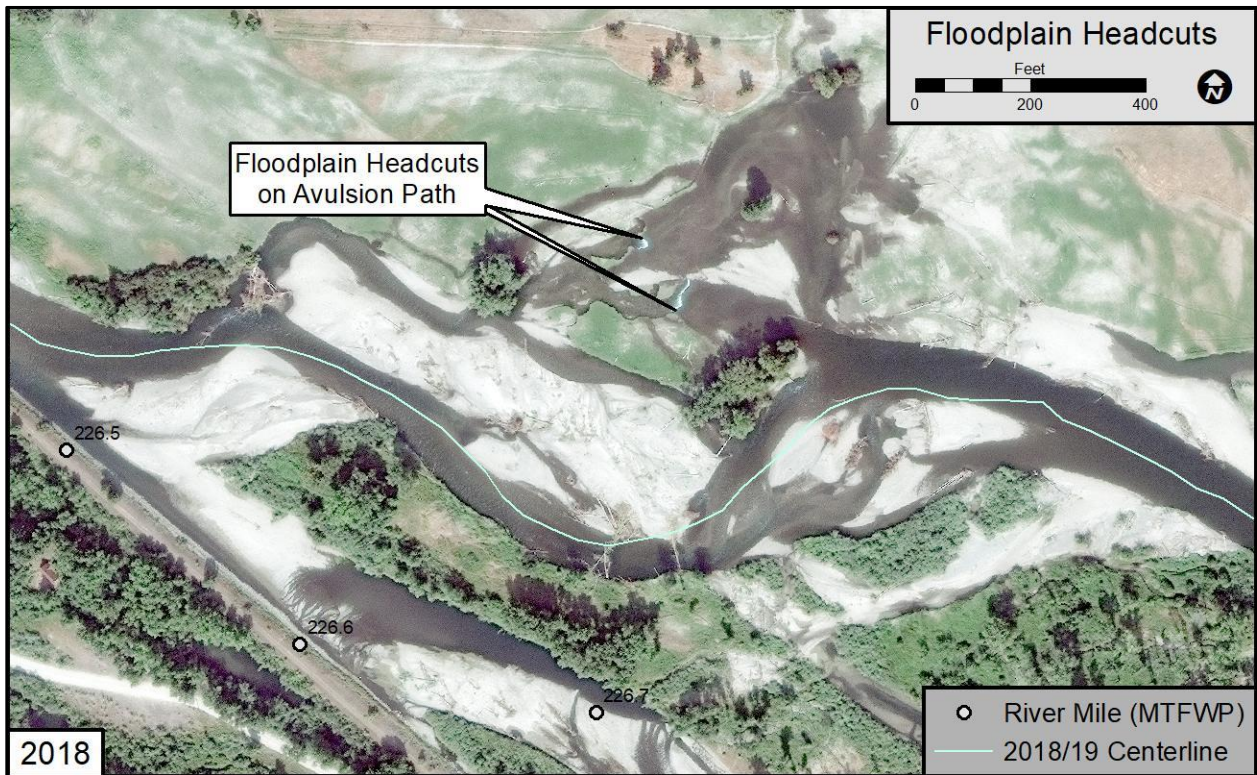
Figure 56. Floodplain headcuts showing an avulsion in process where river crosses valley bottom at RM 227, Reach CF03.

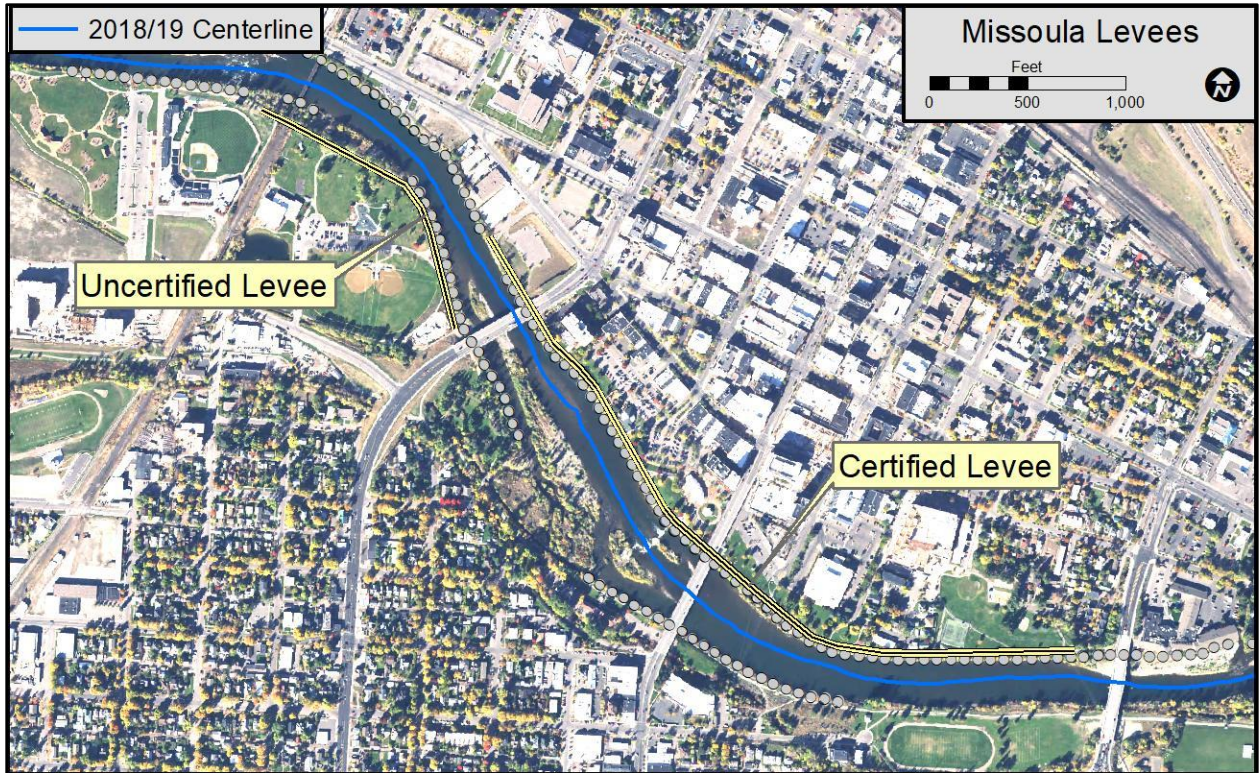
Where the river bisects downtown Missoula, an extensive levee system protects the city from flooding (Figure 61). On the north bank from the Madison Street bridge downstream to below the Orange Street Bridge a ~4,000 foot certified levee prevents floodwaters from entering downtown. This levee also cut off a 1955 channel that ran through what is now Caras Park. On the south bank between Orange Street and the railroad bridge a ~1,600 foot uncertified levee separates the river from the McCormick Recreation Site and Currents Aquatic Center.

Figure 61. Downtown Missoula levees.

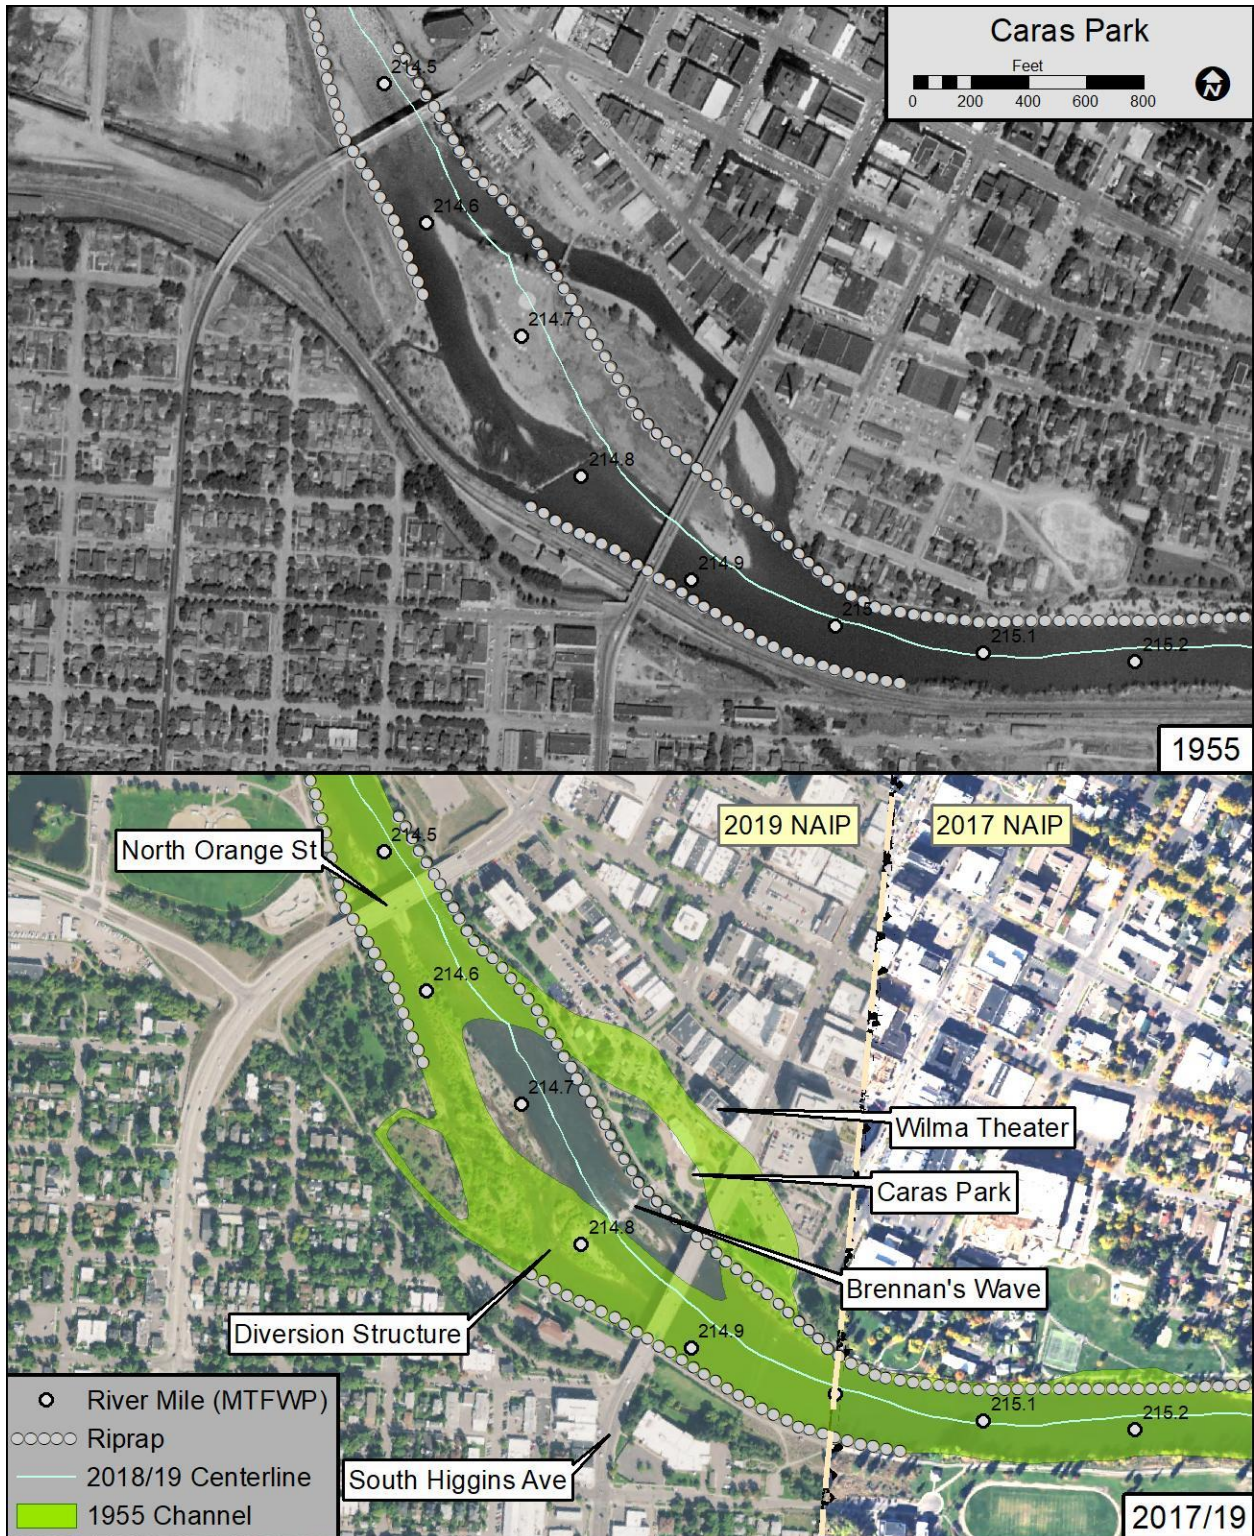
Some areas of interest in this urbanized reach include Caras Park near The Wilma Theater, which was an active side channel in the 1950s (Figure 63). The 1955 imagery shows a large island downstream of the South Higgins Bridge, and a large diversion structure on the south bank. Since then, the area of channel on the north side of the river has been developed into Caras Park and the river flows primarily through a single thread that is crossed by Brennan’s Wave Kayak Park. The grading out of the north channel was complete by 1972. The left bank diversion below is still functional, although it doesn’t have a large rock structure feeding it as it did in 1955.

Figure 63. Comparison of Clark Fork River near Caras Park in 1955 (top) and 2019 (bottom).

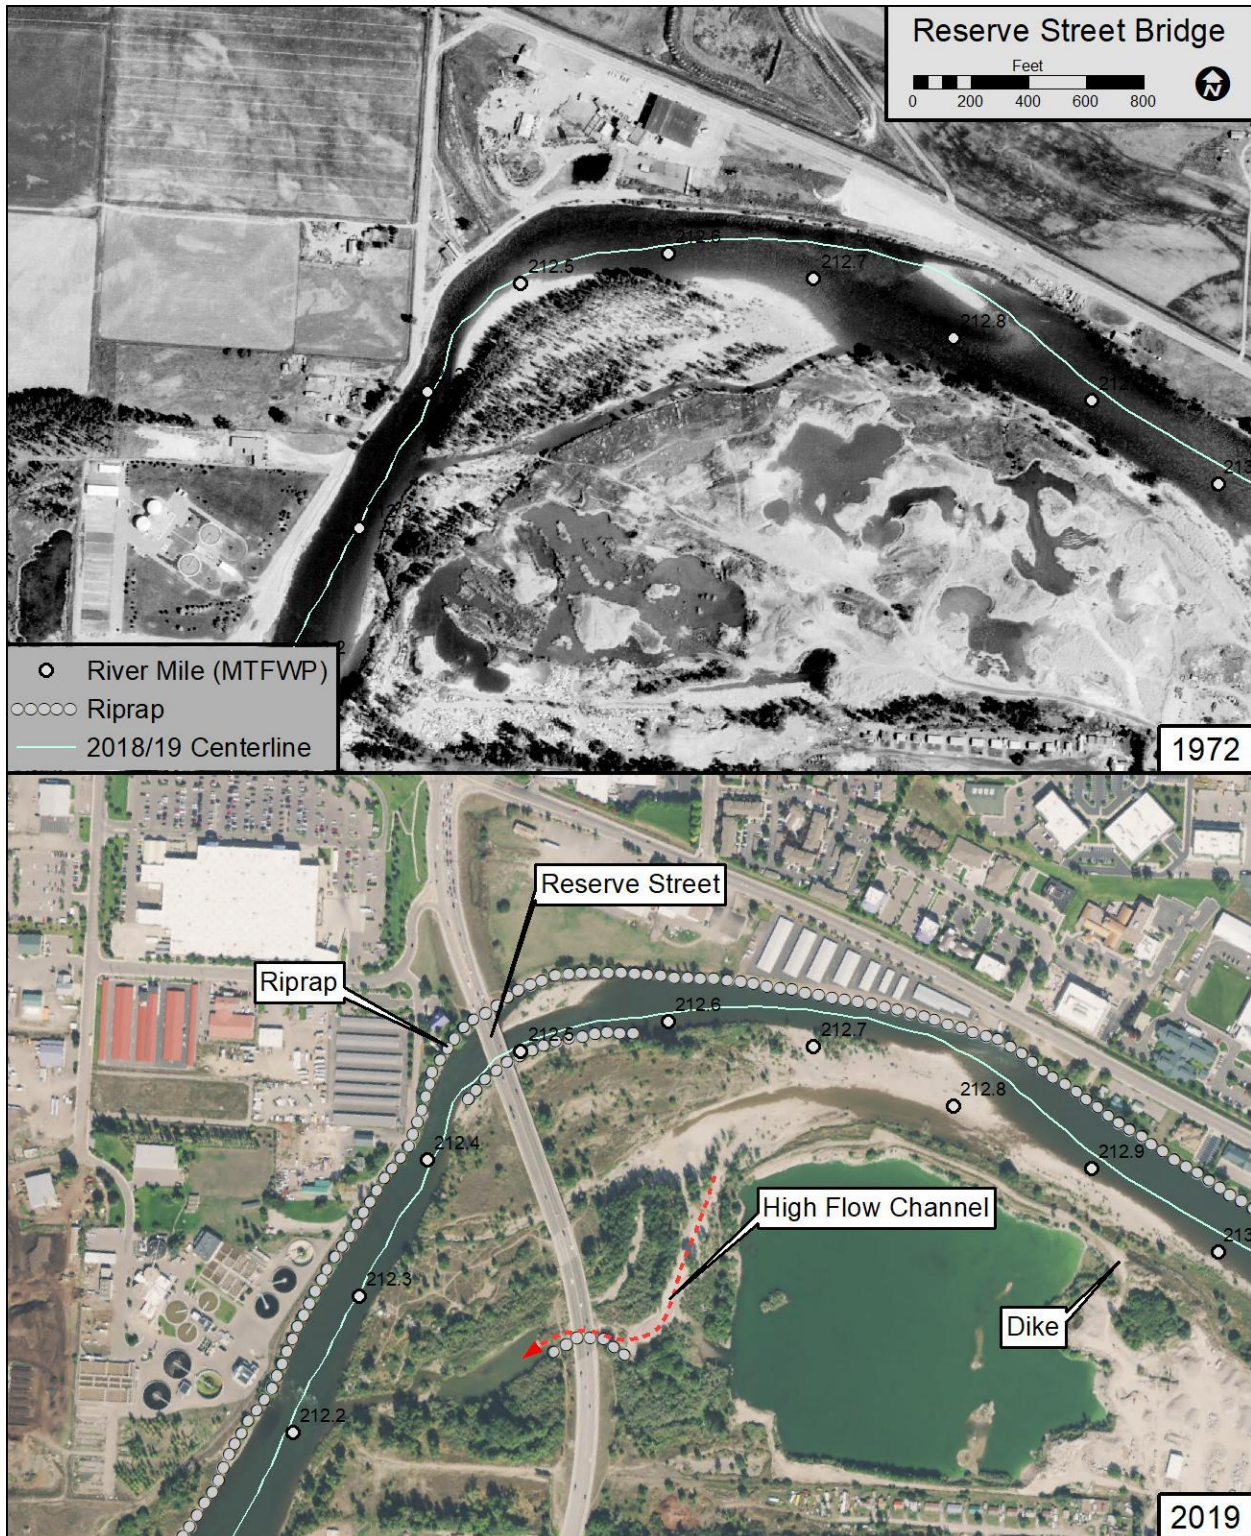
Another area of interest is the gravel pit just upstream of Reserve Street. Figure 64 shows the progressive development of the pit from a broad area of gravel scalping in 1972 to a single consolidated pit protected by a dike in 2019. The 2019 image also shows a high flow channel that carries water under the Reserve Street Bridge due west of the gravel pit. This channel has enlarged in recent years. The relative elevations for this area as captured by LiDAR data are shown in Figure 65. The channel is clearly an active component of the Clark Fork River flow routing in this area, and the recent enlargement at the head of this channel shows up as wet ground in the 2019 image in Figure 64. The 2019 image also shows continuous riprap on the right bank across from the pit. The right bank of the river is locked into place here, and high water relief through the meander core is a relatively efficient pathway as it is shorter than that of the main channel thread (Figure 66). As such, we would expect this flow split to persist and potentially expand further during channel-forming flood events. The channel is also connected to the western edge of the pit itself, such that any river breach into the pit could rapidly cause a major avulsion at this site.

Figure 64. Gravel pit and high flow channel development at Reserve St Bridge, 1972 (top) and 2019 (bottom).

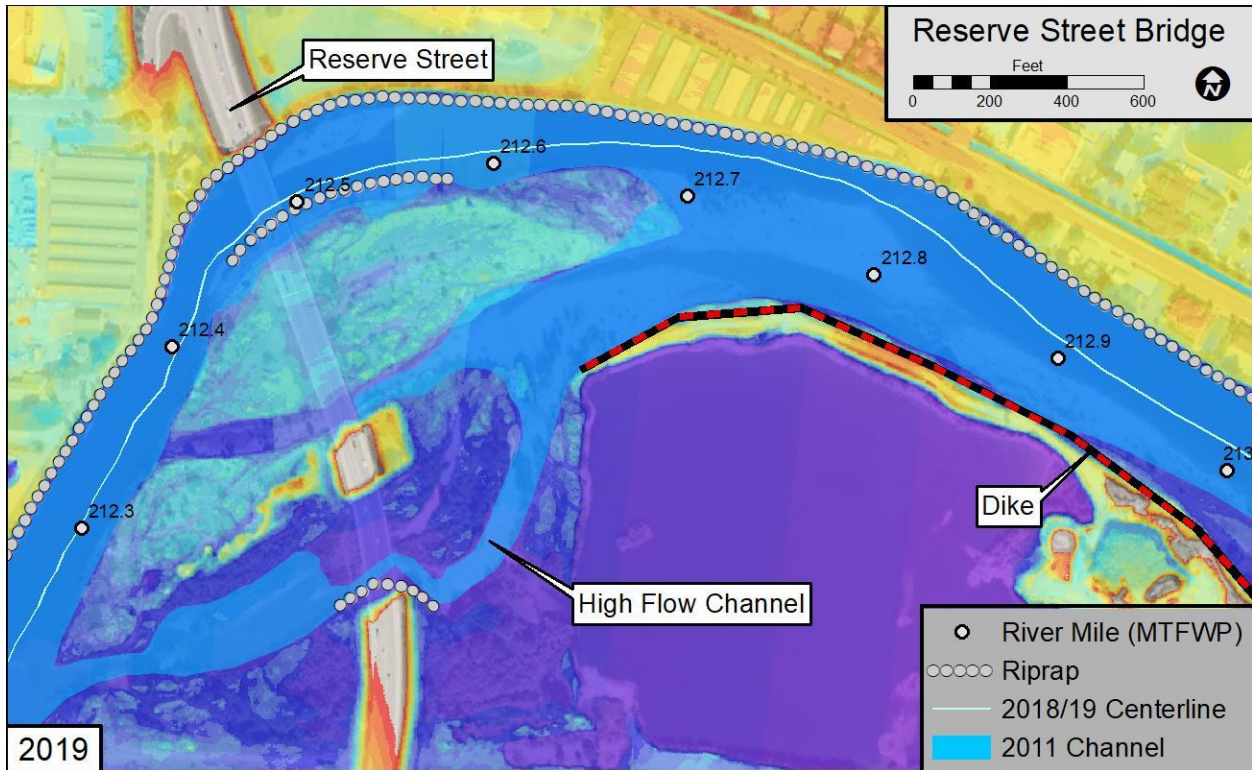
Figure 65. Relative Elevation Map for gravel pit area at Reserve Street Bridge showing side channel connectivity to main river.

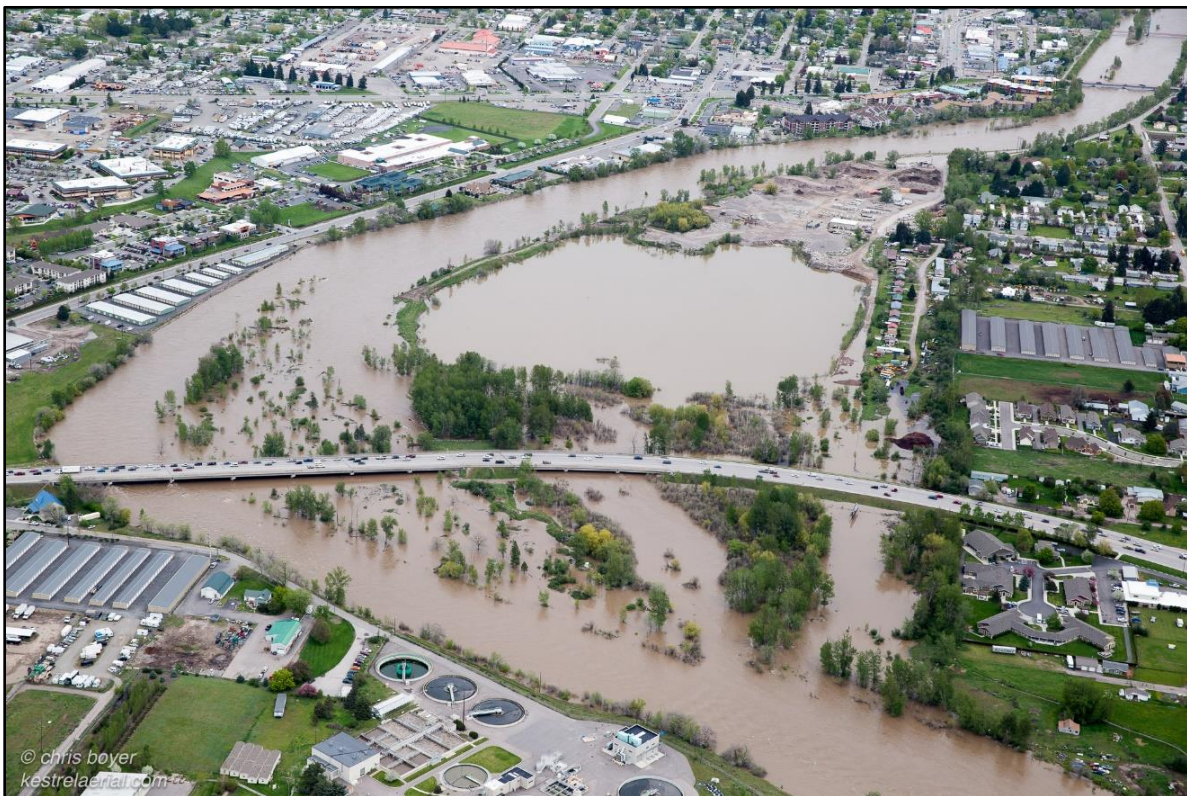
Figure 66. View upstream of Reserve St Bridge showing gravel pit and high flow paths under bridge to the right of the main channel (May 10, 2018).

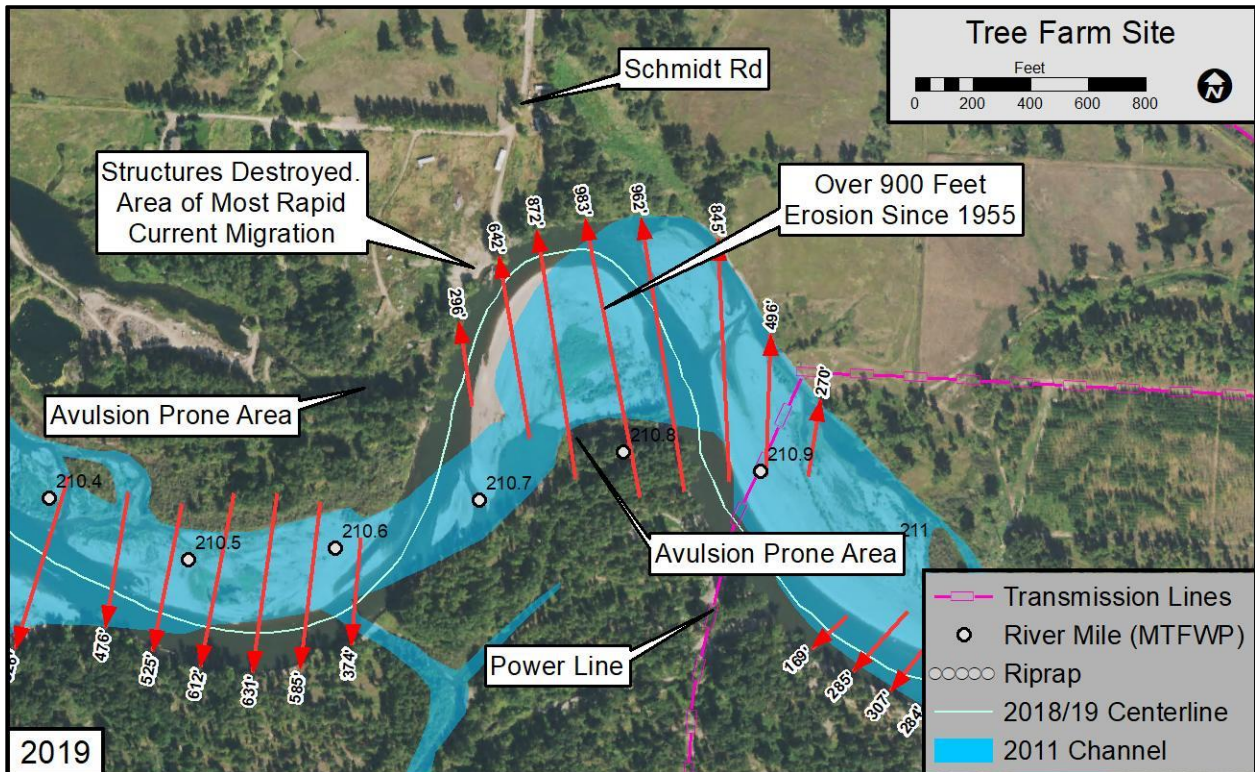
As described previously, the maximum migration 1955-2019 migration distance measured in Reach CF06 was 983 feet at RM 210.8, which is about a mile downstream from the railroad crossing/powerline described above. This site is at the south end of Schmidt Road, where a large bendway has migrated northward at an average rate of 15 feet per year since the 1950s (Figure 71). Another powerline crosses the river just upstream of this bend, and evidently power lines were downed across the river at this site during the 2018 flood. Figure 71 shows the 2011 banklines on the 2019 imagery to capture recent patterns of movement on this bend. As is typical with meander bend evolution, the most rapid movement in recent years has been on the downstream limb of the bend as the bend has translated down-valley. Since 2011, there has been no northward migration on the apex of the bend, but the downstream limb has migrated about 200 feet down valley. This area flooded badly in 2018 and several structures were destroyed (Figure 72).

This bend will probably cut off in coming years, there are several chute channels and a major scour pocket in the core of the meander where the open gravel abuts woody vegetation (“avulsion prone area” in Figure 71). The biggest near-term risk at this site is likely a power pole that is close to the “Power Line” label in Figure 71 where the river has migrated about 100 feet towards the pole since 2011 and now is within about 70 feet of its base. The south end of Schmidt Road is where the trailer home shown in Figure 18 was destroyed by the flood of 2018.

Figure 71. Northward-migrating bendway at RM 210.8 showing down-valley bend translation since 2011 destroyed several structures on the right bank.

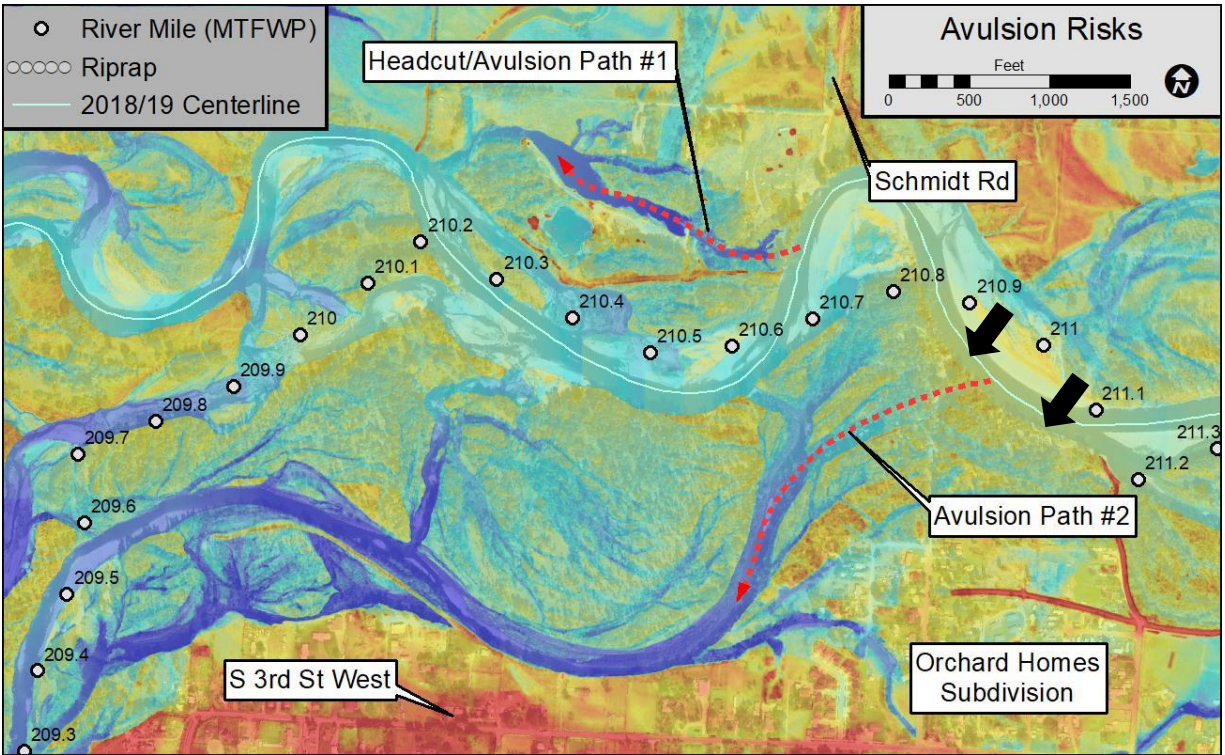
Another concern in the Kelly Island area is the potential for future major potential changes in flow paths in the around Schmidt Road (Figure 73). Channel migration in the area near the south end of Schmidt Road is encroaching into an older channel the has an identified headcut at its upstream end. This headcut is at the upstream end of an old gravel pit that forms a clear avulsion risk. Figure 74 shows a profile through that avulsion route. The headcut is less than 100 feet from the 2019 bankline. Continued westward migration of the channel coupled with eastward upstream migration of the headcut will very likely result in the formation of a new active channel through the old gravel pit. As the headcut is about four feet high, an avulsion at this location could be rapid.

Another avulsion risk is in the southern part of the river corridor, in the area where the utility pole described in Section 5.6.2 is threatened. This is labeled as “Avulsion Path #2” in Figure 73. The REM shows fingers of floodplain channels extending up through the riparian corridor to the utility pole site (black arrow at RM 211 in Figure 73). The LiDAR profile (Figure 75) for this avulsion path shows that as the river continues to migrate westward at RM 211, it will continue to intercept that floodplain swale, which will lower the bank height and allow more water to spill onto the floodplain and into a major partially abandoned channel north of S 3rd West Street. Activation of this channel could seriously threaten developments north of S 3rd West St as channel shifts from being an overflow channel to a primary thread of the Clark Fork River. This channel has been largely abandoned since at least the mid-1990s.

Figure 73. Major avulsion risks in CF06; black arrows show recent migration areas and colored lines follow LiDAR profiles.

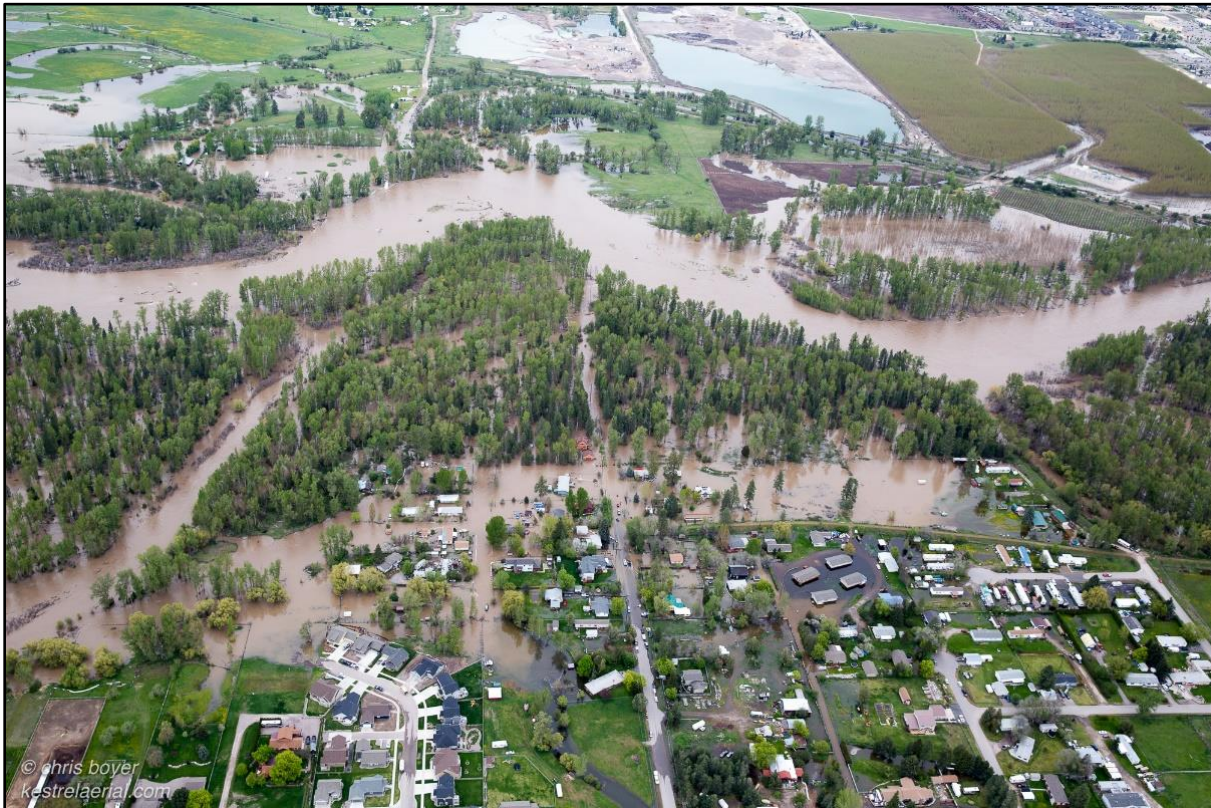
Due south of the Schmidt Road erosion area described above, there were major flooding problems on the south floodplain, where the Tower Street/Orchard homes neighborhood was built in low floodplain areas that are dissected by a floodplain swale extending south of South 3rd St West (Figure 76 and Figure 77). These areas are largely out of the modern Channel Migration Zone of the Clark Fork River, which reiterates the concept that flood risk and erosion risk are two different issues. Not surprisingly, high groundwater was described as a contributor to flooding issues in this area.

Figure 76. 2018 flooding of Orchard Homes/Tower Street area-- Reach CF06 (May 10, 2018).

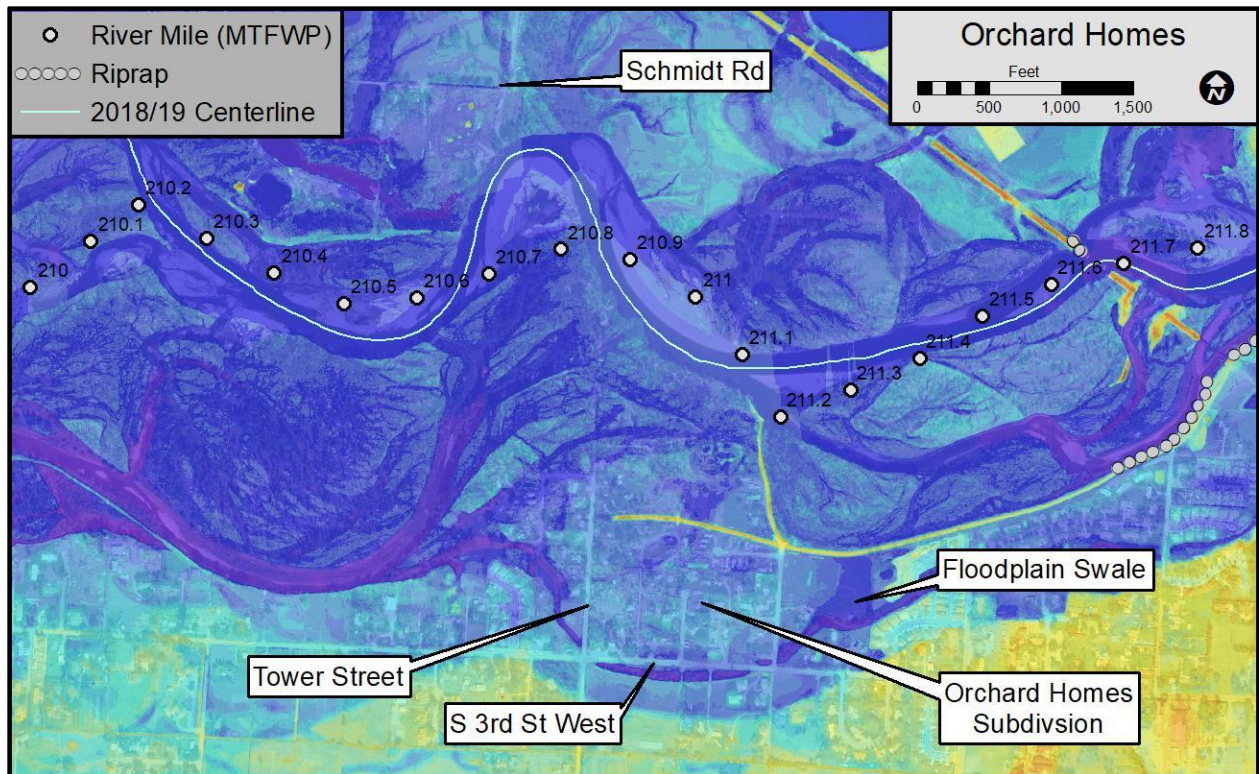
Figure 77. Relative elevation model results showing low topography and historic swales in Orchard Homes subdivision.

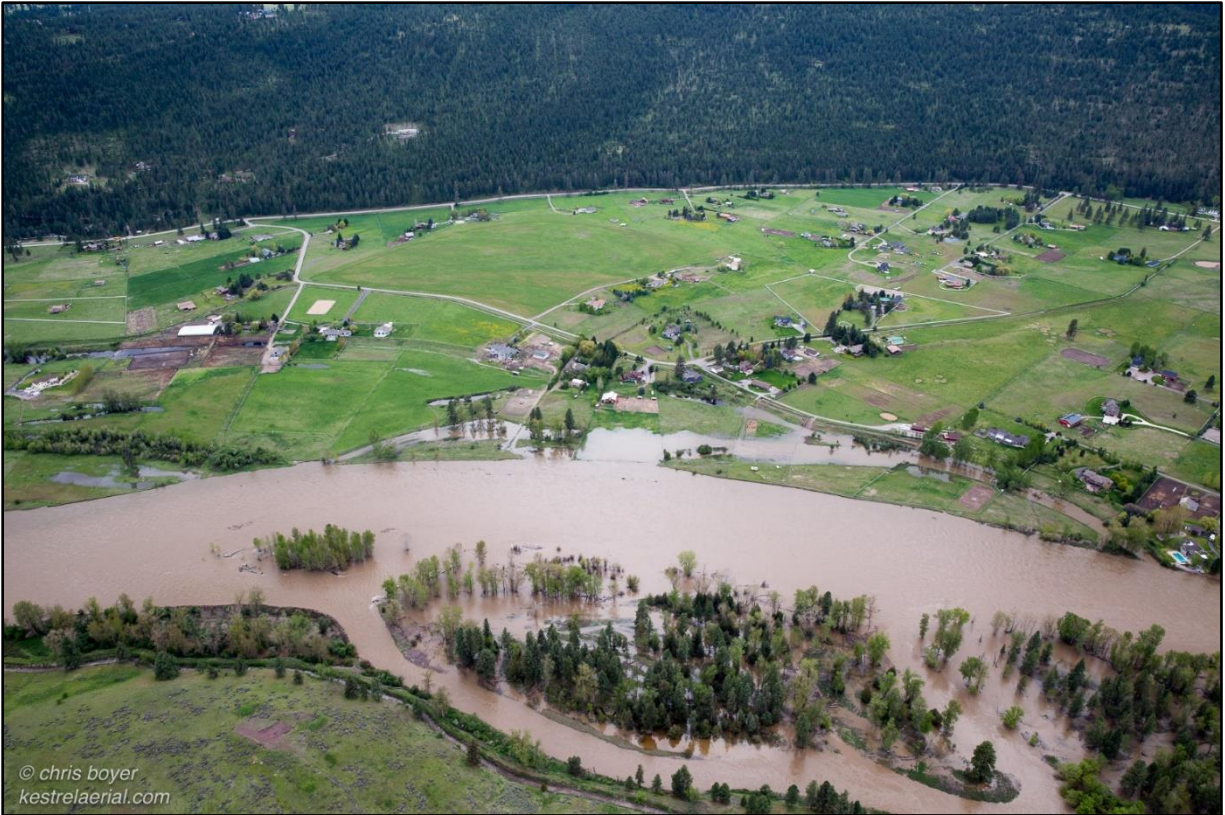
Figure 79 shows a 2018 flood photo of the bankline at RM 204.7 where the river has migrated southward on the order of 200 feet since the 1950s. This shows how floodwaters commonly access old river channel features on the floodplain that may be topographically subtle.

There are numerous structures within the CMZ in Reach CF07, including a swimming pool that is about 50 feet from the river. This pool can be seen on the far right side of Figure 79. Just upstream of this swimming pool is the bankline that has shown the most movement in this reach, with about 150 feet of migration since the 1950s. Over the last decade a large mid-channel bar has formed off this bank, likely driving increased erosion on the left bank; between 2017 and 2019 one section of this bank migrated ~50 feet to the south (Figure 80).

Figure 79. View south across river showing flooded low terrace swale at RM 204.7 (May 10, 2018).

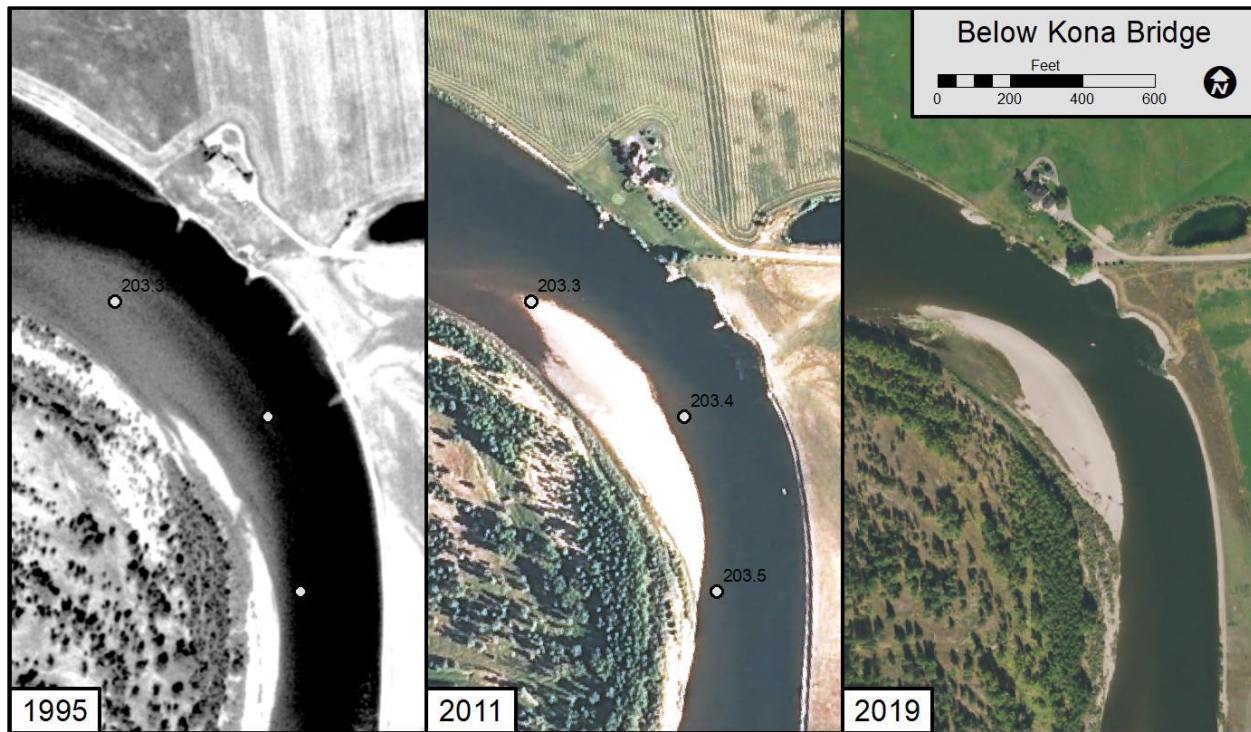
Just downstream of Kona Bridge, the first large meander bend in Reach CF08 has been an area of high erosive pressure on the right bank for decades. In the 1990s a series of barbs can be seen on the bank extending about 60 feet out into the river (Figure 82). By 2011 the upper barb had eroded out, and the others damaged. By 2019, the original barbs were severely damaged and large scallops had developed along the bank. This bend migrated 370 feet between 1955 and 2019. The scallops deepened by ~30 feet between 2017 and 2019. The home that this bank armor is protecting is well within the Erosion Hazard Area mapped for Reach CF08.

Figure 82. Right bank armoring just below Kona Bridge in 1955, 2011, and 2019.

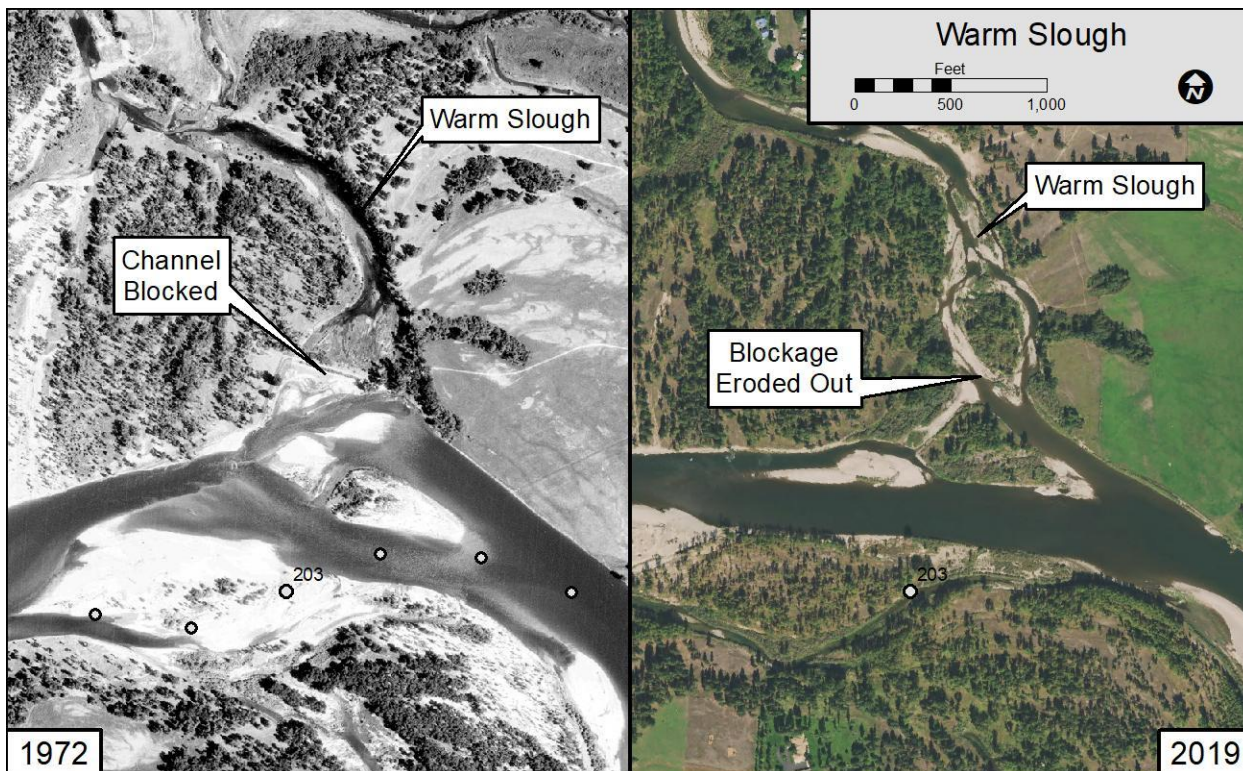
Just downstream of the barbs described above, a prominent side channel known as Warm Slough leaves the river at RM 203 and flows north of Council Grove State Park (Figure 81). This channel was artificially blocked by a large berm in 1972, but the river has progressively eroded out the berm and reactivated the channel. During the 2018 flood there was noted flooding on this channel, with water flowing across Mallard Way and other minor roads. This channel will potentially continue to enlarge and carry additional flow as its entrance is on the outside bank of a large meander, such that the entrance angle to the channel is low and prone to substantial flow capture (Figure 81).

Figure 83. Warm Slough side channel re-activation through constructed blockage at Council Grove State Park, 1972-2019, RM 203.0.

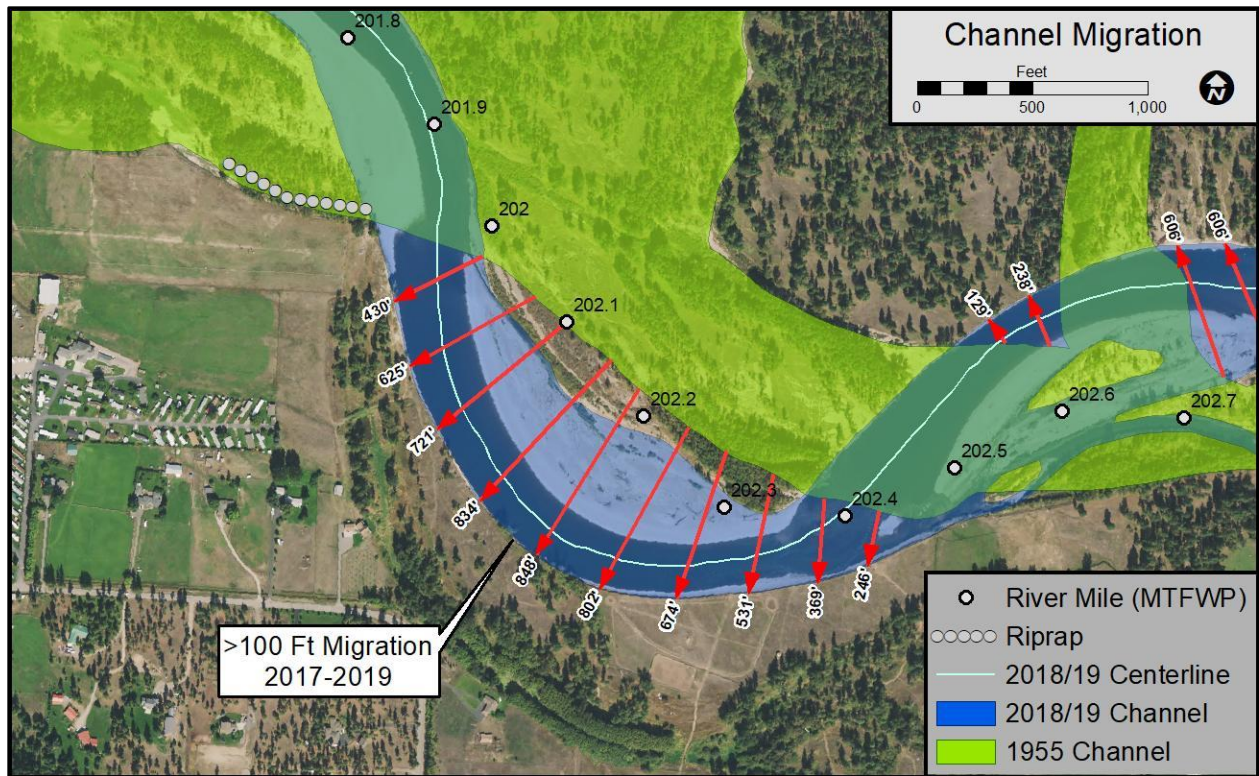
Just downstream, another large bend has migrated ~850 feet across from Council Grove State Park, with over 100 feet of that migration occurring since 2017 (Figure 84).

Figure 84. Meander migration at RM 202.2, Reach CF08.
