March 3, 2021

Clark Fork and Bitterroot Rivers Channel Migration Mapping Missoula County

Karin Boyd
Applied Geomorphology, Inc.
211 N Grand Ave, Suite C
Bozeman, MT 59715

Tony Thatcher
DTM Consulting, Inc.
211 N Grand Ave, Suite D2
Bozeman, MT 59715

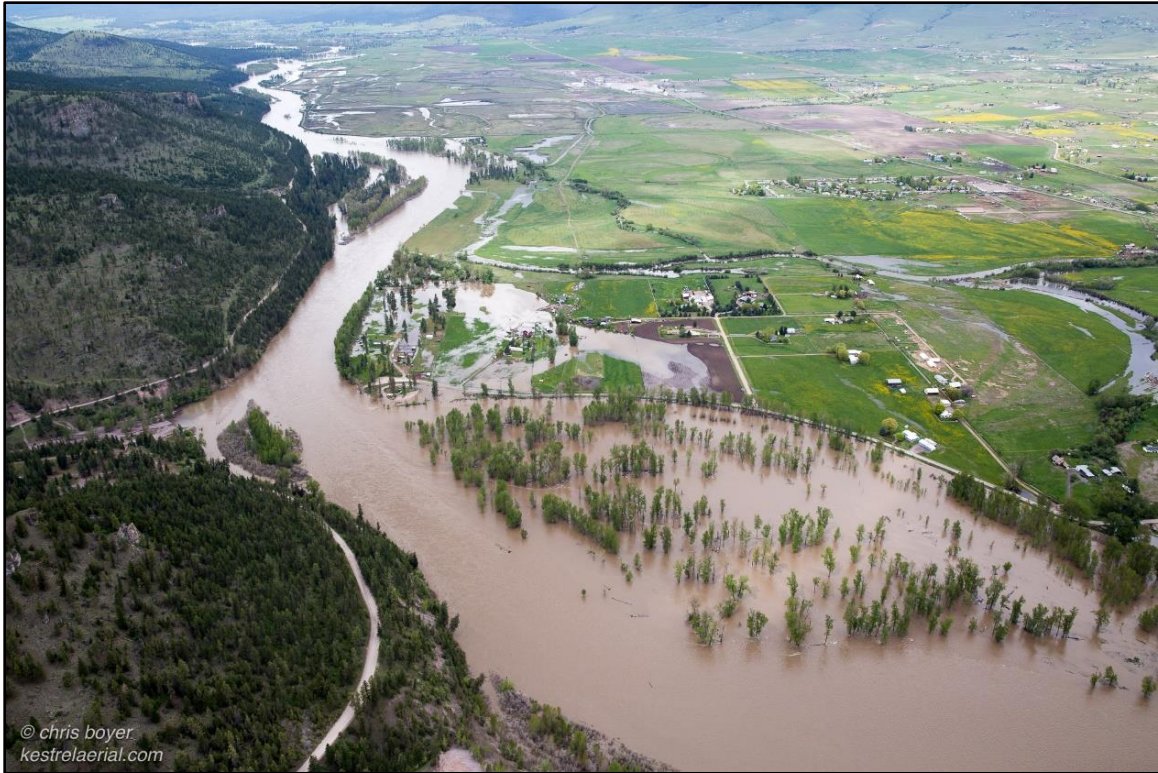
In the upper portion of the reach, natural overflow paths appear in part blocked by Harper’s Bridge Road (Figure 86), although the road overtopped in 2018, activating swales and flooding residences (Figure 87). Although transportation embankments cross and appear to block these swales, many of them still convey flow during floods and meet criteria as avulsion hazards. This does not imply that there is a high risk of the river completely relocating into one of the swales, but rather that there is potential for their expansion during floods which can lead to an increase in their activation frequency. This is especially the case in the event of any blockage in the river such as an ice jam or series of debris jams.

Figure 86. View downstream of Reach CF09 during 2018 flood; note Harpers Bridge Road acting as a levee in right foreground (May 10, 2018).

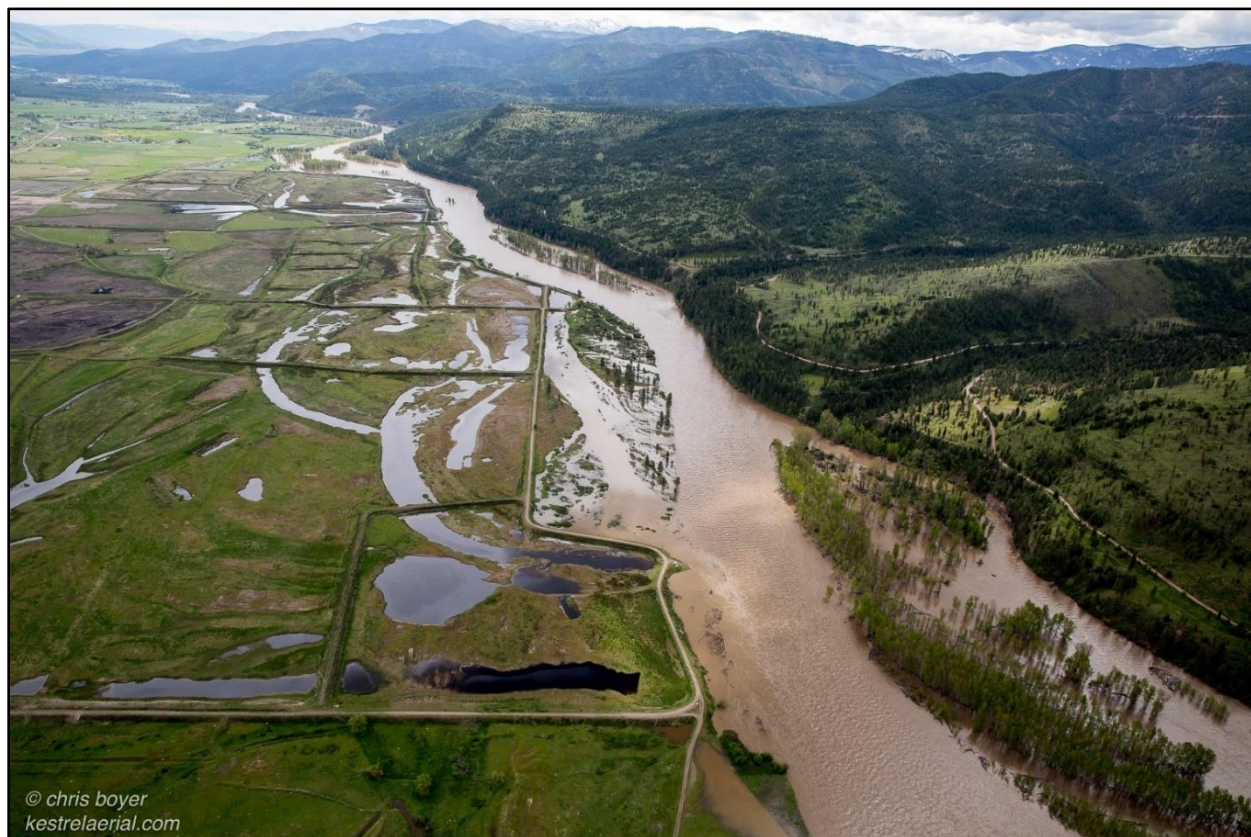
The dike system at Smurfit Stone is shown in Figure 88. Much of the CMZ in this area is mapped as restricted due to the bank armoring and diking system that limit channel movement into the area. However, this restriction may not be perpetual if the system were to degrade or be intentionally modified. These issues are discussed in more detail in Section 0.

Figure 88. View upstream showing Smurfit Stone dike system that confines river to narrow corridor against the bluffline to right (May 10, 2018).

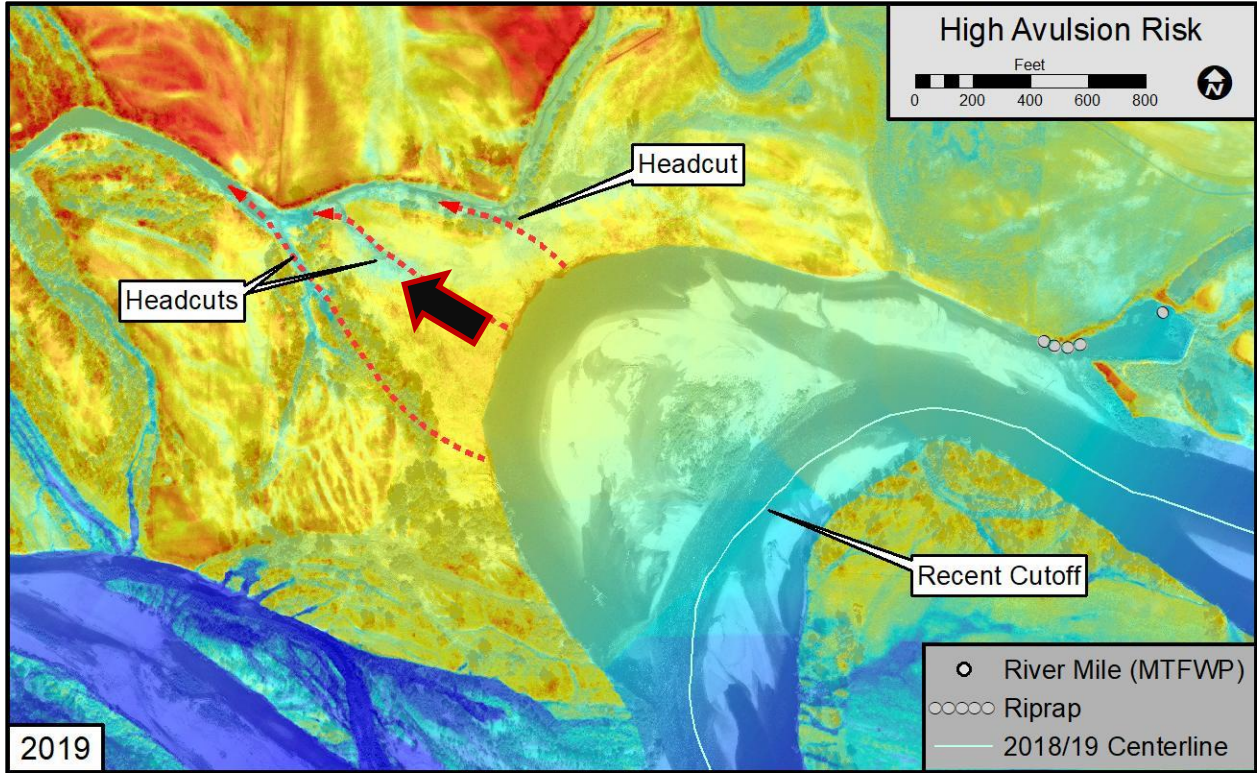
Figure 92. High avulsion risk at RM 193 as river migrates towards a large swale/ditch; headcuts appear to have formed in 2018. Arrow shows likely avulsion path.

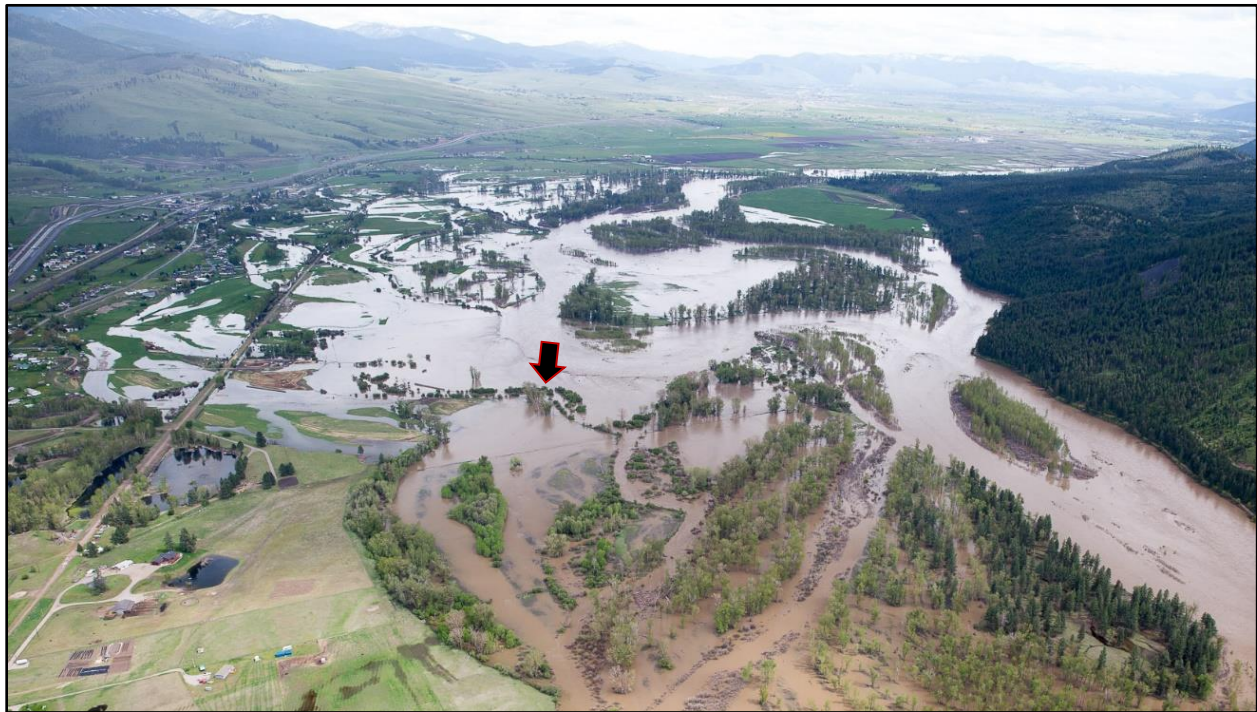
Figure 93. View upstream at RM 192 showing high risk avulsion route (red arrow) (CAP May 8, 2018).

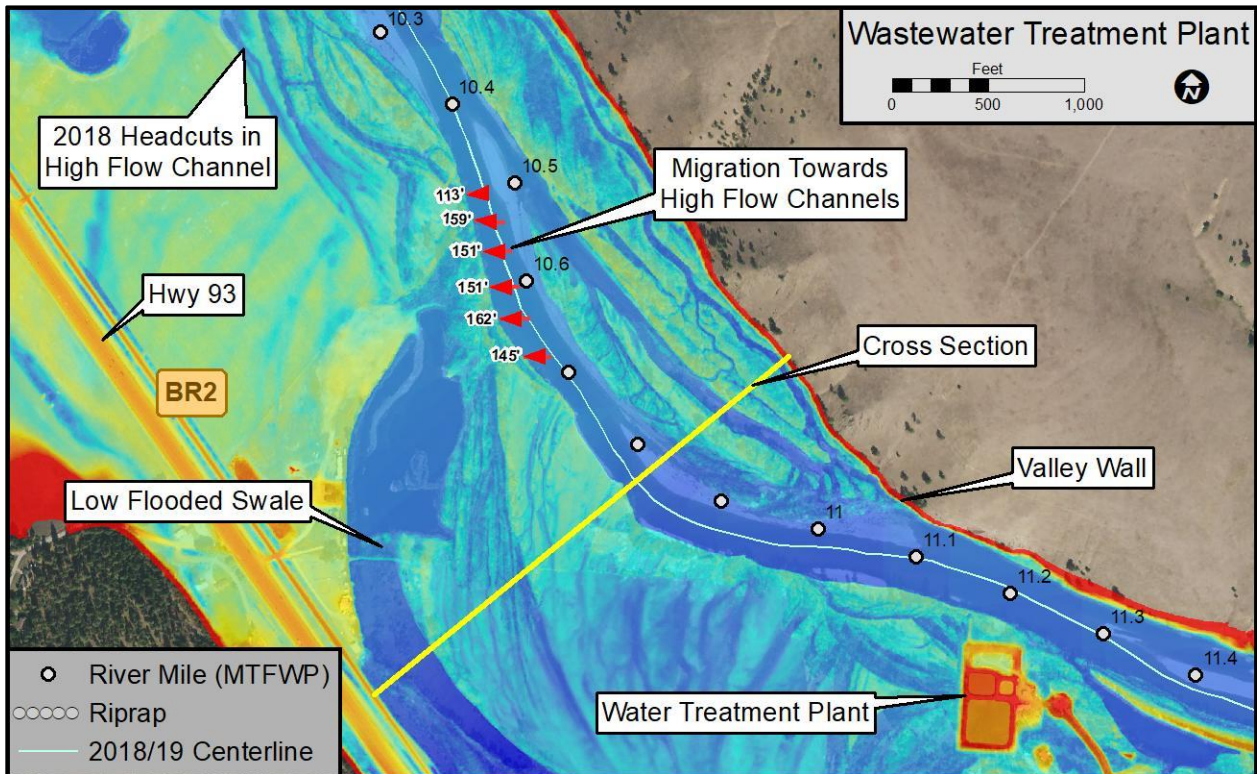
One area identified by Missoula County as a concern is the area around the Lolo Wastewater Treatment Plant. In 2018 the fields due west of the water treatment plant flooded, but the plant itself remained dry inside retaining walls. A Relative Elevation map of the area shows a large, abandoned swale extending directly under and west of the plant (Figure 99). This swale is about 330 feet wide and 1.2 miles long; it is clearly an old primary thread of the Bitterroot River that was abandoned by at least the 1950s. Figure 99 also shows left bank erosion at the lower end of the swale; this bank has migrated about 160 feet towards the swale outlet since the 1950s (Figure 100). The outlet is vegetated, but just upstream is a large, abandoned gravel pit pond. Continued migration in this area has the potential to breach the pond although this will take decades if typical migration rates are sustained. In 2018, overflows at this migrating bank traveled down high flow channels on the west floodplain and created distinct headcuts which will promote channel deepening on the floodplain. A plot of the cross section drawn in Figure 99 shows that the elevations of the river, the swale, and a series of floodplain channels are all similar and thus their continued connectivity via flood flows and/or groundwater should be expected (Figure 101).

Figure 99. REM below Water treatment plant showing low swale and channels head cutting in 2018. Cross Section shown in Figure 101 is marked by yellow line.

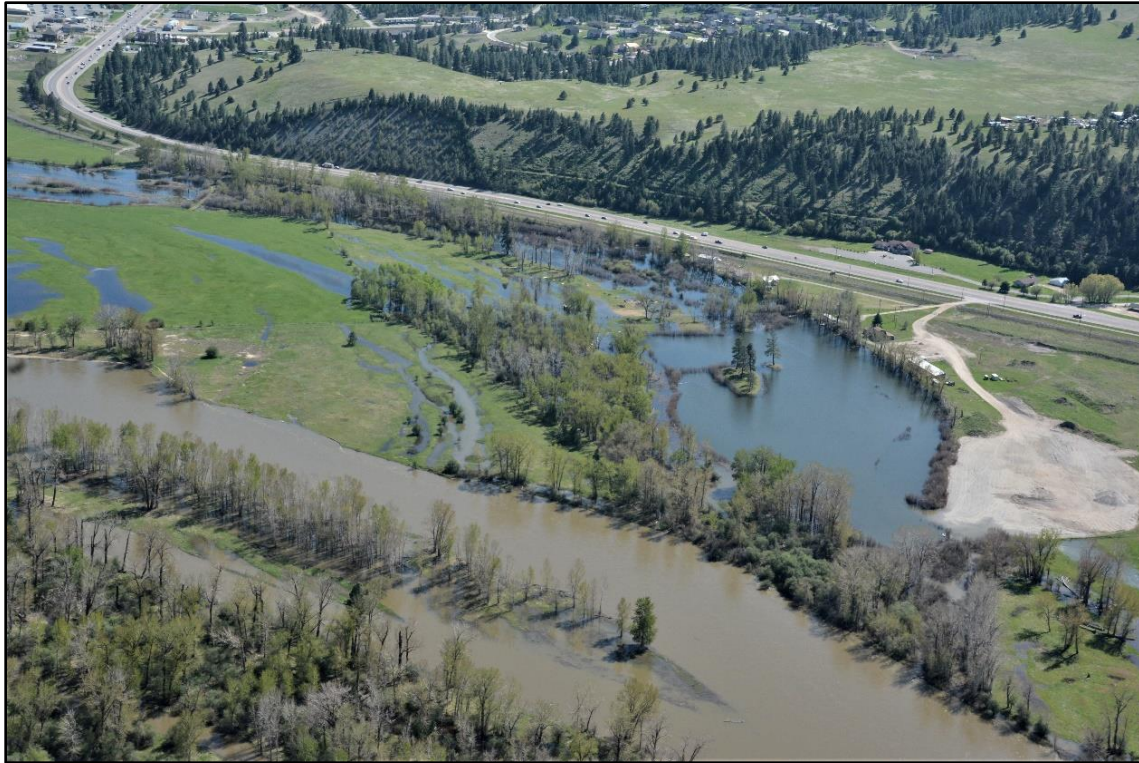
Figure 100. View upstream showing lower end of flooded swale below water treatment plant; migrating bank follows the vegetated strip between swale and river (CAP May 8, 2018).

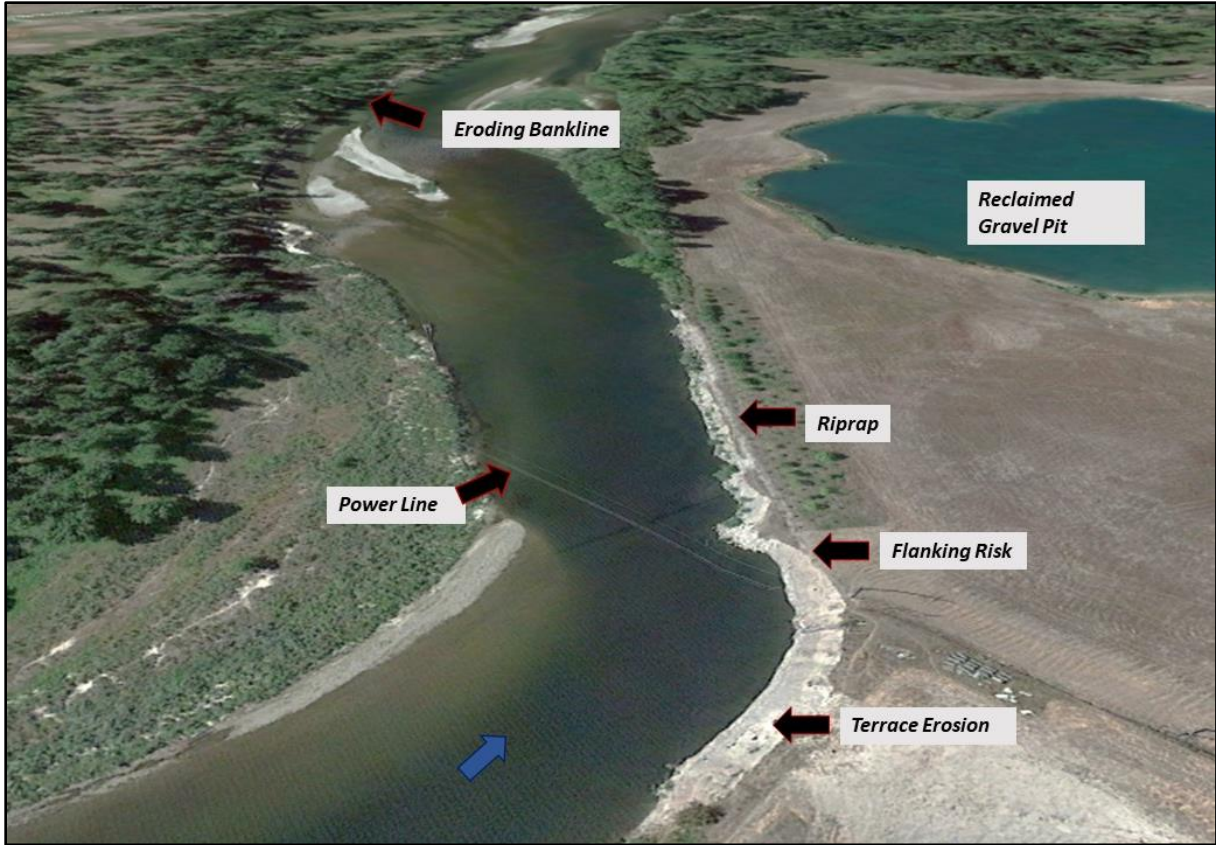
upstream of the pit, the right bank has been slowly migrating northward into a terrace since the 1950s (1.4 feet per year on average). A power line crosses the river at this eroding bankline (Figure 103). Just downstream there is about 430 feet of right bank riprap protecting the gravel pit area. Probably the biggest risk in this area regarding channel migration is the potential for the river flanking the armor at the power line. When rivers erode behind armor, unusually rapid rates of bank erosion can occur due to the hydraulic eddies formed at the flanking site. Further downstream the river is currently migrating southward away from the reclaimed pit. This area fortunately has a wide swath of riparian area on the south side of the river that is dissected by swales/high flow channels that will help alleviate flooding pressure at the gravel pit, which sits on relatively high ground.

Figure 103. Google Earth oblique image showing major features at RM 4.4; view is downstream.

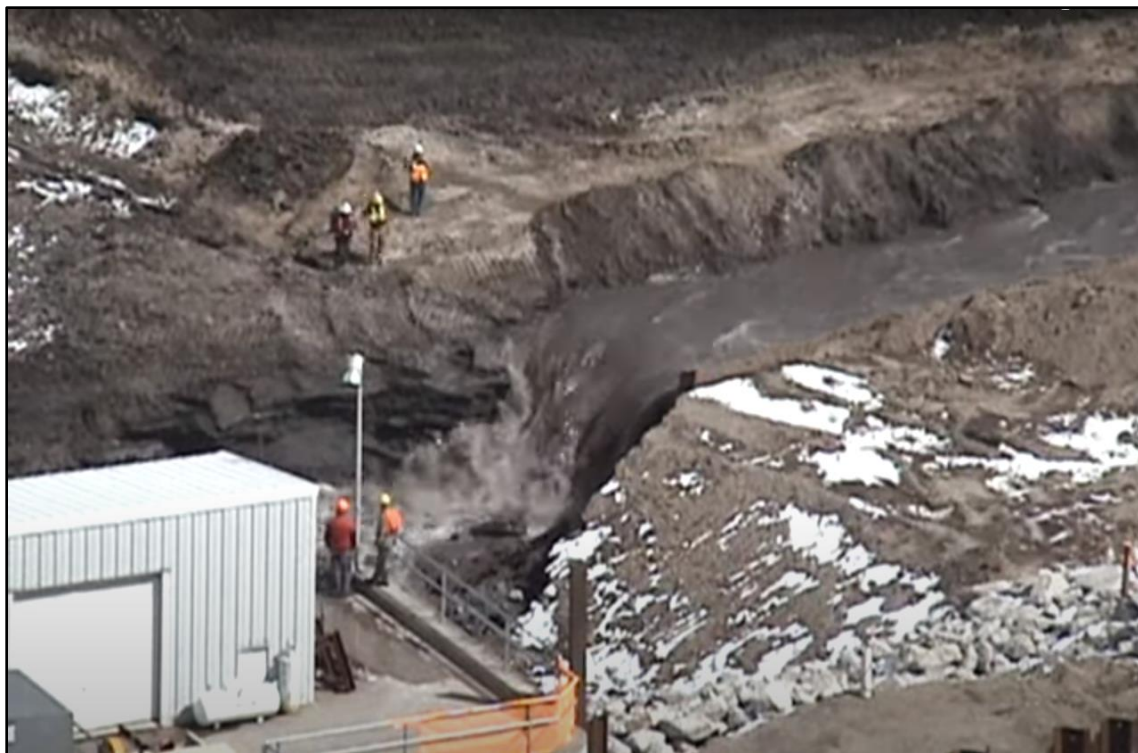
Wilcox (2009) described how the 2008 removal of the dam resulted in base-level lowering of 9 meters (29 feet) at the dam site. This means the bed of the channel below the dam was 29 feet below the bed

of the reservoir upstream, creating a steep drop in the river over the dam site (Figure 106). Subsequent erosion introduced a pulse of reservoir sediment to the river. In the first two years following dam breaching, Wilcox (2009) estimated that several hundred thousand cubic meters of sediment were eroded from reservoir segments on both the Clark Fork and Blackfoot Rivers. As flows were high during the first two years following dam breaching, sediment was also delivered to the reservoir site from upstream, making it difficult to calculate the volume of sediment actually derived from the reservoir. Wilcox (2009) indicated that downstream geomorphic adjustments to reservoir-derived sediment delivery was much higher in the first year relative to the second year following dam removal, when easily-transportable fine sediment was sent downstream. The downstream response included side channel deposition on the order of three feet deep in side channels of the Kelly Island area. Fine sediment also settled into the voids of existing gravel deposits. One question raised by Wilcox (2009) was whether dam removal had resulted in short term changes in geomorphic conditions, or “threshold-crossing shifts to new ecogeomorphic conditions.”

Figure 106. Large headcut formed as Milltown Dam was breached on March 28, 2008 showing base level lowering that drove channel downcutting upstream and accelerated sediment delivery below (extracted from a youtube video by American Whitewater).

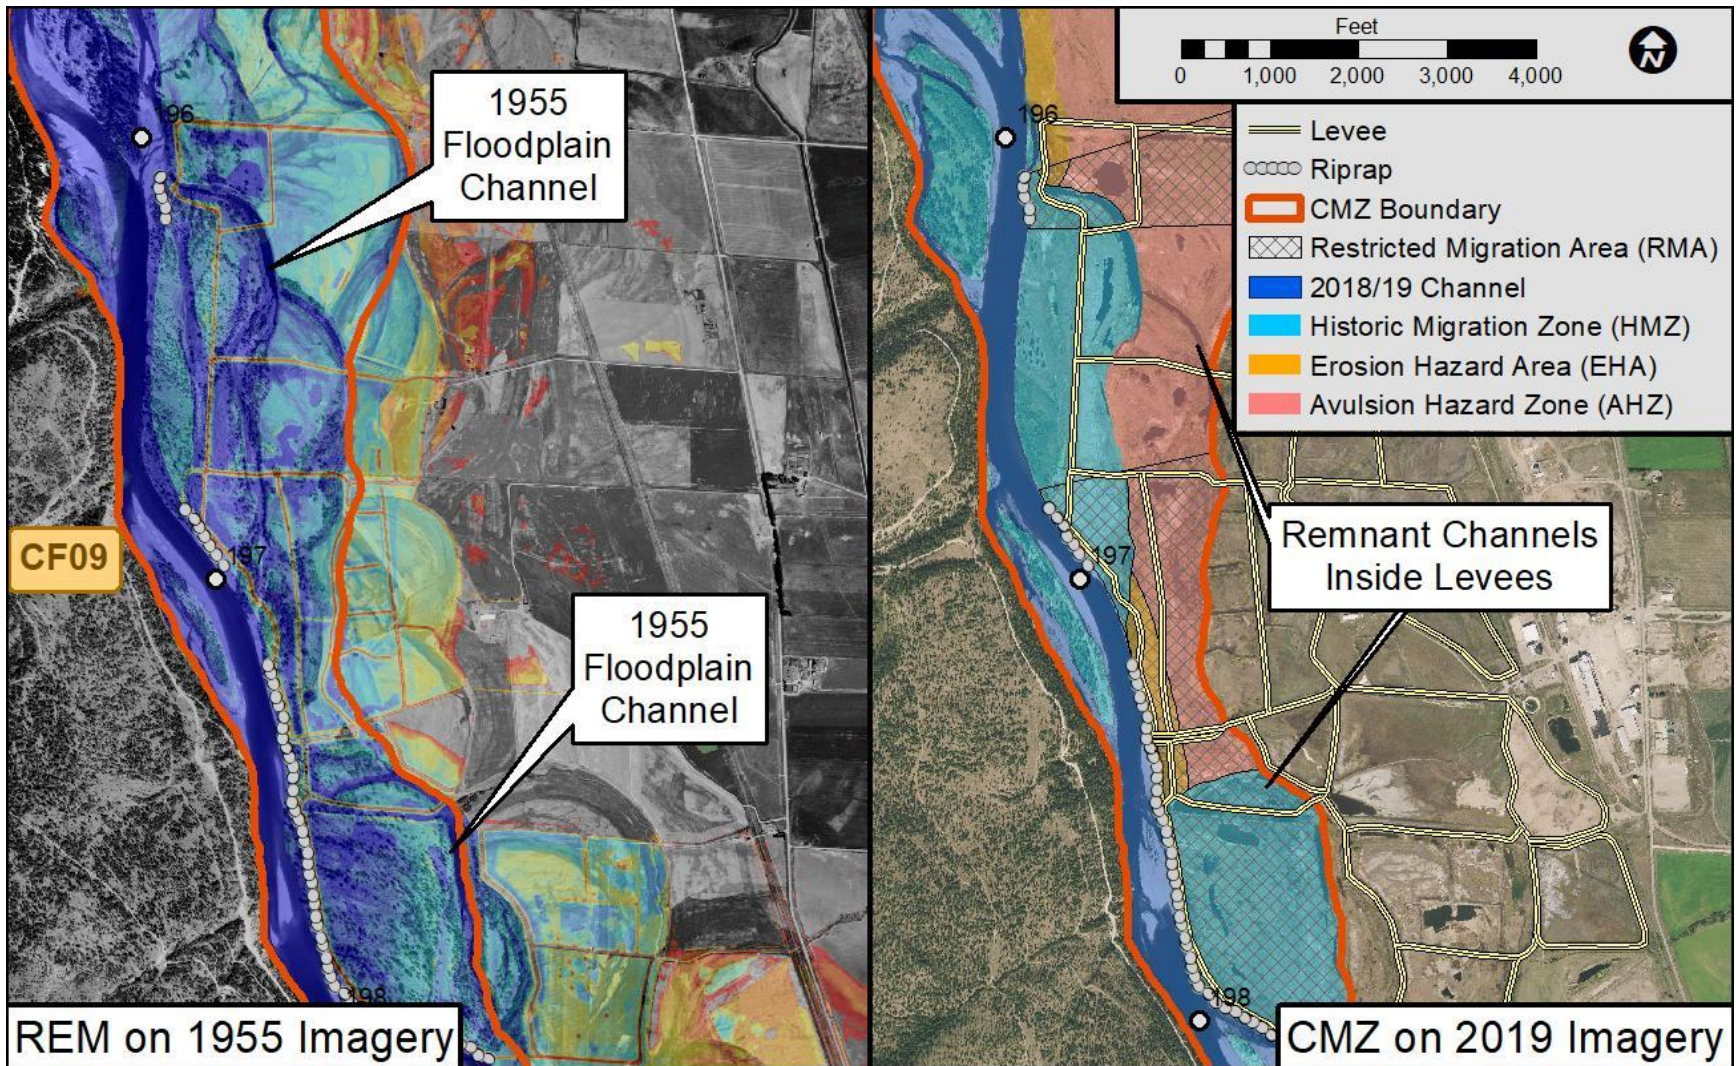
Figure 109 shows the Relative Elevation Modeling (REM) results as well as the CMZ map for the Smurfit Stone site. Much of the mill site occupies the Historic Migration Zone where, in the 1950s, floodplain channels were continuous and active. These older channels are still visible as swales in the treatment ponds in the REM, and they stand out due to ponding in the 2018 flood photo (Figure 110).

Figure 109. REM (left) and CMZ (right) maps for Smurfit Stone.

Since the primary means of protecting the CFR berm from channel migration is bank armor, the following discussion describes aspects of armor construction, maintenance, and current conditions with respect to river process. Figure 109 shows that most of berm is currently armored. In most areas the armor is on the CFR berm itself where it forms the stream bank, and in other areas there is a floodplain buffer between the armored streambank and berm.

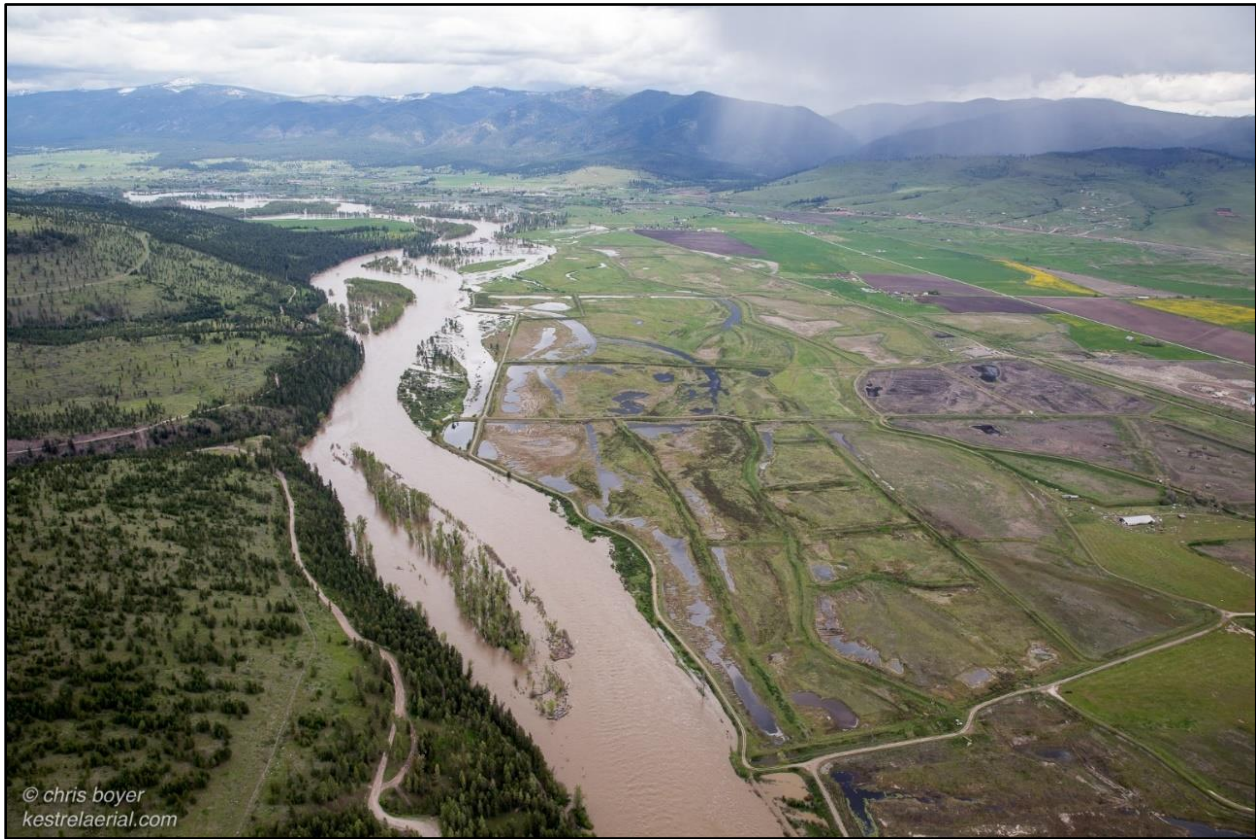
Figure 110. View downstream of Clark Fork River at Smurfit Stone during May 2018 flood.

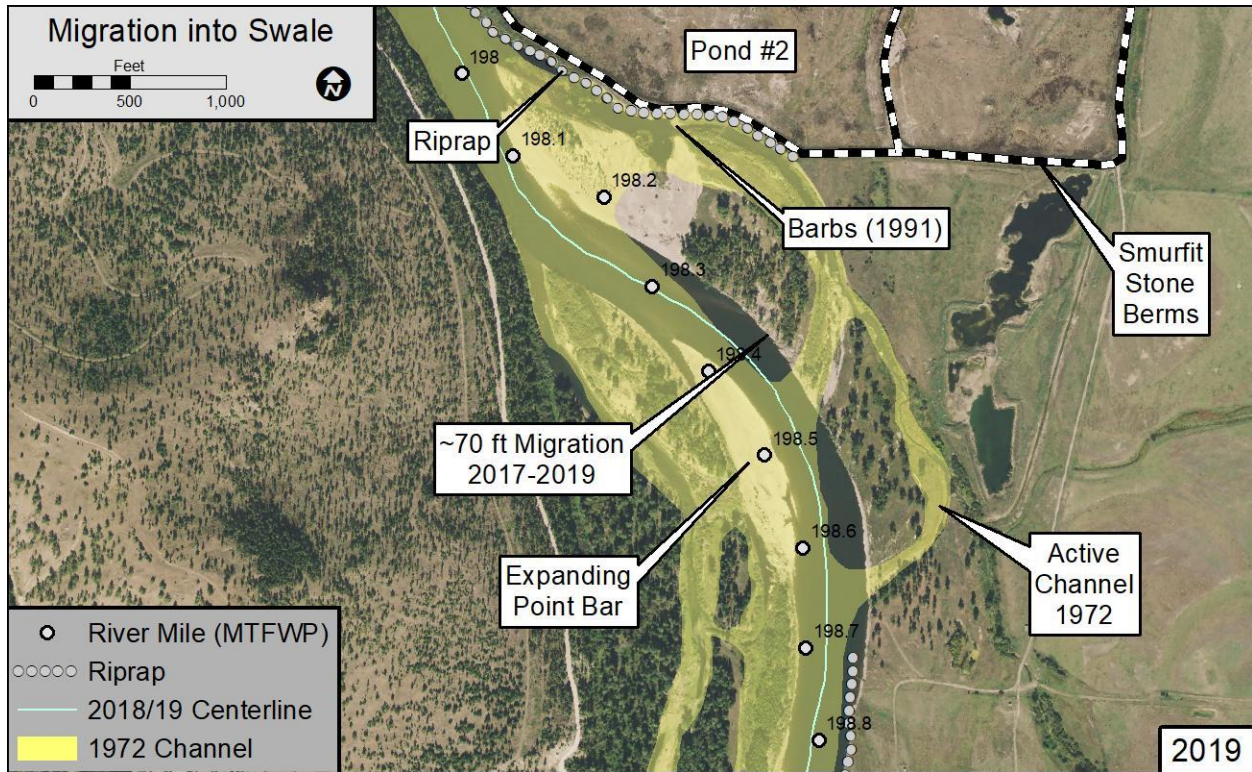
On the upstream end of the Smurfit Stone Mill Site at RM 198, The river has been migrating to the northeast towards the Pond #2 Berm (Figure 113 and Figure 114). About 1,000 feet upstream of the berm, the river has migrated about 70 feet since 2017 towards a swale that was a primary thread in the 1970s (Figure 113). A growing point bar on the left bank of the river will continue to drive right bank erosion and bend development at this location. As a result, increased activation of this meander should be expected, along with the erosion potential that comes with a higher frequency, duration, and magnitude of flow.

Figure 113. Bank migration just upstream of Smurfit Stone showing 2018 migration towards abandoned meander that flows against Berm along Pond #2.

The 300 feet of riprap was probably deemed necessary when the bendway cutoff and re-oriented the river to the west, which would have increased erosive pressure on the right bank near RM 198 (Figure 113). The 2,200 feet of additional rock appears to have been placed on the right bank of the older channel on the south side of Pond #2.

The 1995 imagery shows barbs at the location labeled in Figure 113. At that time, a primary channel was hitting this bank at a right angle.

Figure 114 shows that this area around Pond #2 is marked by a substantial narrowing of the river’s Channel Migration Zone as it approaches the Smurfit Mill Site. This can create problems regarding sediment continuity, as abrupt artificial narrowing of stream corridors commonly results in deposition upstream (such as at bridges). Any increased rate of sediment storage in the area shown in Figure 113 will drive additional channel movement and create new stressors on the existing berm/armor system.

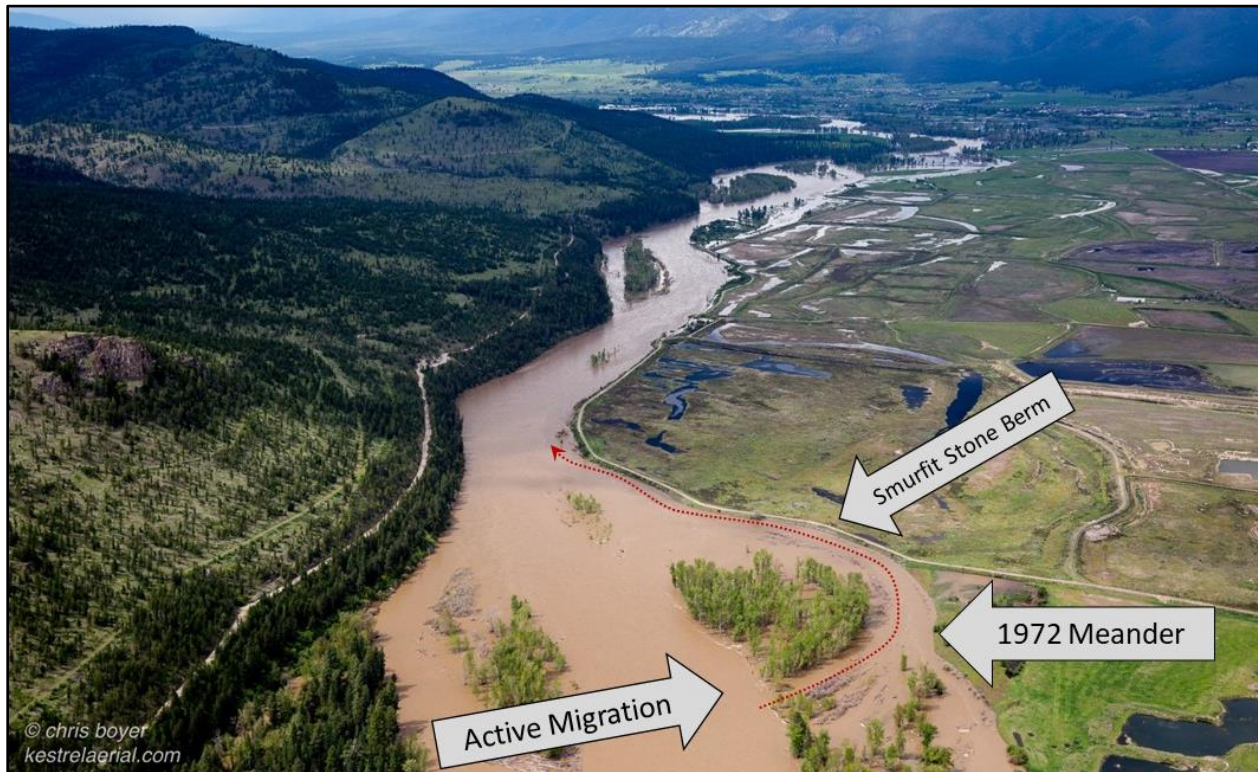
Figure 114. 2018 flood photo showing high flow activation of meander swale that flows against Smurfit Stone berm at upper end of mill site (May 10, 2018).

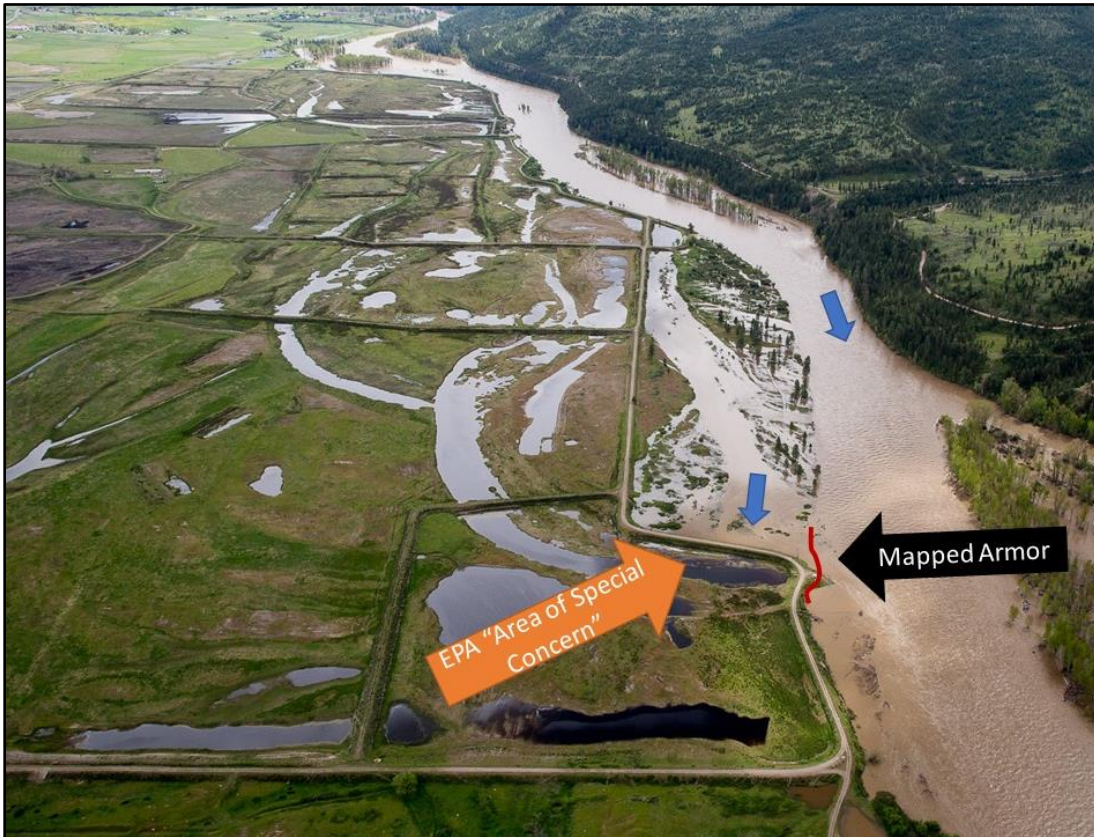
Another example of potential armor damage is shown in Figure 118. This is located at the downstream (northern) end of the mill site. In 2018, a scour pocket formed at the head of the armor which will increase its risk of failure in coming years. East of the armor, floodwaters have scoured out floodplain area between the armor and the Smurfit Stone Berm. Figure 119 shows that at high flow the water flowing behind the armor hits the berm at a right angle, increasing the potential for local scour at the toe of the berm. This section of berm, which runs at a high angle to the Clark Fork River corridor axis, should be monitored and maintained as necessary. This section of the CFR berm was identified as an “area of special concern” by the EPA following the 2018 flood (Newfields, 2016).

Figure 119. View upstream of armor at RM 196.15 showing flow behind treatment hitting Smurfit Stone berm at right angle.

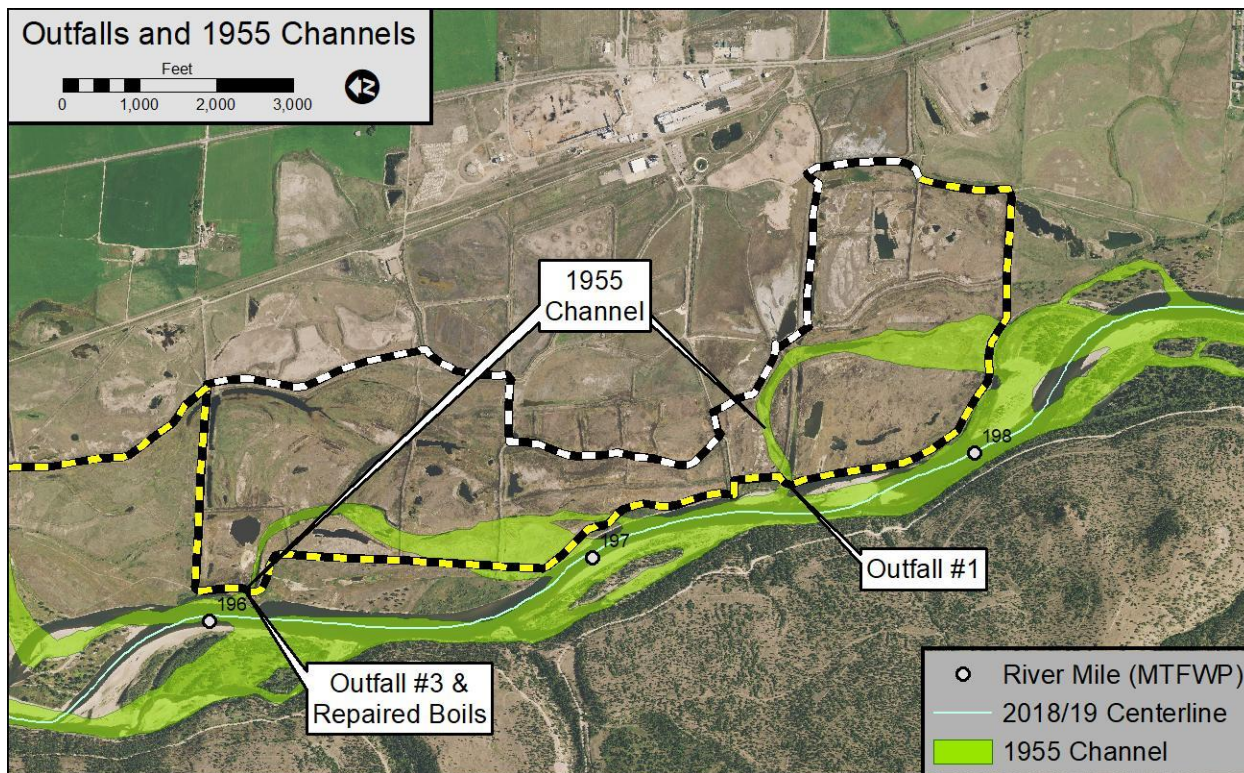
The 2018 flooding revealed areas of concern associated with two Smurfit Stone outflows. Narrow surface cracks adjacent to former holding pond HP2 south of Outfall 1 and a repaired boil area in former holding pond HP13 near Outfall 3.

One thing to consider in monitoring these areas is their location in the Clark Fork River Channel Migration Zone. Figure 120 shows the locations of these outfalls on a 1955 image, with the active 1955 channels mapped. Both outfalls are located on recent channels mapped as active in 1955. This could have strong implications for berm stability, as there have been other situations where levees have breached in such settings.

Figure 120. 1955 image of Smurfit Stone showing Outfall #1 and #3 locations on 1955 channel threads.
