July 31, 2020

Sun River Channel Migration Mapping

Executive Summary

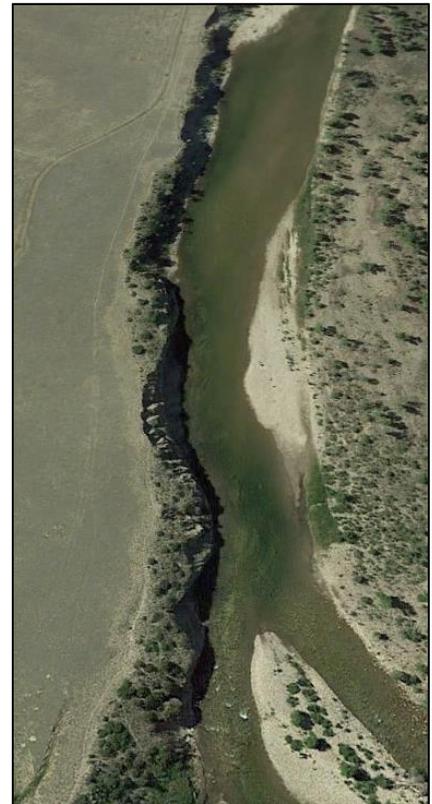
Figure 57. Sandstone bluffline clipped out of CMZ in Reach SR6 (Google Earth)

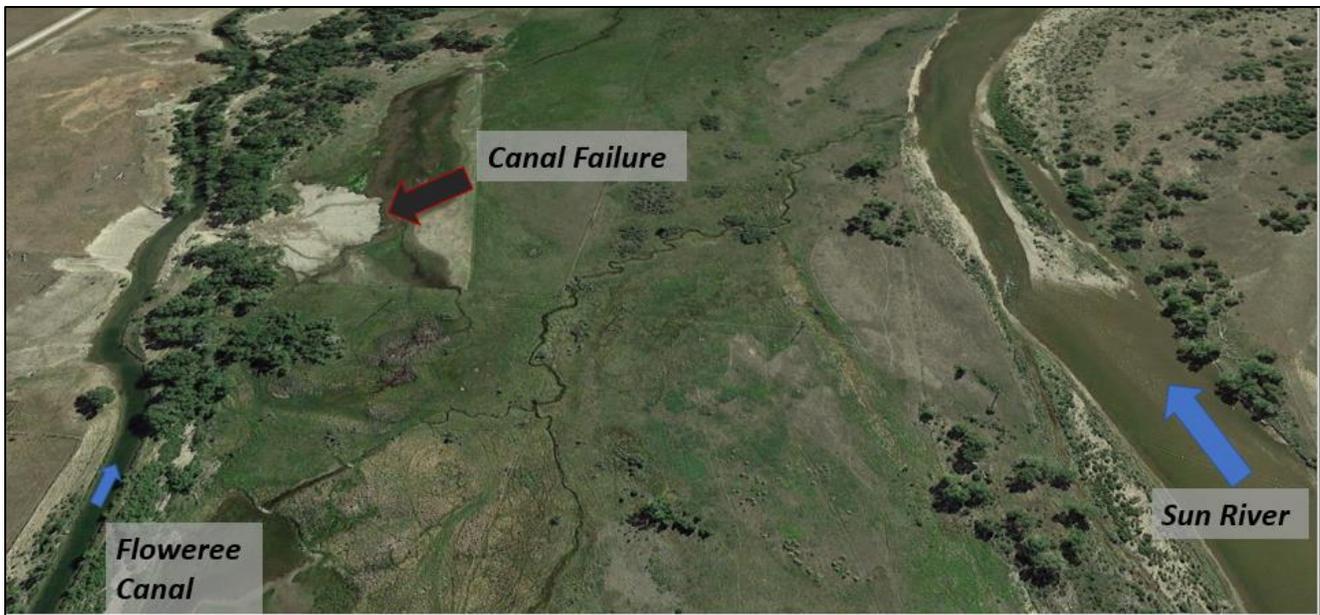
The Floweree Canal closely parallels the river in the upper few miles of Reach SR6, and sometime between 2011 and 2014 there was a substantial hillslope failure along the canal that caused it to breach at RM 66.6, forming a distinct alluvial fan on the Sun River floodplain (Figure 58). Canal seepage supports numerous wetlands on the floodplain as well. In some areas such as just below the mouth of Spring Creek, the stream corridor is tightly confined between pivot fields, and in several locations the streambanks have been armored to protect those pivots (Figure 59).

Figure 58. View downstream showing Floweree Canal breach forming alluvial fan on Sun River floodplain (Google Earth).

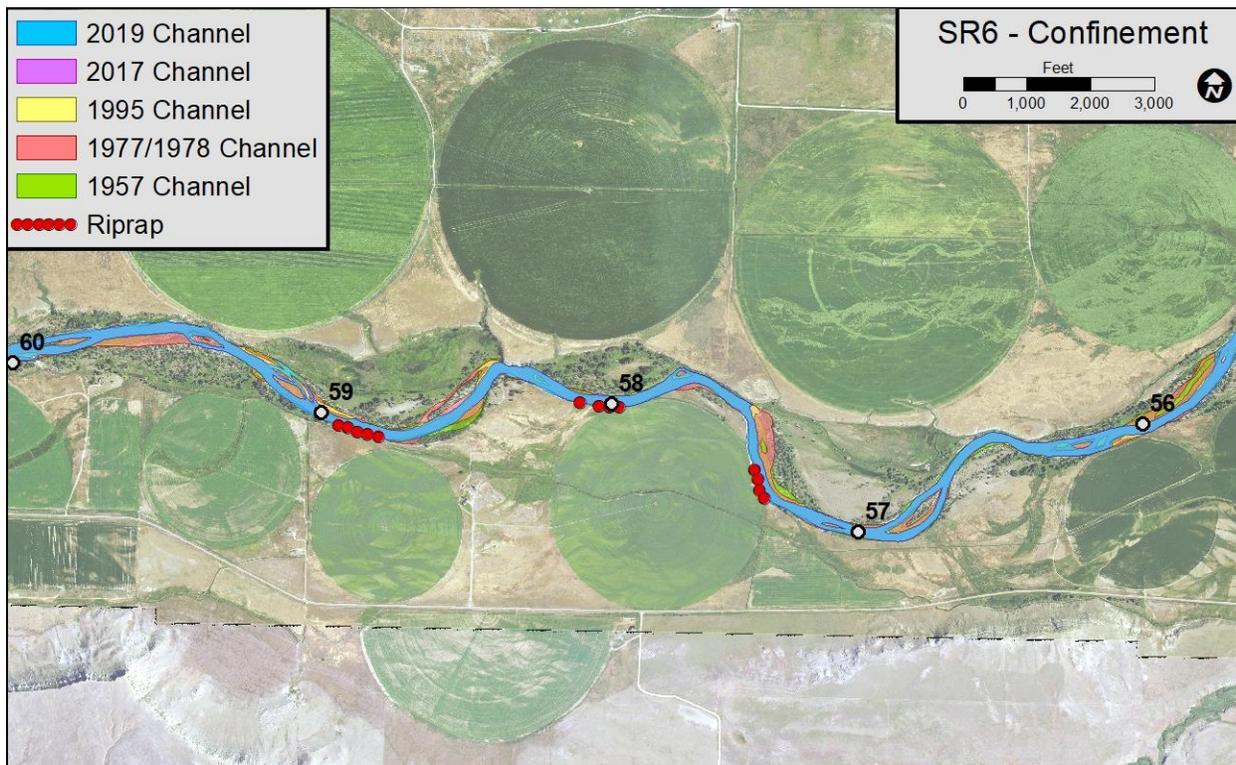
Figure 59. Bankline mapping showing armor and minimal channel movement between pivots in Reach SR6.

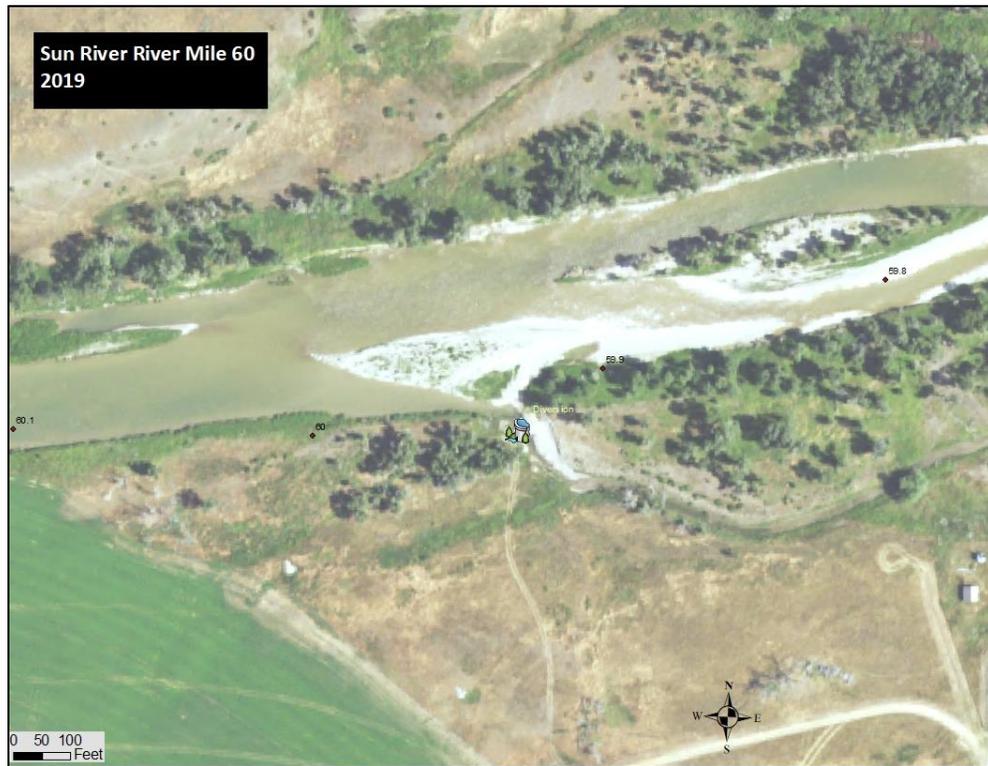
1. A diversion structure at RM 60R, which is about a mile below the mouth of Spring Creek, appears to have some sedimentation issues at its entrance. A large bar has formed that but it appears that the flow split into the ditch has been effectively managed by hardening the upper face of the bar to form a deflector (Figure 60). In 1978, a rock weir extended into the river to deflect flows towards the ditch, this is probably what drove the sedimentation just downstream. The bar has been established since at least 1995. A return flow channel at the headgate will be important to maintain so the ditch is not overrun in high water. The ditch itself poses an avulsion hazard as it flows parallel to the river across a low meander, it should be monitored for that risk.

Figure 60. Bar formation at diversion, RM 60.

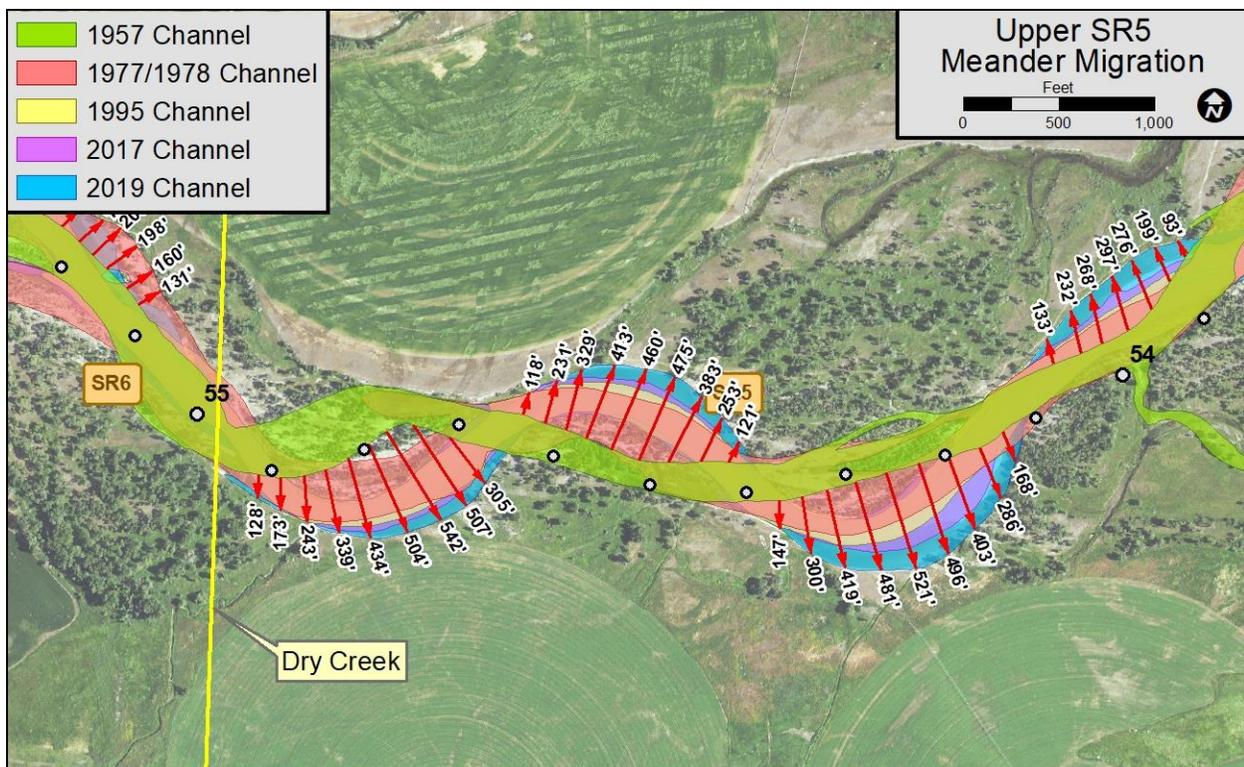
Figure 62. Meander migration in upper SR5 near the mouth of Dry Creek.

1. Progressive southward bank movement immediately downstream of the mouth of Dry Creek is threatening a pivot field (Figure 62). The river was about 60 feet from the edge of the field in 2019. The banklines show that the most rapid erosion is on the downstream limb of the bend as it translates down valley to the east. This will reduce the erosive pressure on the field with time. As the river is pinned on the north side by a bluff, it will be important to provide some room for channel adjustment in this area to prevent a need for perpetual bank armor expansion. About 9 acres of the pivot field are within the mapped CMZ of the Sun River.

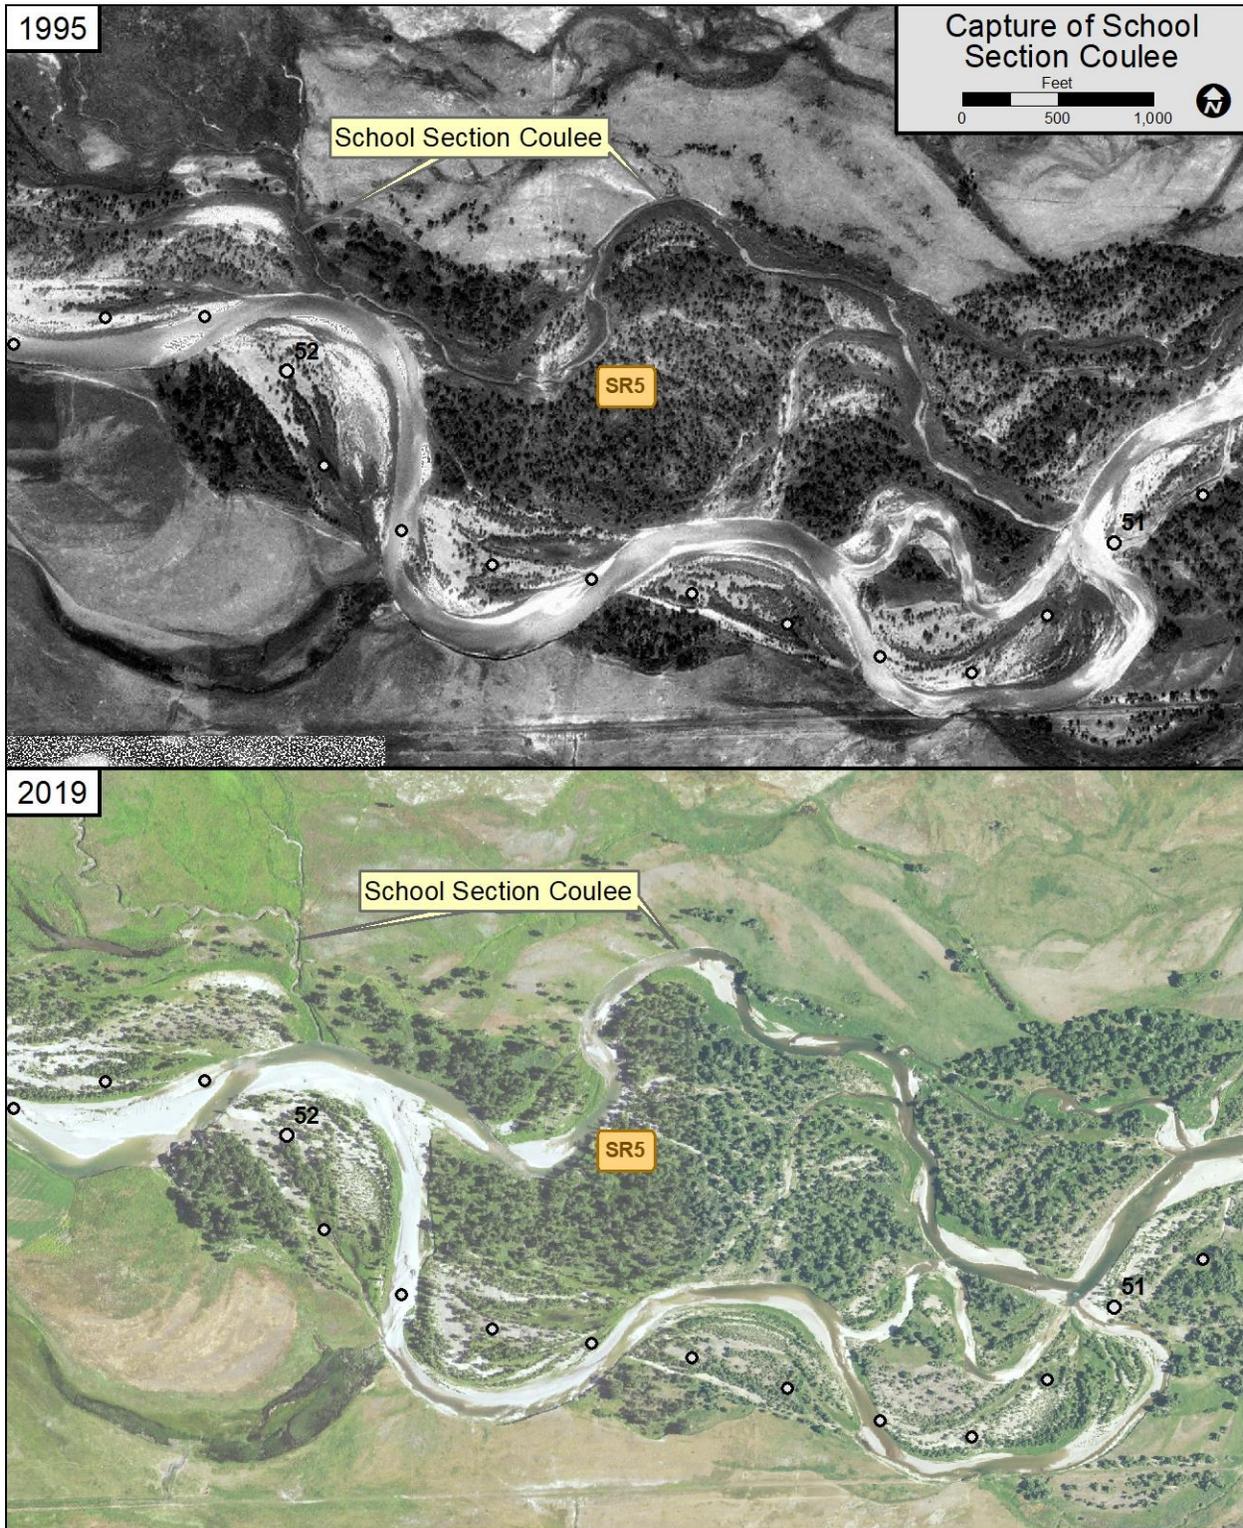
Figure 63. Sun River capture of swale that routed School Section Coulee in 1995.

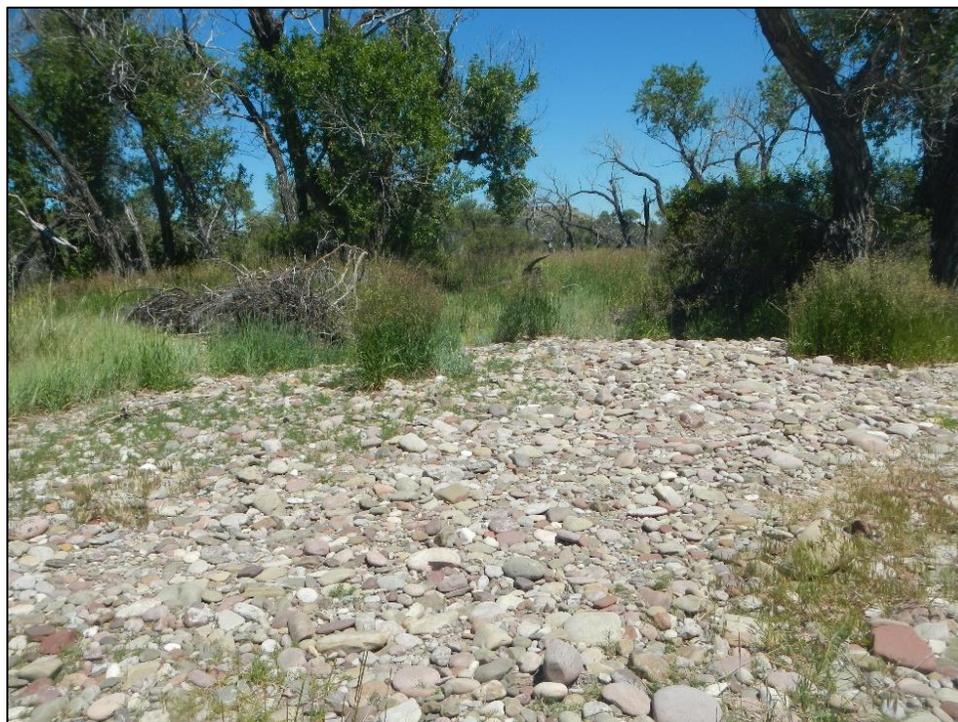
Figure 69. Coarse bedload deposition on floodplain just below Lowry Bridge.

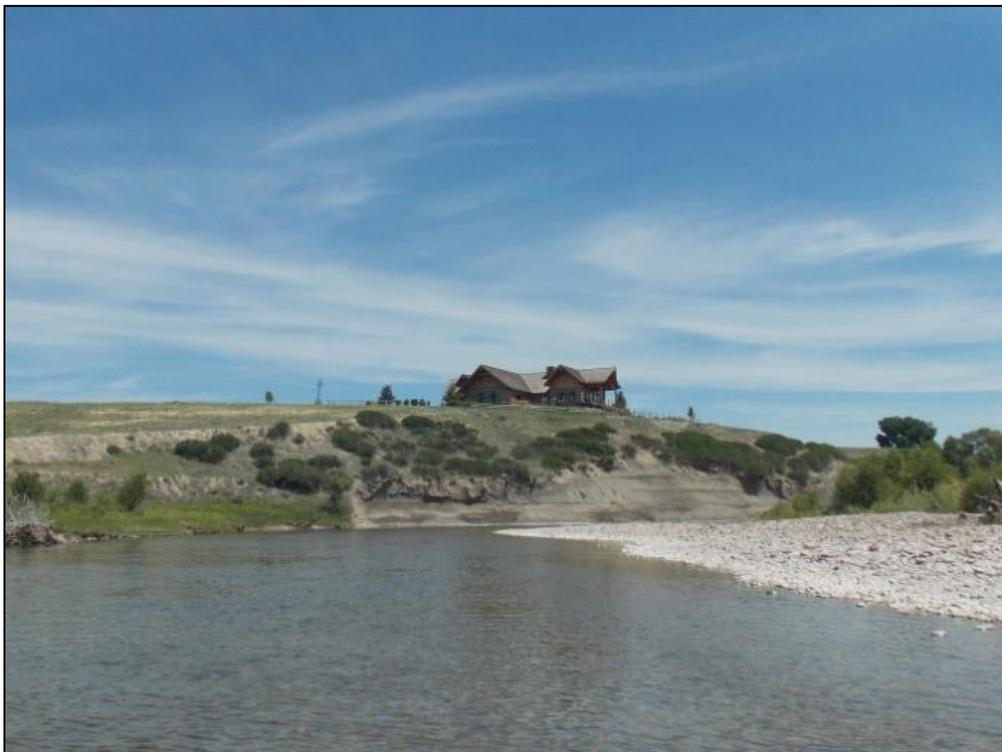
3. At RM 41.8, a house sits on a high terrace that has actively eroded in recent years (Figure 73). This is referred to as Site SR-5 by Kellogg (2014), who described the bank stratigraphy as alluvial deposits overlying glacial lake sediments. His recommendations included water management on the terrace to reduce seepage and potentially slope stabilization. Recent bankline mapping corroborates Kellogg’s 2014 observation that the river is trending essentially parallel to the bank, reducing erosive pressure at the site. Regardless, this site is a good example of how high terrace areas are not immune to bank erosion and this structures on terrace margins commonly fall into Channel Migration Zone areas and are thus at risk.

Figure 73. Home on high terrace, RM 41.8L.

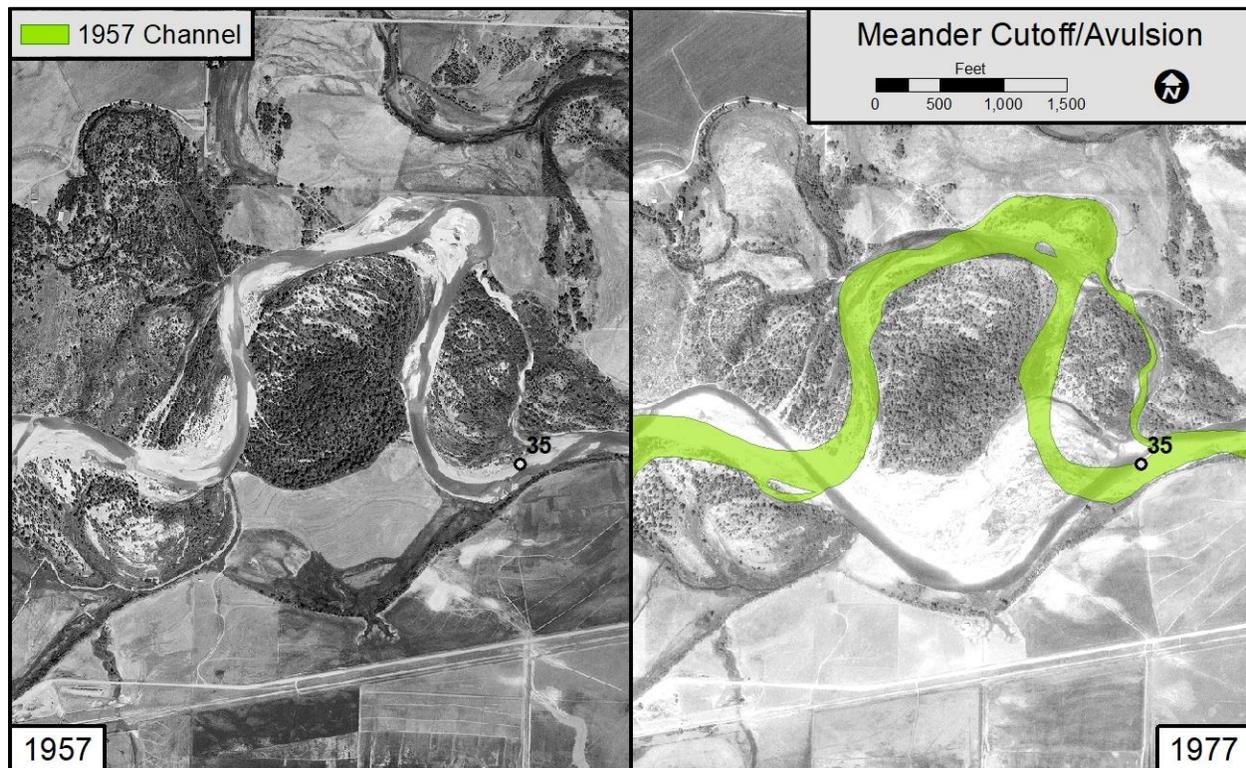
Figure 78 shows an example of an avulsion in Reach SR2 that occurred between 1957 and 1977. The original meander has been abandoned as an oxbow, and about a half mile of new channel has formed to the south, through a field. These types of avulsions tend to be more common through fields than in riparian areas, because riparian forests support floodplain integrity better than hay or other herbaceous crops.

Figure 78. Meander cutoff/avulsion in Reach SR2 between 1957 and 1977.

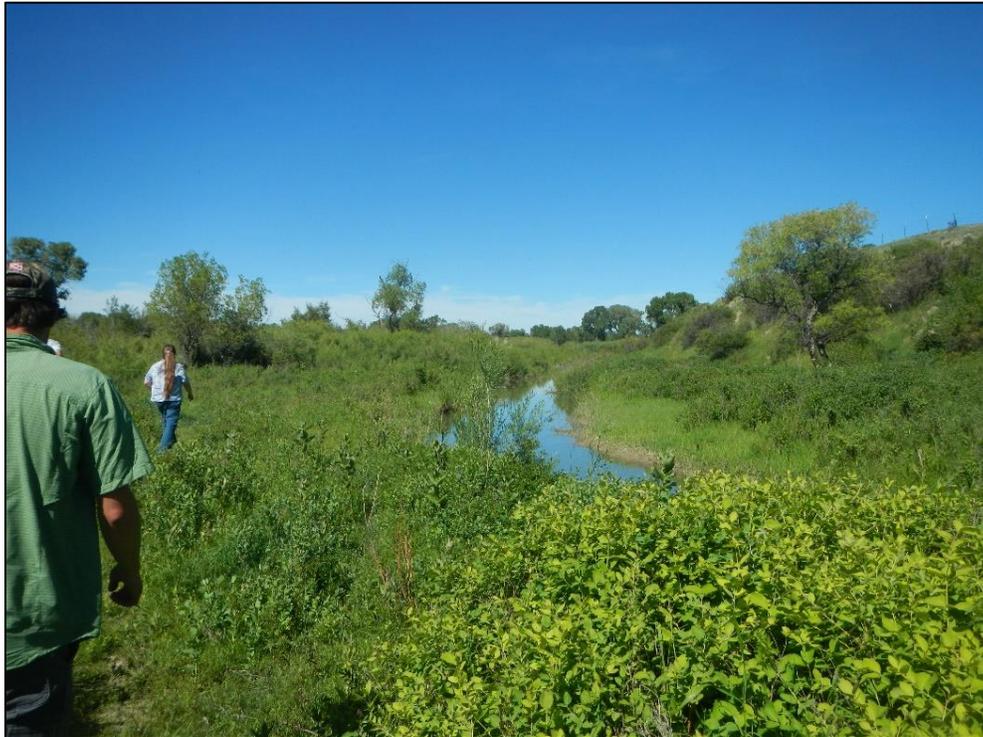
Figure 80. View down Adobe Creek above avulsion point.

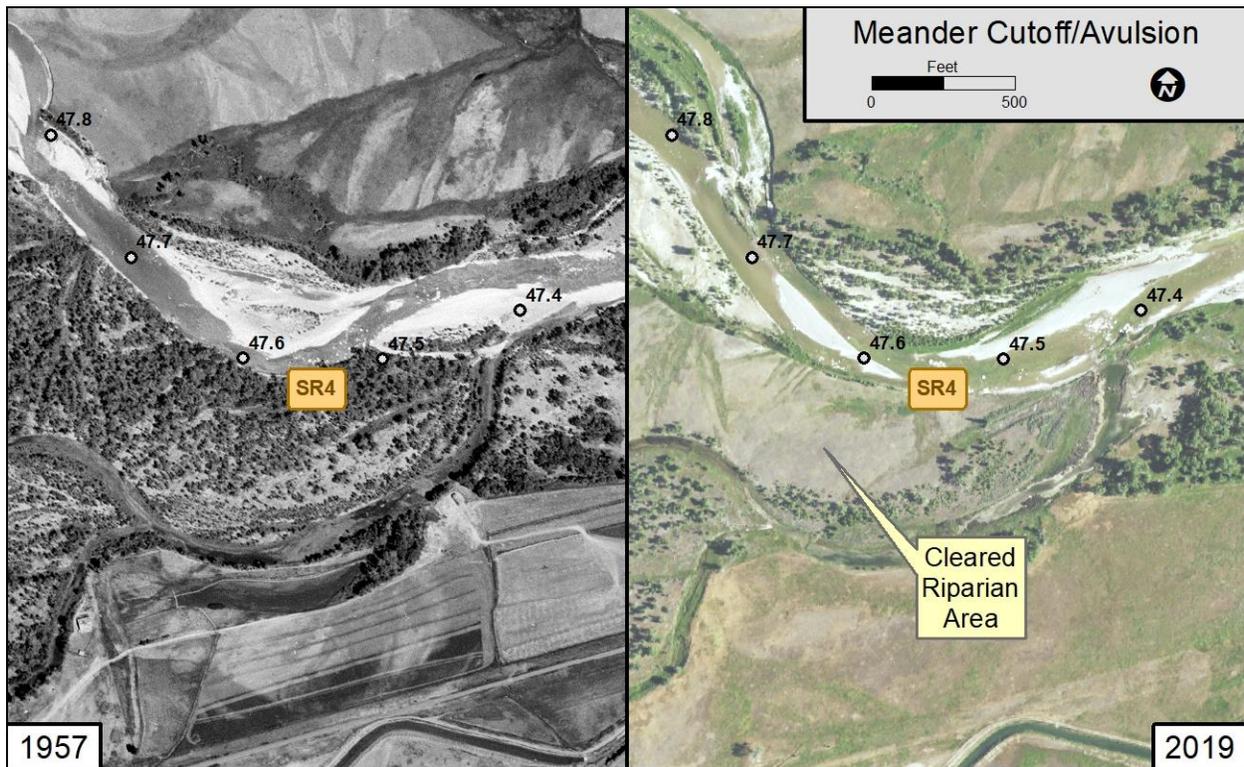
The CMZ mapping has revealed some riparian degradation on the Sun River. The cause of this degradation is probably active clearing to improve agricultural lands (Figure 89). However, the continued persistence of a robust riparian corridor on segments of the Sun River indicates that riparian restoration could be an effective means of improving floodplain/bankline resilience, and possibly reducing bank migration rates.

Figure 89. Riparian clearing on Sun River floodplain between 1957 (left) and 2019) right, Reach SR4.
