CERTIFIED CORNER RECORDATION

Corner of sections 29, 30, 31 and 32 T. 1 N., R. 10 E. P.M.M. Park County

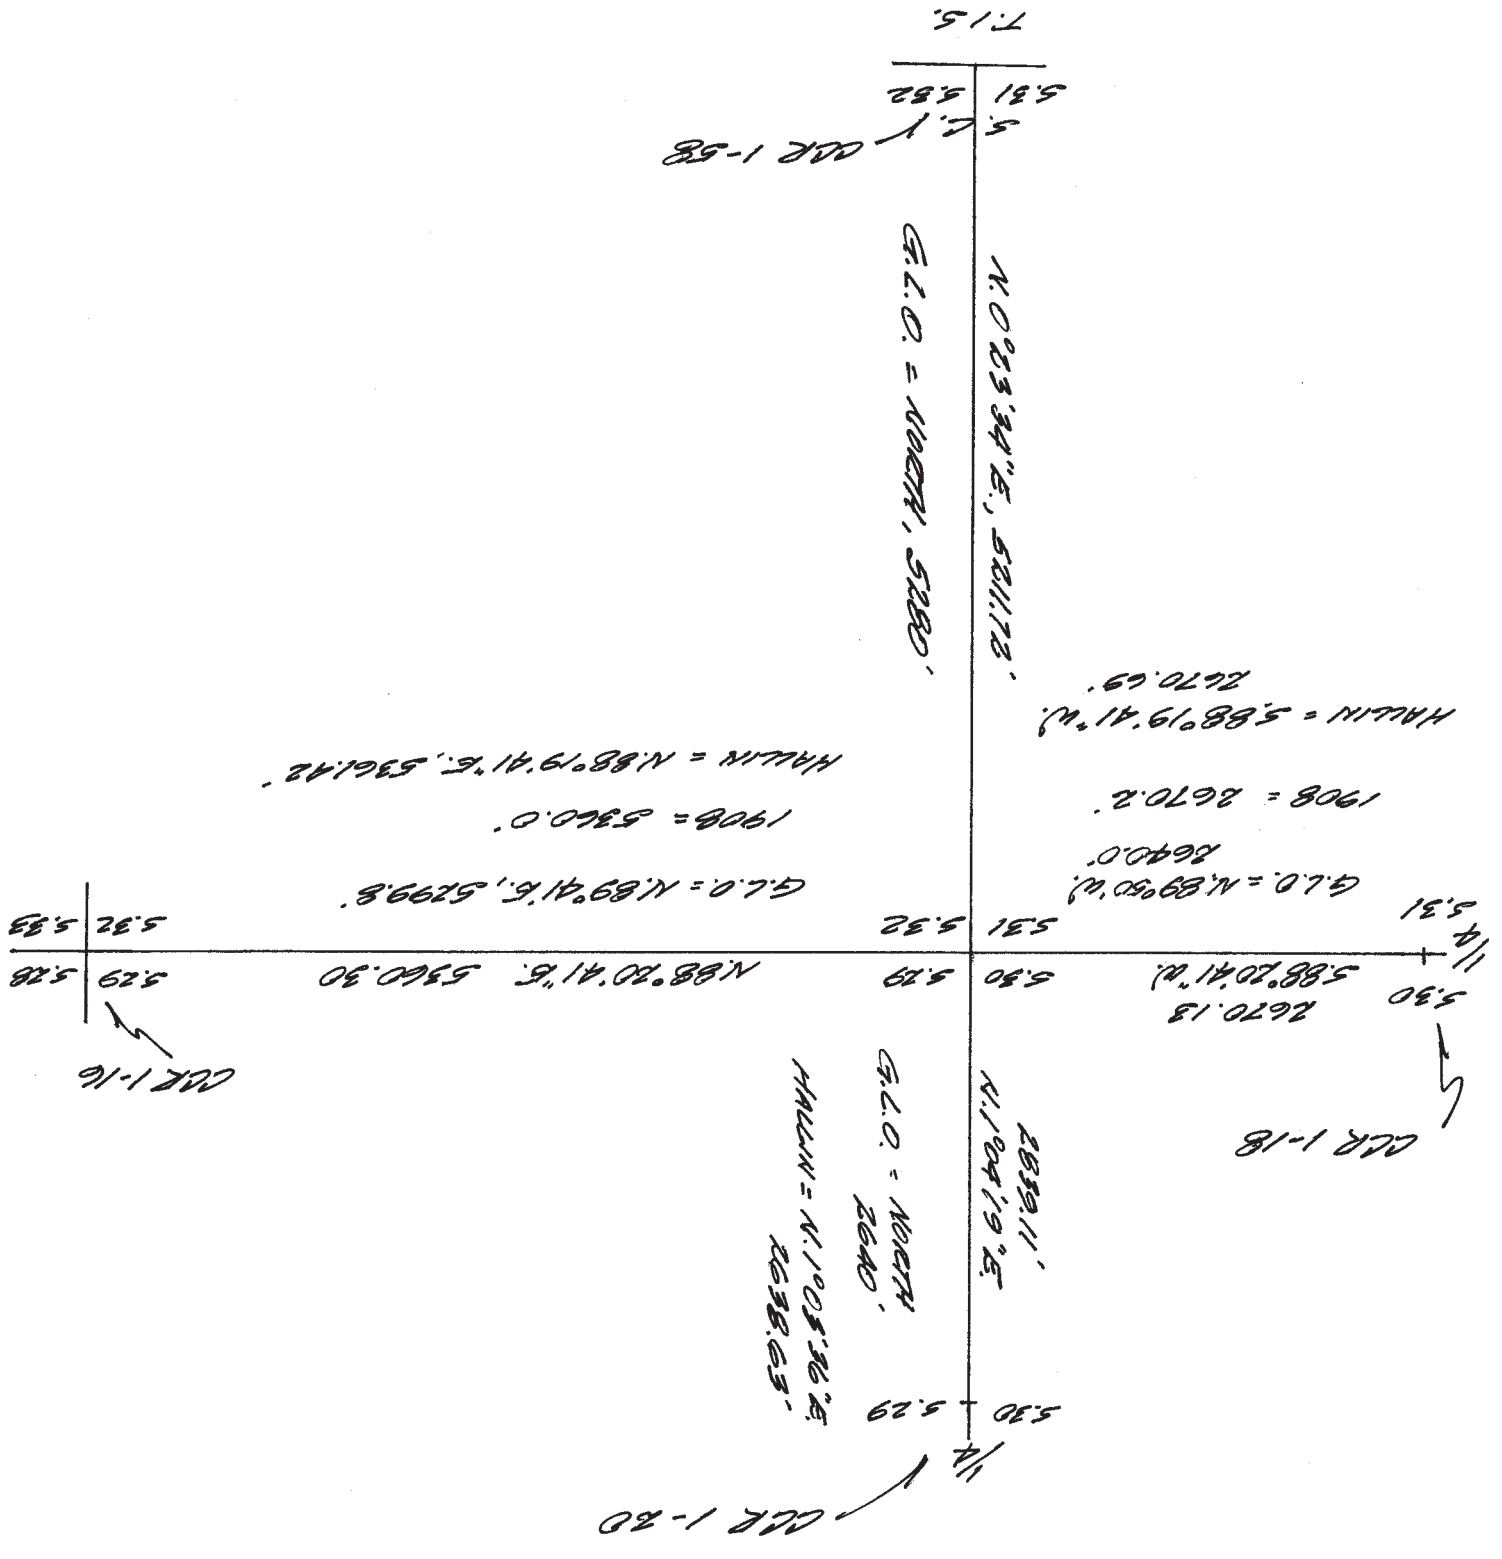
Given the above, I re-established the position for the corner by the same E-W single proportionate method as shown below and at that point, set a 3/4 x 24 in. rebar, flush with the ground, with a 3 in. diam. aluminum cap marked as shown overleaf. From that monument, for reference monuments, I set 1/2 x 24 in. rebar with yellow plastic caps marked "W.Latvala 6305LS" at positions also shown overleaf.

The monument is situated 55.2 ft. SW of the centerline of U.S.Hwy. 89, and 59.8 ft. NE of the centerline of the railroad tracks, on line with fences extending N. across the highway and extending W. across the railroad tracks.

Upon first consideration, the procedure used by Mr. Hallin for re-establishment for this corner position (east-west single proportionate measurement), does not seem applicable for an interior section corner. Inspection of his certificate (C/S 245) however reveals an unusual condition: a severe break in bearings at the 1/4 corner between sections 19 and 30. I found this same condition further north in the west tier of sections of T.1 N., R.10 E., between sections 19 and 18, and section 18 and 7 (C/S 1062, 1990), and between sections 6 and 7 (C/S 1211, 1993.) Those bearing breaks indicate a N-S chaining error of 8 to 10 chains (10.13 chs. bet. 6/7, 8.73 chs. bet. 7/18, 10.16 chs. bet. 18/19, and 8.01 chs. bet. 19/30) on the line north from the standard corner of sections 31 and 32 of the township.

The 1908 notes support the hypothesis of a chaining error, having measured south 4,040 ft. (2640 ft. + 1400') from the found one-quarter corner between sections 29 and 30 to Willow Creek. Willow Creek is about 1000 ft. south of the centerline of the railroad tracks where they intersect a straight line between the section corners 1 mile east and west of the subject corner. That intersection would therefore be about 3040 ft. (4040' - 1000') south of the one-quarter corner between sections 29 and 30 found in 1908, or 400 ft. longer than the GLO record. Hallin's distances east and west match the 1908 distances within 1.5 ft. in each direction indicating that his position closely matched the 1908 position, and his C/S 245 indicates that the line between sections 29 and 30 is 5677.26 ft. long, some 397 ft. longer than the GLO record. That 400 ft. (6.06 chs.) is 2-4 chs. less than the error observed further north on that same north-south line through the township, but in the same direction. Either three point control (E, S & W) or the method (single proportion E-W) used by both Hallin and the 1908 surveyor therefore would satisfy the *Manual* requirement (Section 5-23) to place the evident chaining blunder where it was made, between sections 29 and 30. The resultant position from an E-W proportion was apparently acceptable to adjoiners in 1908 and still was in 1977.
