Beaverhead River Channel Migration Mapping

This report contains the results of a Channel Migration Zone (CMZ) mapping effort for approximately 83 miles of the Beaverhead River from its beginning at Clark Canyon Dam, downstream to its confluence with the Big Hole River just north of Twin Bridges MT. The Beaverhead River mapping is part of a larger effort to map approximately 440 miles of rivers in the Missouri River headwaters watershed.

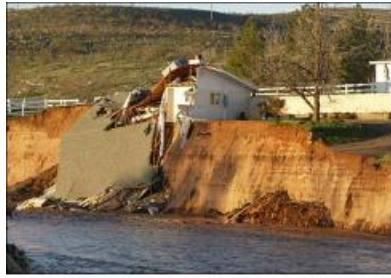
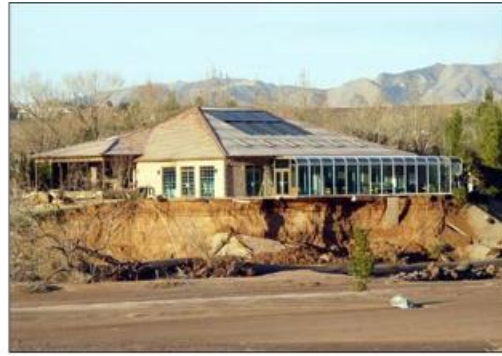
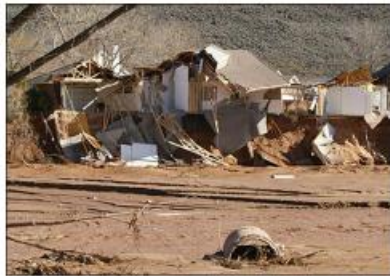
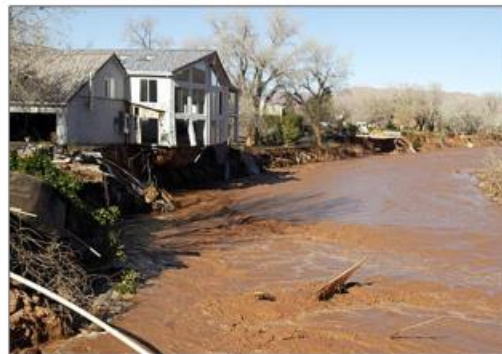
Figure 4. Photos from a 2005 flood in Saint George Utah, where homes several feet above the mapped floodplain were destroyed by channel migration (www.Utahfloodrelief.com).

The CMZ maps do not delineate areas prone to flooding. The difference between mapped flood boundaries and CMZ boundaries can be substantial. In cases where the floodplain is broad and low, the CMZ tends to be narrower than the flood corridor (Figure 3). In contrast, where erodible terrace units bound the river corridor, the CMZ is commonly wider than the floodplain, because the terraces may be high enough to prevent flooding, but not immune to erosion (Figure 4). This is a common problem in Montana because of the extent of high glacial terraces that are above base flood elevations, but not erosion-resistant. Figure 5 shows a property on the Yellowstone River in Park County that was progressively undermined during the 1996-1997 floods, prompting the owner to burn it down to prevent any liability associated with the structure falling into the river. This has been a chronic problem in river management, as landowners assume that if their home is beyond the mapped floodplain margin, it is removed from all river hazards. After experiencing massive 2005 flood damages in Saint George Utah (Figure 4), several property owners reflected on this issue (www.Utahfloodrelief.com):

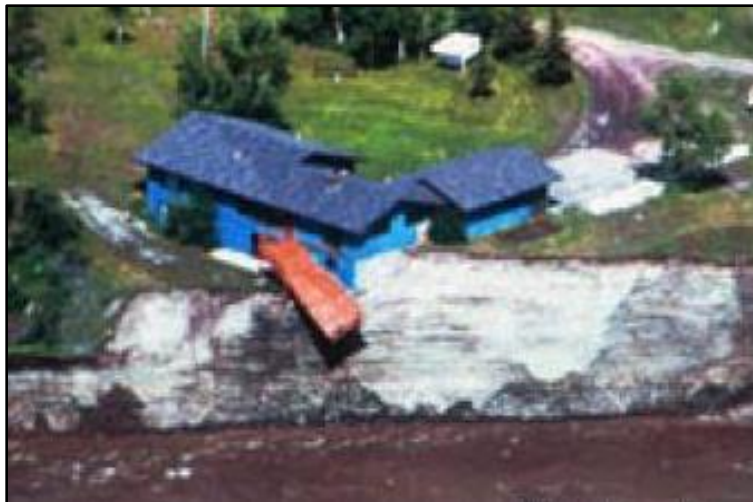
Figure 5. Yellowstone River home on high glacial terrace that was burned down in 1997 to prevent its undermining by the river.

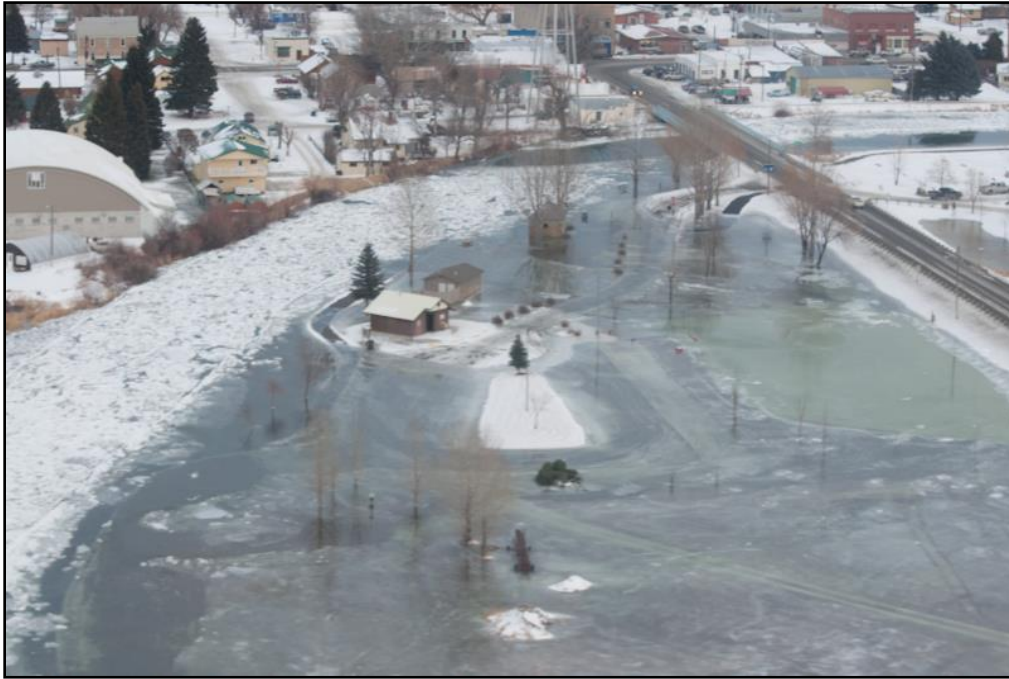
Figure 7. Ice jam and flooding at Twin Bridges, MT, January 4, 2011. (Madison County, MT Office of Emergency Management).

Beaverhead with the Big Hole and Ruby Rivers near Twin Bridges, where in 2011, ice jams caused flooding in town (Figure 7 and Figure 8).

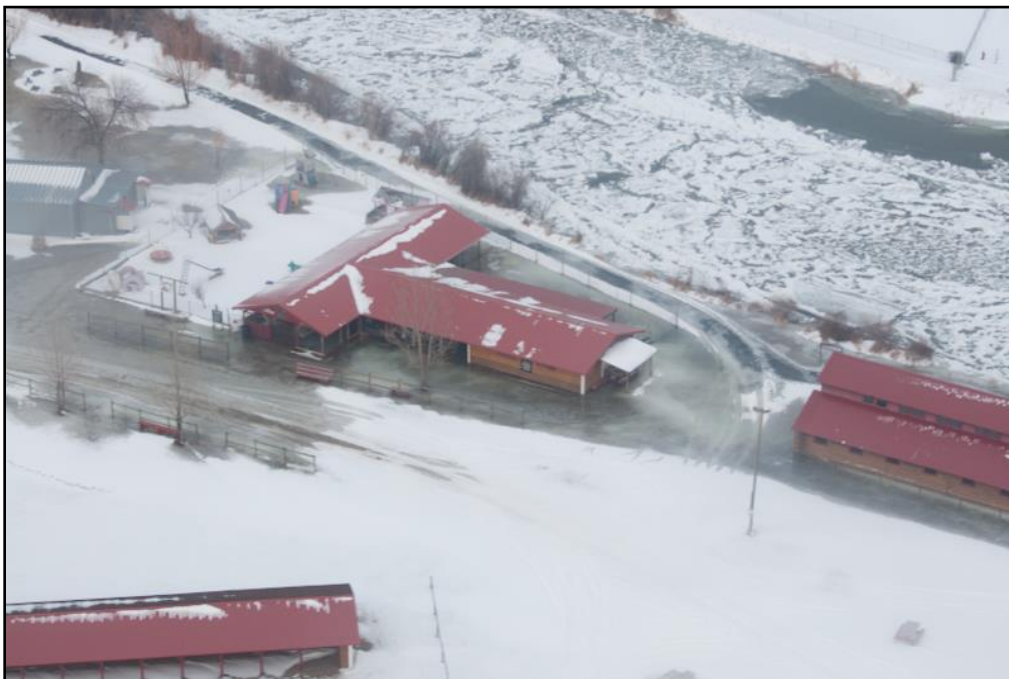
Figure 8. Ice jam and flooding at Twin Bridges, MT, January 4, 2011. (Madison County, MT Office of Emergency Management).

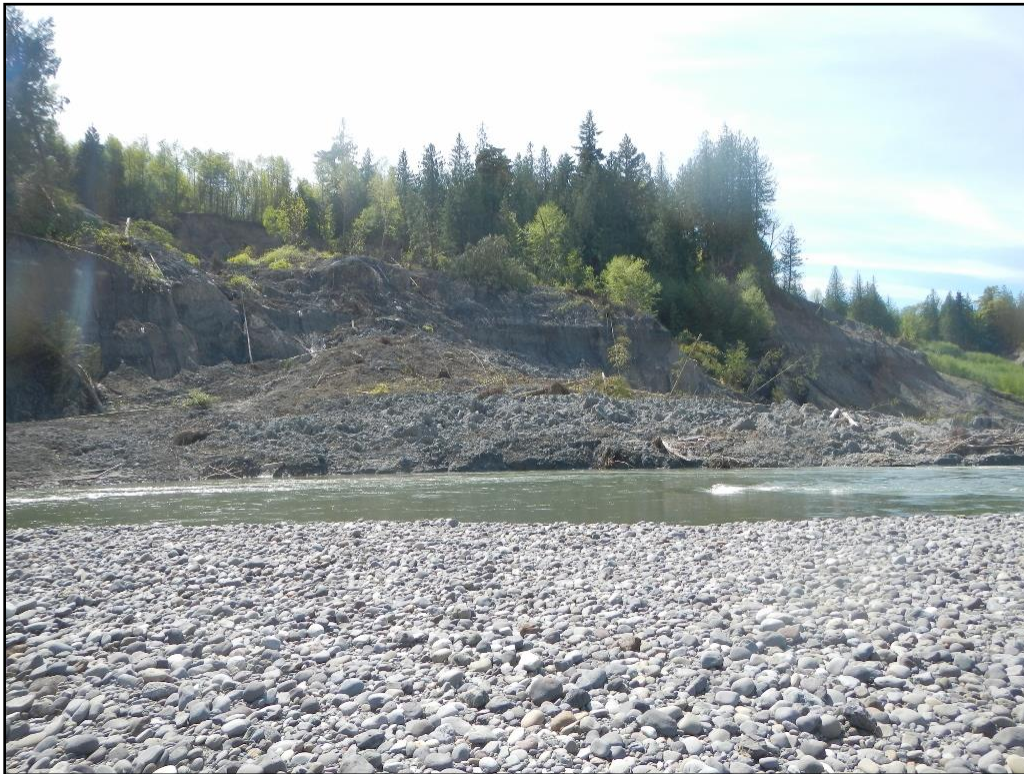
Clark Canyon hosts several active landslides that impinge into the river corridor (Section 2.2). These landslides have the potential to create river hazards by blocking the channel and potentially diverting or impounding flow. Figure 9 shows an example of a landslide that occurred in February 2014 on the south wall of the Nooksack River Valley near Bellingham, Washington. The landslide originally blocked the channel, and the effect was seen at a gaging station downstream where river flows rapidly dropped from over 2,000 cubic feet per second to about 400 cubic feet per second in the early morning hours of February 21. The river breached the landslide and flows returned to normal, however in some cases impacts have been much worse. Probably the most recently renown landslide into a river system was the 2014 Oso Slide into the North Fork of the Stillaguamish River, which dammed the river causing extensive flooding upstream (Figure 11). Prior to that, the 1959 Quake Lake slide occurred about 72 miles east of Clark Canyon, creating a lake that is 6 miles long and 190 feet deep.

Figure 9. Hillslope failure on Nooksack River near Bellingham Washington on February 21, 2014.

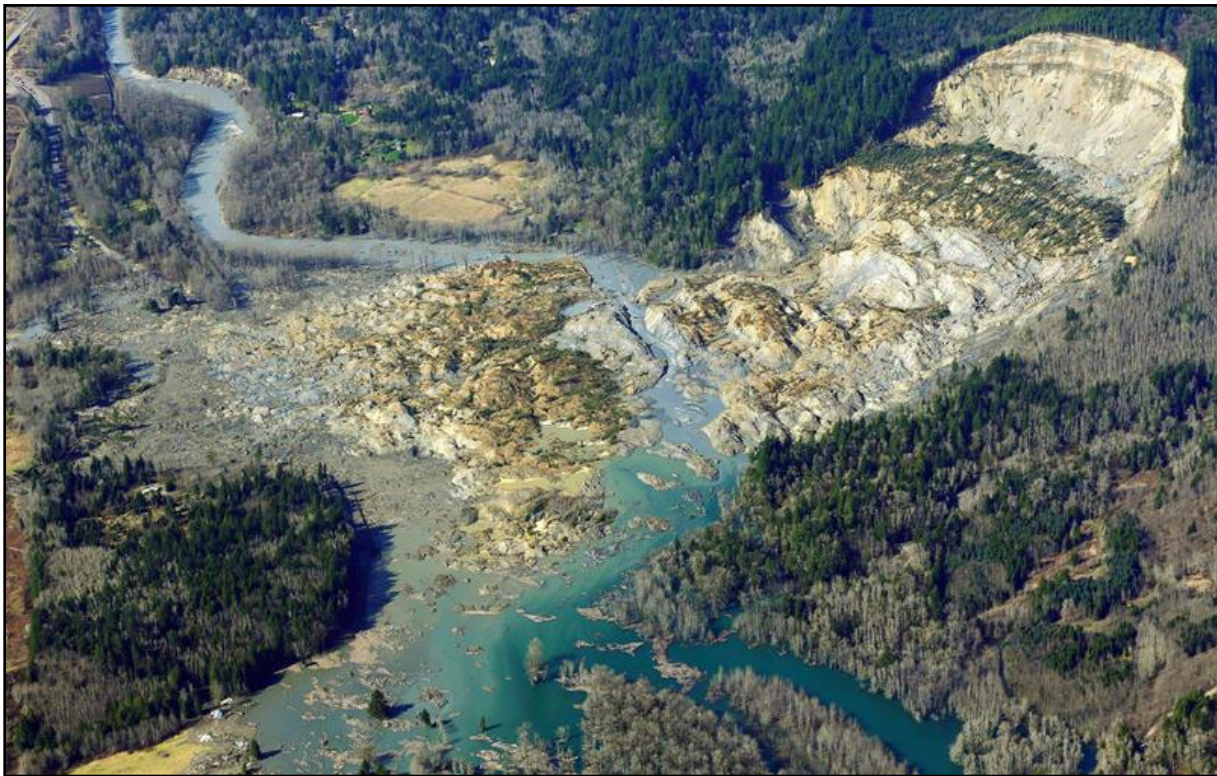
Figure 11. Massive mudslide in Oso Washington on March 22, 2014, deflecting the North Fork of the Stilliguamish River (AP Photo/Ted Warren).

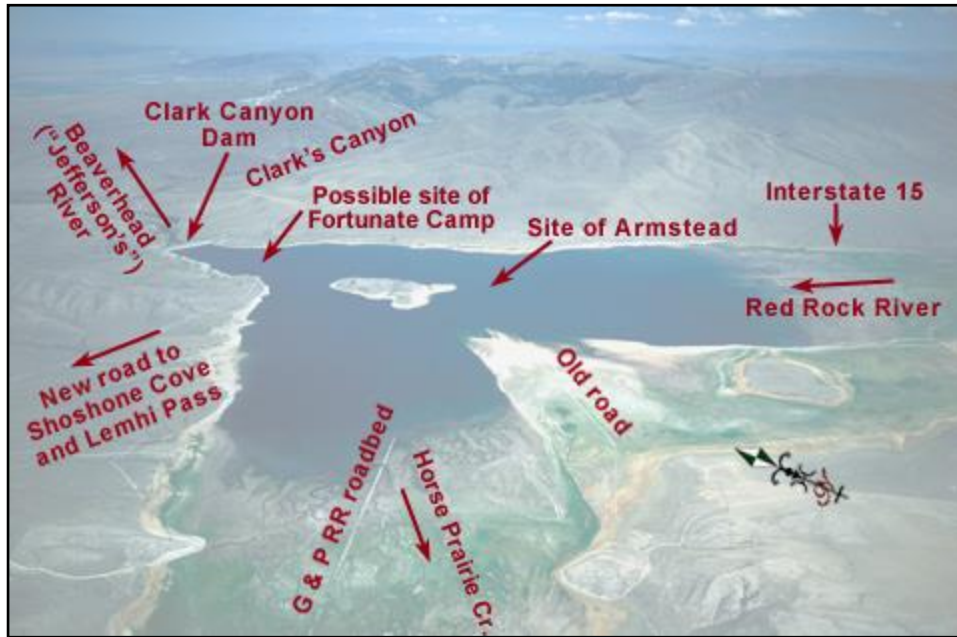
Figure 13. Clark Canyon Reservoir looking east showing historic and current features. (www.lewis-clark.org).

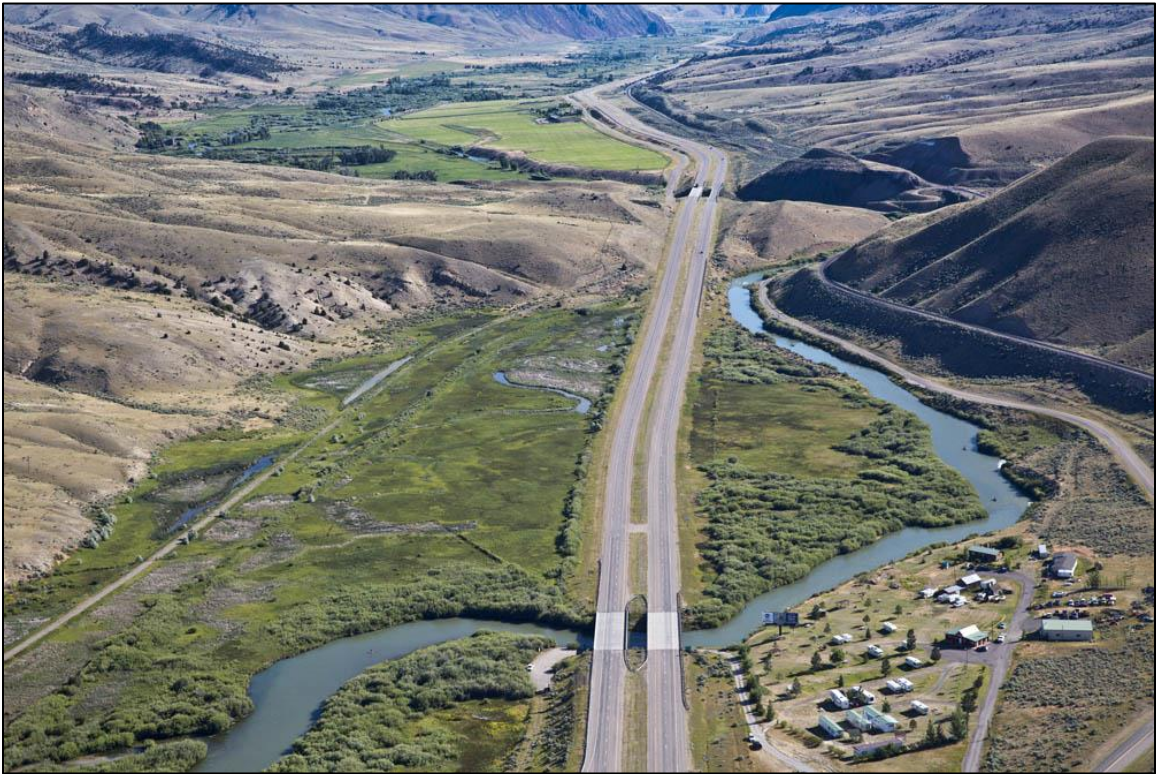
Landslides have also affected the valley form through the canyon; There is a large slide on the west side of the channel at High Bridge that has confined the corridor (Figure 15). Gradient changes in the river near Grasshopper Creek reflect a lower slope upstream from two active landslides and steeper gradients where the river is constricted by the toes of these landslides (Bartholomew et al., 1999). Landslides have periodically blocked, constricted, or diverted to the river, and Bartholomew and others (1999) indicated this may be associated with major earthquakes. Landslides are most common in mixed volcanic rocks.

Figure 15. View downstream from near Clark Canyon Dam showing large a landslide deflecting the Beaverhead River to the east at High Bridge (Kestrel).

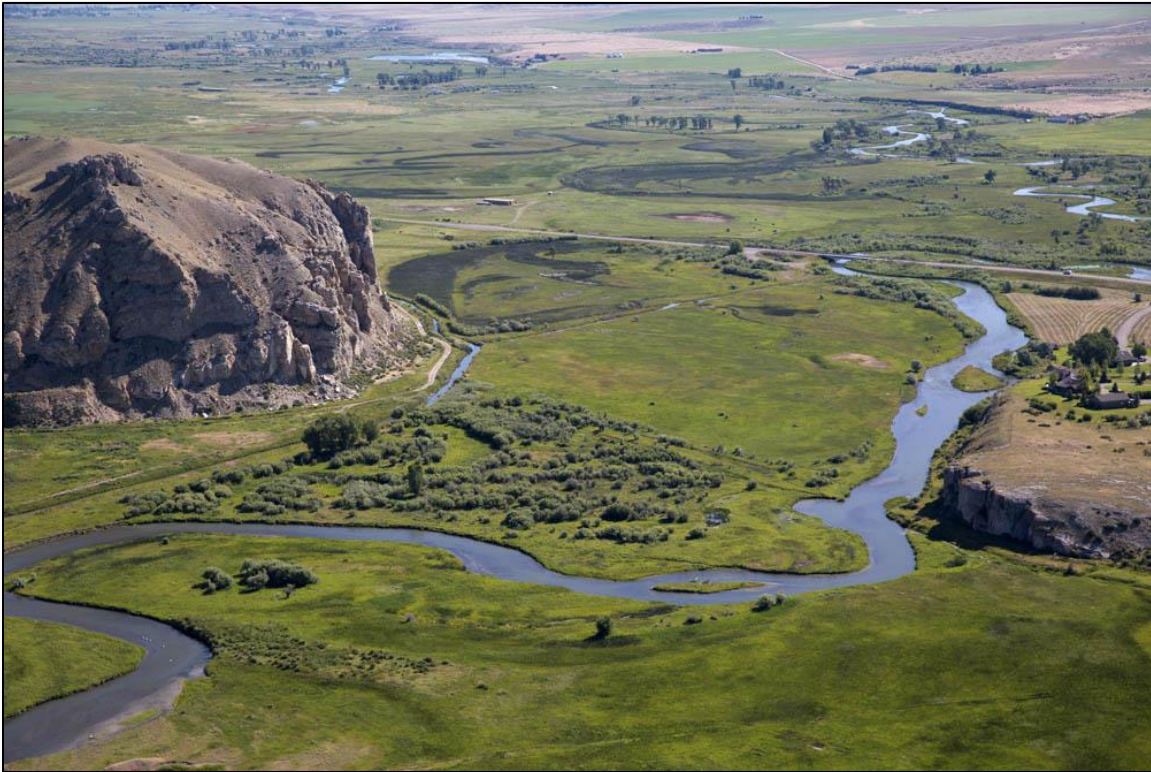
At RM 28, Beaverhead Rock (also known as Point of Rocks) marks a distinct pinch point in the stream corridor (Figure 19). According to Meriwether Lewis, Beaverhead Rock was the first landmark that Sacajawea recognized

Figure 19. View downstream showing corridor constriction at Beaverhead Rock (Point of Rocks)(Kestrel).

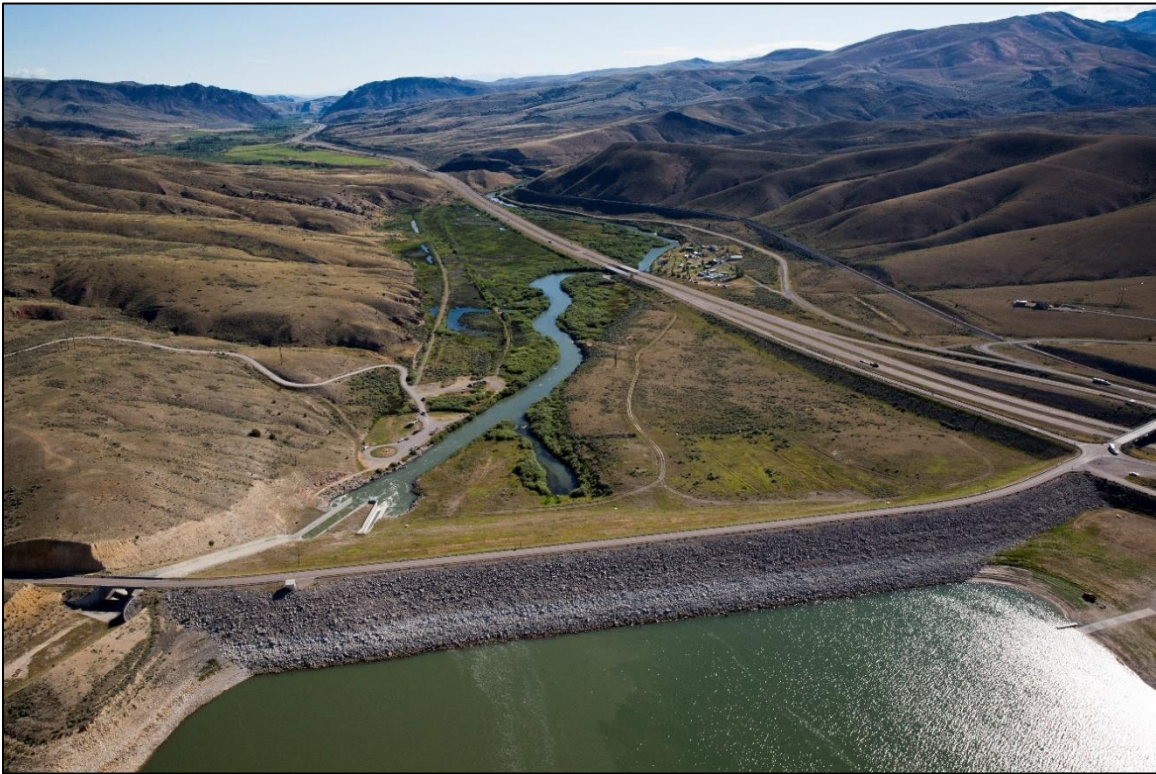
The Clark Canyon Dam (Figure 20) is located at the upstream end of the project reach approximately 18 miles south west of Dillon, MT. The mainstem reservoir was built between 1961 and 1964 with the purpose of storing and regulating water for irrigation use downstream as well as providing flood control. The dam is a zoned earthfill dam with a height of 147.5 feet and a width of 2,950 feet. It is currently owned and managed by the Bureau of Reclamation as part of the East Bench Unit irrigation system (Bureau of Reclamation, 2016). The reservoir has an exclusive flood control capacity of over 79,000 acre feet, and includes storage capacity allocated to assist with flood and power operations of the Corps of Engineers Missouri River Main Stem System (CCWSC, 2004).

Figure 20. View downstream over Clark Canyon Dam, Montana. (Kestrel).

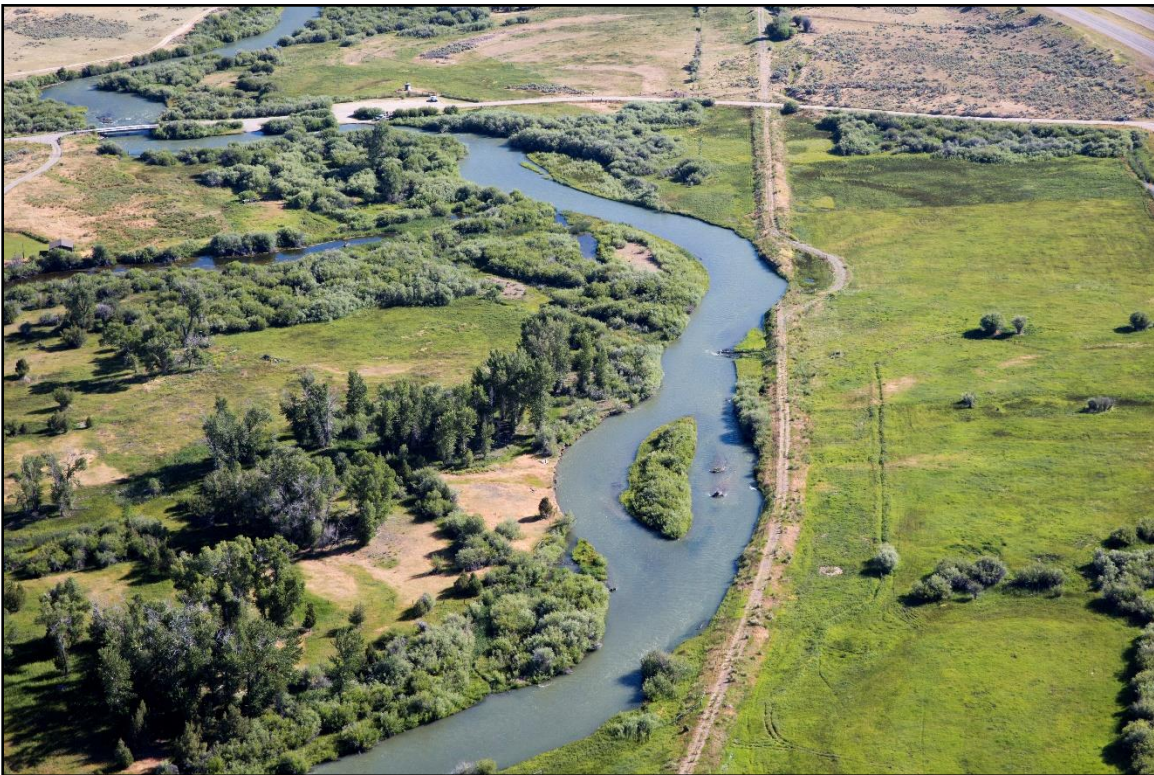
Figure 25. A historic rail grade in Clark Canyon showing a breach in the abandoned rail grade, July 12, 2016. (Kestrel)

A total of 33.4 miles of features that act as berms or levees were mapped on the Beaverhead River. These features were identified remotely using air photos and the LiDAR elevation data, and their influence on flooding and channel migration is unknown. Reportedly, some of these features were illegally installed during the 1984 flood (R. Hartz, pers. comm.). The majority (23.8 miles) of the mapped dikes and levees are associated with the transportation network. The railroad (consisting of an abandoned line and an active line) accounts for 5 miles, almost all of which is in Clark Canyon. Agriculture accounts for 2.9 miles, while the remaining 1.7 miles are attributed to various other land uses such as residential or industrial uses, or as channel plugs in old swales. Figure 25 show an example of the abandoned railroad grade in Clark Canyon which has been partially breached by bank erosion. A typical floodplain dike is shown in Figure 26. Unless these features represent maintained infrastructure or are visibly armored, they are not considered to restrict channel migration.

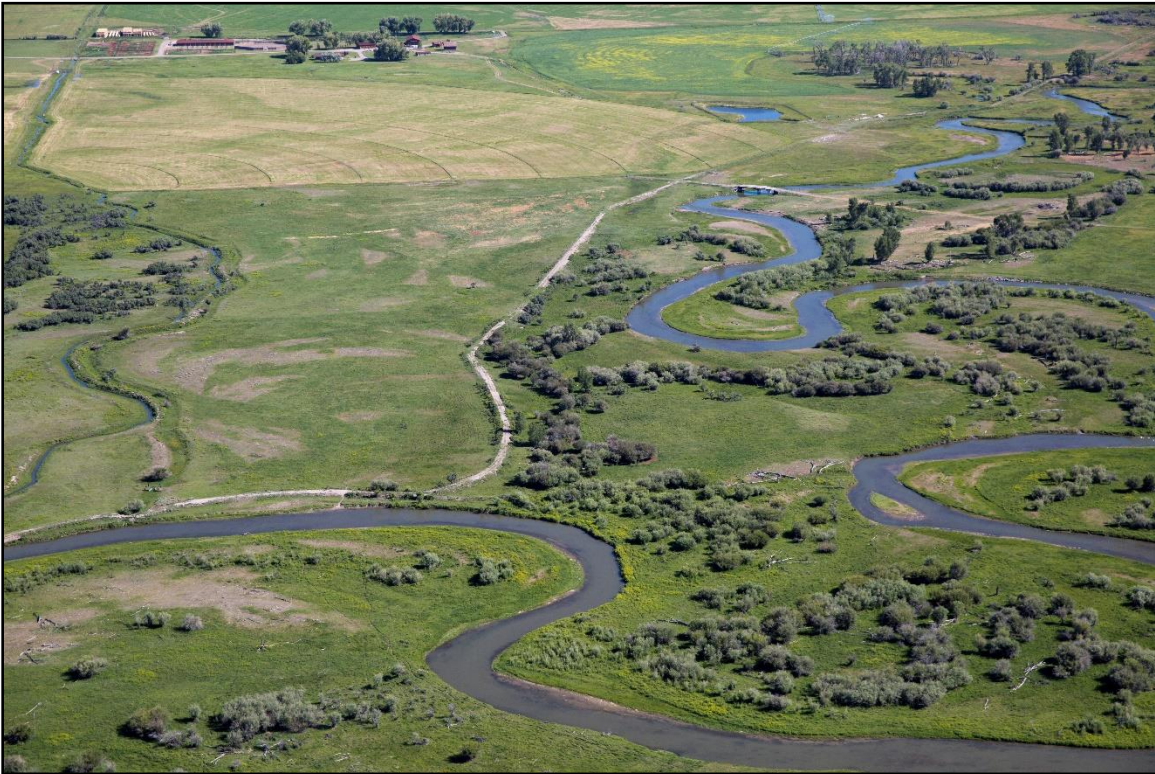
Figure 26. A 1.4 mile levee below Beaverhead Rock, July 12, 2016. (Kestrel)

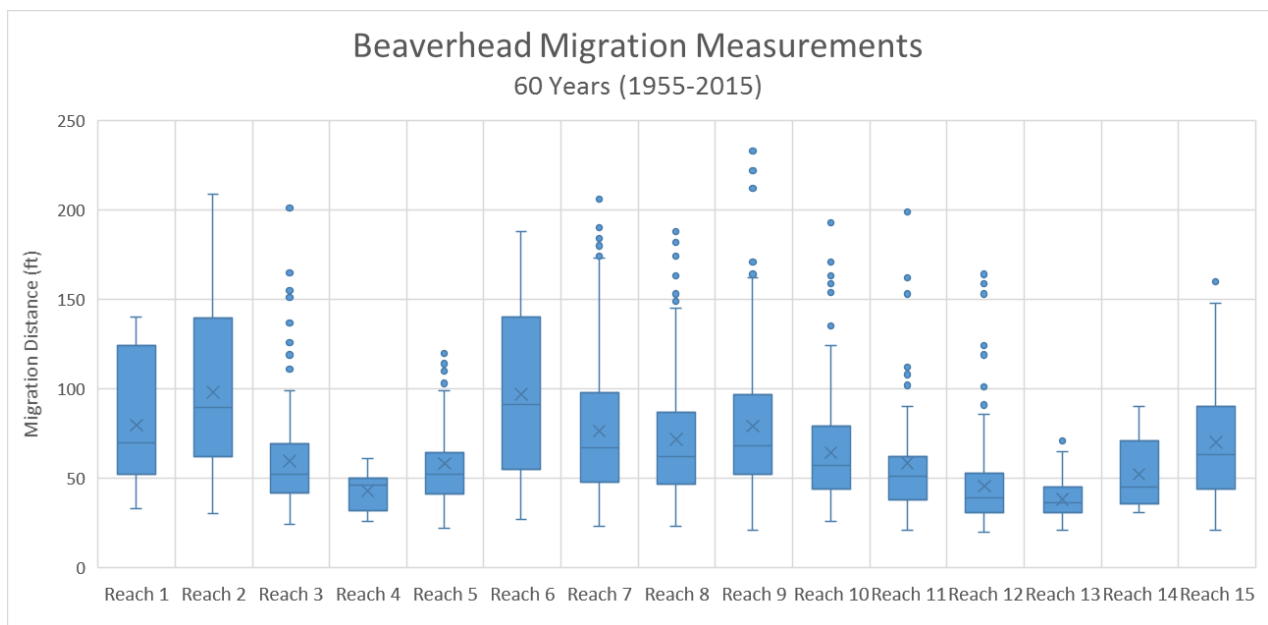
Figure 34. Distribution of migration measurements by reach.

The EHA is based on measured migration rates. Within the GIS, migration distances were measured where it was clear that the migration was progressive lateral movement versus an avulsion. A total of 1,953 measurements were made through the project length where a bank had migrated at least 20 feet since 1955. The 20-foot minimum was selected as an easily measurable distance that was not compromised by the resolution of the data. The migration distances vary substantially both within and between reaches, with several reaches showing over 150 feet of bank migration since 1956 (Figure 34).

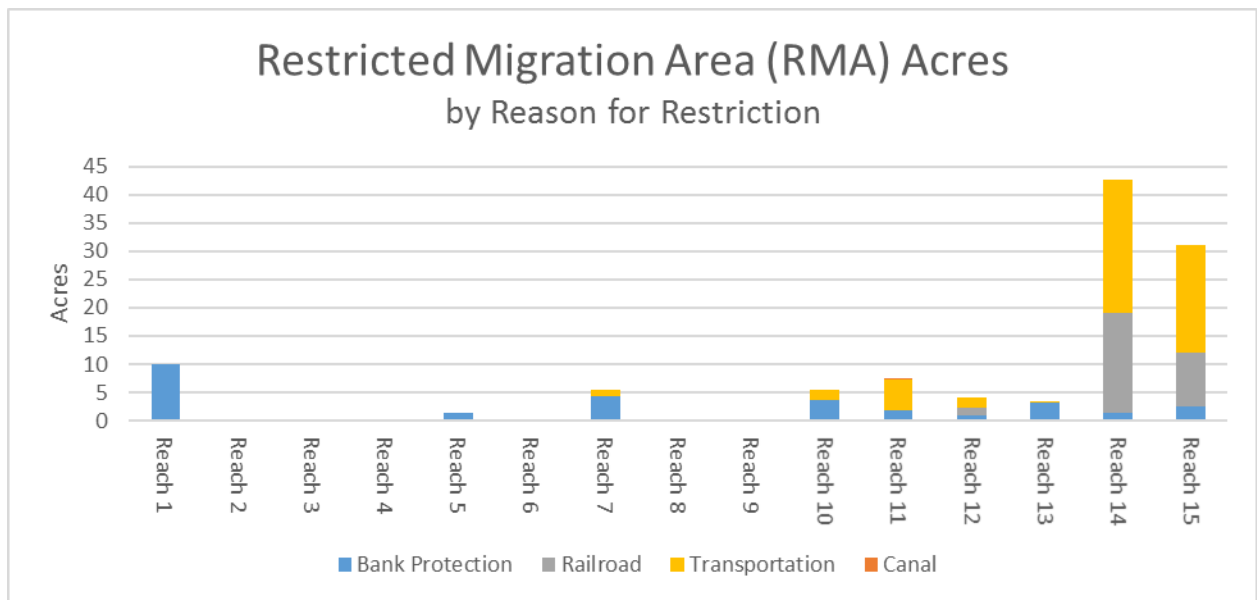
Figure 39. Acres of the CMZ mapped as restricted by reach.

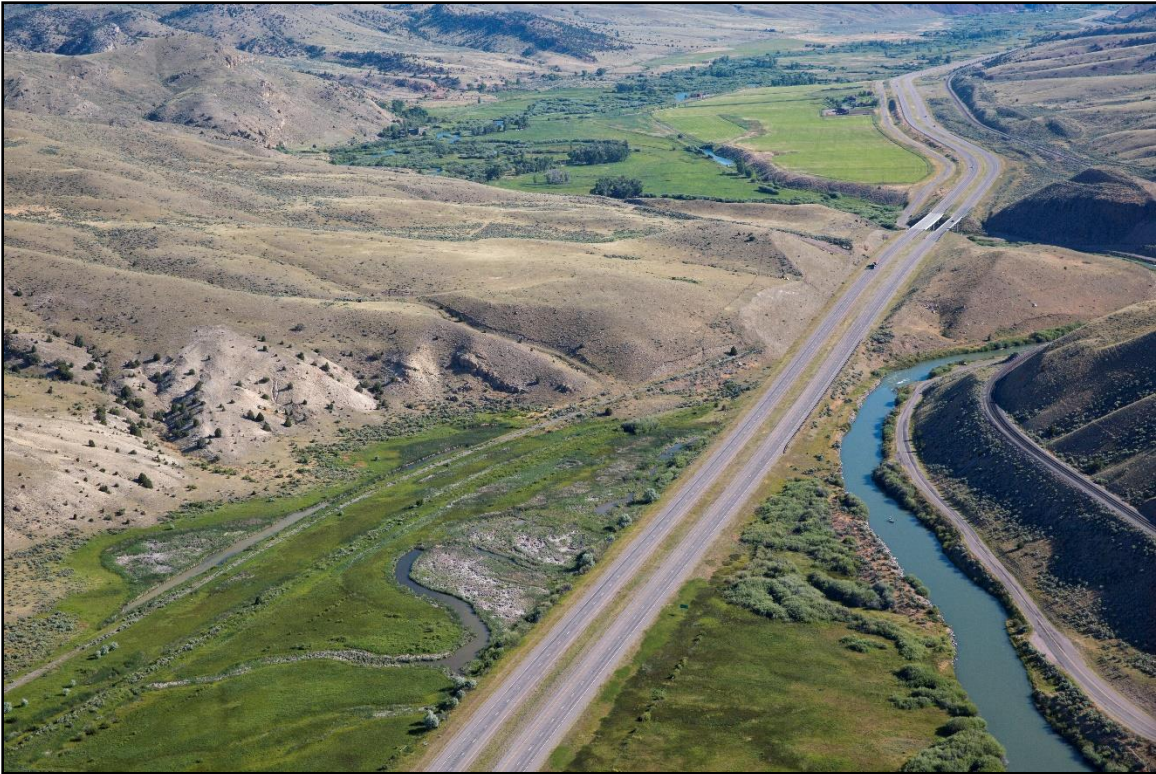
Figure 42. View downstream below Clark Canyon Dam showing 1955 meander isolated by interstate bridge and major landslide crossing river valley just downstream. (Kestrel)

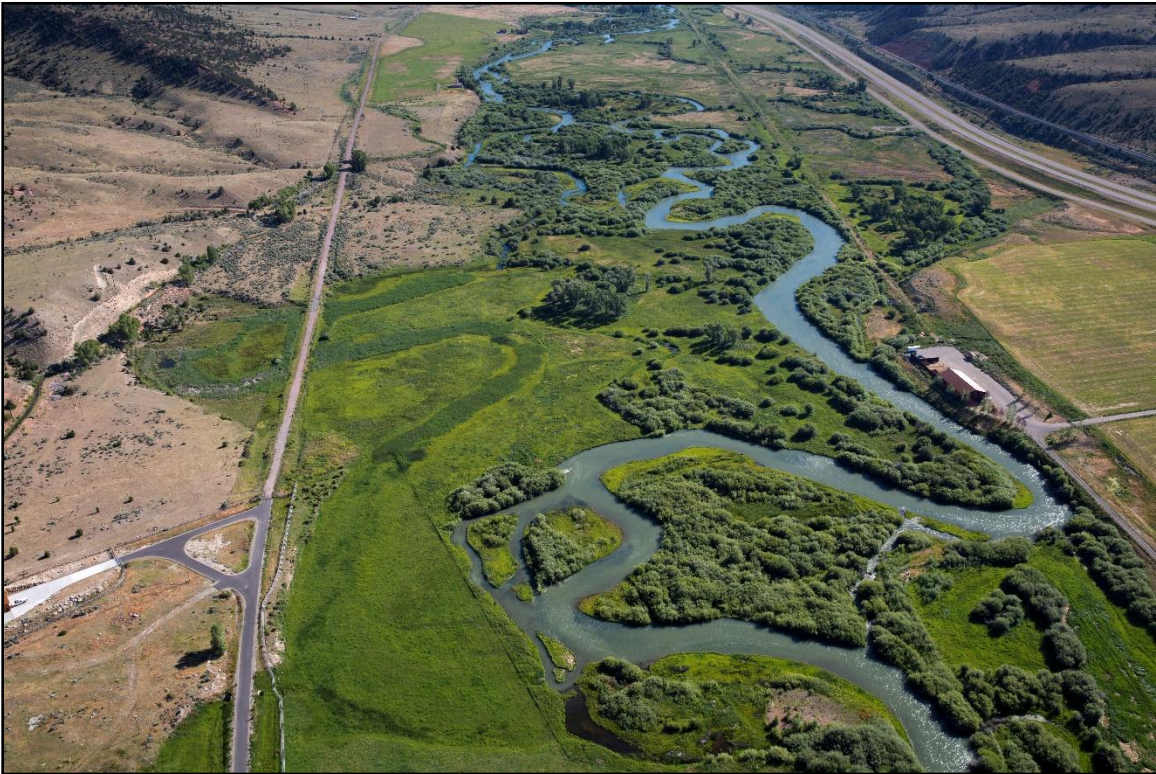
Figure 43. View downstream from RM 80 showing an active avulsion/cutoff on the near meander and a pre-2013 avulsion in the distance. (Kestrel)

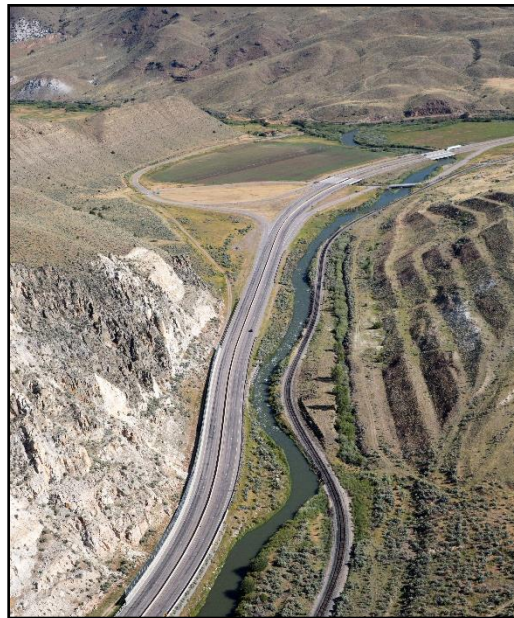
Figure 44. View downstream towards Grasshopper Creek showing Paleozoic-age sandstones on left valley wall, terraced right valley wall; an active landslide can be seen in distance at mouth of Grasshopper Creek (hummock ground surface).

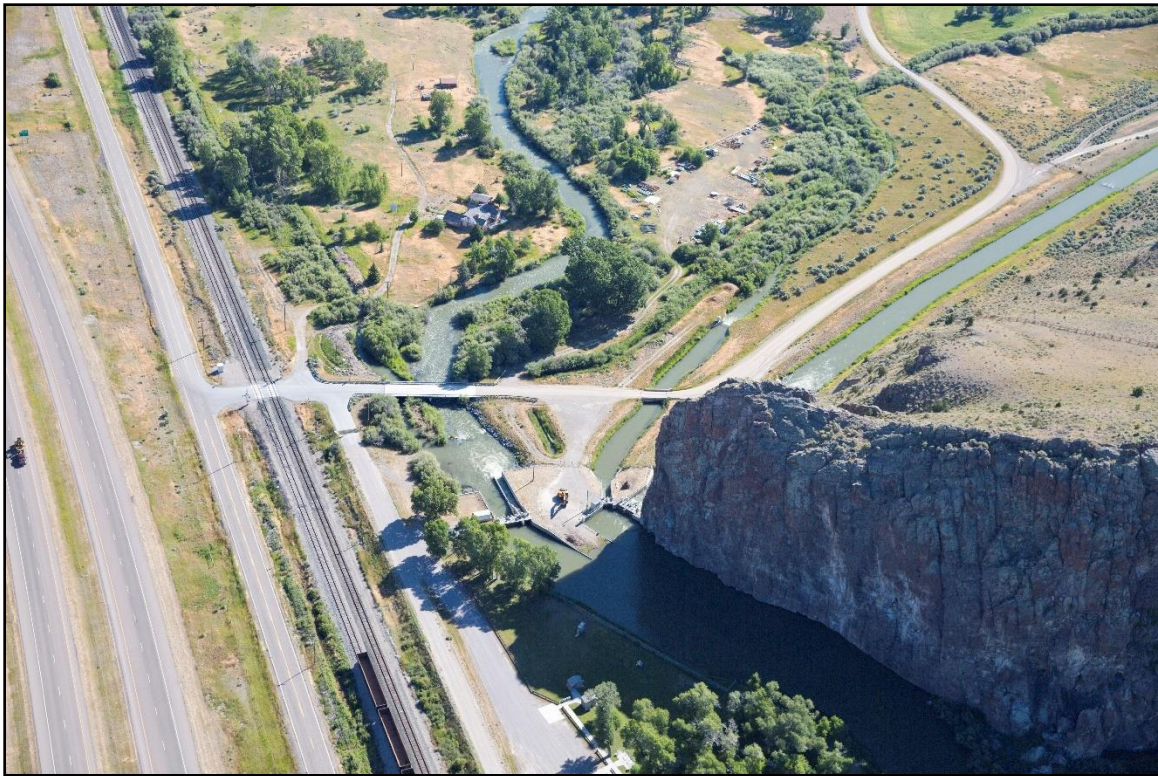
Figure 45. View downstream of Barretts diversion and location of projected trace of Blacktail Fault. (Kestrel)

Because of the geologic controls, only 23 migration measurements were made in Reach 14. The 100-year buffer width, which is 87 feet, was largely clipped out as restricted migration area or geologic control. At Barretts Diversion, the river crosses over the projected trace of the Blacktail Fault, entering the main Beaverhead River Valley. This distinct transition is marked by a prominent outcropping of Tertiary volcanic rocks, which some identify as the actual Beaverhead Rock described by Lewis and Clark (Alt and Hyndman, 1997).

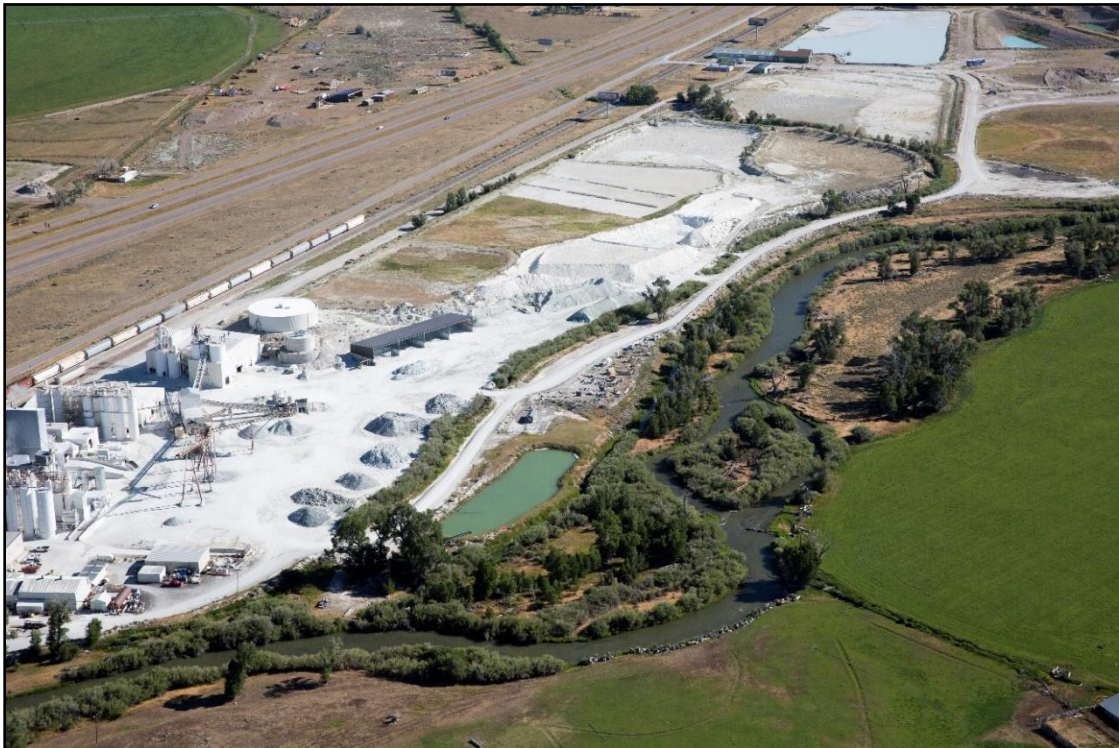
Figure 46. View downstream (north) showing channel confinement between Barrett Talc Plant and armored irrigated fields. (Kestrel)

Just downstream of Barretts Diversion, Reach 13 marks the entrance of the Beaverhead River into the Beaverhead River Valley. Although this emergence from the canyon includes an abrupt loss of confinement, Reach 13 is somewhat unique in that it is geologically controlled by Pleistocene-age alluvial fans formed on Rattlesnake and Blacktail Deer Creeks (Section 2.2; Figure 16). As a result, the reach is less dynamic than reaches downstream. The reach is also affected by land uses adjacent to the channel; in upper Reach 13, Barretts Minerals operates a talc plant on the left bank of the river at RM 67. The site is used to process the talc that has been mined from open pits in marbles of the Ruby Mountains, and prepare it for shipping. The talc is then shipped by rail. With the talc plant on the left bank and irrigated land on the right bank, the river is moderately confined in the upper portion of Reach 13 (Figure 46).

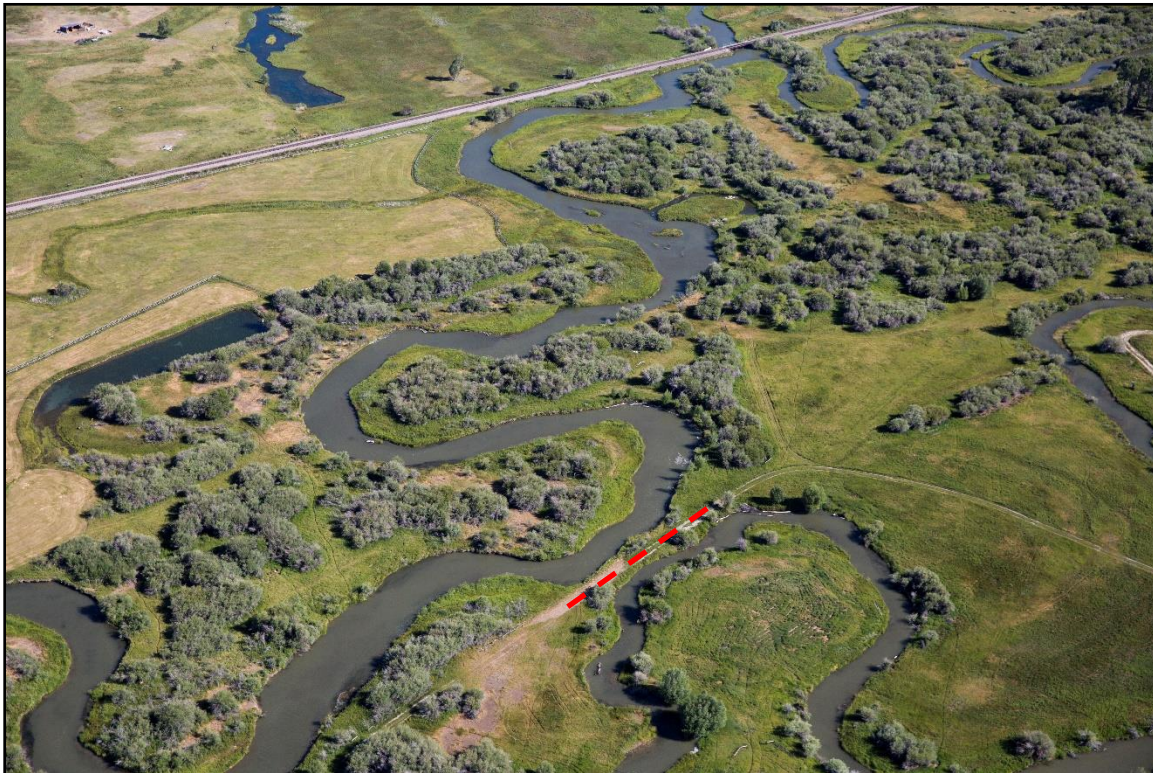
Figure 49. View downstream showing potential avulsion site between Beaverhead River (left) and Poindexter Slough (right). (Kestrel)

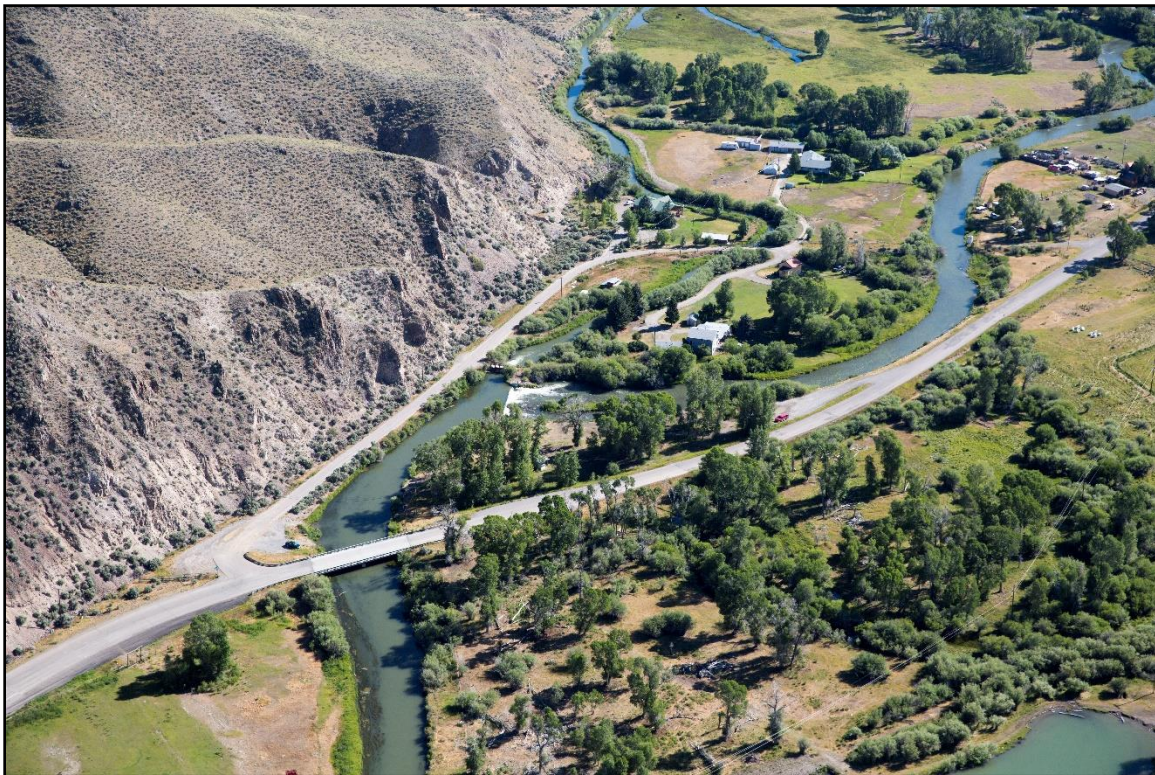
Figure 50. View downstream of Reach 11 showing exurban development and geologic control. (Kestrel)

Reach 11 is located due west of Dillon, and within this reach the channel is notably straight, following volcanic rock exposures on the west valley wall (Figure 50). The reach is relatively straight with meander scars suggesting a long history of manipulation due to its proximity to town. Currently, the reach is most distinctly characterized by exurban development. There are several ponds adjacent to the river at RM 55 that pose some avulsion risk. Downstream of the I-15 Bridge, the CMZ widens substantially as the river enters a split flow reach that has an avulsion hazard area to the south at the mouth of Blacktail Deer Creek. The lowermost ~900 feet of Blacktail Deer Creek was an active side channel of the Beaverhead River in 1955. Just south of this old side channel, there are additional channels that are lower than the main thread and thus prone to capture.

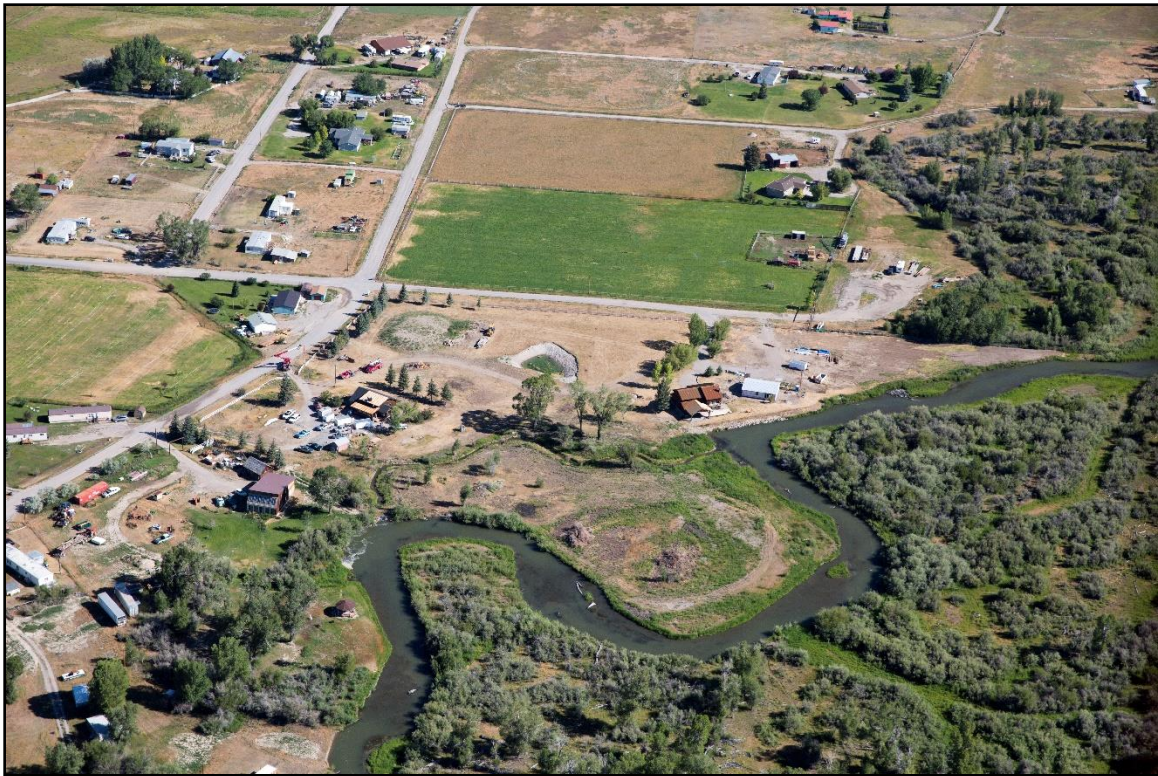
Figure 51. View downstream showing left bank development near Webster Lane. (Kestrel)

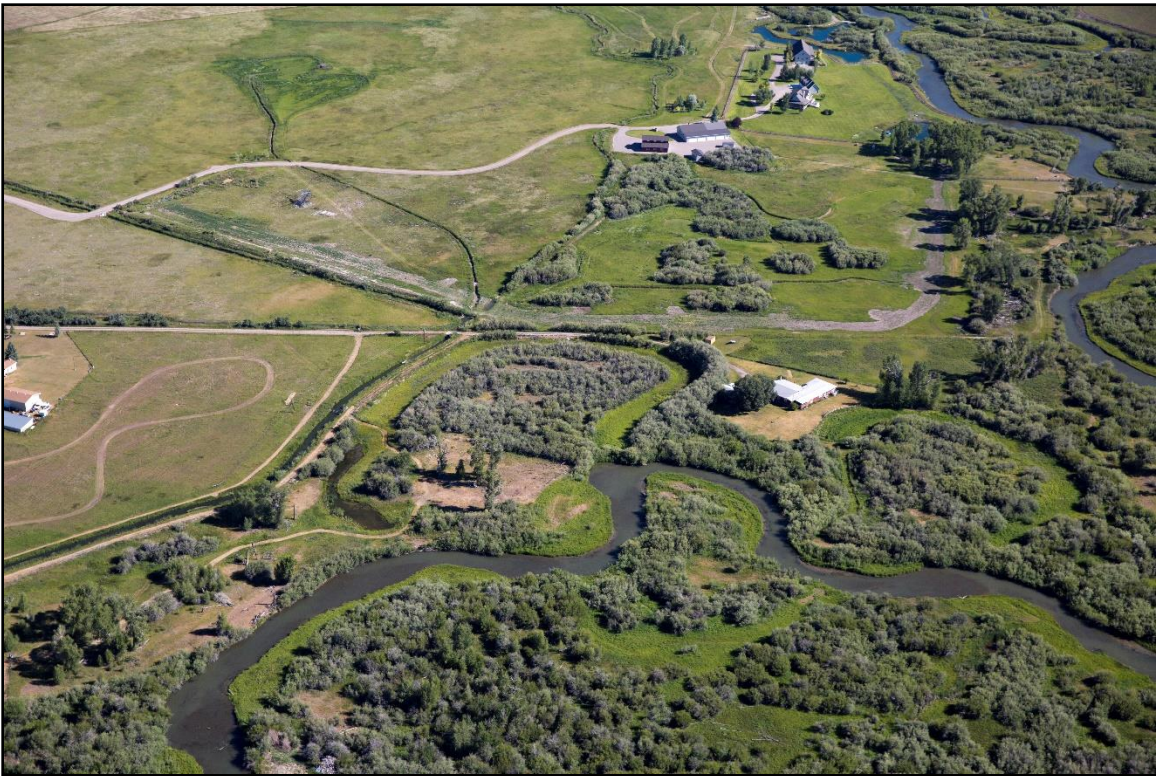
Figure 53. View downstream showing two 1955 oxbows, RM 49.4. (Kestrel)

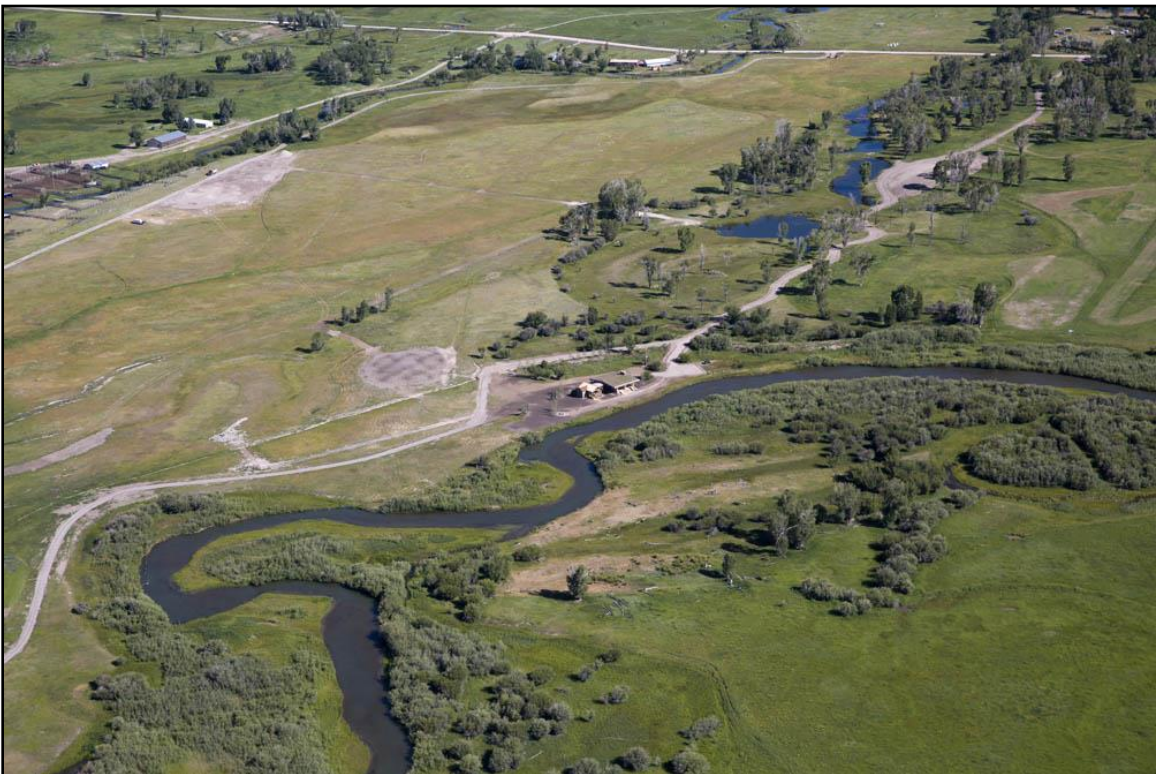
Figure 54. View north showing new home and ponds in historic channel trace that connected the Beaverhead River to Albers Slough. (Kestrel)

One striking aspect of Reach 10 is its perching above Albers Slough and other sloughs to the west. This perching is described in Section 2.2, and is especially evident in the inundation modeling output (Figure 17). At RM 44.1, a major historic channel historically connected the Beaverhead River to the sloughs to the west. This channel has been converted to a series of ponds, and a house has been recently constructed at its junction with the Beaverhead River (Figure 54).
