Beaverhead River Channel Migration Mapping

This report contains the results of a Channel Migration Zone (CMZ) mapping effort for approximately 83 miles of the Beaverhead River from its beginning at Clark Canyon Dam, downstream to its confluence with the Big Hole River just north of Twin Bridges MT. The Beaverhead River mapping is part of a larger effort to map approximately 440 miles of rivers in the Missouri River headwaters watershed.

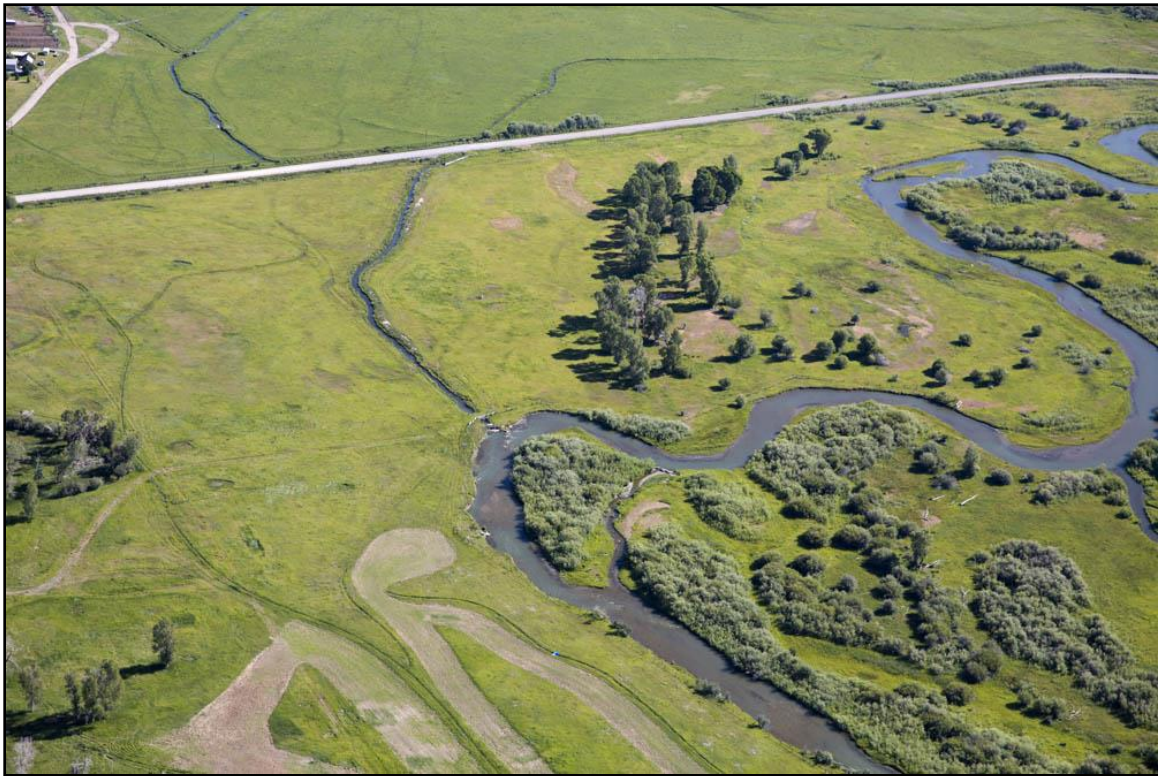
Figure 55. View downstream at RM 43.6 showing diversion structure at risk of abandonment by bendway cutoff. (Kestrel)

Just downstream at RM 43.6, and irrigation structure is at risk of abandonment due to meander cutoff, as a chute channel is visible through the core of the meander (Figure 55). This situation is not uncommon on the river.

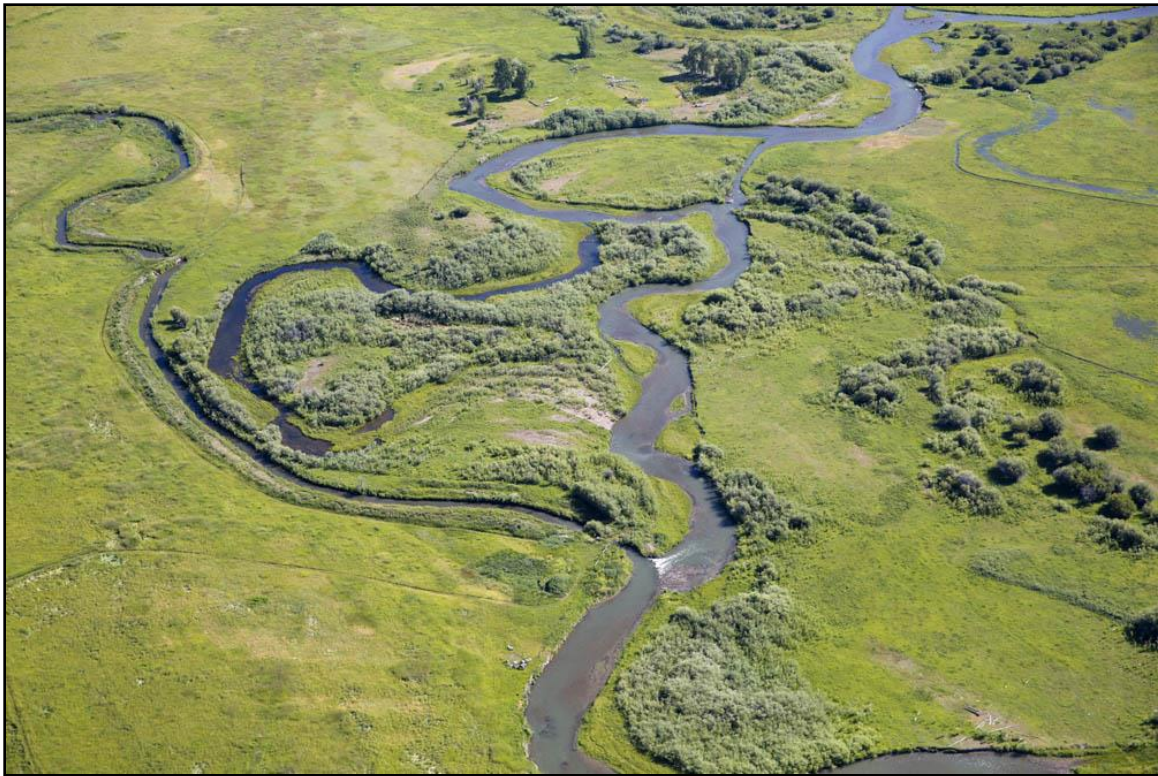
Figure 56. View downstream showing area of 1979-2013 avulsion and active chute channel cutoff just beyond, RM 40.9. (Kestrel)

Reach 9 consists of the 6.6 miles of river downstream of Anderson Lane Bridge, ending near Staudaher East Side Ditch. Immediately below the bridge the channel appears to have been straightened prior to 1955. The river locally flows against a low terrace on the east valley wall, but otherwise occupies a wide, broad floodplain. In general, Reach 9 hosts a meandering channel through a cottonwood corridor with variable tree densities. There are numerous historic cutoffs, avulsions, and areas of high avulsion risk (Figure 56). The entire reach shows a major loss of riparian cover since 1955 and 1979 (Figure 57).

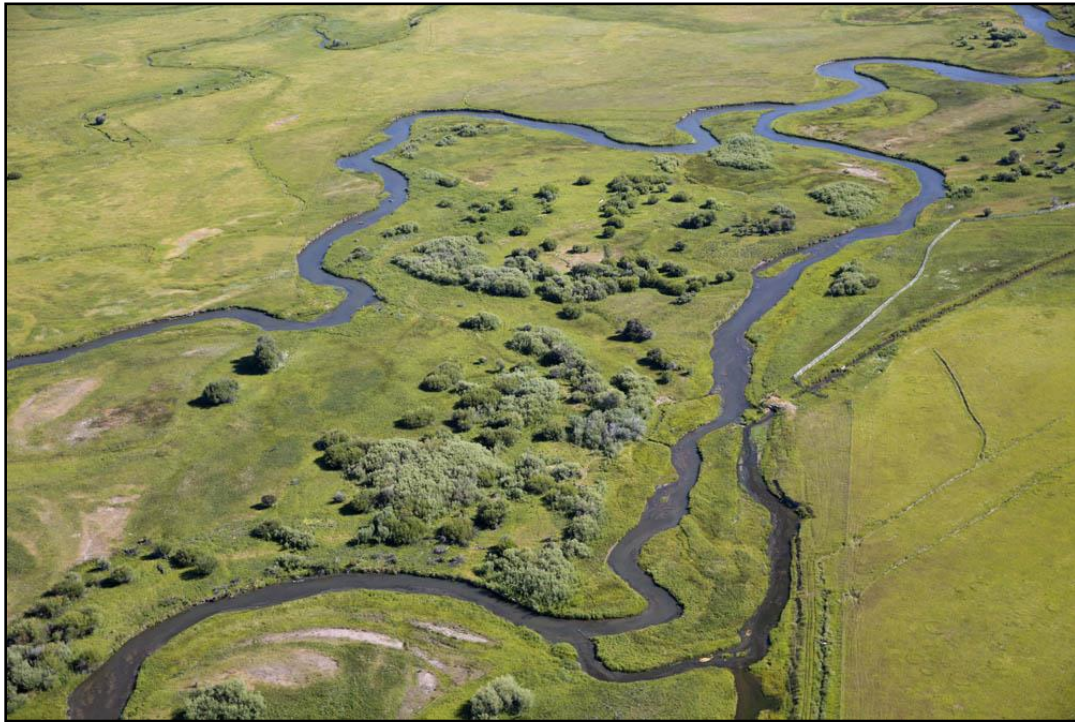
Figure 59. View downstream showing area of 1979-2013 avulsion RM 35.8; new channel is to left. (Kestrel)

Reach 8 extends from Staudaher East Side Ditch to Beaverhead Rock. It consists of a meandering channel that flows through a highly degraded riparian corridor. Albers Slough runs along the west valley wall. The reach hosts numerous large avulsions post-1979 that probably occurred during the 1984 flood (Figure 58 through Figure 60). The avulsion shown in may result in the abandonment of a point of diversion if the original channel is abandoned (Figure 59).

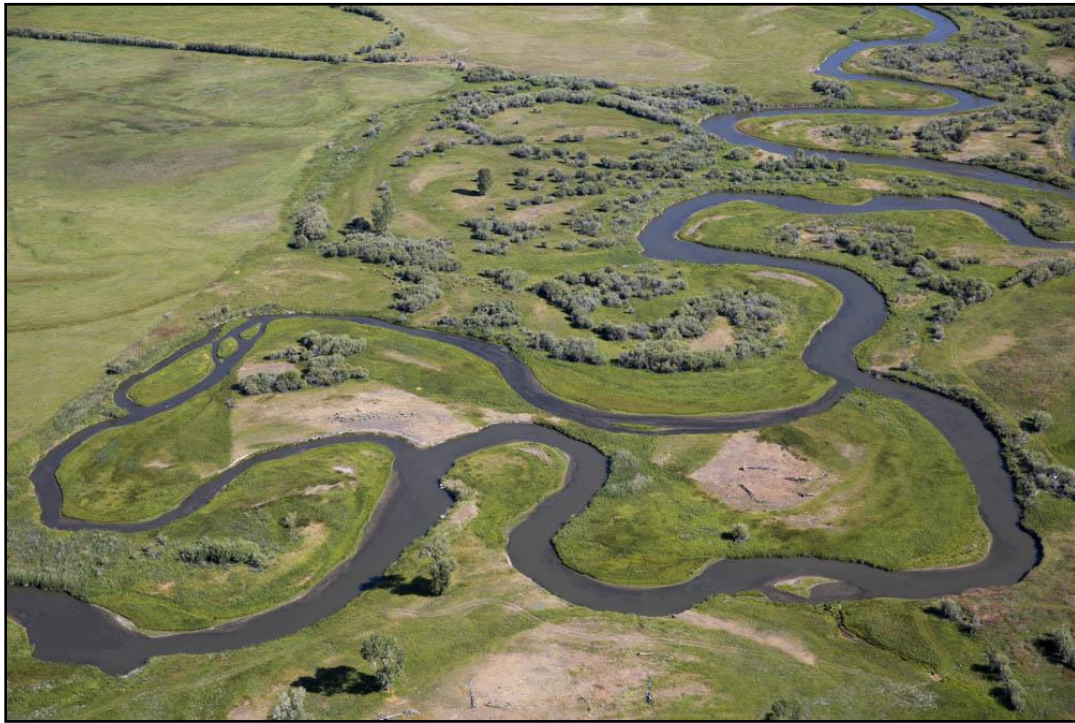
Figure 61. View downstream showing area of imminent cutoff (center of photo), RM 24.7. (Kestrel)

Reach 7 extends downstream from Beaverhead Rock to Big Dry Gulch. Like Reach 8 upstream, it hosts a meandering channel within a highly degraded riparian corridor. The channel is markedly sinuous with extensive meander scars on the floodplain. At RM 24.7 a large meander/island complex is close to cutting off which will abandon two channels, each of which is over 1,000 feet long (Figure 61). Further downstream, there is a good example of an avulsion hazard at RM 17.7 where an older side channel provides a flow route that would shorten the main river by about 1,700 feet (Figure 62).

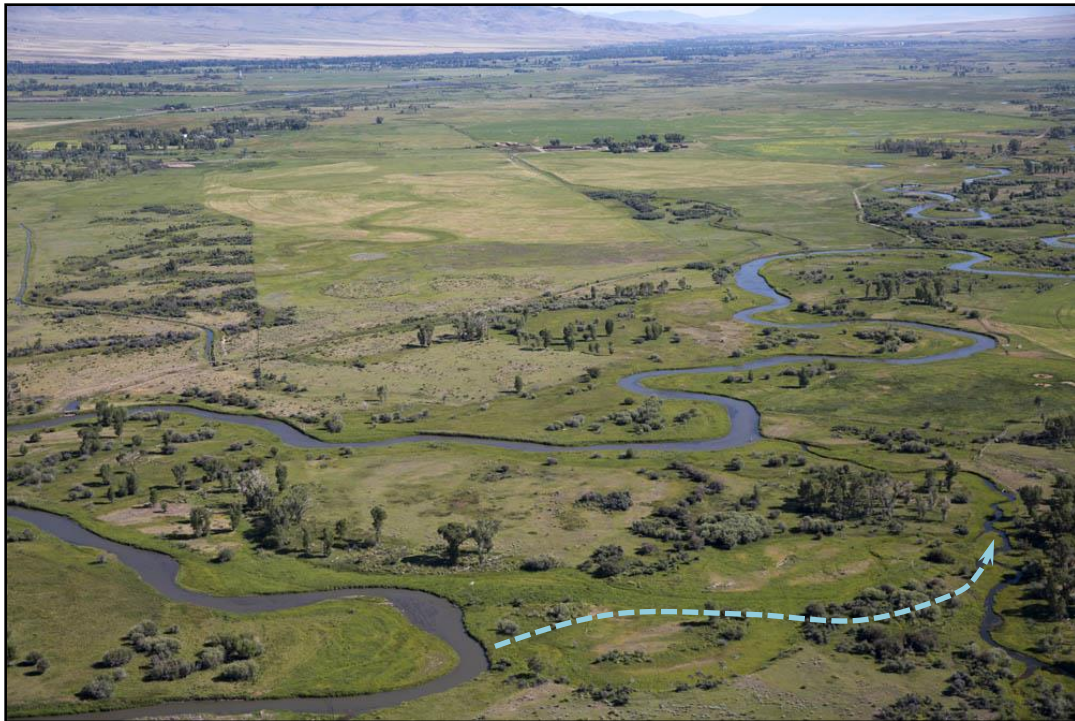
Figure 62. View downstream showing potential avulsion path through abandoned channel (right foreground), RM 17.7. (Kestrel)

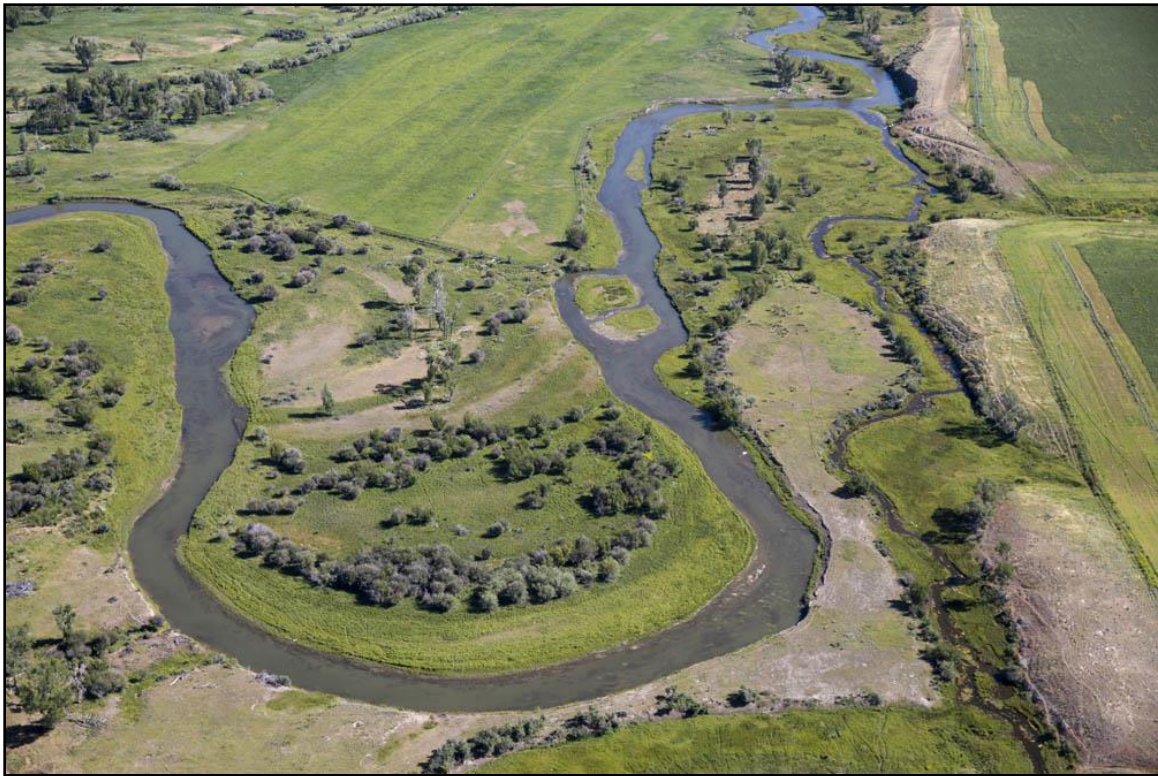
Figure 64. View downstream of active erosion into low terrace on right bank (in distance), RM 12.3. (Kestrel)

Reach 5 is less than 3 miles long and is located upstream of Silver Bow Lane. Like many other sections of the lower Beaverhead, there has been a dramatic loss of the riparian corridor since 1955. There is a very high avulsion risk at RM 13.5 that will shorten the channel by about a mile. On the lower end of the reach the channel is partially confined by a terrace on the east valley margin which has been clipped out of the CMZ (Figure 64).

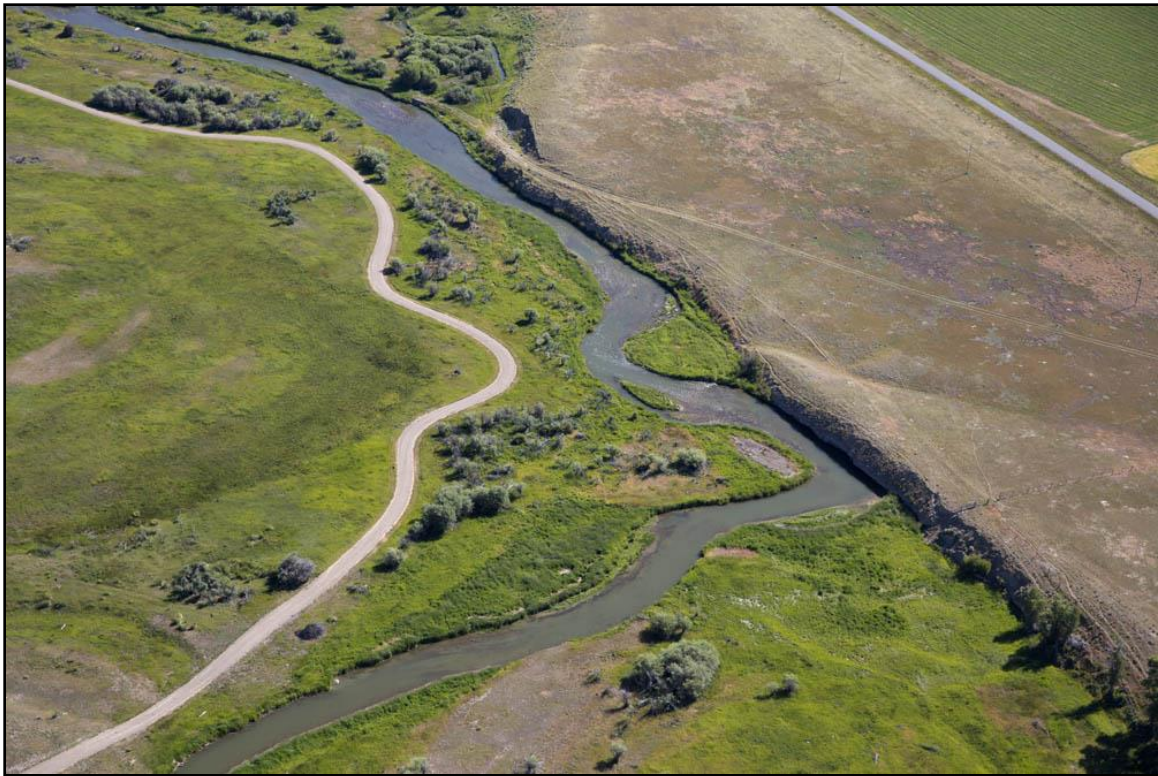
Figure 65. View downstream of low terrace defining CMZ margin, Reach 4. (Kestrel)

Reach 4 is downstream of Silver Bow Lane Bridge. This channel segment closely follows the east terrace margin, such that migration rates are low and the CMZ is narrow (Figure 65).

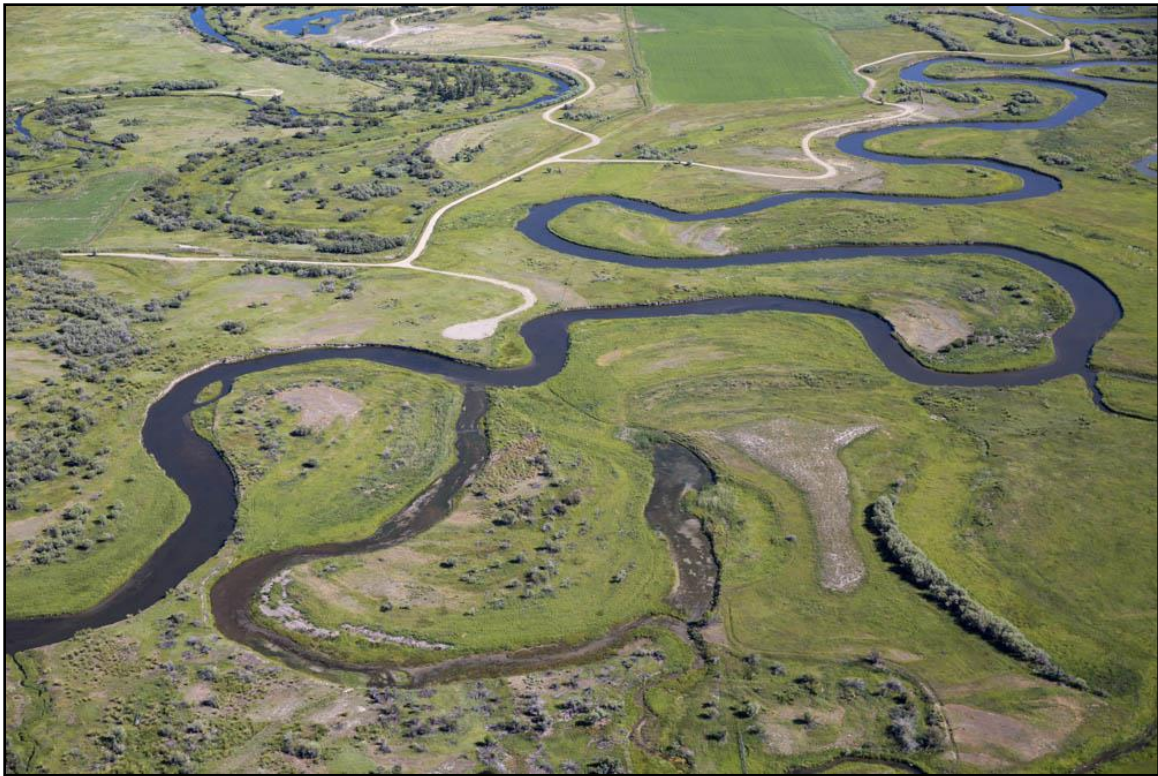
Figure 66. View downstream of Reach 3 high amplitude meander bends. (Kestrel)

Reach 3 extends from below Nye Road to the mouth of the Ruby River. The reach is unconfined and marks the coalescence of the Beaverhead River floodplain with those of the Big Hole and Ruby Rivers. It is a fairly long and sinuous reach with meander amplitudes that commonly reach 1,000 feet (Figure 66). At RM 9.5, the 1955 imagery shows an excellent example of an engineered bendway cutoff (Figure 67), which was probably undertaken to intentionally narrow the meanderbelt. Like other reaches, this area has experienced a major loss of riparian cover since 1955, with much of that loss occurring since 1979. Numerous avulsions were mapped in Reach 3 and several more avulsions are likely in the coming decades. At RM 5.0, the Beaverhead River is migrating eastward such that it will potentially capture the lower half mile of the Ruby River.

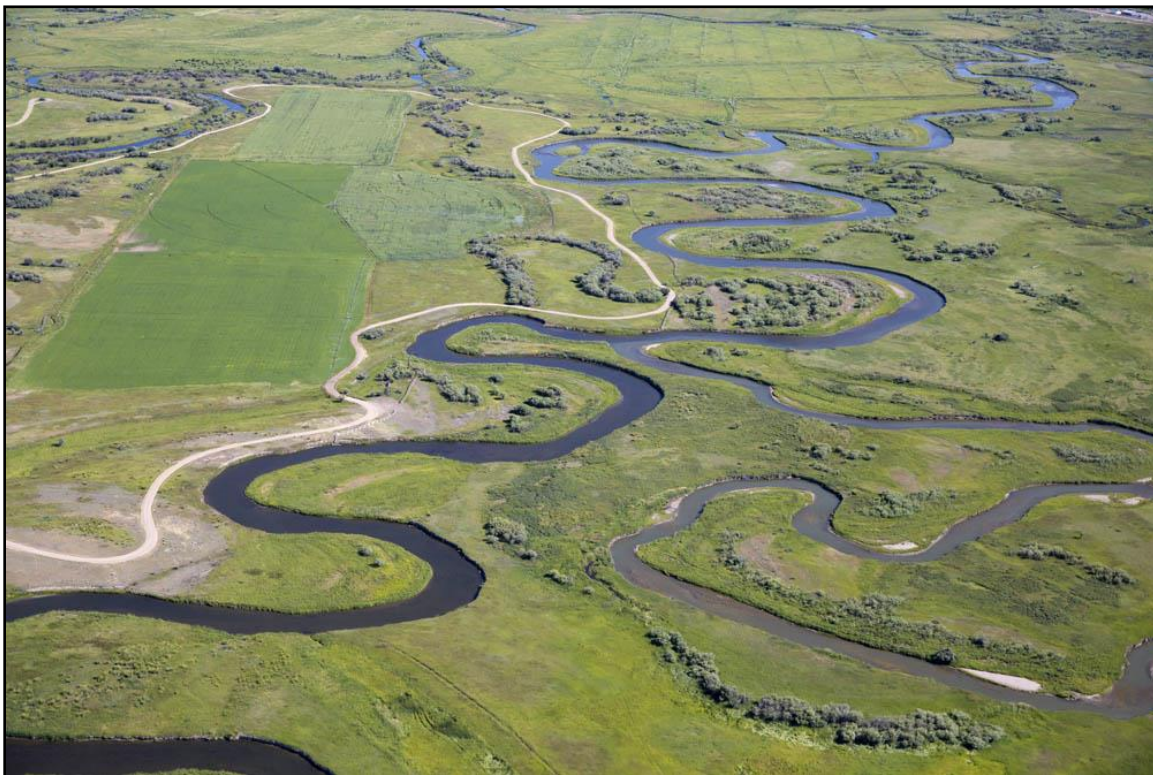
Figure 68. View downstream showing the Ruby River confluence and increased riparian cover downstream. (Kestrel)

Reach 2 is located just upstream of Twin Bridges. It is an unconfined river segment that crosses broad coalescing floodplains of the Beaverhead, Big Hole, and Ruby Rivers. The riparian corridor becomes more robust downstream of the mouth of the Ruby, which may reflect increasing sediment inputs at that point (Figure 68). At RM 3.4, a long ditch on the edge of a pivot field creates a demonstrable avulsion risk (Figure 69). This reach, as well as lower Reach 3, is located about one half mile east of the route shown in the 1870 General Land Office (GLO) maps (Figure 70). This is common in this area; miles of the lower Ruby River have dramatically relocated as well. Reach 2 has the highest mean migration rate in the project reach, and the erosion buffer width is therefore the largest, at 163 feet.

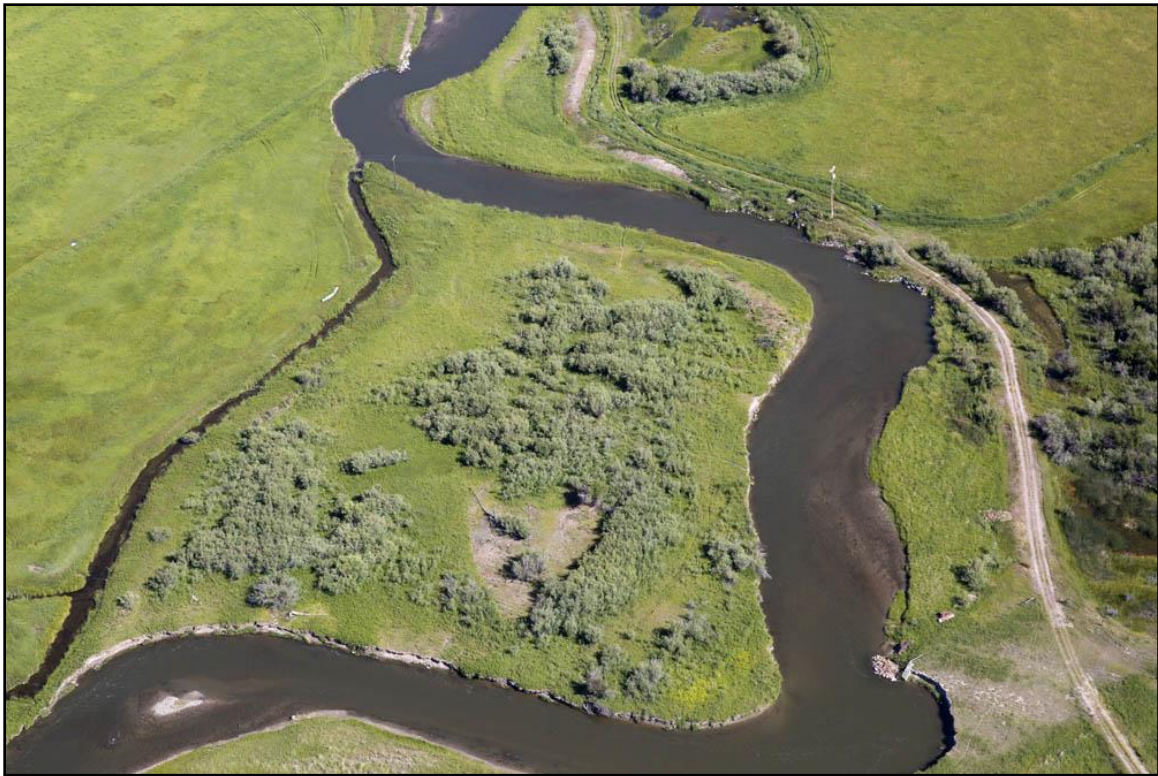
Figure 69. View downstream showing potential avulsion route through ditch, RM 3.4. (Kestrel)

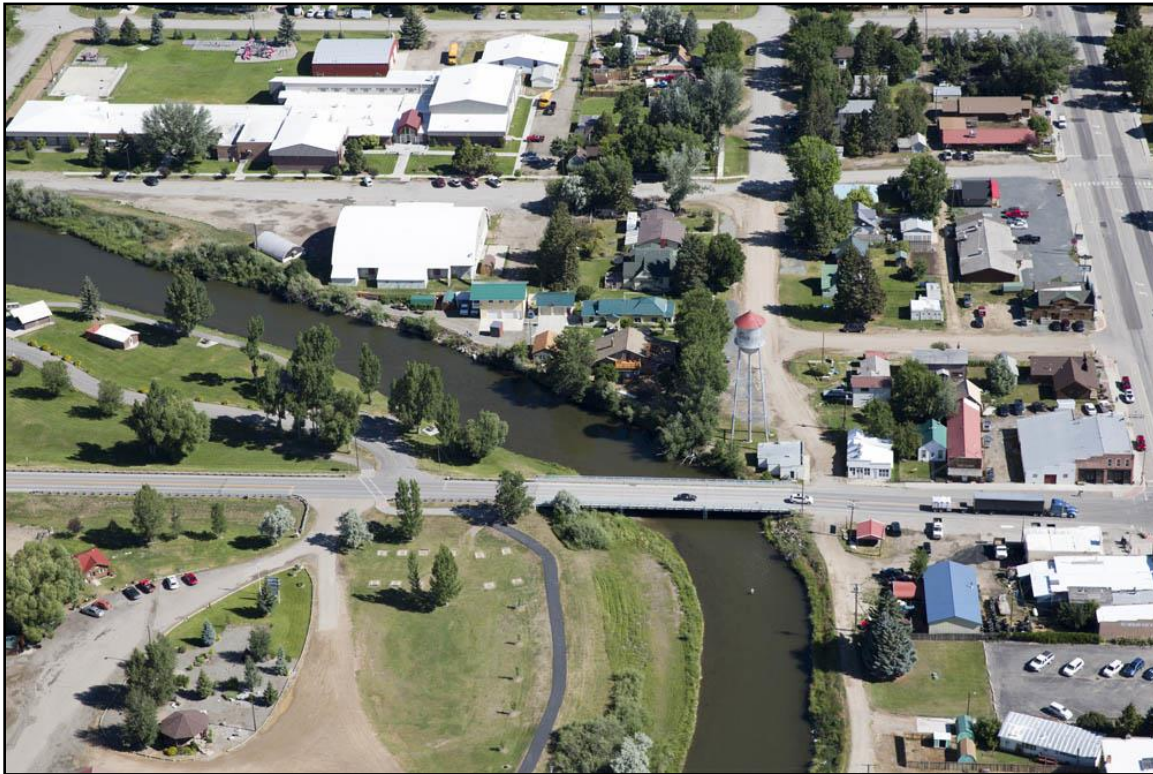
Figure 71. View downstream showing the Beaverhead River in Twin Bridges. (Kestrel)

Reach 1 extends through Twin Bridges to the confluence of the Beaverhead River with the Big Hole River. It is largely confined through town (Figure 71). The confluence with the Big Hole River is characterized by a dramatic increase in open bar area on the Big Hole, which highlights the overall lack of sediment delivery down the Beaverhead (Figure 72).

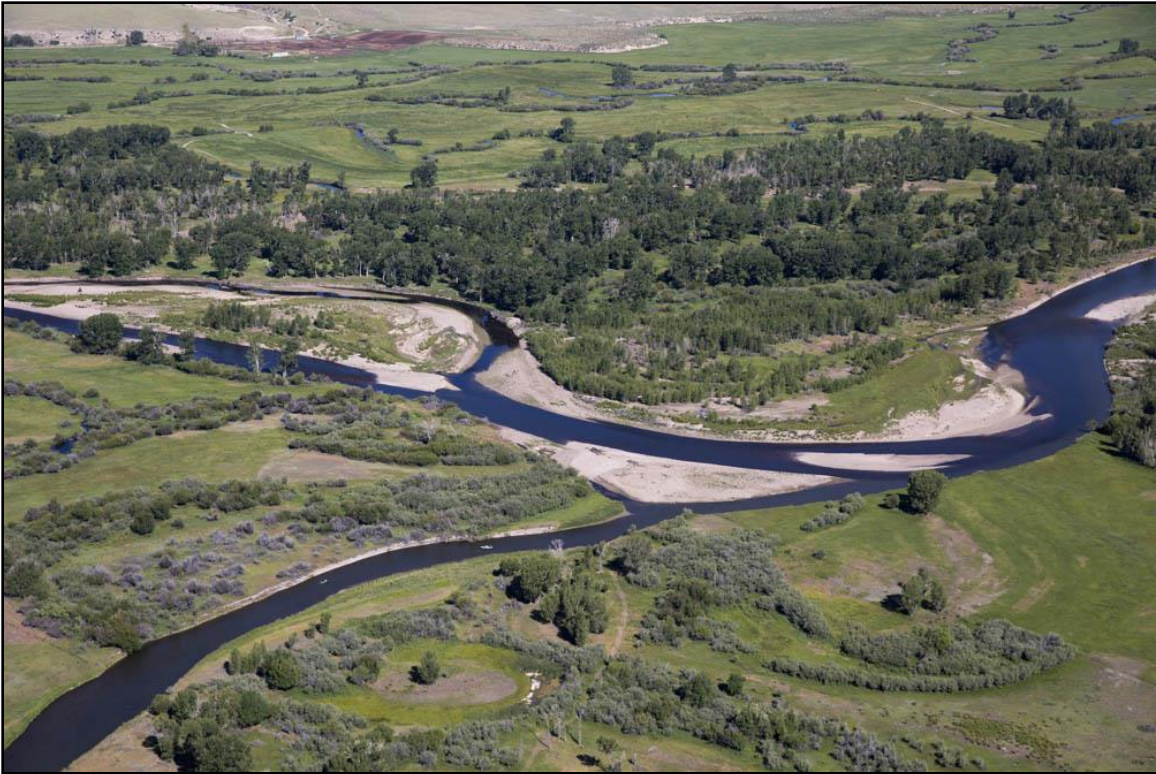
Figure 72. View downstream showing the confluence of the Beaverhead River and the sediment-laden Big Hole River. (Kestrel)

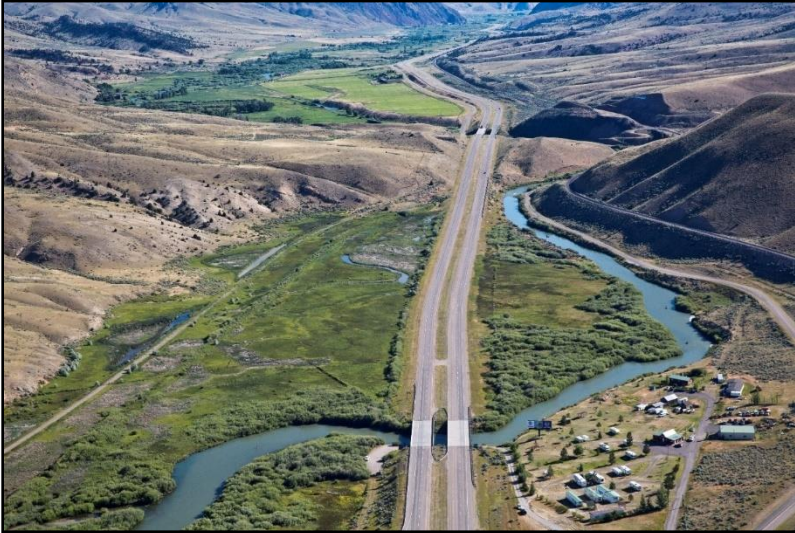
Figure 73. I-15 crosses the Beaverhead River below Clark Canyon Reservoir (RM 82.7 and RM 81.6), July 21, 2016. (Kestrel)

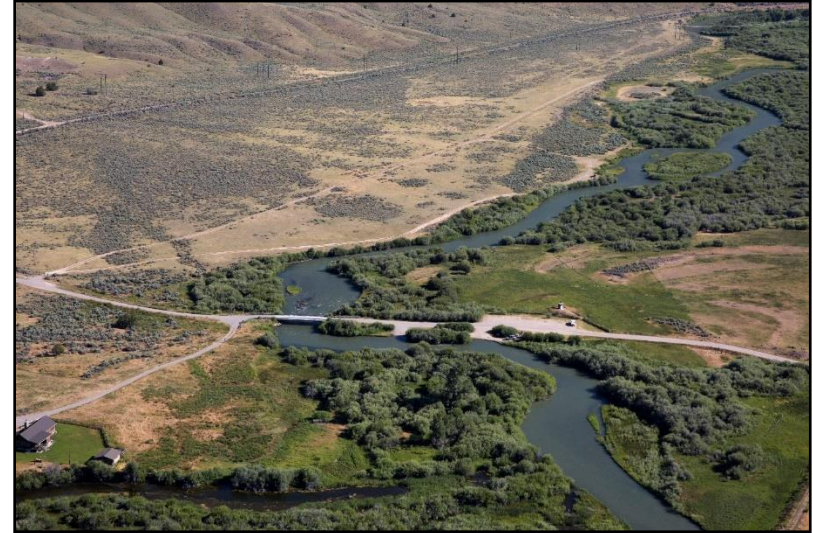
Figure 75. Hennaberry Road bridge (north) at river mile 77.3, July 21, 2016. (Kestrel)

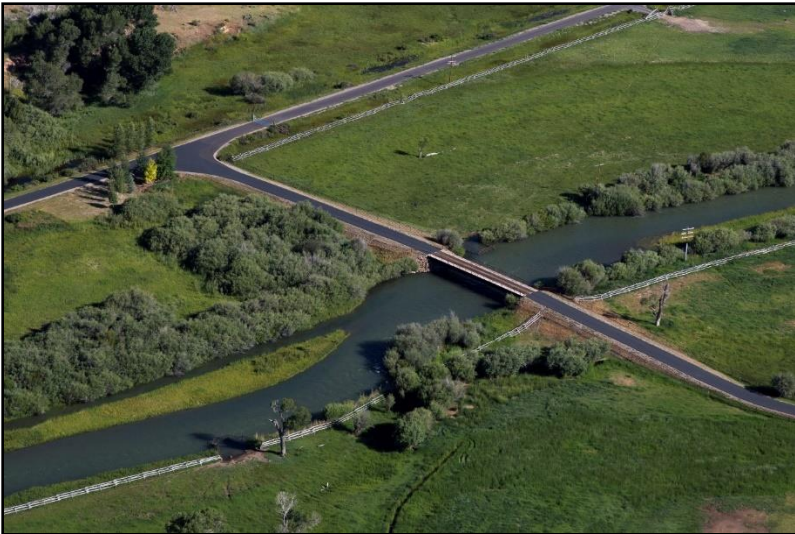
Figure 74. Hennaberry Road bridge (south) at river mile 80.4, July 21, 2016. (Kestrel)

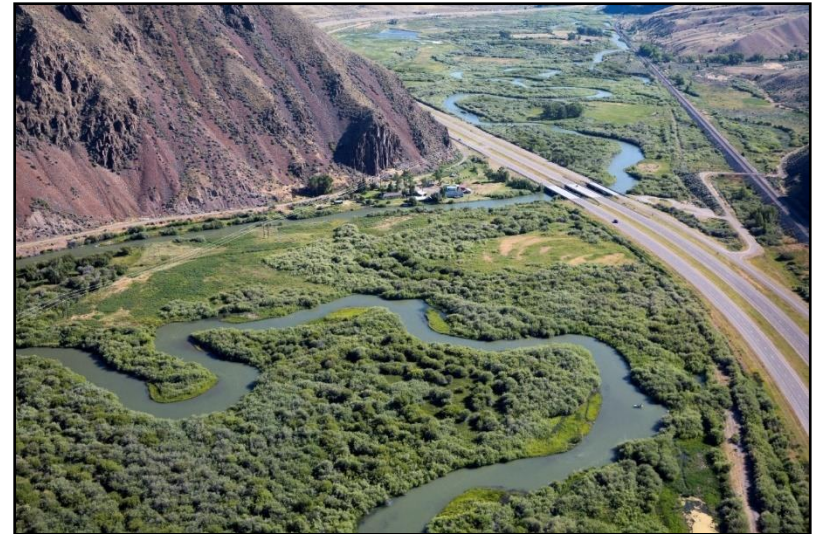
Figure 76. Interstate 15 (3rd crossing) and High Road at river mile 75.4, July 21, 2016. (Kestrel)

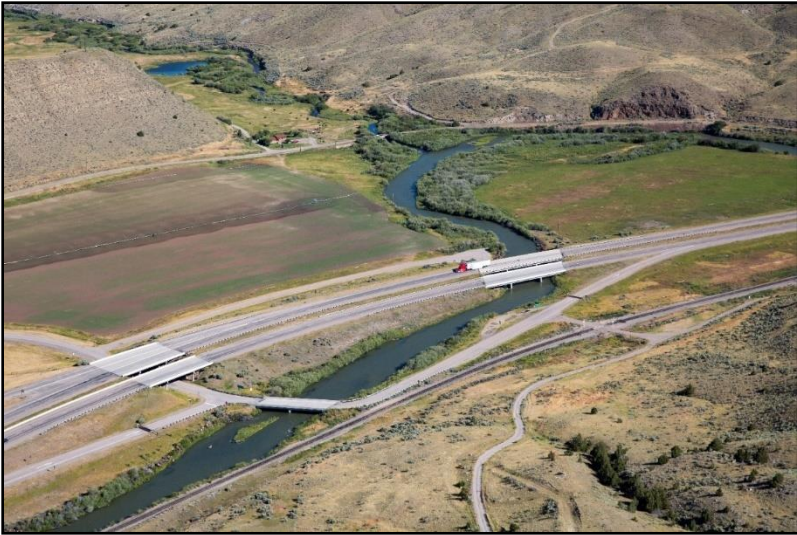
Figure 77. Interstate 15 (4th crossing) and Grasshopper Road onramp at river mile 71.5, July 21, 2016. Grasshopper Creek enters at the upper left of the photo. (Kestrel)

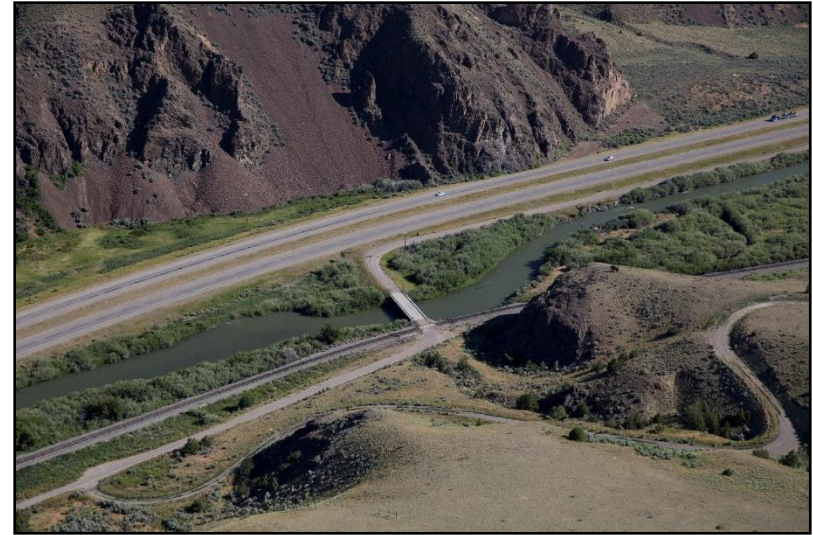
Figure 79. Frontage road bridge at river mile 70.3, July 21, 2016. (Kestrel)

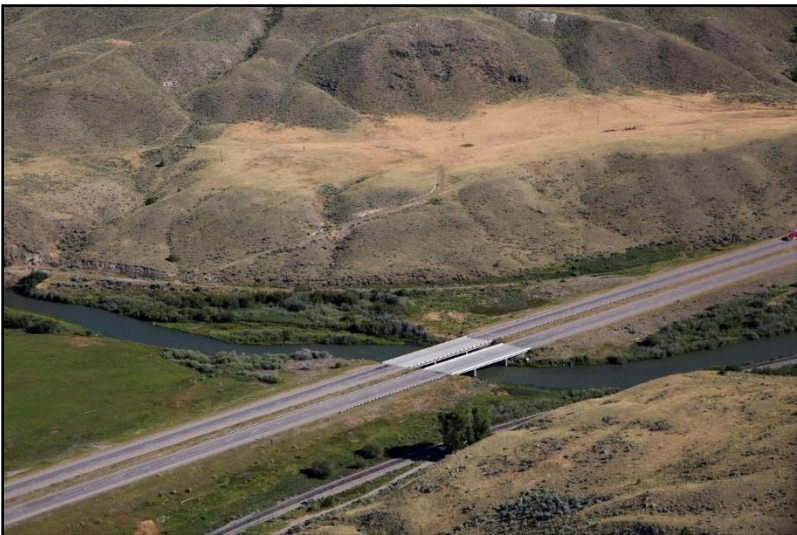
Figure 78. Interstate 15 (5th crossing) at river mile 70.9, July 21, 2016. (Kestrel)

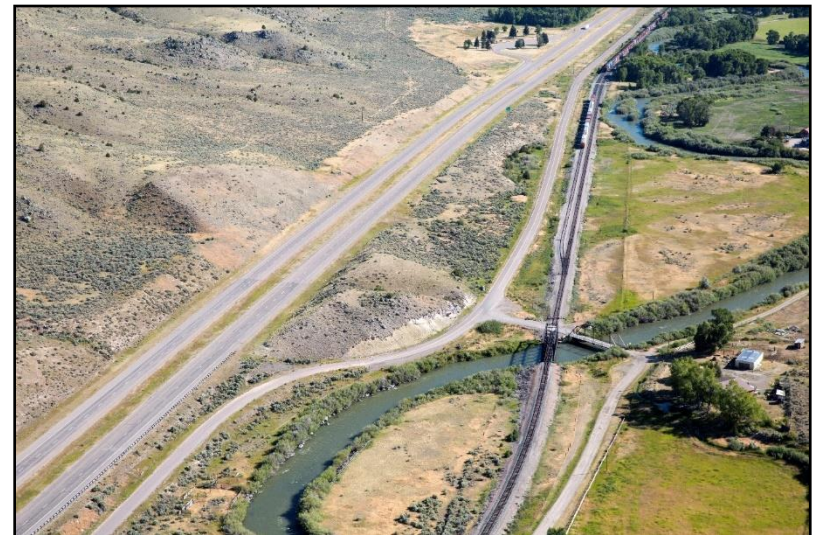
Figure 80. Union Pacific railroad crosses the Beaverhead River as it exits Clark Canyon along with Ryan Canyon Road (river mile 69.2), July 21, 2016. (Kestrel)

The Union Pacific Railroad largely follows the eastern valley edge through Clark Canyon, crossing to the west side of the valley at river mile 69.2 (Figure 80). The rail line crosses back to the east side of river at river mile 62, where it crosses the river's main channel, a side channel, as well as Poindexter Slough (Figure 83). A final crossing back to the west side occurs at river mile 53.5 where it parallels Highway 91 on the north side of Dillon (Figure 90).

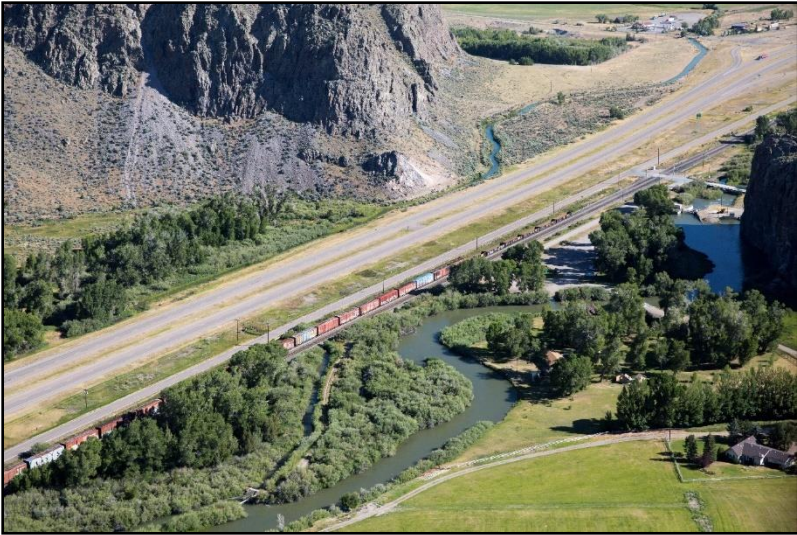
Figure 81. Barretts Park bridge at river mile 68.0, July 21, 2016. (Kestrel)

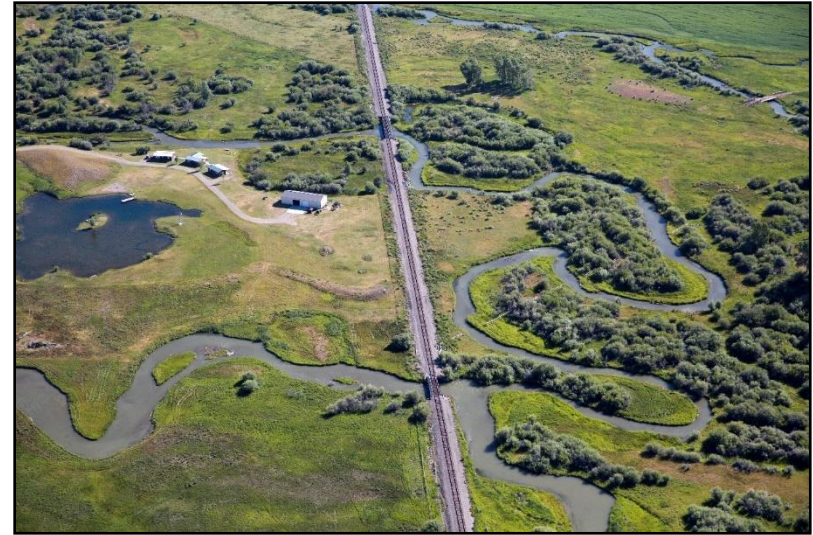
Figure 83. Union Pacific railroad crosses the Beaverhead River (2 crossings)(river mile 62.0) and Poindexter Slough (top of photo), July 21, 2016. (Kestrel)

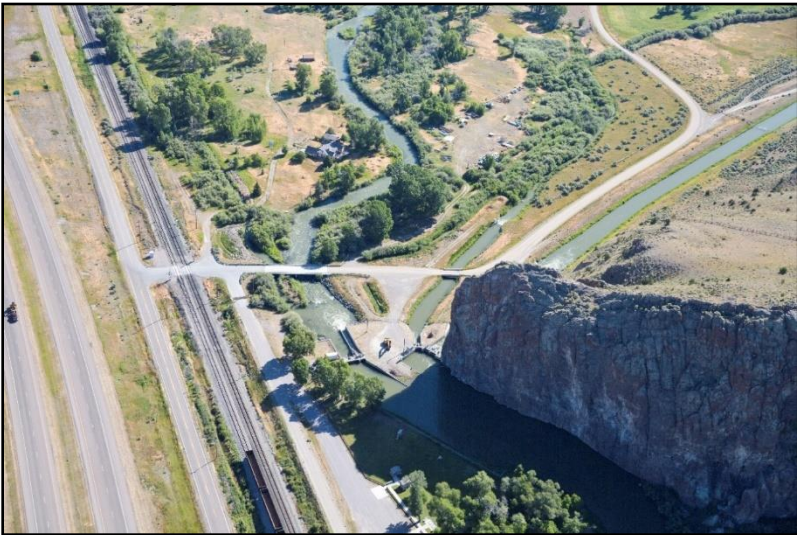
Figure 82. Barrett's Diversion at river mile 67.8, Montana, July 21, 2016. (Kestrel)

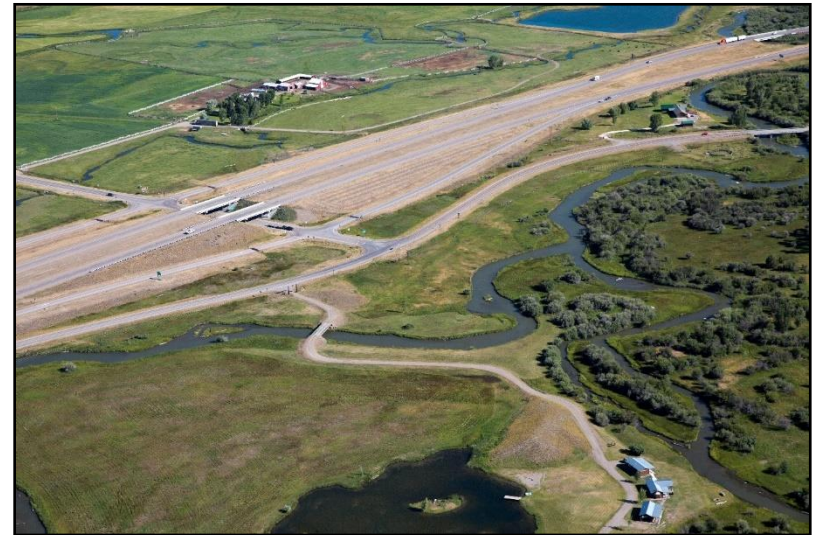
Figure 84. A private road (center, river mile 61.5) and Hwy 91 (upper right, river mile 61.1) cross the Beaverhead River, July 21, 2016. (Kestrel)

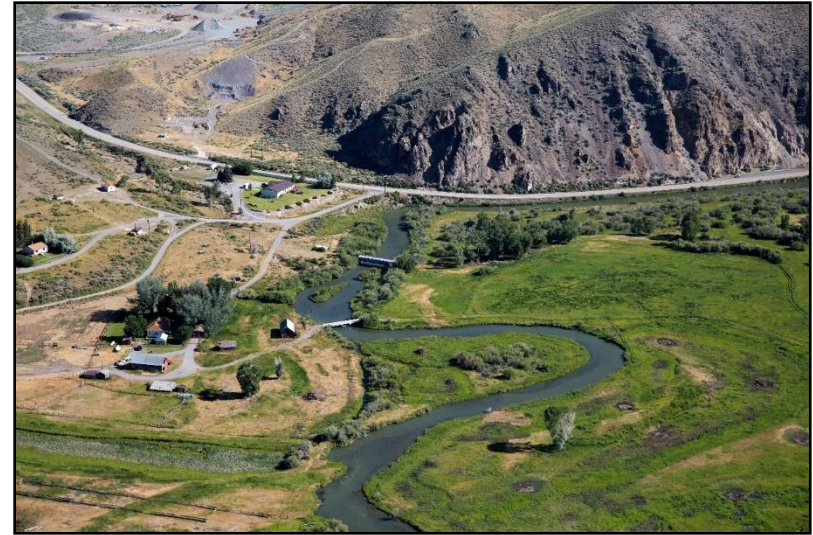
Figure 87. Two private crossings at river mile 56.4, July 21, 2016. (Kestrel)

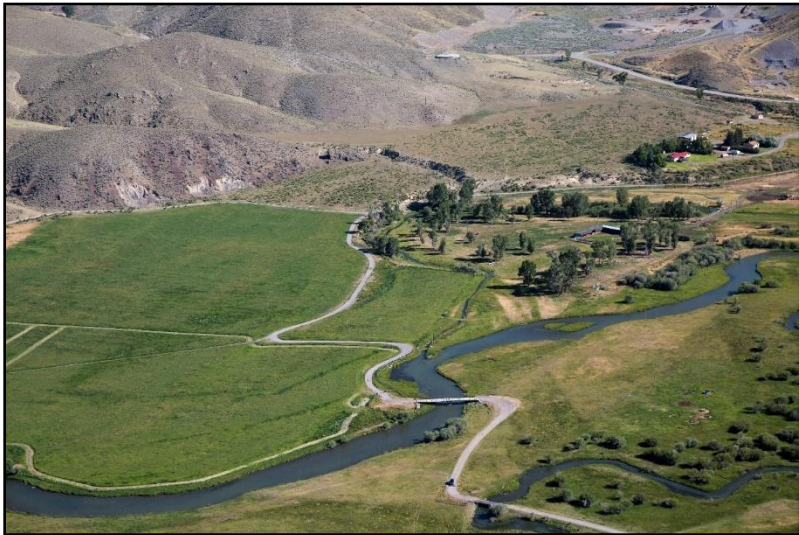
Figure 86. Private road bridge at river mile 57.1, July 21, 2016. (Kestrel)

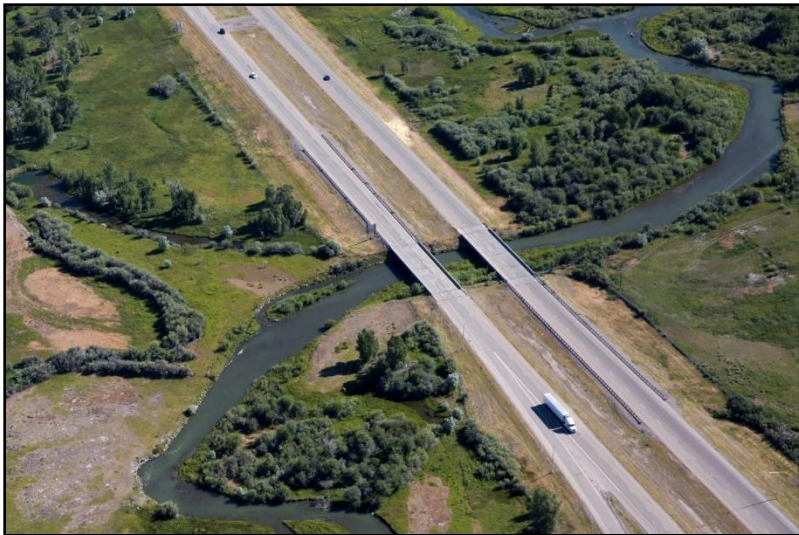
Figure 89. Interstate 15 (7th crossing) at river mile 54.1, July 21, 2016. (Kestrel)

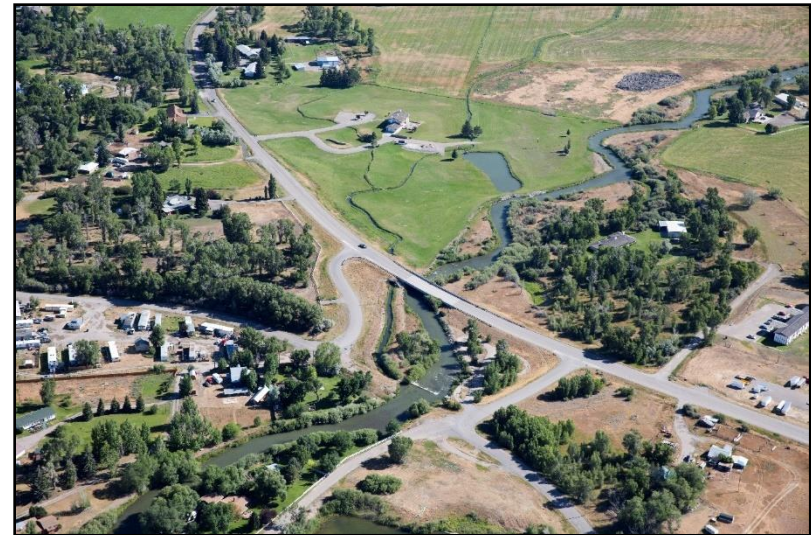
Figure 91. Highway 91 bridge at river mile 53.1, July 21, 2016. (Kestrel)

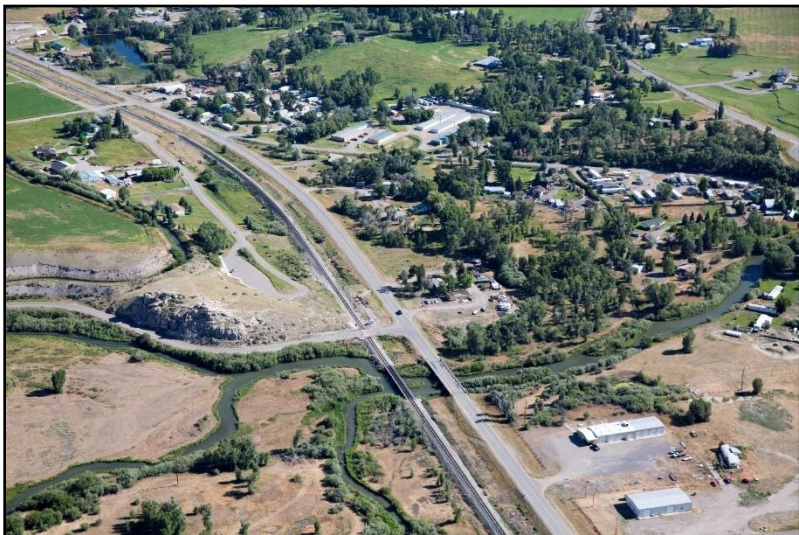
Figure 90. Union Pacific railroad and Highway 91 cross the Beaverhead River at river mile 53.5, July 21, 2016. (Kestrel)

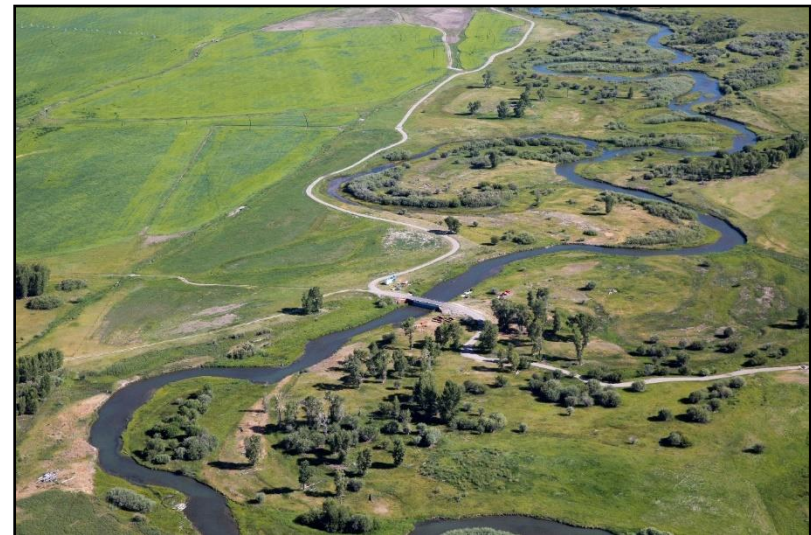
Figure 92. Private bridge at river mile 45.4, July 21, 2016. (Kestrel)

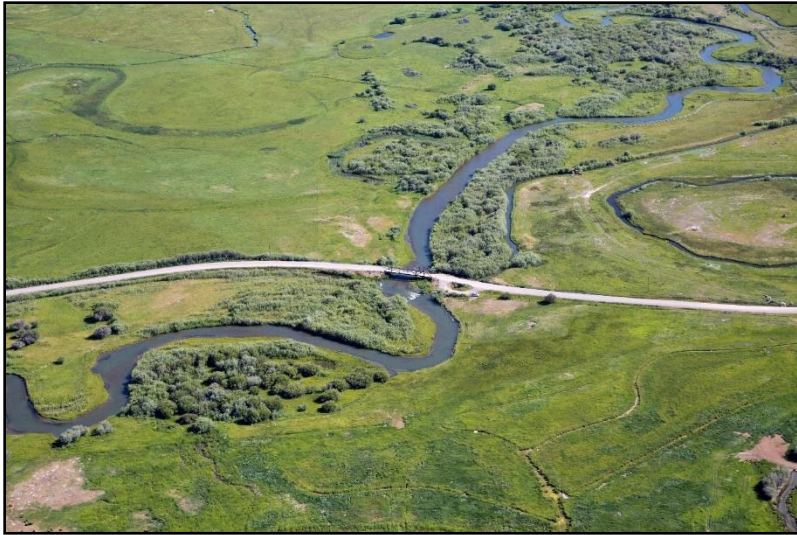
Figure 93. Anderson Lane bridge at river mile 42.8, July 21, 2016. (Kestrel)

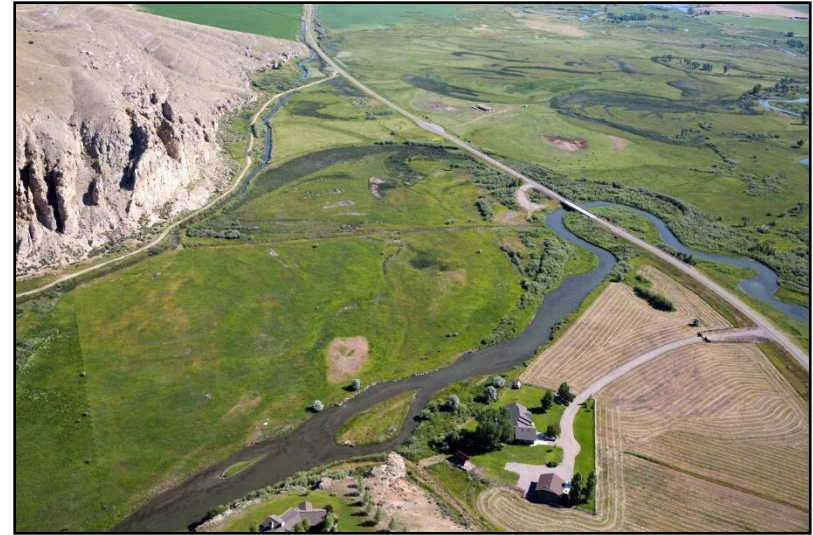
Figure 95. Highway 41 bridge at river mile 28.2, with Beaverhead rock on the left, July 21, 2016. (Kestrel)

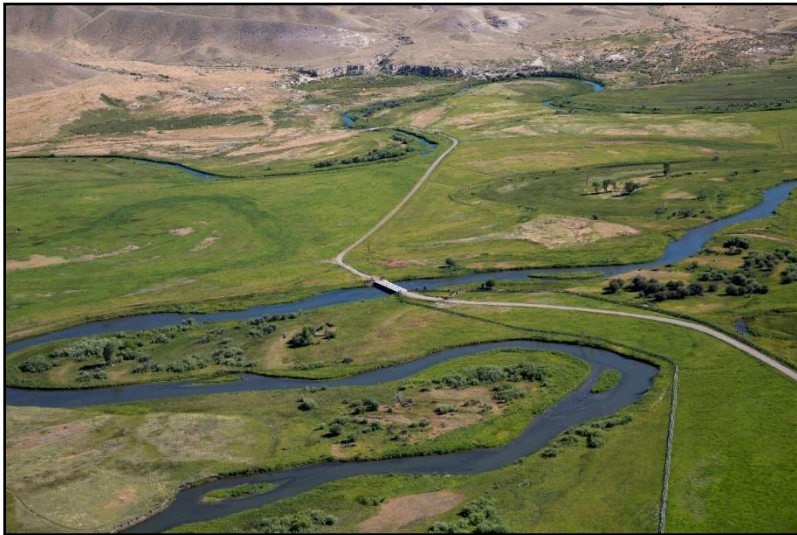
Figure 94. Diamond O Ranch bridge at river mile 33.1, with Albers Slough at the top of the image, July 21, 2016. (Kestrel)

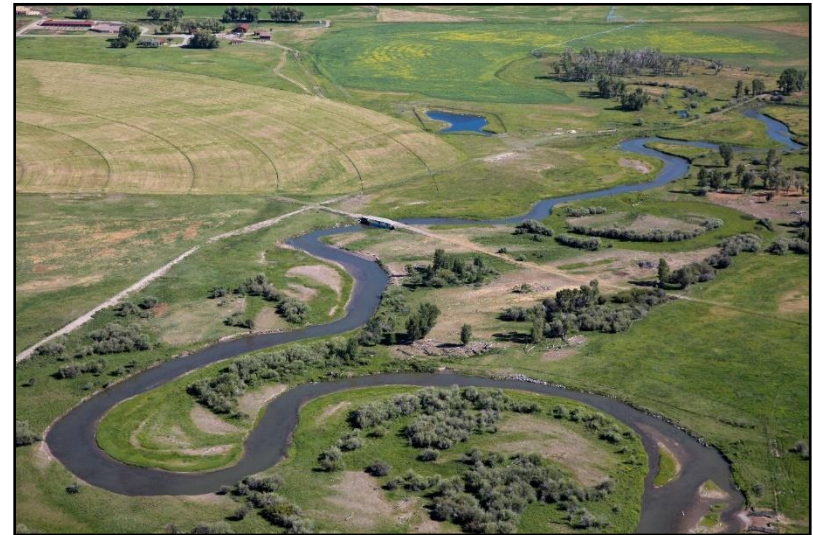
Figure 96. Private bridge at river mile 15.8, July 21, 2016. (Kestrel)

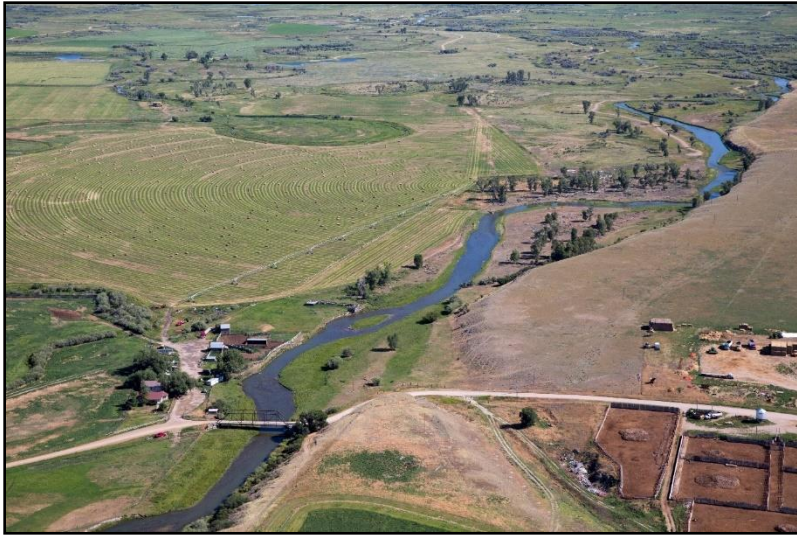
Figure 97. Silver Bow Lane bridge at river mile 12.0, July 21, 2016. (Kestrel)
