Beaverhead River Channel Migration Mapping

This report contains the results of a Channel Migration Zone (CMZ) mapping effort for approximately 83 miles of the Beaverhead River from its beginning at Clark Canyon Dam, downstream to its confluence with the Big Hole River just north of Twin Bridges MT. The Beaverhead River mapping is part of a larger effort to map approximately 440 miles of rivers in the Missouri River headwaters watershed.

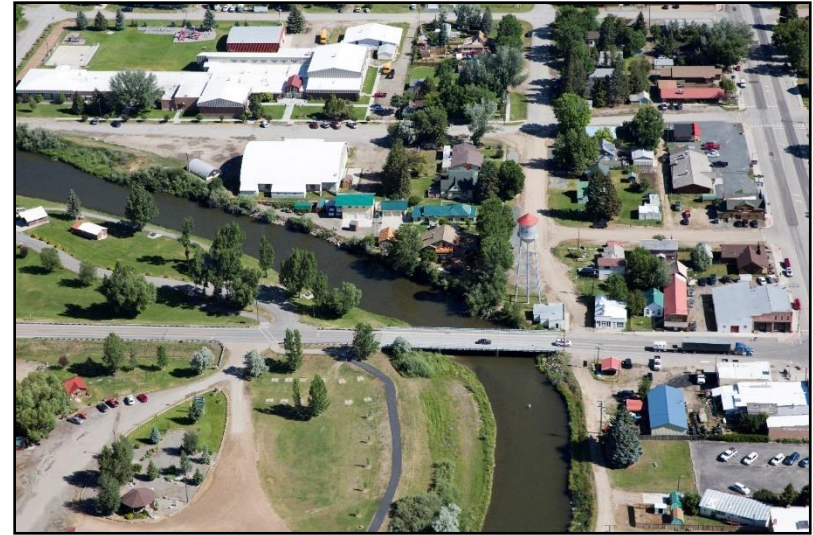
Figure 99. Highway 41 bridge in Dillon at river mile 2.2, July 21, 2016. (Kestrel)

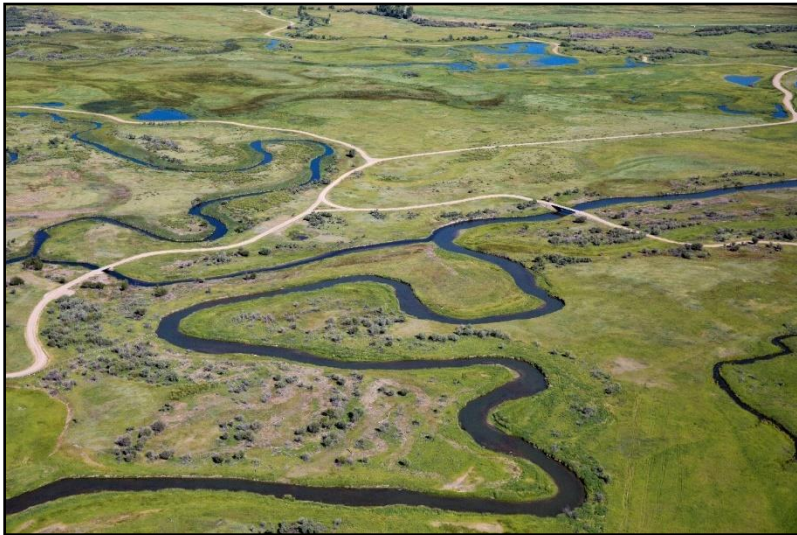
Figure 98. Private bridge at river mile 8.7, July 21, 2016. (Kestrel)

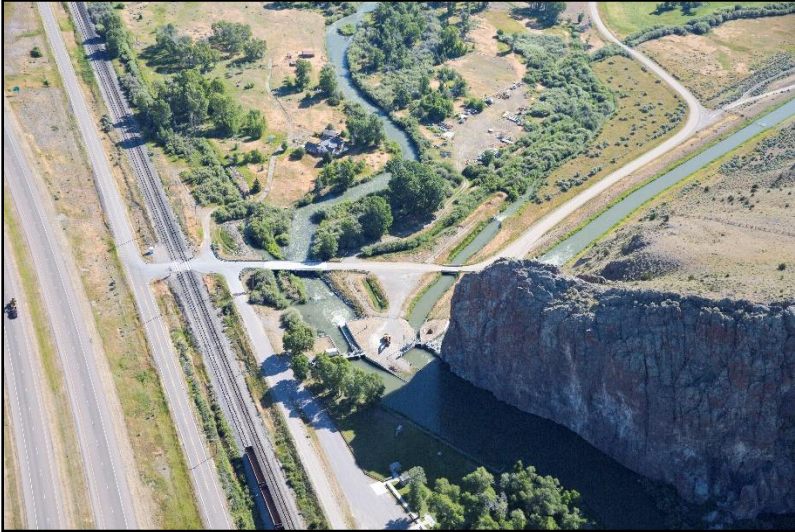
Figure 100. Diversion at Barretts, RM 68, July 21, 2016 (Kestrel).

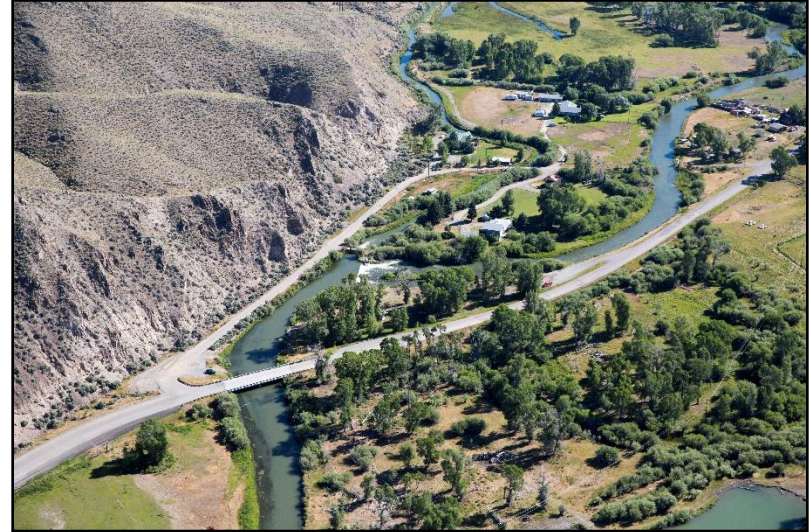
Figure 102. Smith Rebich Ditch Diversion at RM 55.6, July 21, 2016 (Kestrel).

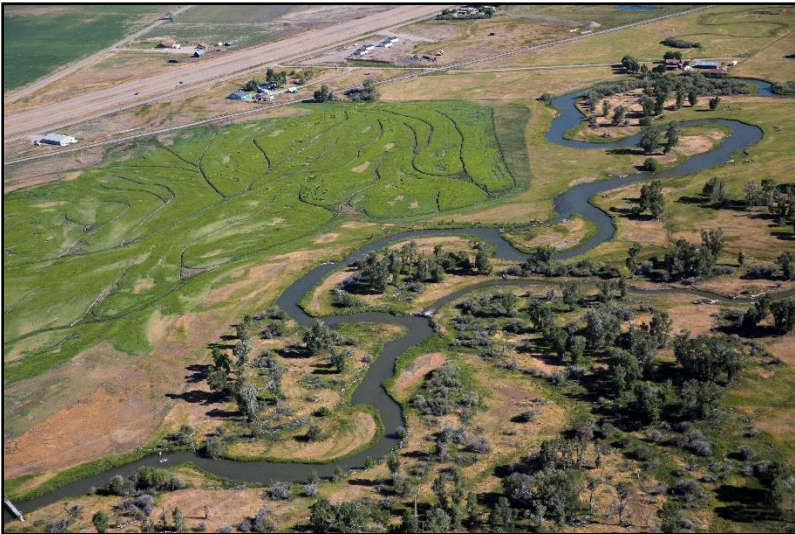
Figure 101. Poindexter Diversion, RM 63.5, July 21, 2016 (Kestrel).

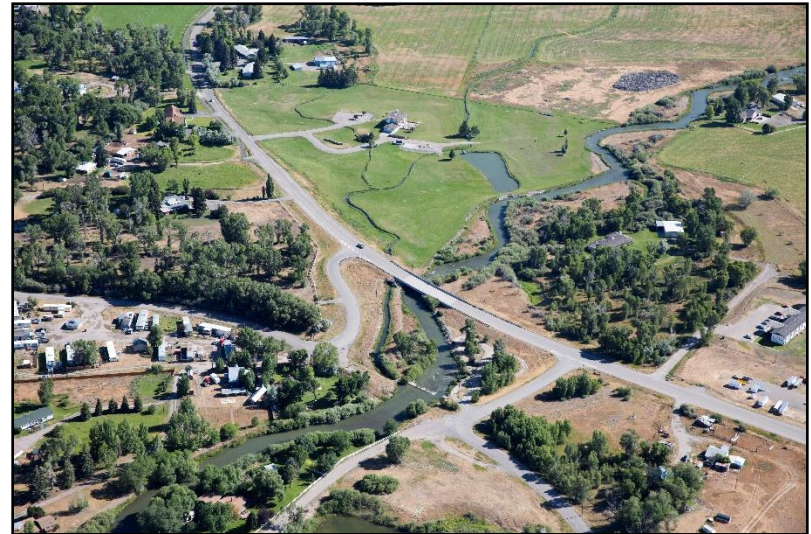
Figure 103. Diversion at RM 53.1, Lacknar Lane, July 21, 2016 (Kestrel).

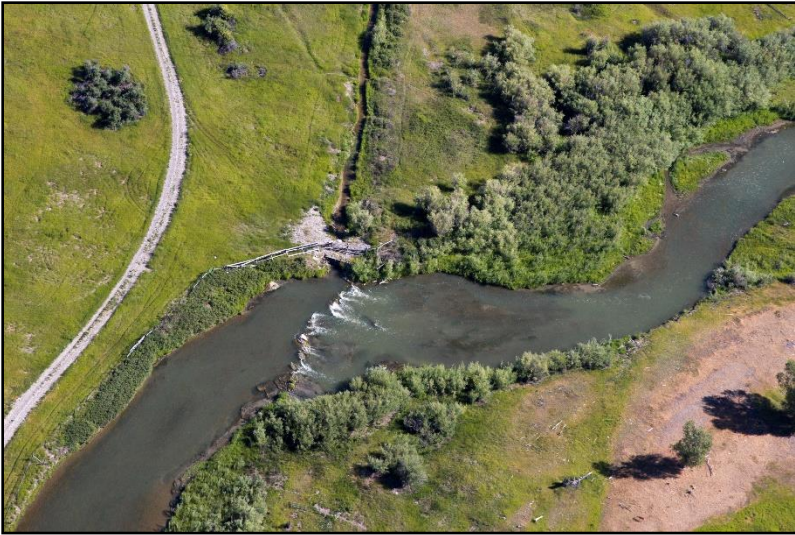
Figure 104. Diversion at RM 46.2 July 21, 2016 (Kestrel).

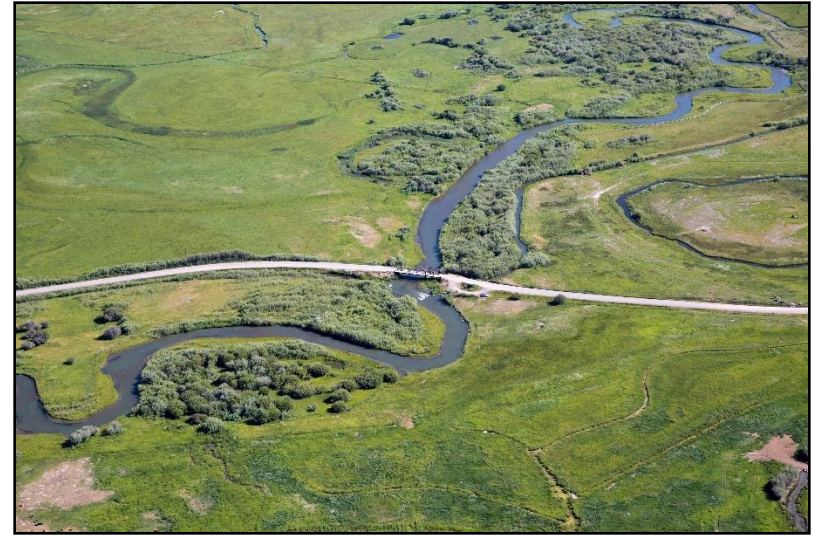
Figure 106. Diversion at RM 42.8, Anderson Lane, July 21, 2016 (Kestrel).

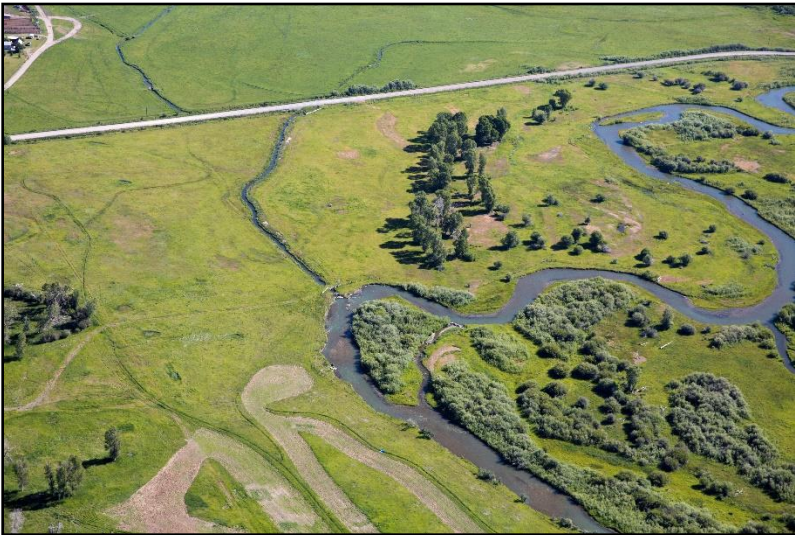
Figure 105. Diversion at RM 43.6, July 21, 2016 (Kestrel).

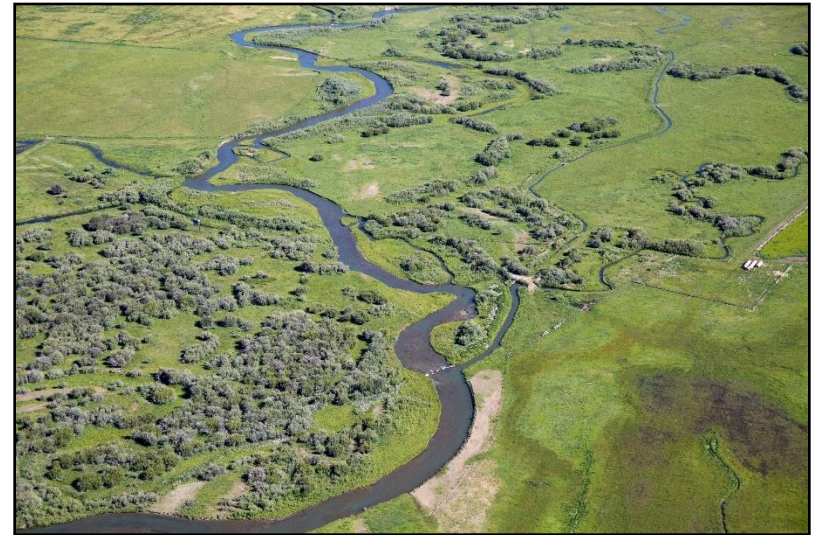
Figure 107. Diversion at RM 41.5, July 21, 2016 (Kestrel).

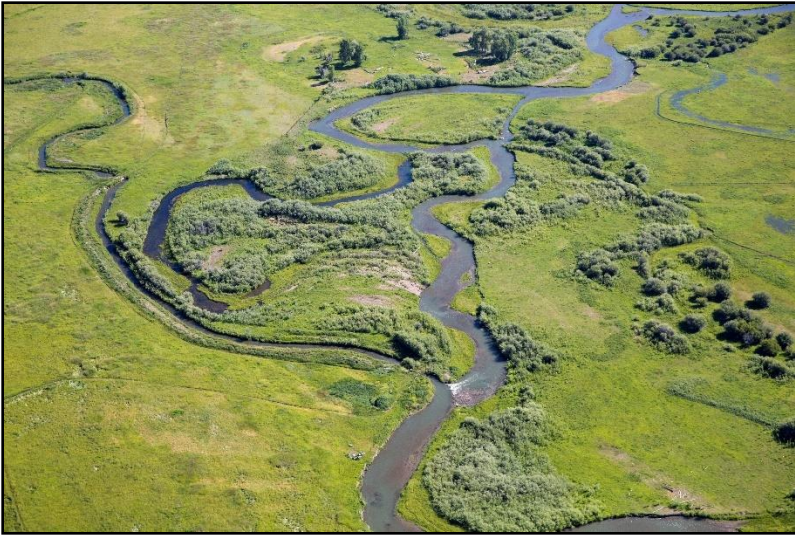
Figure 108. Diversion at RM 40.9, July 21, 2016 (Kestrel).

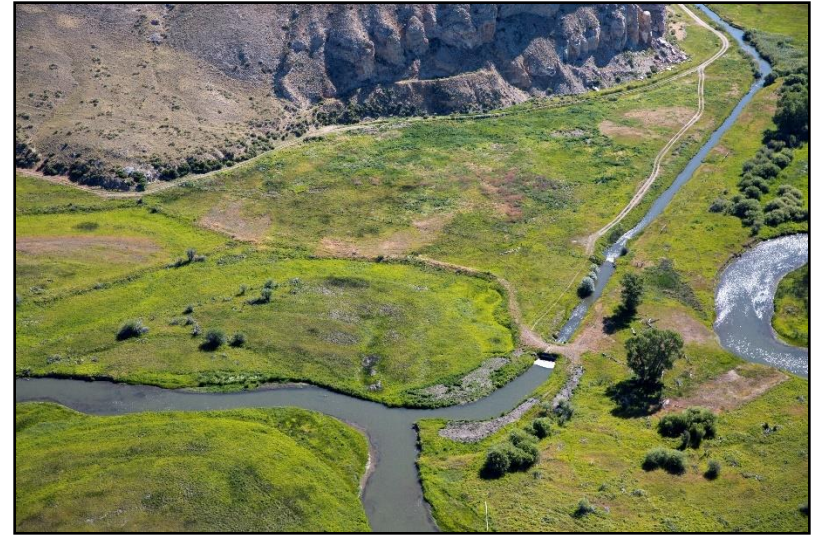
Figure 110. Co-op Ditch Diversion at RM 29.2 (Beaverhead Rock), July 21, 2016 (Kestrel).

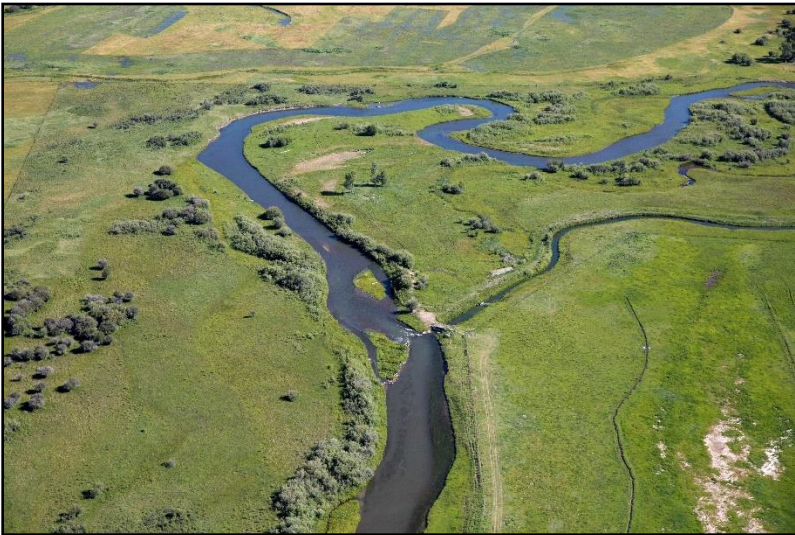
Figure 109. Diversion at RM 37.9, July 21, 2016 (Kestrel).

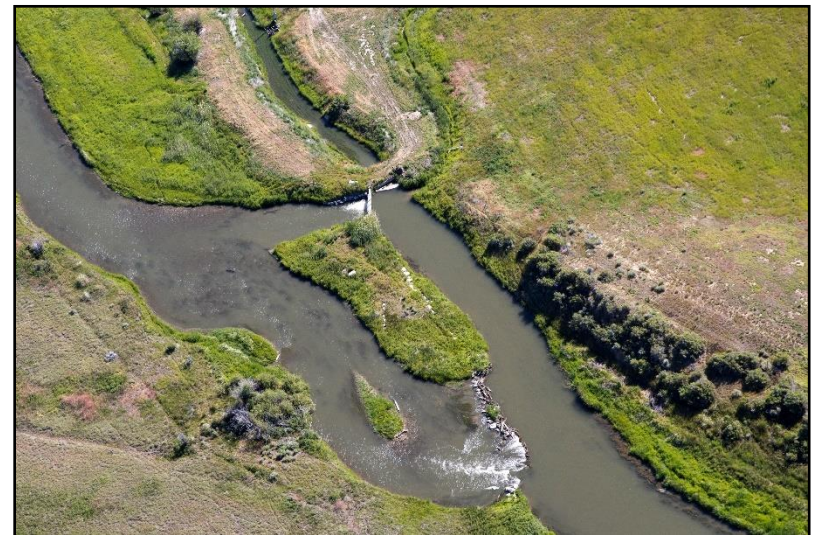
Figure 111. Diversion at RM 26.4, July 21, 2016 (Kestrel).

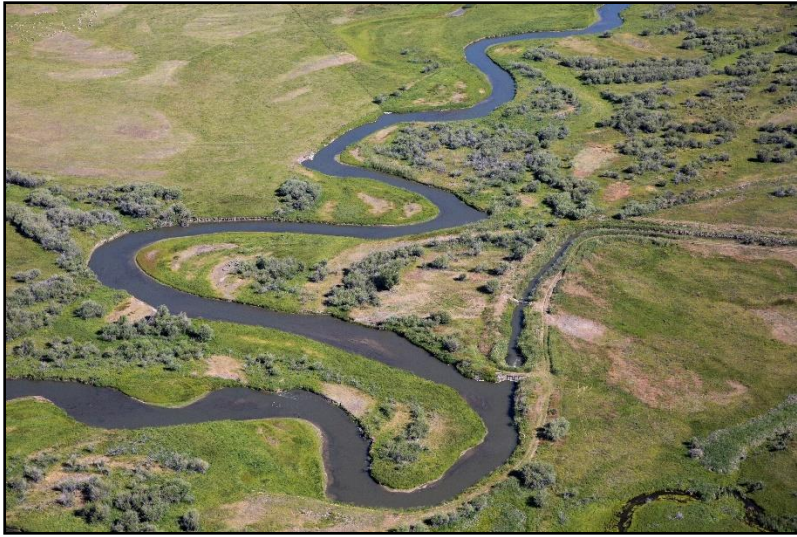
Figure 112. Diversion at RM 24.2, July 21, 2016 (Kestrel).

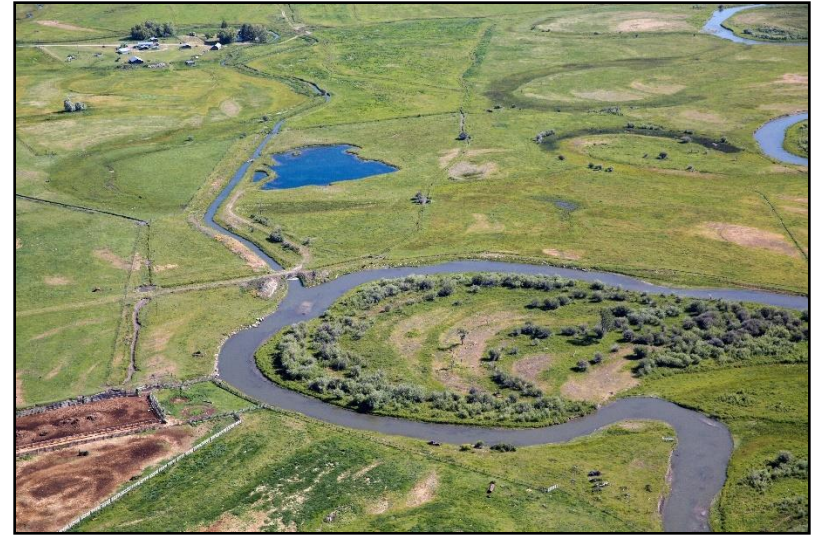
Figure 113. Diversion at RM 23.0, July 21, 2016 (Kestrel).
