Madison River Channel Migration Mapping

Abstract

This report contains the results of a Channel Migration Zone (CMZ) mapping effort for approximately 62 miles of the Madison River from Varney Bridge south of Ennis to its confluence with the Jefferson River near Three Forks, Montana. This is a part of a larger effort to map approximately 440 miles of rivers in the Missouri River headwaters watershed. In the upper project area, the river flows through the middle Madison Valley which contains extensive glacial terraces and local bedrock exposures in the bed and banks of the river. Between Varney Bridge and Ennis Lake the river is typically multi-thread, with numerous islands and active channel movement. The floodplain is broad and low, and relic channel features are common. Some avulsion risks have been identified where spring creeks parallel the main river; one historic avulsion into a spring creek was mapped south of Ennis. Mean migration rates are typically on the order of one foot per year where the river is reworking alluvial sediments. Ice jams are common, posing additional hazards. As the river approaches Ennis Lake it flows through a broad anastomosing channel pattern through

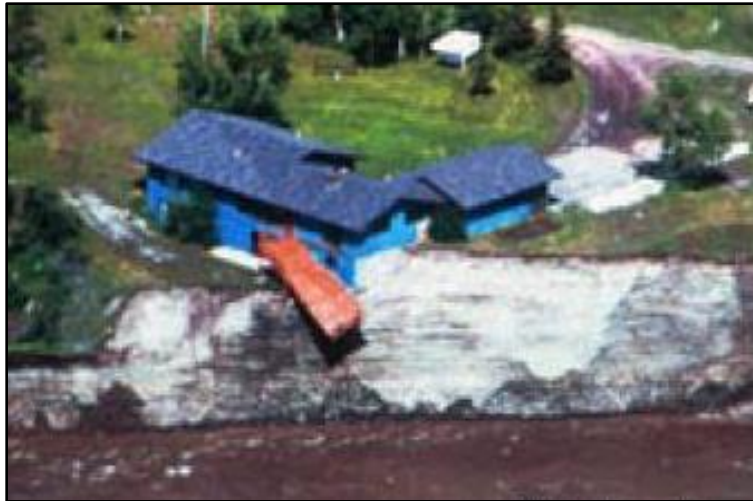
Figure 4. Yellowstone River home on high glacial terrace that was burned down in 1997 to prevent its undermining by the river.

Figure 4 shows a property on the Yellowstone River in Park County that was progressively undermined during the 1996-1997 floods, prompting the owner to burn it down to prevent any liability associated with the structure falling into the river. This has been a chronic problem in river management, as landowners assume that if their home is beyond the mapped floodplain margin, it is removed from all river hazards. After experiencing massive 2005 flood damages in Saint George Utah (Figure 5), several property owners reflected on this issue (www.Utahfloodrelief.com):

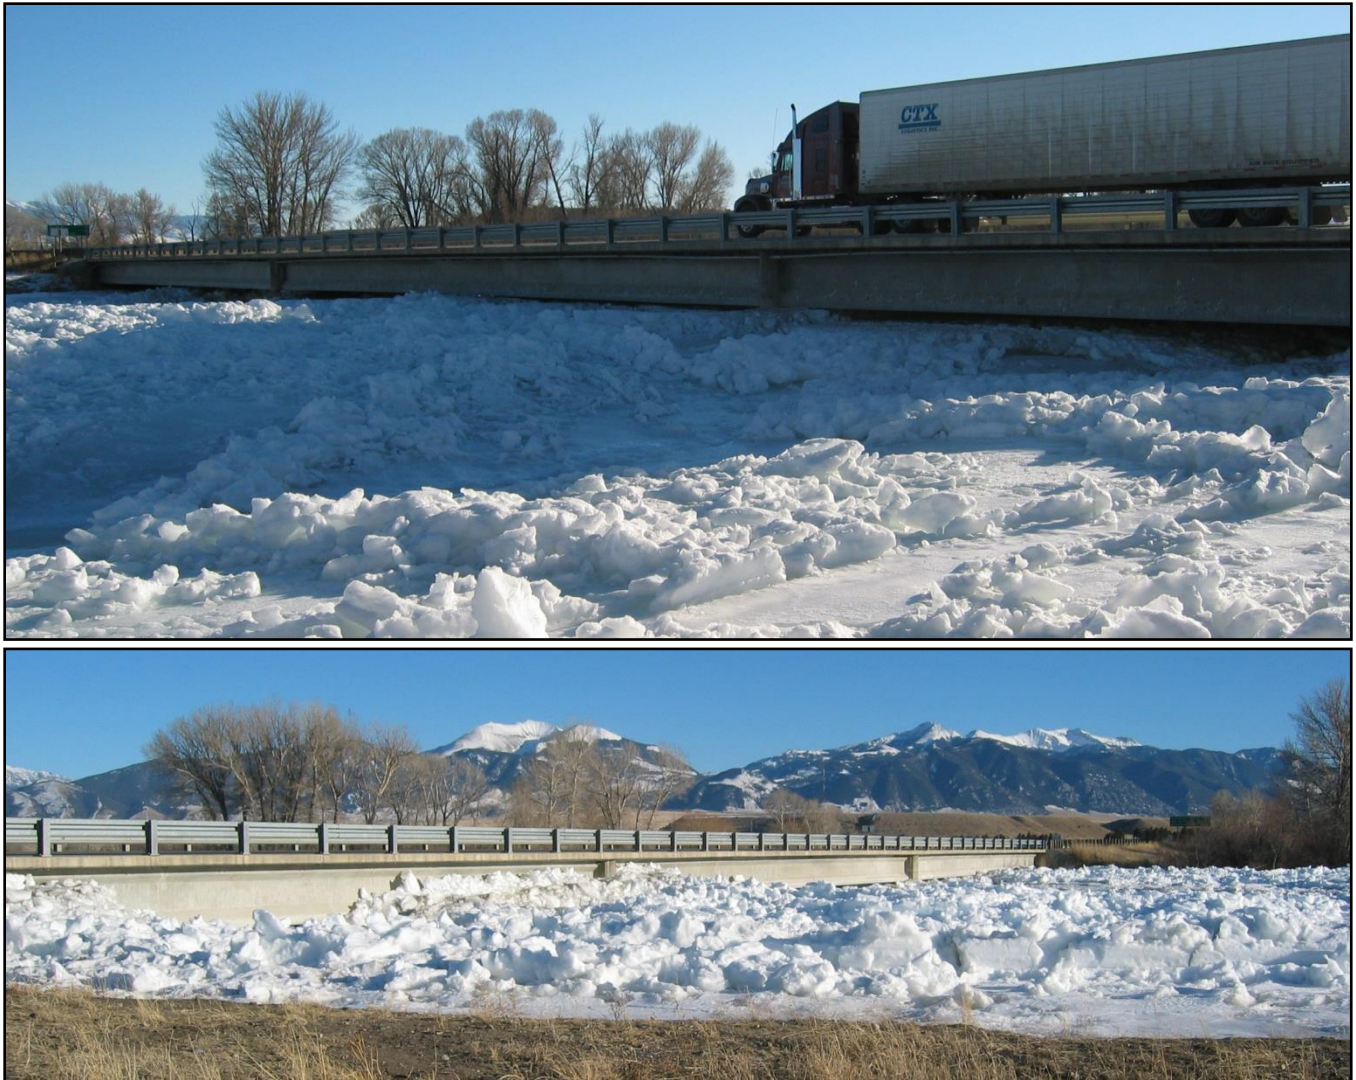
Figure 7. Ice gorging in Ennis on January 28, 2007 (T. Thatcher).

common in February and March. The National Weather Service has identified the Madison River as having 17 reported ice jams (Figure 6). Ice jamming and gorging plays an important role on the river, especially from Ennis to Ennis Lake (Figure 7) and at Three Forks. Gorging refers to the formation of huge ice jams that can cause serious flooding. It happens when ice forms, and large chunks break loose, growing into larger slabs with more freezing. The slabs accumulate to form dams which cause flooding upstream. On rivers like the Madison, ice gorging can be especially problematic due to the low bank heights and shallow river conditions. According to the Bureau of Land Management (BLM 2009):

In the town of Ennis, approximately 0.9 miles of levees protect the town, city park, and sewage treatment lagoons from flooding (Figure 69), though flooding associated with ice gorging is known to overtop the levees below the bridge (Figure 7, Figure 20).

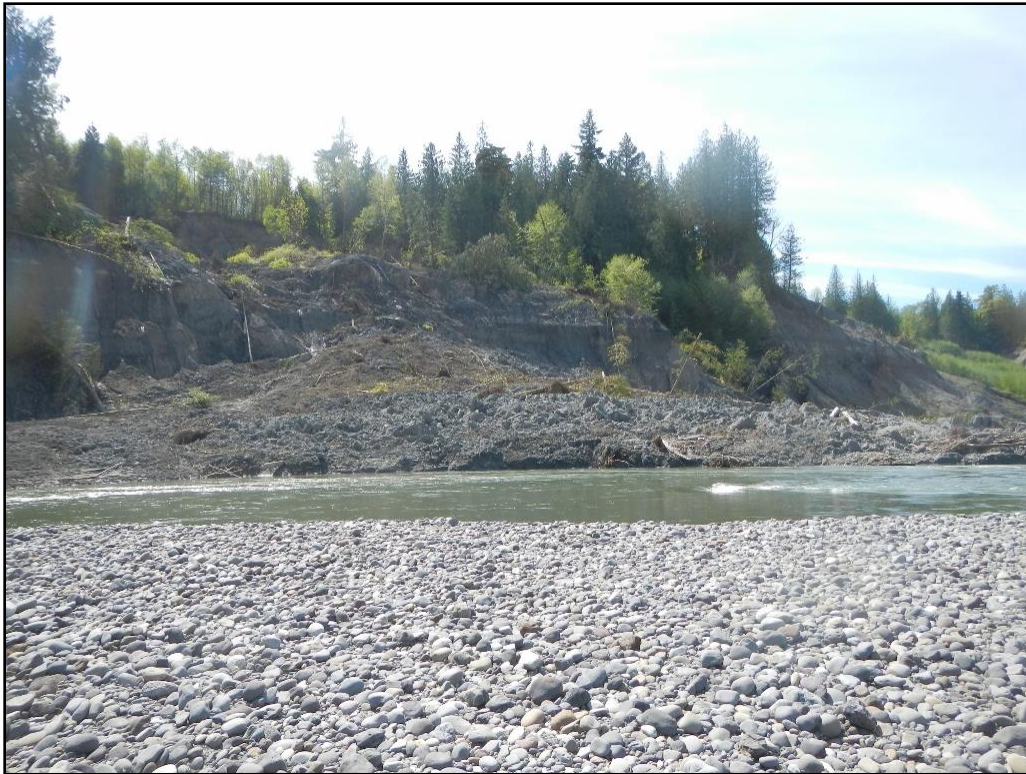
Figure 8. Hillslope failure on Nooksack River near Bellingham Washington on February 21, 2014 (K. Boyd).

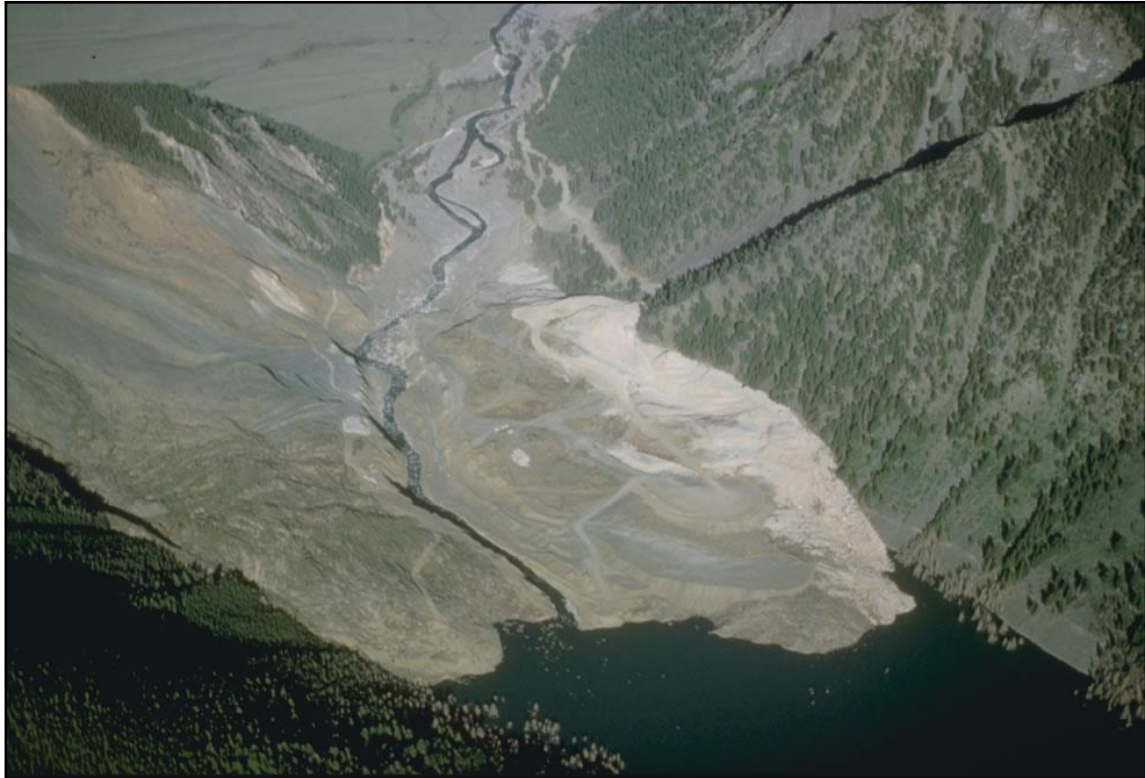
Figure 12. Massive landslide resulting from the August 17, 1959 earthquake. The slide dammed the Madison River below several miles below the Hebgen Dam, creating Quake Lake (USGS).

The landslide was made up of about 37 million cubic yards of material that was up to 430 feet deep, blocking the Madison River to form Quake Lake. To prevent catastrophic flooding downstream, the Corps of Engineers (COE) excavated a spillway into the landslide deposits. Water first passed over the spillway on September 10, 1959, and the river immediately started downcutting into the spillway channel. The eroded material was transported down the Madison River. The erosion of the spillway caused much concern. Boulders as large as 100 tons (approximately 30-foot diameter) were placed in the channel as armor by the COE (Turner, 1995). Because of these concerns, in late September of 1959 the COE decided to lower the spillway by about 50 feet to reduce the

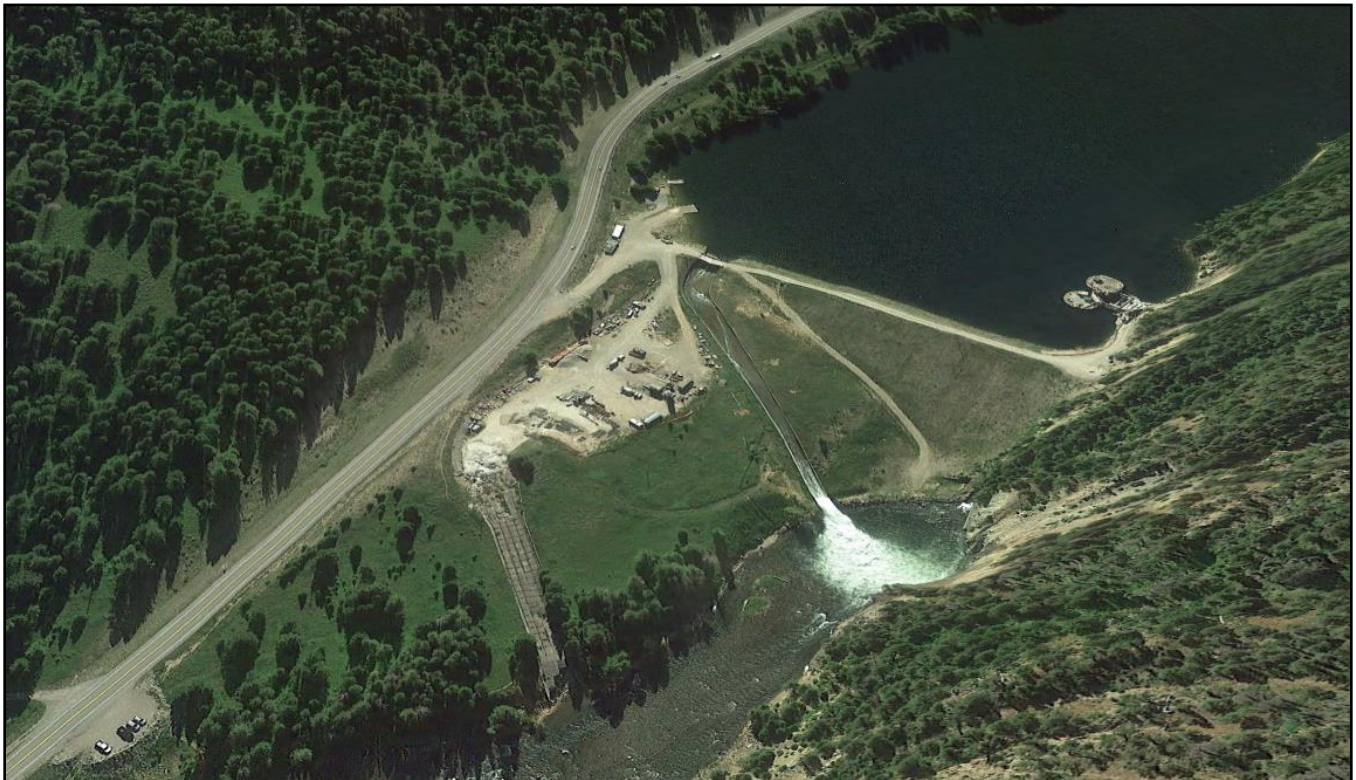
Figure 13. Hebgen Dam, Montana. (Google Earth).

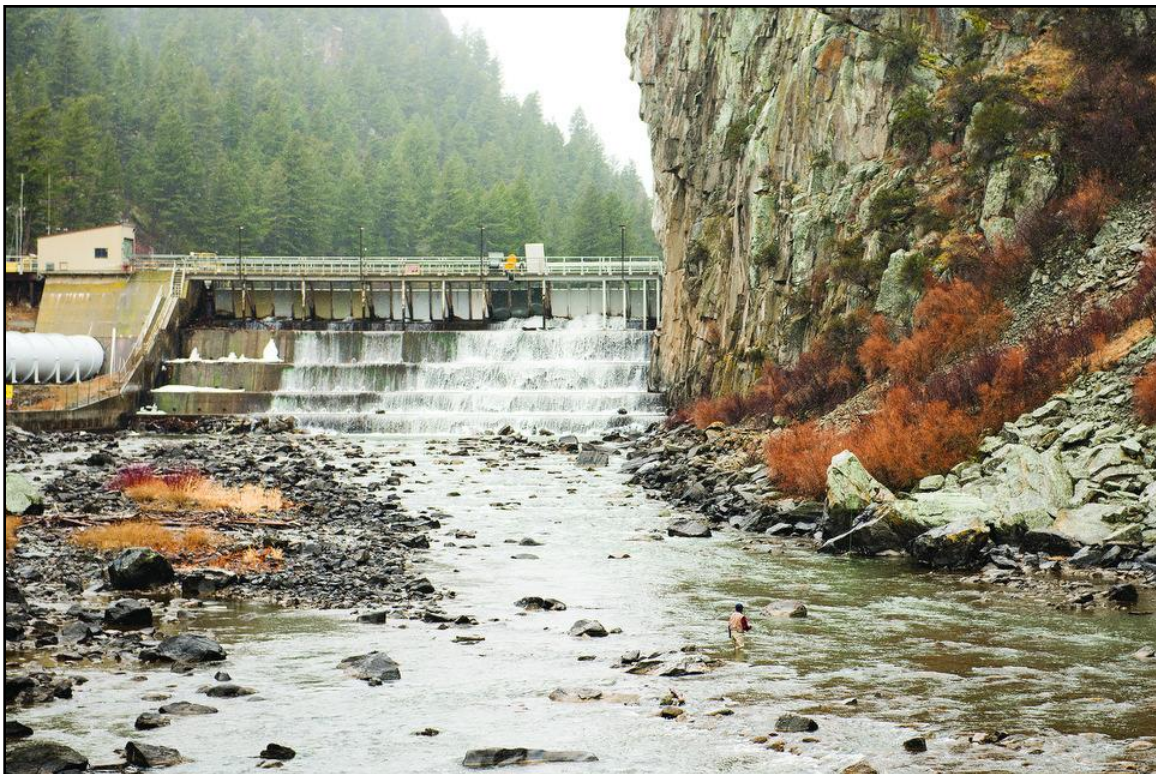
Figure 14. Madison Dam (Bozeman Daily Chronicle).

Madison Dam is a timber-crib structure constructed in 1906, replacing the original dam that was constructed in 1901. It is a run-of-the-river dam located at the head of Bear Trap Canyon, just north of Ennis, Montana. It is 35 feet high and 257 feet long, and the associated power plant has a generating capacity of nine megawatts. The dam and power plant are currently owned by NorthWestern Corporation. The dam creates Ennis Lake, a 27,200 acre-foot reservoir that covers 3,900 acres. As Madison Dam is a run-of-the-river structure, it does not appreciably impact the hydrology below the dam, though the shallow Ennis Lake does trap sediment and increase water temperatures (FERC, 1997). Several fish kills have occurred in the lower Madison coincidental with either a rapid increase in water temperature or long-term high temperatures. High arsenic concentrations in water and sediments in Ennis Lake have been identified as a water quality issue (FERC, 1997).

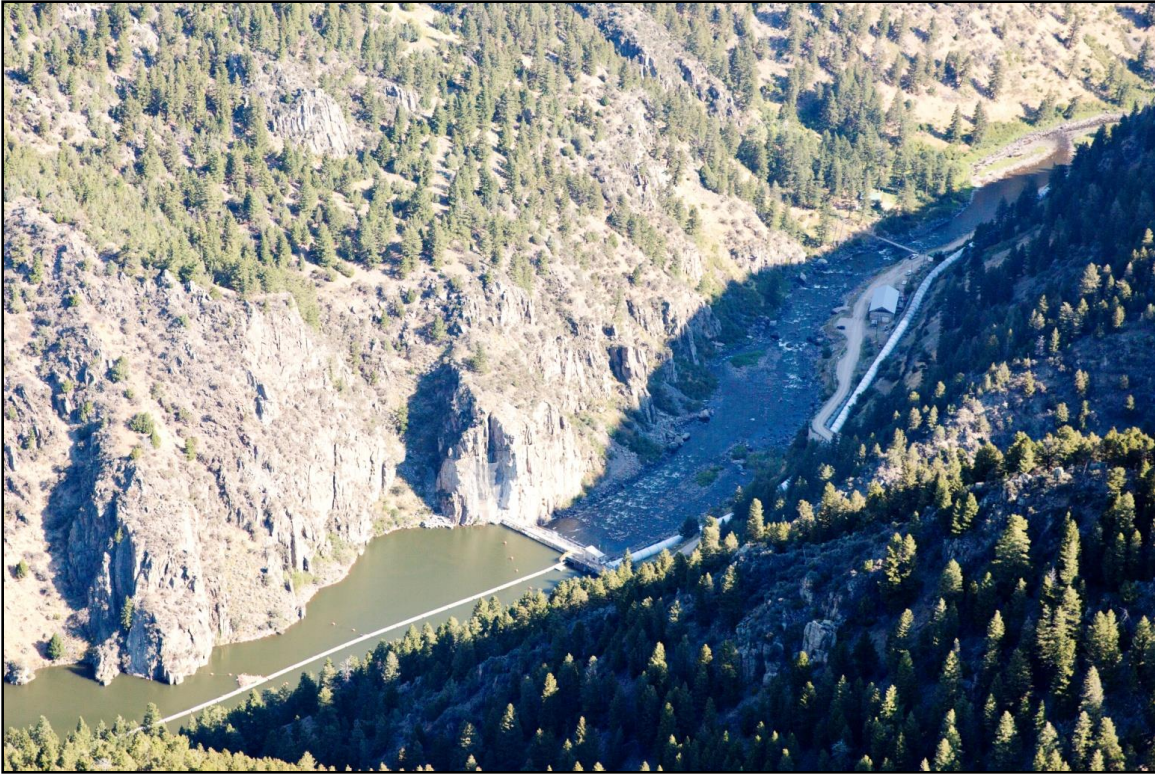
Figure 15. Madison Dam on July 21, 2016 at the head of Bear Trap Canyon. (Kestrel)

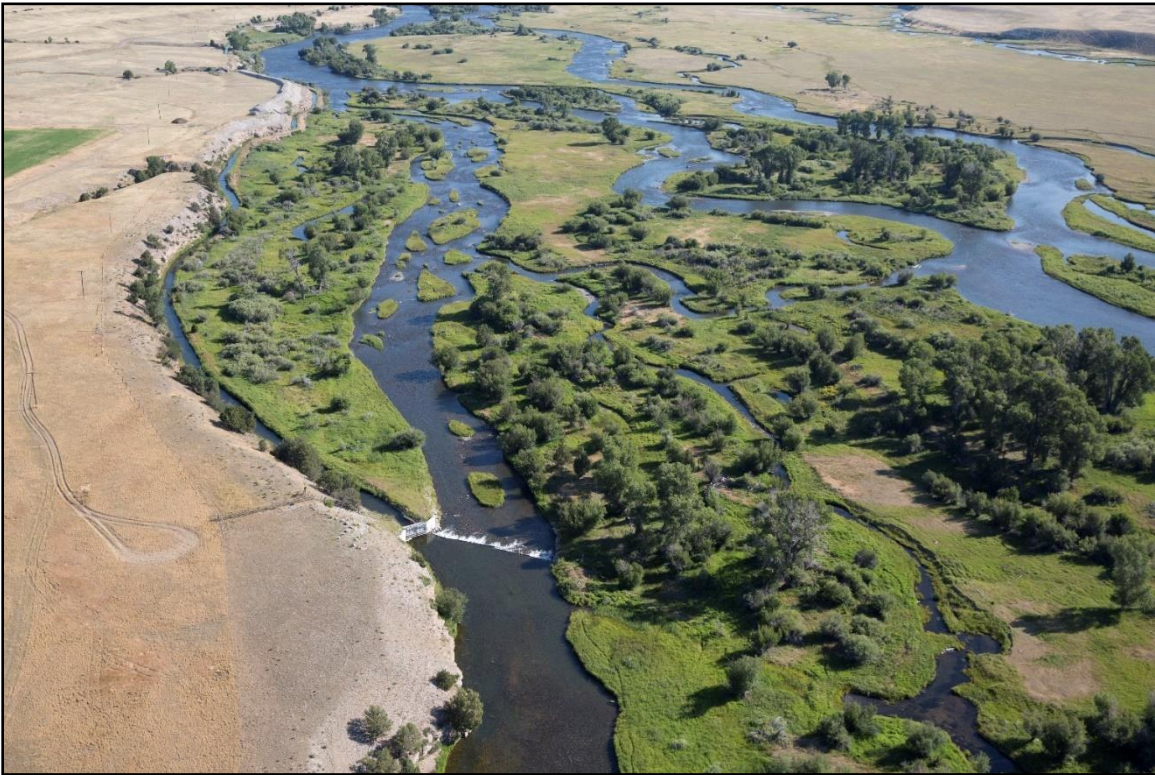
Figure 16. The West Madison Canal diversion on the Blaine Spring Creek channel. (Kestrel)

While there are no diversions into major canals on the Madison River, the Montana Department of Natural Resources and Conservation Water Rights data show 104 headgate points of diversion listed for the Madison River from Varney Bridge to the mouth. Above Ennis, a diversion that spans the Blain Spring Creek channel feeds the West Madison Canal (Figure 16). This is the only diversion structure in the Madison study area that spans a channel. The lower river, below the Madison Dam, has a number of local diversions that feed ditch systems including the Sloan, Hutchinson, Dell, Crowley and Darlington Ditches. Aerial photographs of these ditches are compiled in Appendix C. None of these structures appear to greatly impact the river processes.

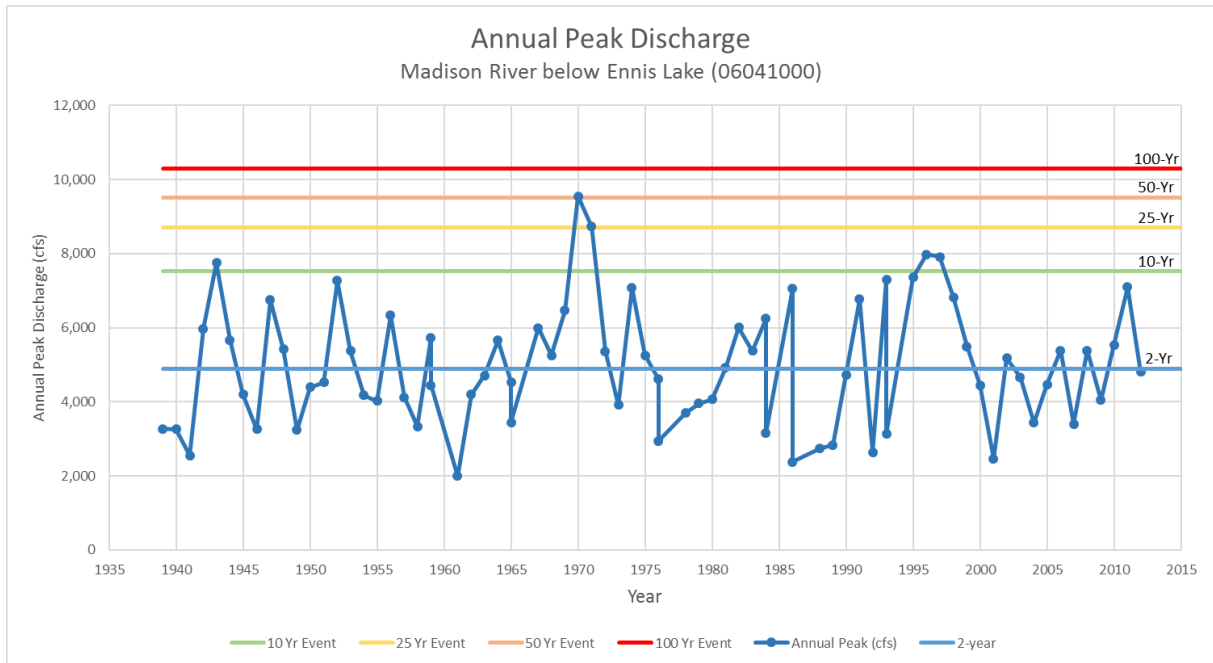
Figure 18. Annual peak flow record for Madison River below Ennis Lake.

Figure 17 and Figure 18 show the annual peak flow records for the Madison River just below Hebgen Lake and below Ennis Lake, respectively. At the Hebgen Reservoir outlet, average peak flow from 1950-2015 is 2,603 cubic feet per second (cfs). The plot shown in Figure 17 shows each point labeled by the month in which it occurred. Releases from the dam cluster around the May-July timeframe to coincide with spring runoff, but a large percentage of the annual peaks were released during the month of November between 1960 and 1994. No annual peak has occurred in late fall since 1994, likely reflecting a change in management strategy at the reservoir (Figure 19). Peaks have occasionally exceeded the 3,500 cubic feet per second maximum recommendation for managing erosion at the Quake Lake outlet, most recently in 2008 and 2011. The high 2008 flow coincides with a month-long period of uncontrolled releases caused by stoplog failure at the dam intake (Section 2.3.1).

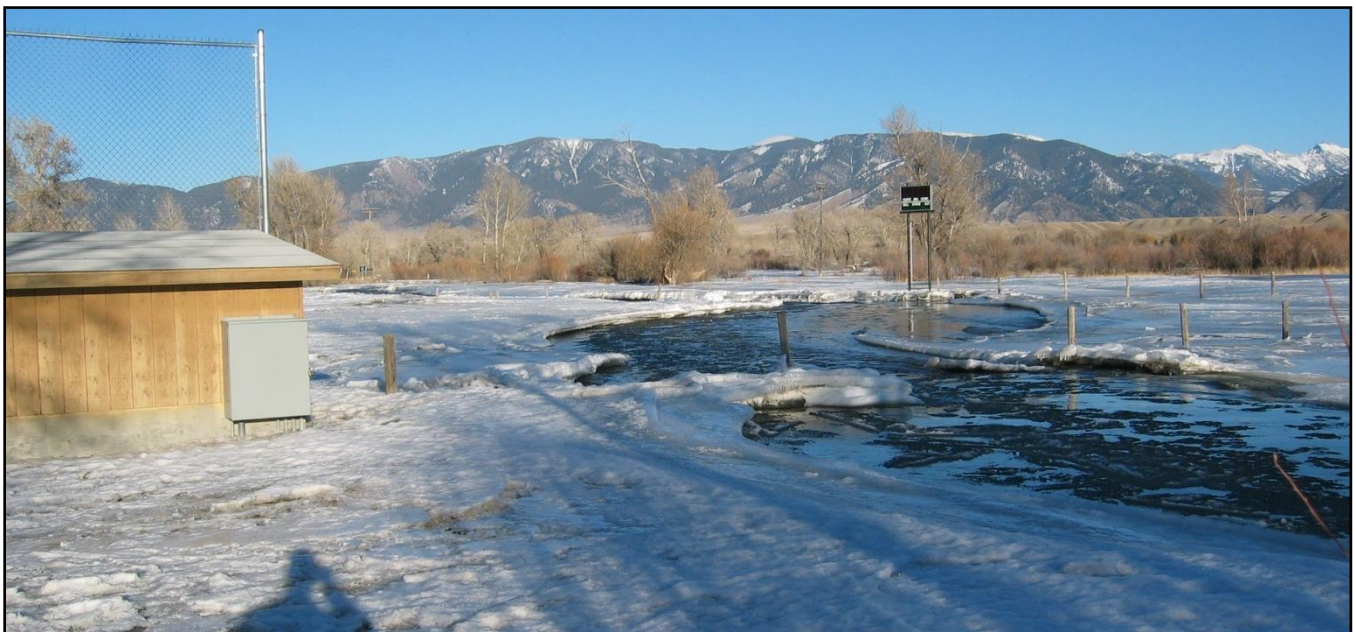
Figure 20. Ice related flooding in Ennis Lions Club Park on January 28, 2007. (Thatcher)

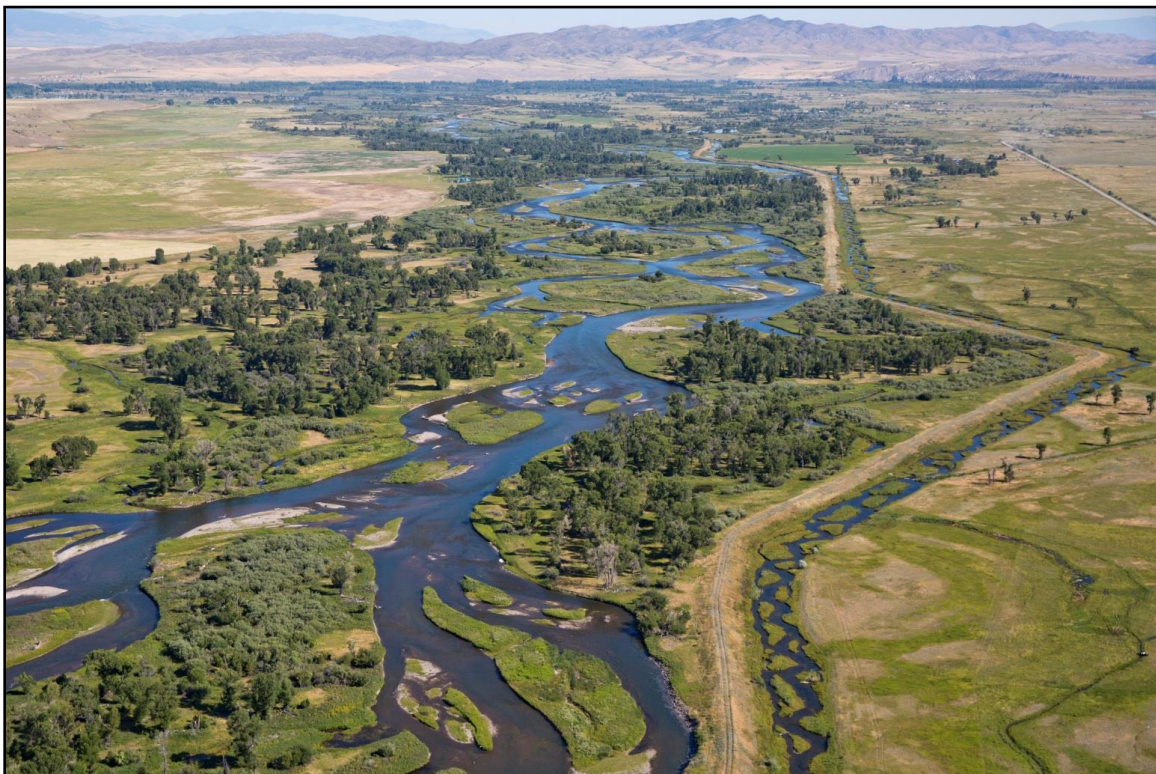
Figure 21. The Madison River south of Three Forks on July 21, 2016, showing the 10.6 mile long Madison River Levee. Darlington Ditch follows the landward side of the levee. (Kestrel)

The primary levee (Figure 21) It is approximately 10.6 miles long, starting in Three Forks (RM 2.1) and extending along the eastern bank of the river up to the Darlington Ditch Diversion (RM 15.8). This levee was reportedly built in the early 1950s to benefit a few large ranches who were experiencing ice jam related flooding (S. Gillilan, Personal Communication, 2016). The levee is now managed by the Madison Dike & Drain District with a board representing all the adjacent landowners who are taxed for ongoing maintenance needs. The river has locally migrated into the levee in several locations, prompting ongoing maintenance. As the levee is not certified, landowners on the landward side are required to apply for floodplain permits as if the levee did not exist. Additionally, recent ice jamming events have reportedly approached the top of the levee above Three Forks. There is also a 1.6-mile long levee on the west side of the river between river miles 5.7 to 7.7. We have no information on the installation date or purpose of this levee, but assume it serves the same purpose as the major levee on the east side of the river. It was in place by 1965. Below the Interstate-90 bridge complex there are a total of 1.4 miles of levee on both banks, all of which were in place by 1965.

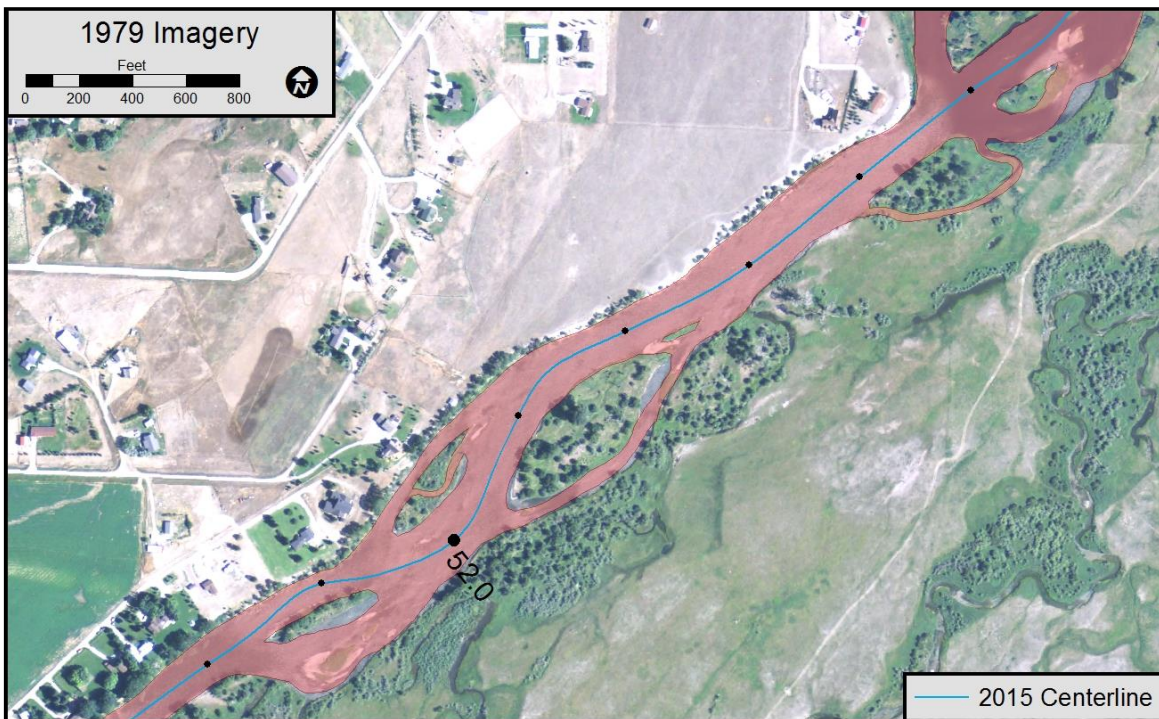
Figure 23. Example 1979 imagery, Madison River CMZ development (Ennis, Reach 8).

Table 1 lists imagery used for this project from the USDA and archives of current GIS data sets. Examples of the imagery used in the analysis are shown in Figure 22 through Figure 25.

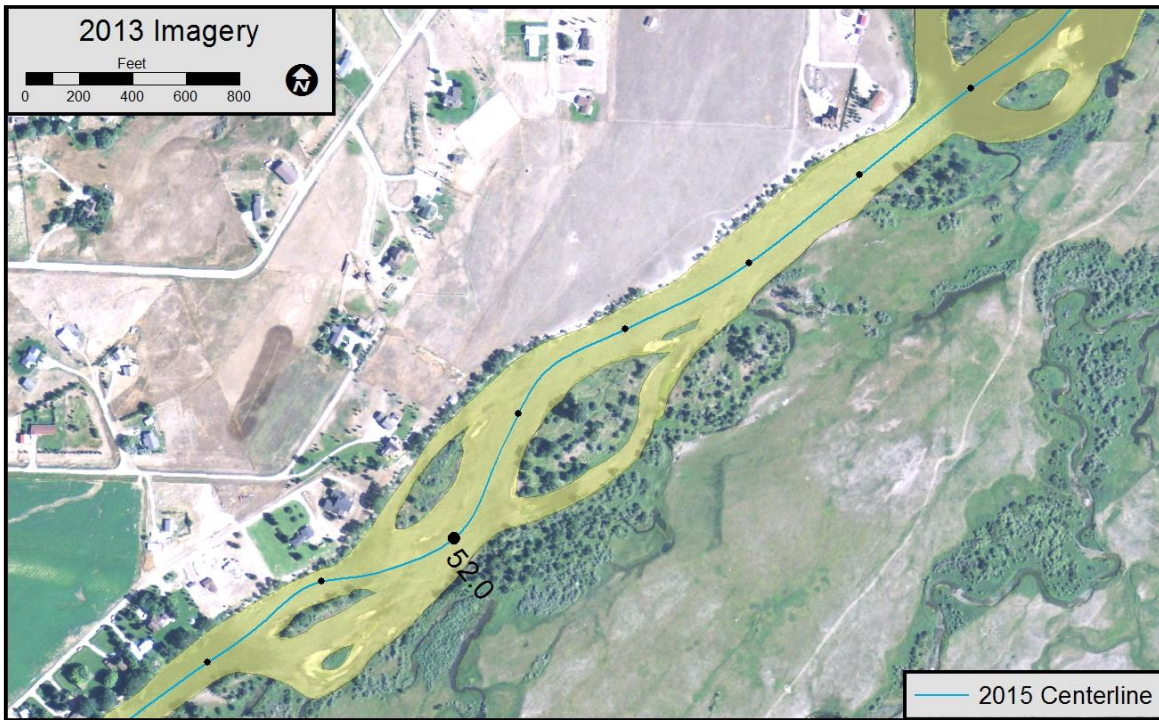
Figure 24. Example 2013 imagery, Madison River CMZ development (Ennis, Reach 8).

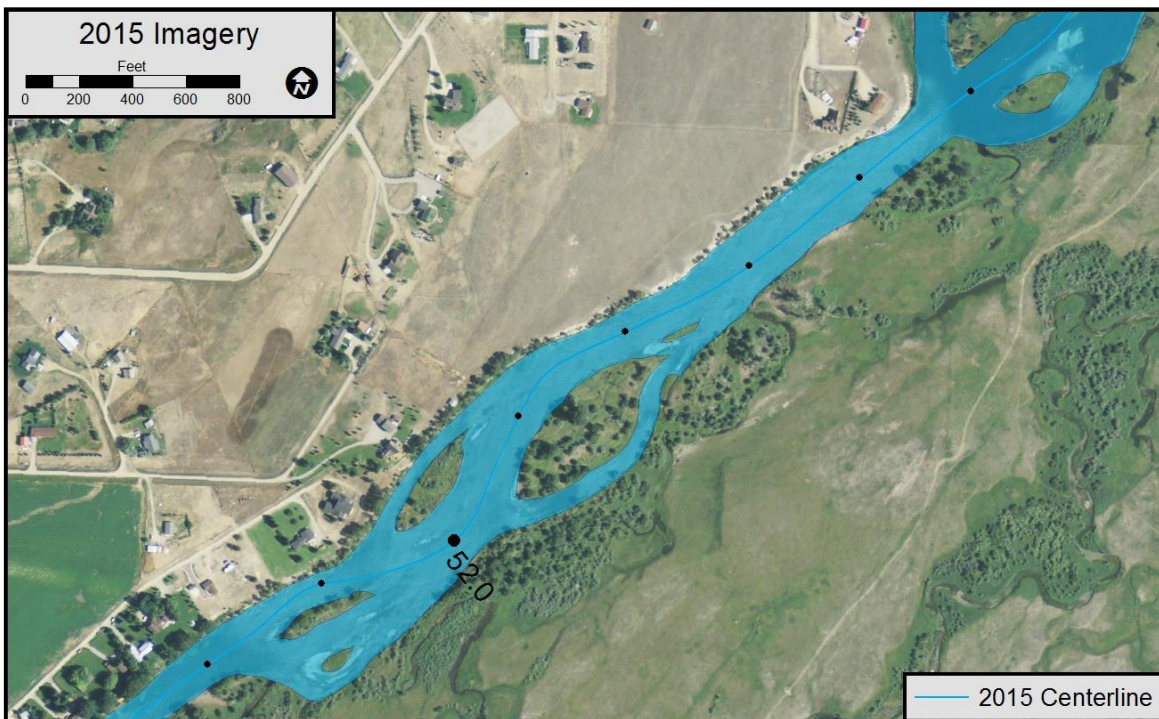
Figure 25. Example 2015 imagery, Madison River CMZ development (Ennis, Reach 8).

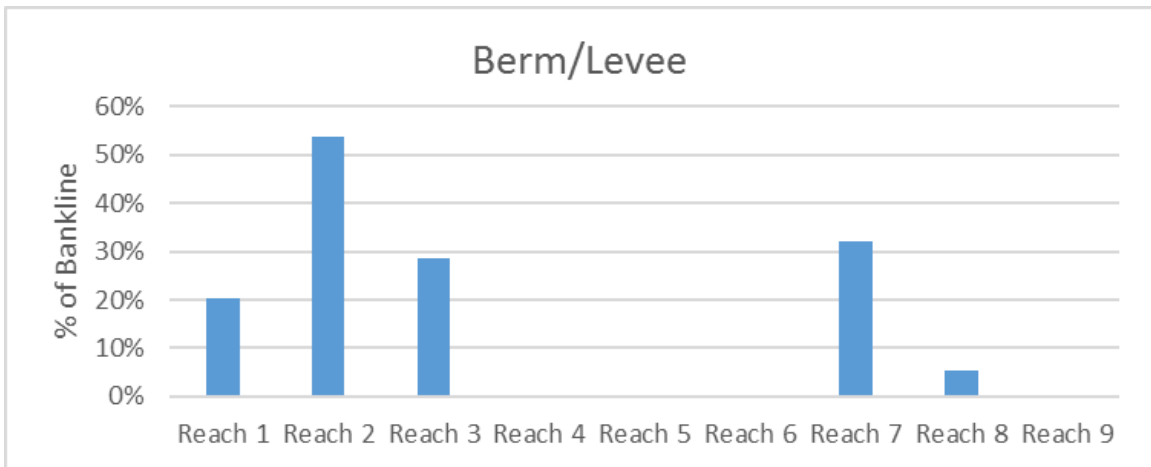
Figure 39. Percentage of bankline protected by berms or levees by reach

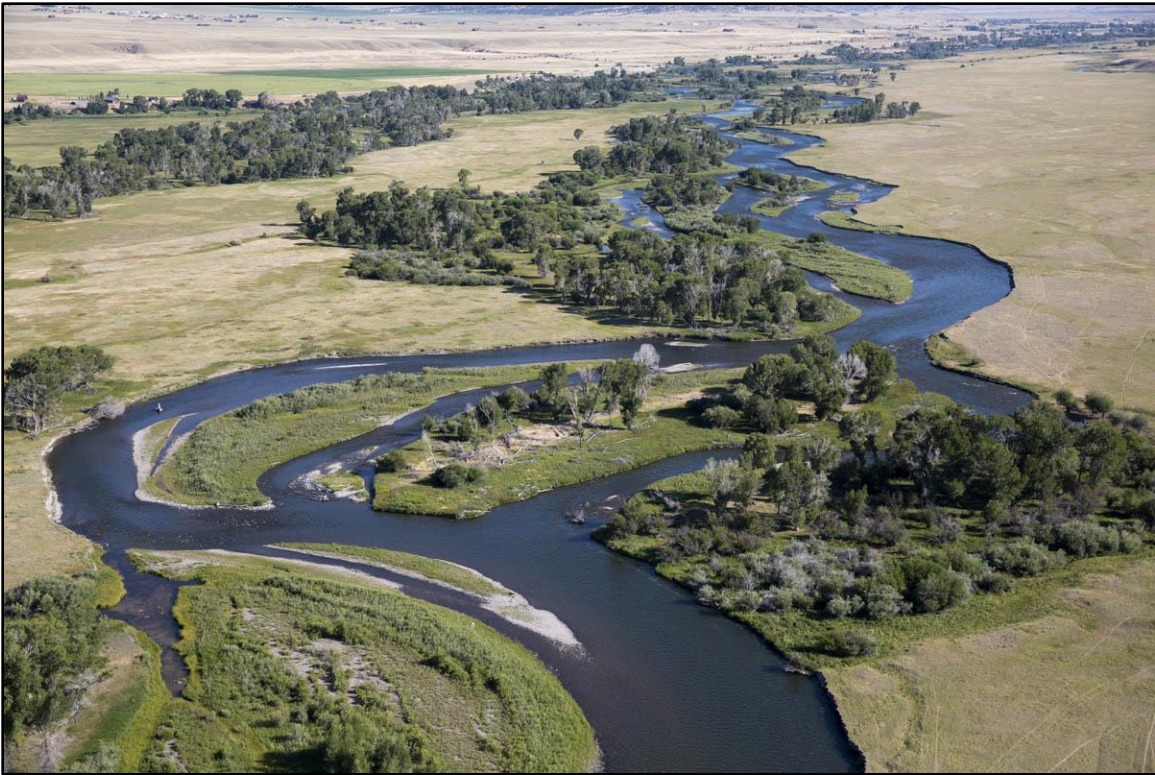
Figure 41. View downstream of meander bend at RM 57.2 showing chute cutoffs and riparian succession in left foreground. (Kestrel)

In Reach 9, the river shows relatively unimpeded migration into both riparian areas and agricultural lands, with a complex planform and riparian colonization on open bars (Figure 41). The floodplain is broad and characterized by fairly dense woody riparian corridors along channels, interspersed with broad grassed areas that are completely devoid of woody vegetation. These grassed floodplain surfaces were present in the 1950s as well, suggesting that disturbance in the active stream corridor is an important aspect of riparian regeneration and succession. The 100-year buffer width in Reach 9 is 111 feet.

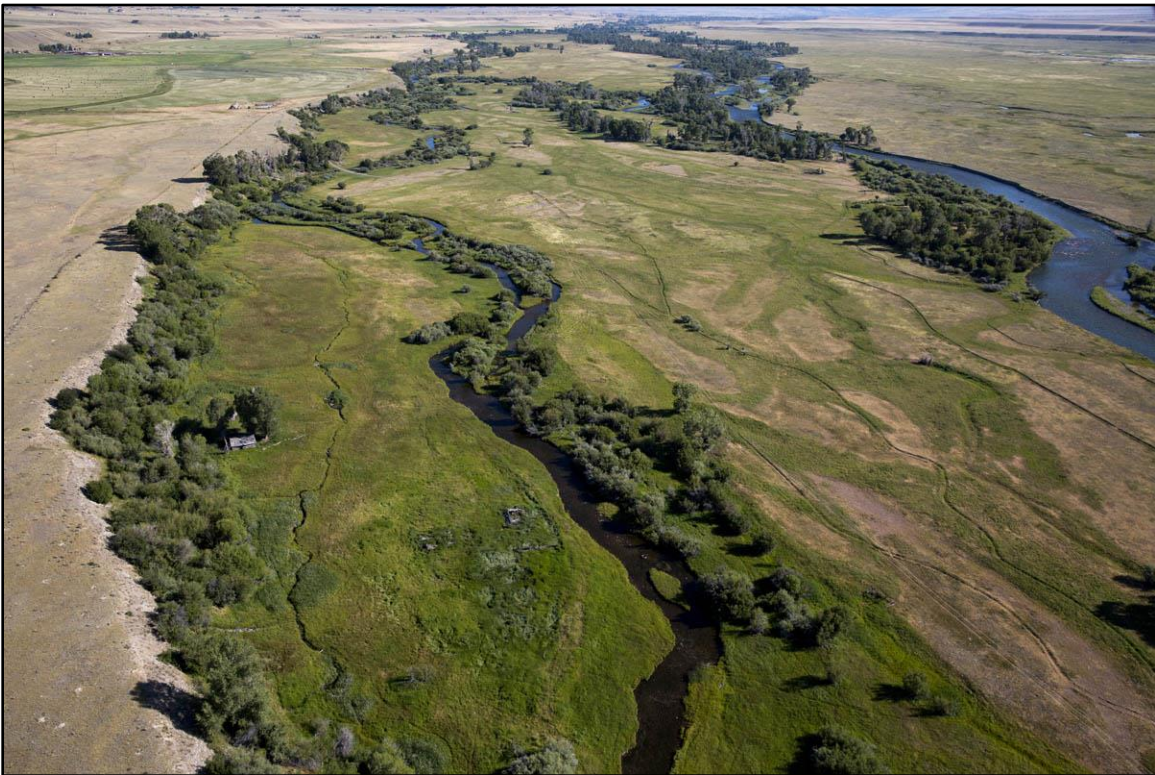
Figure 42. View downstream from near Varney Bridge showing Blaine Spring Creek avulsion risk area; main channel is to right. (Kestrel)

In addition to active stream migration, avulsion processes are active in Reach 9. Blaine Spring Creek, which follows the valley bluff line west of the main river channel near Varney Bridge, creates a classic type of avulsion risk - that of a tributary running parallel to a main thread with a low intervening floodplain (Figure 42). Between Varney Bridge and Ennis, several spring creeks run parallel to the river. They are most concentrated east of the river, originating from the toes of glacial terraces that discharge groundwater from the Madison Range to the east. At RM 59.7, the river captured one of these spring creeks between 1955 and 1979, creating a new active side channel of the Madison (Figure 43). Historically these natural wetland areas east of the river were channelized to drain the floodplain and improve agricultural lands, but in recent years restoration has been underway. For example, O’Dell Spring Creek, which was excavated as a drain ditch in the 1950s, has been restored along about 9 miles of its length (www.riverdesigngroup.com).

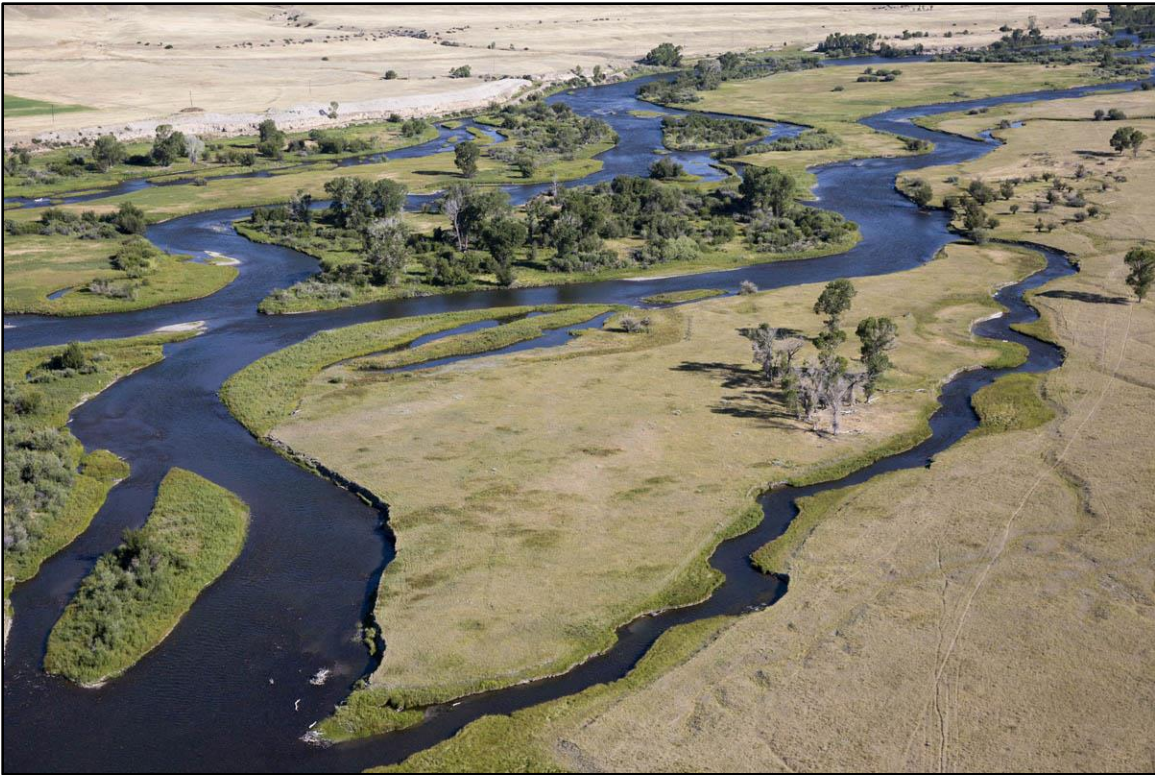
Figure 43. View downstream showing spring creek on right captured by the Madison River between 1955 and 1979. (Kestrel)

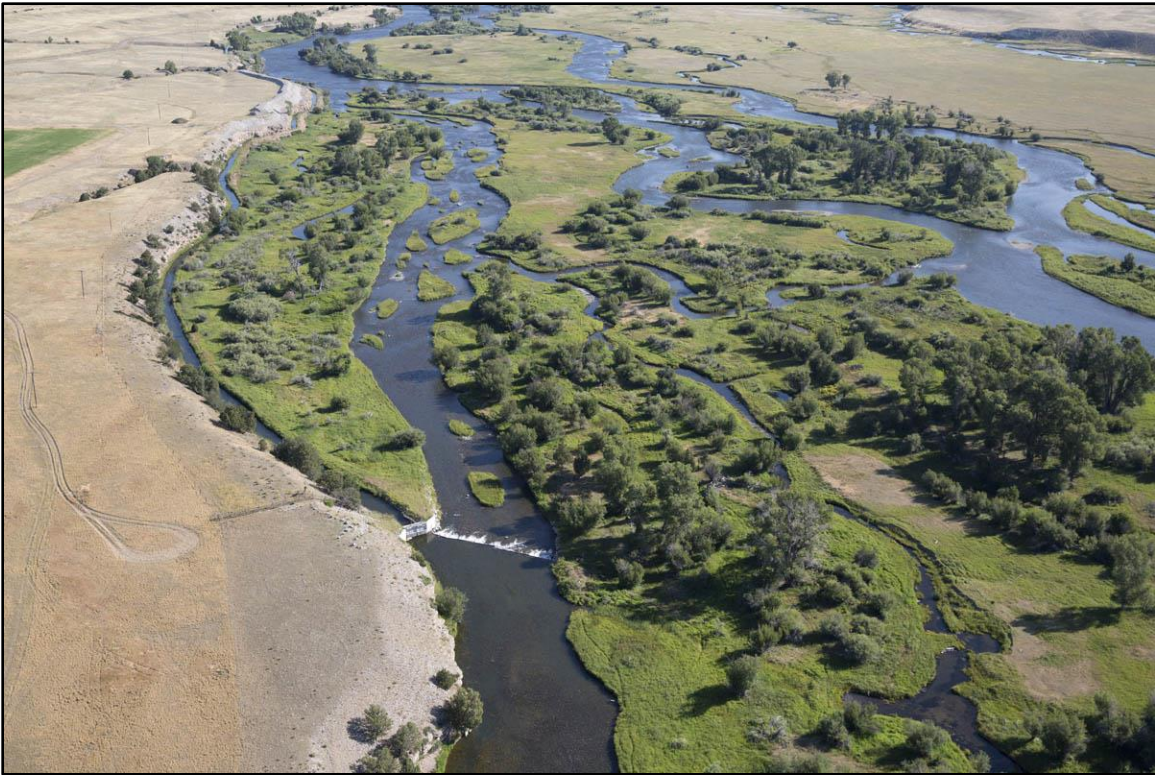
Figure 44. View downstream from lower Reach 9 showing West Madison Canal diversion and bluff line on west side of river; note spring creeks in upper right corner of photo. (Kestrel)

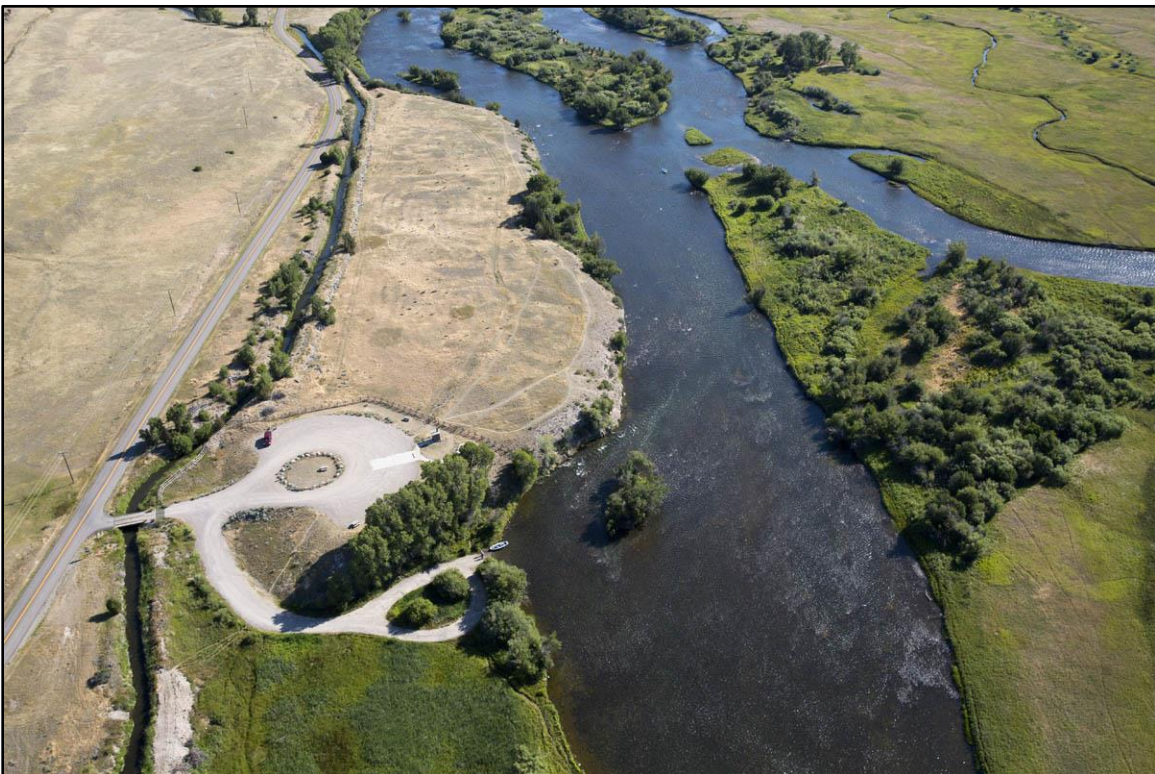
Figure 45. View downstream of Eight Mile Ford Fishing Access showing sandstone bluff line and wide, shallow river cross section. (Kestrel)

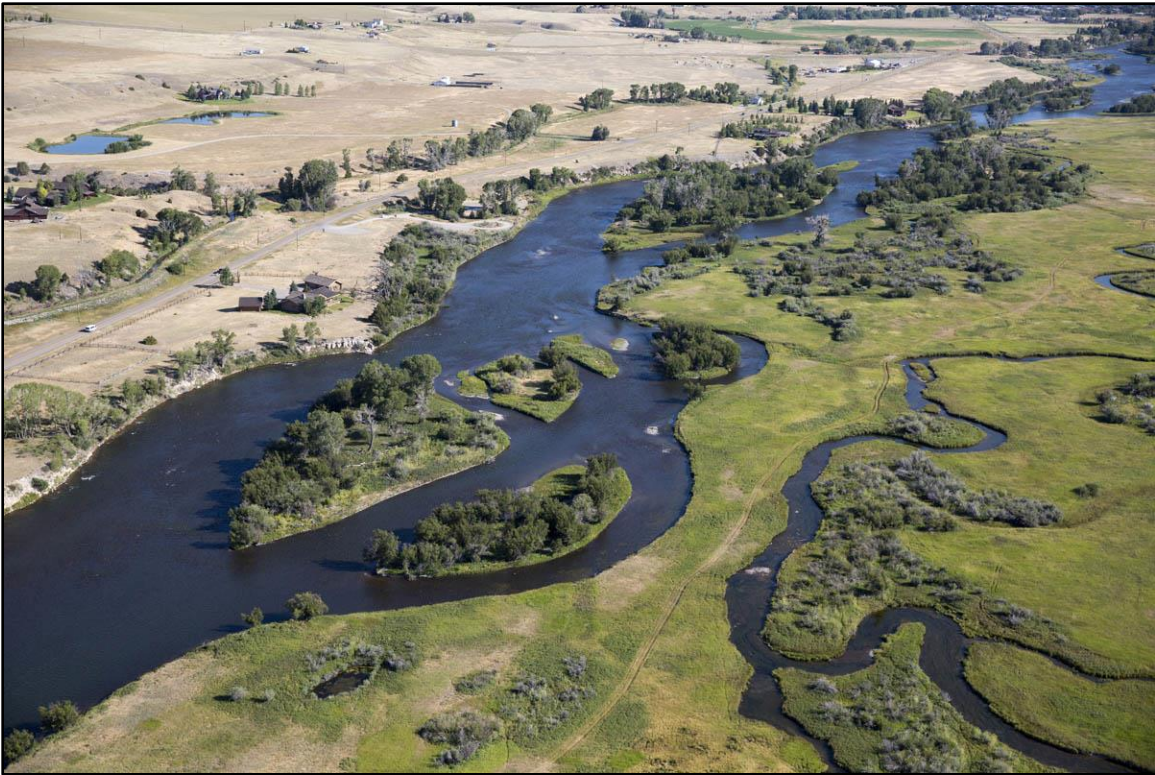
Figure 46. View downstream showing avulsion risk into spring creek, RM 53.9. (Kestrel)

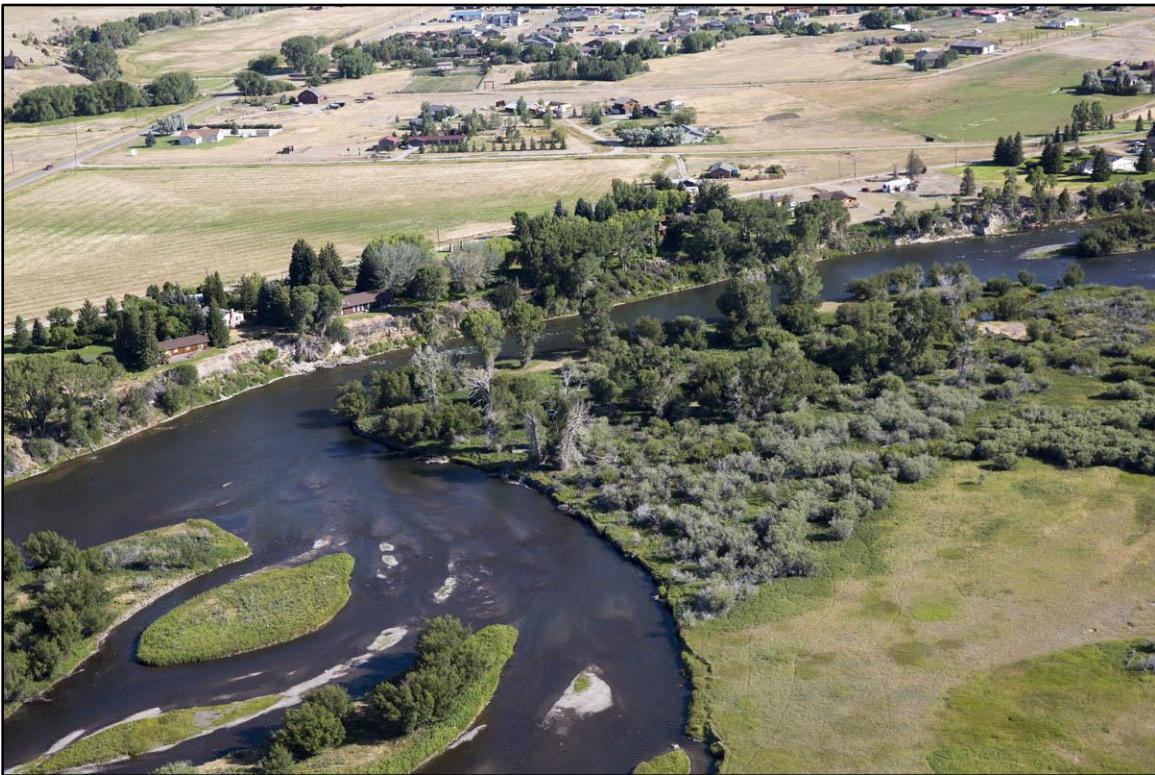
Figure 47. View downstream showing development along bluff line on the outskirts of Ennis. (Kestrel)

Reach 8 begins at RM 55.2, where a high glacial terrace to the east juts out into the Madison River corridor creating a pinch point. The spring creeks on the east side of the river are forced closer to the Madison as a result, increasing their risk of capture. The Madison River itself shifts over to the west side of the floodplain, flowing along bluffs of Miocene-age sedimentary rocks (Figure 44). The river tends to be very wide and shallow, with some sandstone exposures in the riverbed, and a propensity for ice formation within the shallow cross section (Figure 45). The Eight Mile Ford Fishing Access site shown in Figure 45 was reportedly the upper extent of ice gorging on the river in February of 2011. Downstream at RM 53.9, the river is within about 100 feet of one branch of O’Dell Spring Creek. There is a real risk of avulsion into this channel, that runs for over four valley miles downstream before joining the Madison below Ennis (Figure 46). Approaching Ennis, there is increasing development on the left bluff line; however, this area is out of the Channel Migration Zone due to its geology (Figure 47).
