Madison River Channel Migration Mapping

Abstract

This report contains the results of a Channel Migration Zone (CMZ) mapping effort for approximately 62 miles of the Madison River from Varney Bridge south of Ennis to its confluence with the Jefferson River near Three Forks, Montana. This is a part of a larger effort to map approximately 440 miles of rivers in the Missouri River headwaters watershed. In the upper project area, the river flows through the middle Madison Valley which contains extensive glacial terraces and local bedrock exposures in the bed and banks of the river. Between Varney Bridge and Ennis Lake the river is typically multi-thread, with numerous islands and active channel movement. The floodplain is broad and low, and relic channel features are common. Some avulsion risks have been identified where spring creeks parallel the main river; one historic avulsion into a spring creek was mapped south of Ennis. Mean migration rates are typically on the order of one foot per year where the river is reworking alluvial sediments. Ice jams are common, posing additional hazards. As the river approaches Ennis Lake it flows through a broad anastomosing channel pattern through

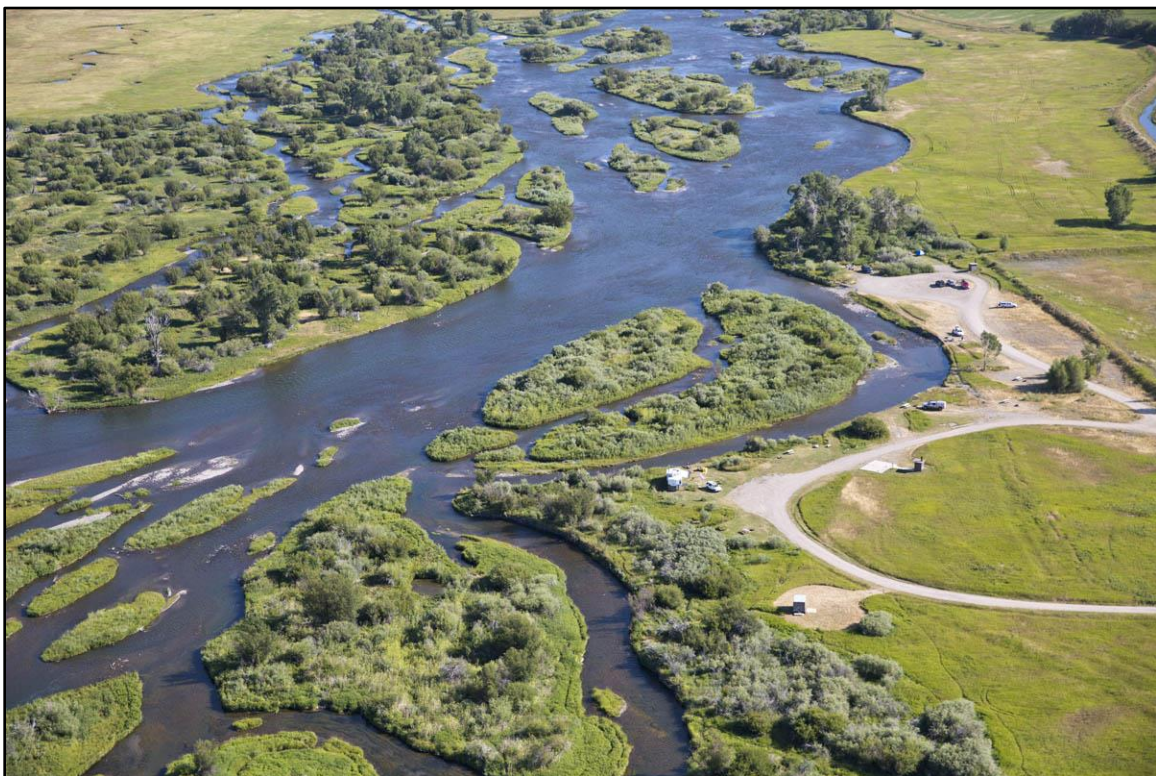
Figure 48. View downstream showing high density of small wooded islands at Valley Garden Fishing Access, Reach 7. (Kestrel)

Reach 7 extends for a few miles below Ennis to near the mouth of Jack Creek. For approximately the upper two miles of the reach, O'Dell Spring Creek parallels the river and has been mapped as an avulsion hazard area. Just downstream of the highway bridge at Ennis the river is migrating towards the water treatment plant lagoons, however as there is still an approximately 225-foot-wide buffer between the lagoons and the channel, and they appear to be under no immediate threat of erosion. Ice gorging in this area, though, has resulted in water overtopping the levee and flowing through the park adjacent to the water treatment lagoons (Section 1.6.2, Figure 7). Towards the mouth of Jack Creek there are several mapped exposures of Holocene swamp deposits (Kellogg et al, 2000), which may be reflective of historic natural marsh and deltaic conditions that extended several miles upstream of the modern lakeshore. The density of small, relatively stable islands increases as well, and these islands support fairly dense cottonwood stands, although historic imagery indicates that the cottonwood density in 1995 was much greater than today (Figure 48 and Figure 49).

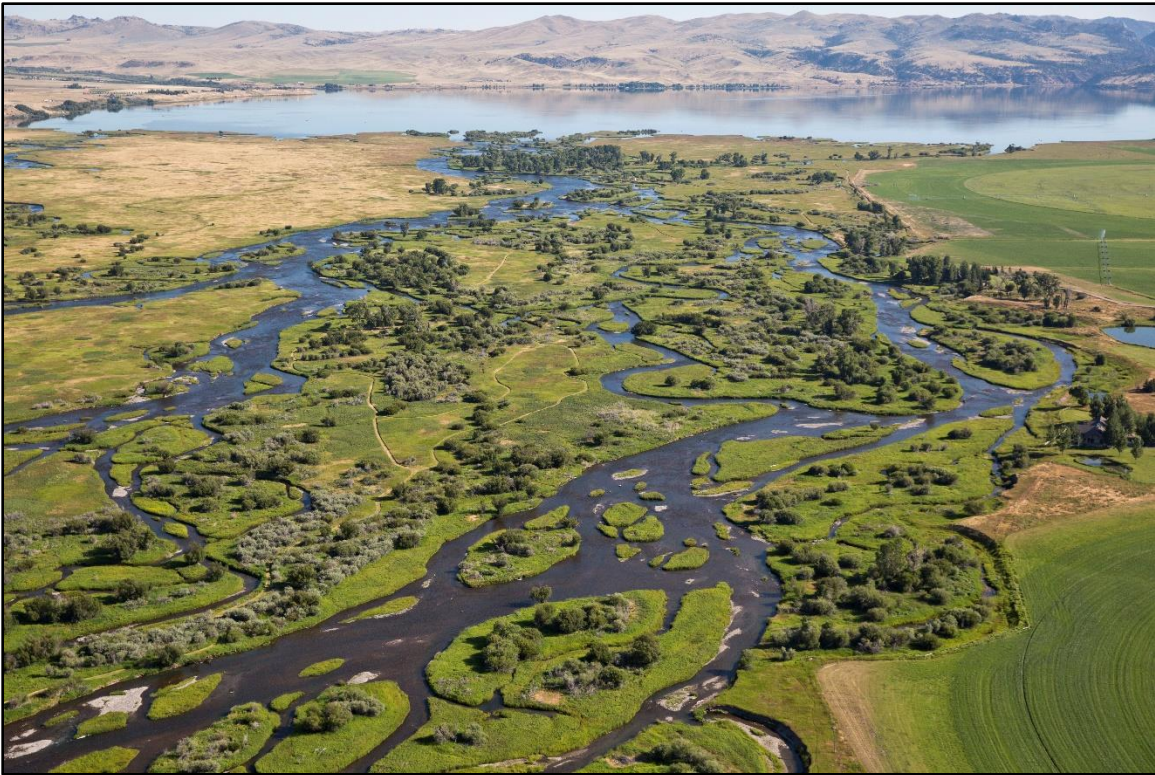
Figure 50. View downstream towards Ennis lake showing anastomosing channel form of Madison River. (Kestrel)

Reach 6 extends from near the Jack Creek confluence to Ennis Lake. It consists of an increasingly more complex anastomosing channel form, referring to multiple channels that diverge and rejoin, separated by persistent islands rather than open bars (Figure 50). The CMZ becomes over a mile wide across the delta (Figure 51). At RM 46.8, a large avulsion occurred in the delta on the east floodplain, it was subsequently blocked by a channel plug (Figure 52).

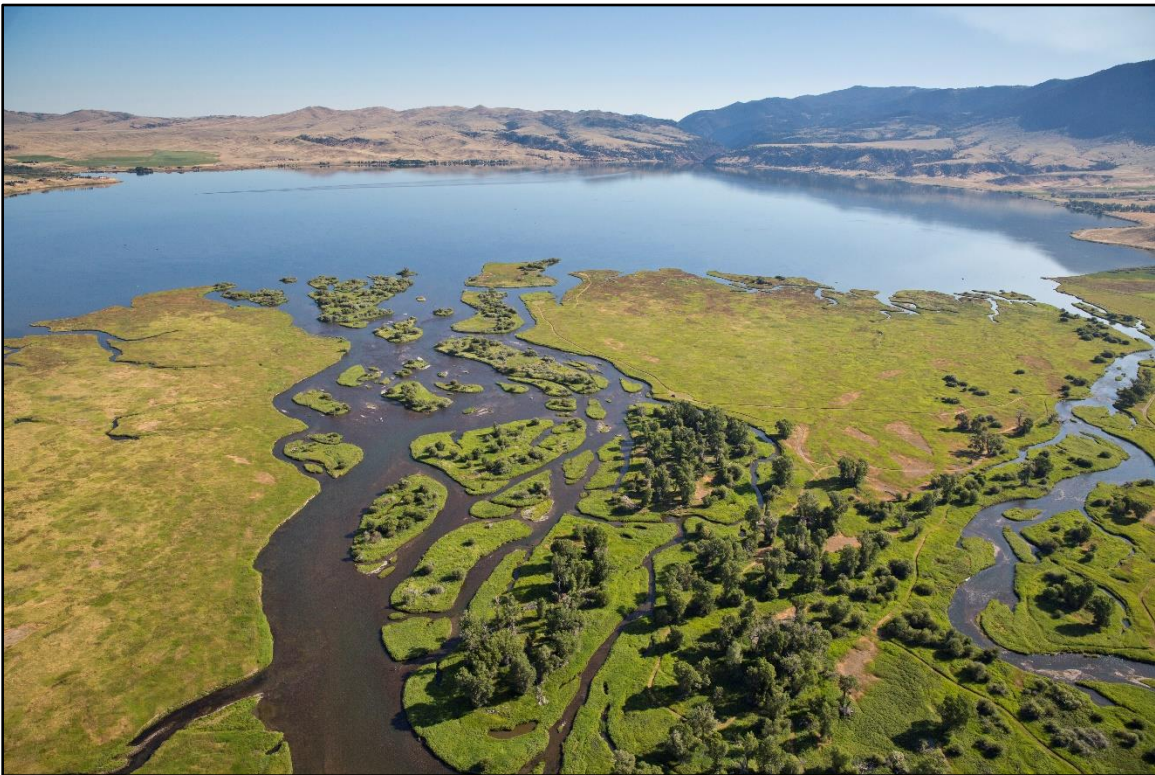
Figure 51. View downstream towards Ennis lake showing Madison River delta at Ennis Lake. (Kestrel)

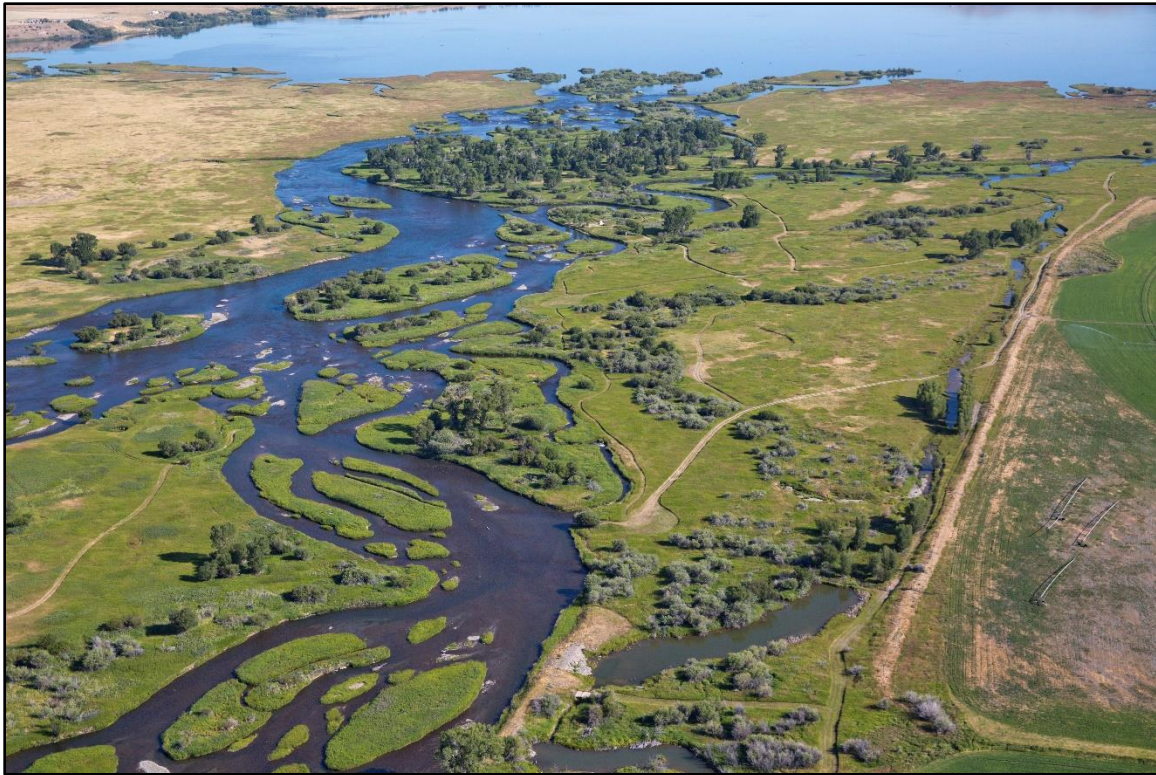
Figure 52. View downstream showing 1955-1979 avulsion blocked by channel plug in foreground. (Kestrel)

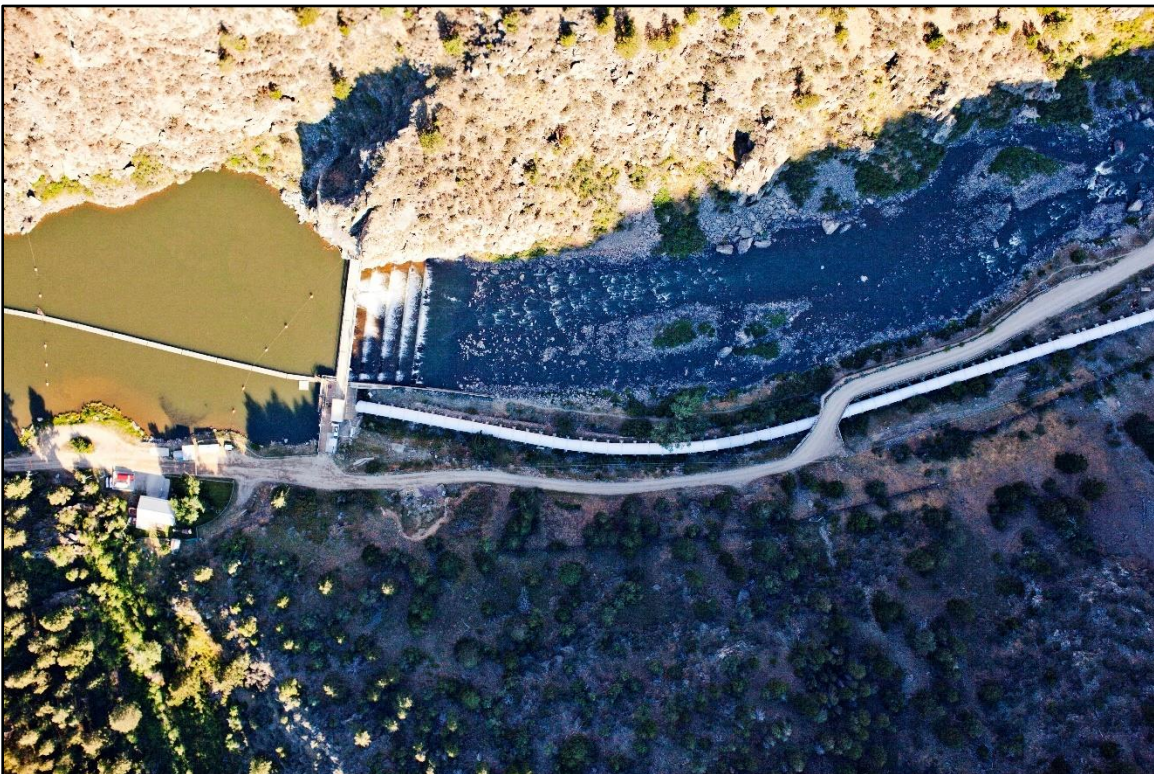
Figure 54. Sediment-starved channel form below Madison Dam. (Kestrel)

The Madison River flows through Bear Trap Canyon in Reach 5. The canyon is a major geologic feature, with an approximately 1,300 foot-deep canyon cut into crystalline basement rocks (Archean-age gneiss and schist). At the head of the canyon just below the dam, the channel bed is stripped of sediment indicating that Madison River bedload is trapped upstream in the lake (Figure 54). In the canyon, coarse sediment delivery is primarily related to hillslope processes and alluvial fan deposits at the mouths of tributaries. Rapids are common where bedrock is exposed or rockfalls have entered the channel (Figure 55 and Figure 56).

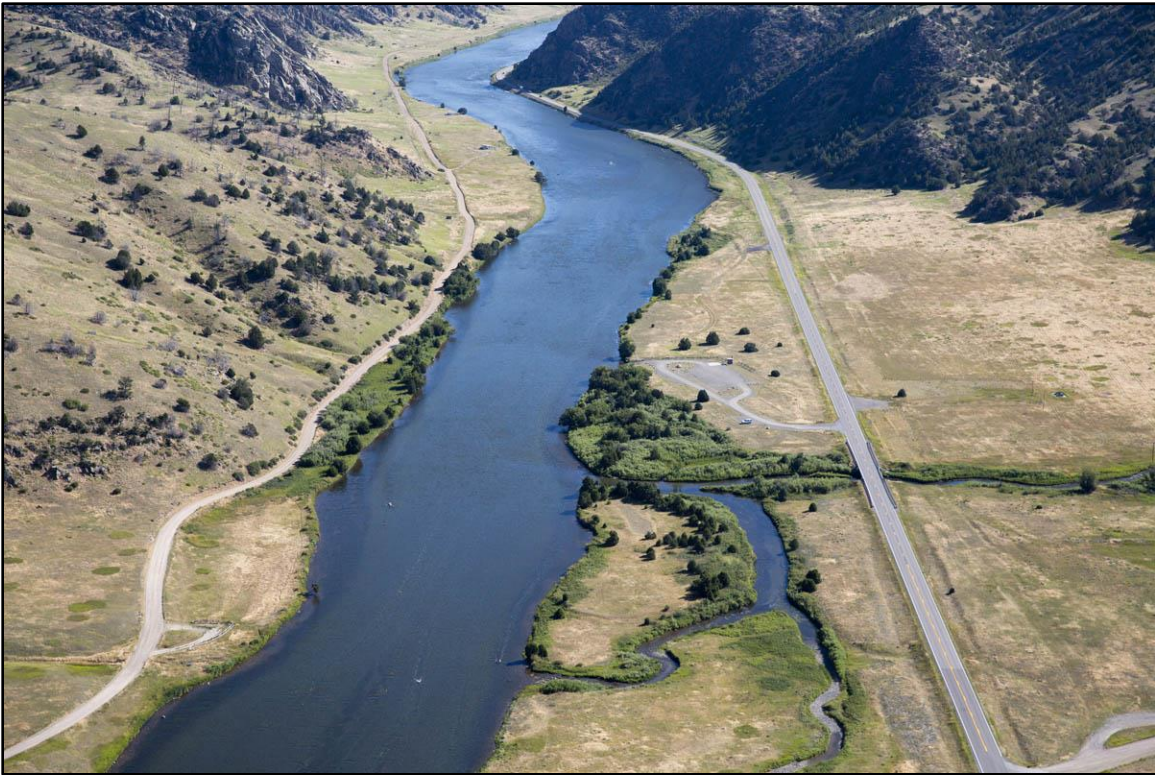
Figure 58. View downstream at mouth of Cherry Creek showing expanding terrace areas and minimal woody riparian fringe. (Kestrel)

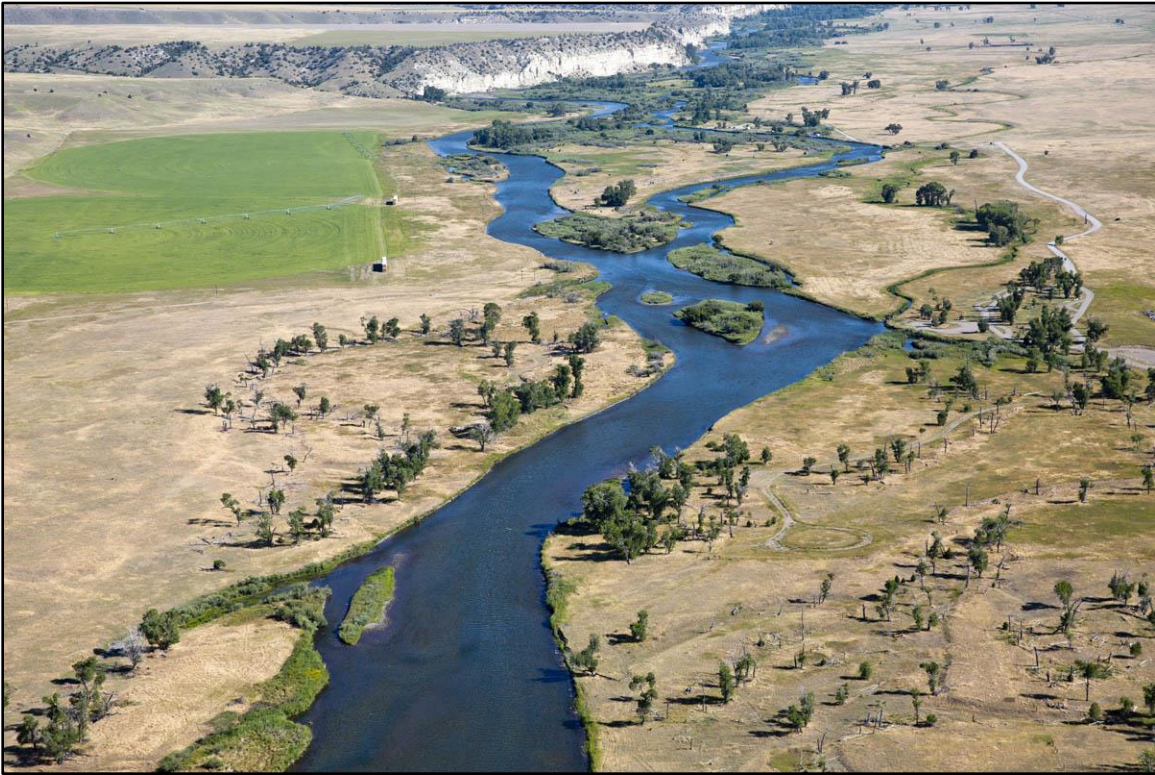
Figure 59. Lowermost Reach 4 showing expanded floodplain with historic channel remnants and cottonwood swaths. (Kestrel)

Reach 4 appears to be essentially “underfit,” in that upstream sediment trapping and flow controls have reduced the ability for the channel to erode banks and migrate laterally. This, in turn, has resulted in the aging of floodplain cottonwoods with minimal regeneration (Figure 59).

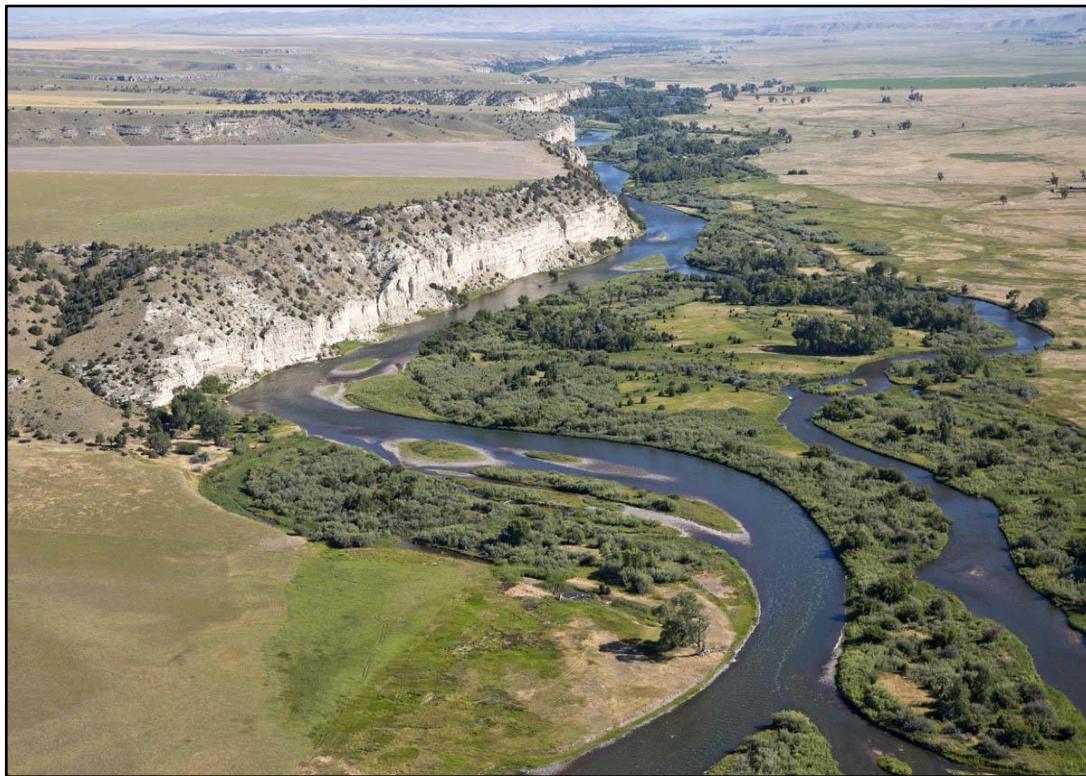
Figure 60. View downstream into Reach 3 showing west bank sandstone bluff (Kestrel).

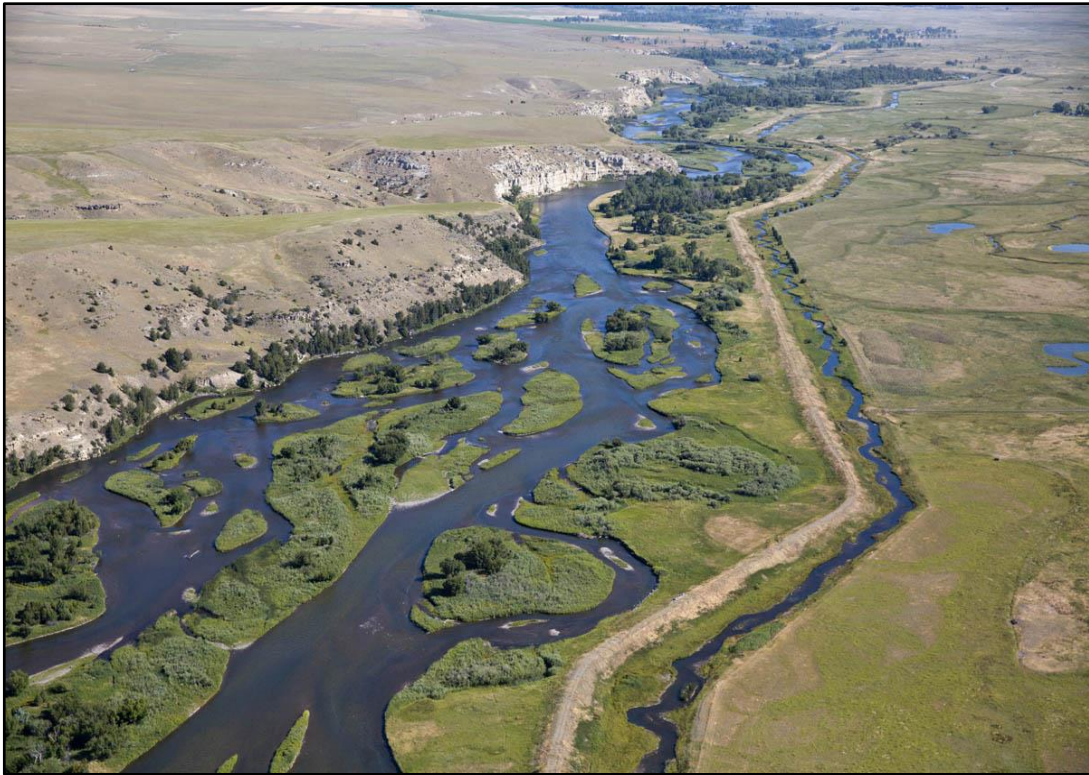
Figure 61. View downstream showing Lower Madison Levee confinement on east bank, with Darlington Ditch flowing on the right (landward) side of the levee. (Kestrel)

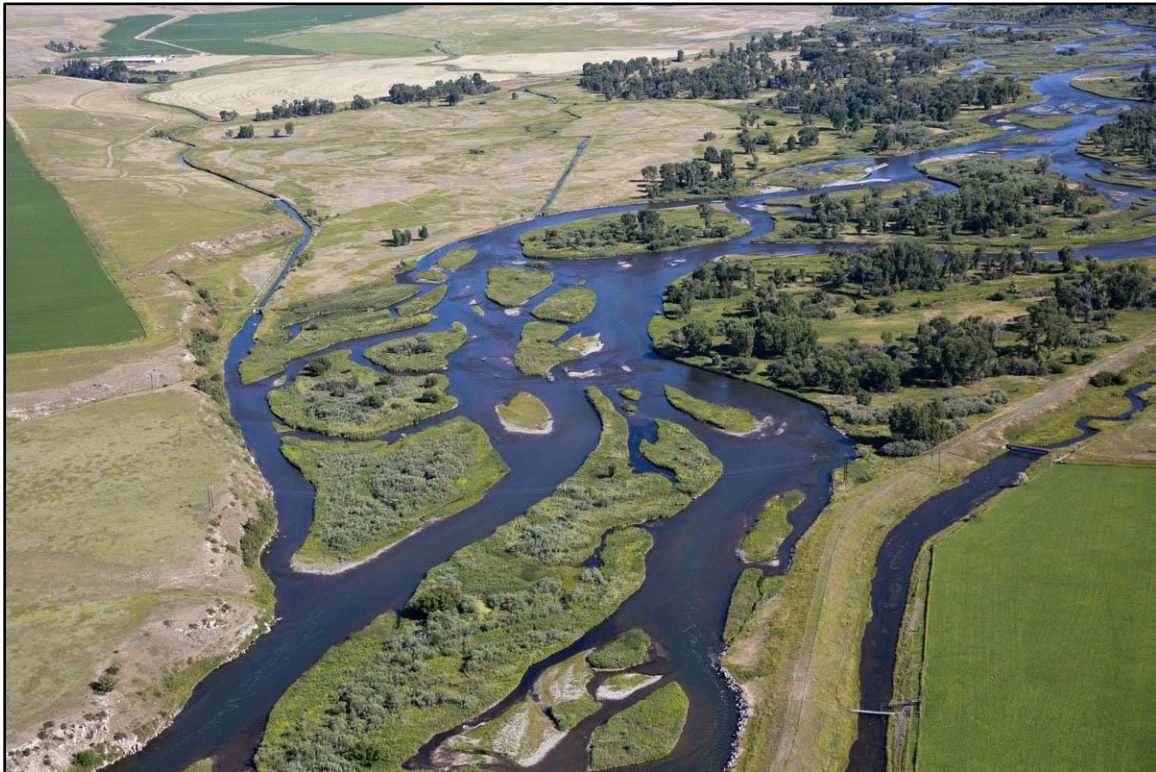
Figure 63. View downstream showing armored levee on right bank at pinch point (foreground). (Kestrel)

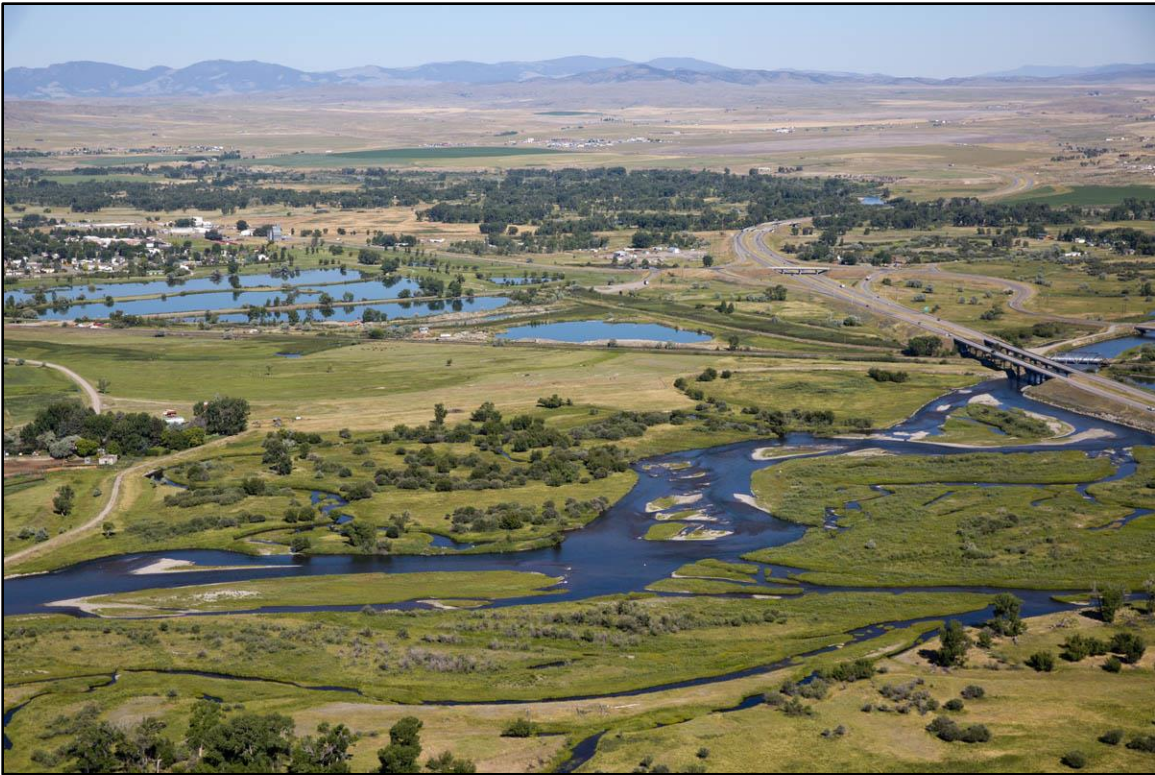
Figure 64. View downstream showing corridor constriction at I-90 bridge on right. (Kestrel)

Reach 2 extends from below Cobblestone to the I-90 bridge at Three Forks. The river still intermittently follows the sandstone bluff on the west side of the valley in this section, and there is an increase in residential development on that bluff line as the river approaches Three Forks. The extent of irrigated land also increases in the downstream direction. Between RM 6.0 and RM 7.5, levees follow both sides of the river, separating irrigated lands from the channel. The greatest impact from levees is on the east side of the river, as the Lower Madison Levee narrows the available corridor and creates distinct pinch points. At Climbing Arrow Road, for example (RM 10.0), the channel network hourglasses down to less than one third of its typical width. The levees in these constricted areas tend to be ripped apart due to bank erosion (Figure 65). Even more dramatic is the constriction at the bottom end of Reach 2 at the I-90 bridge (and associated crossings), where the CMZ is abruptly narrowed from about 1,800 feet to 250 feet (Figure 64). The bridge approach and crossings are extensively armored.

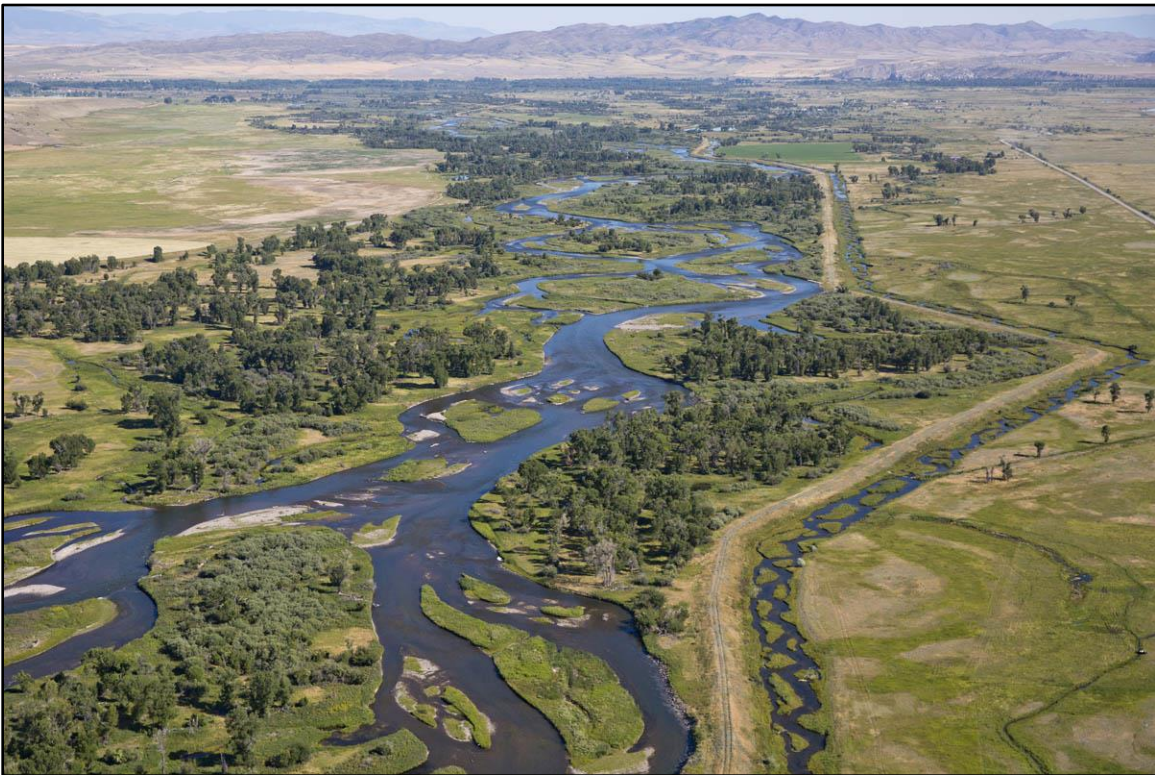
Figure 65. View downstream showing wide stream corridor, riparian forest, lower Madison Levee, and restored Darlington Ditch. (Kestrel)

Where the stream corridor is wide and channel migration is unimpeded, the combined effects of good floodplain connectivity, common disturbance, and good soils have promoted the development of a dynamic channel planform and a vibrant woody riparian corridor (Figure 65). Reach 2 has the highest migration rates in the project area, resulting in an erosion buffer width of over 300 feet.

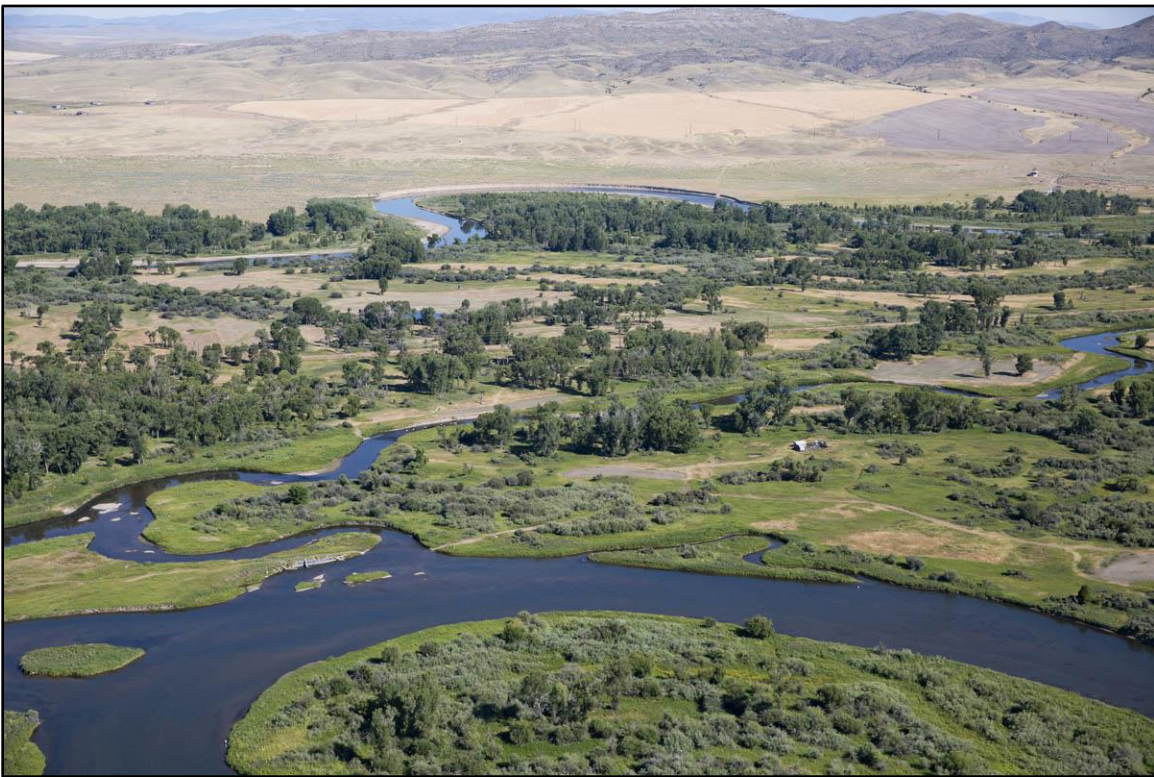
Figure 66. Lower Madison (foreground) showing breached dike. (Kestrel)

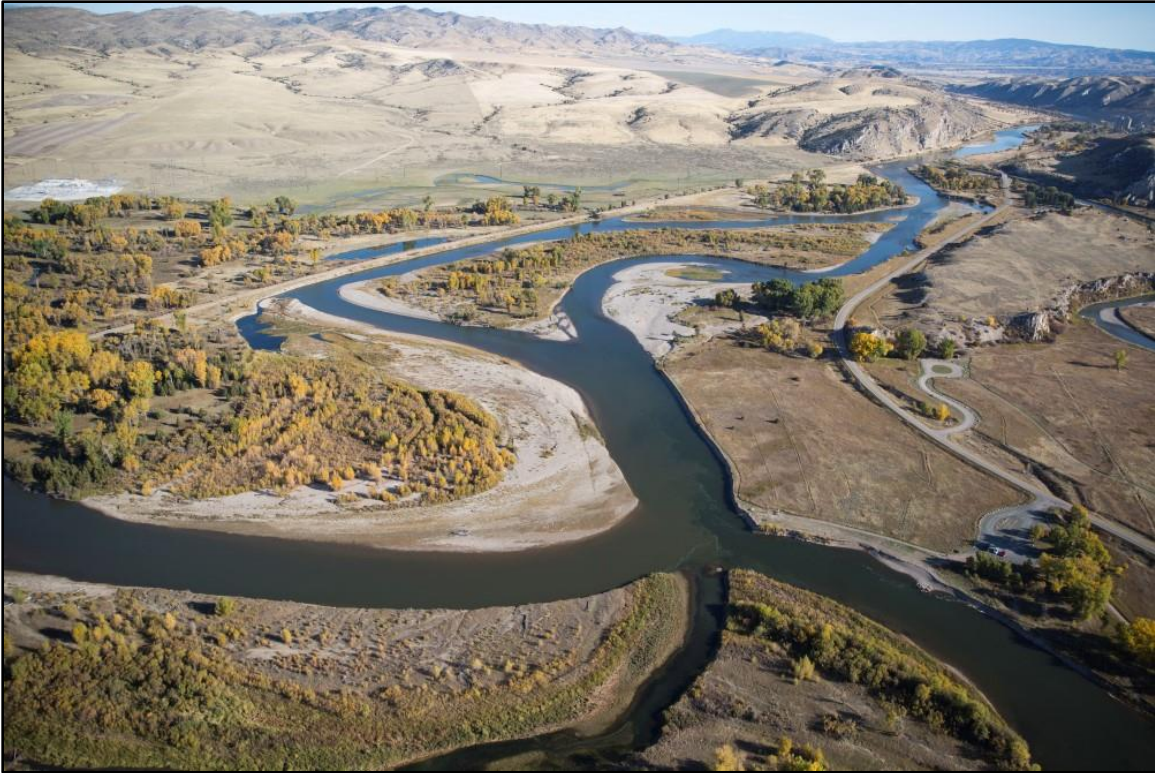
Figure 67. Relative turbidity and bar formation from Jefferson River (left) and Madison River (right), Headwaters State Park. (Kestrel)

Reach 1 is the downstream-most reach in the project area, extending from the I-90 bridge near Three Forks to the Jefferson River confluence in Headwaters State Park. It is about four miles long, consisting of a complex multi-thread system that has had historic intermingling with Jefferson River channels. Numerous old dikes are present on the floodplain, some of which have been breached (Figure 66). Avulsions are common in this area of coalescing floodplains. At its confluence with the Jefferson River, it is clear that the sediment load on the Madison River is relatively low, evidenced by lower turbidity, as well as less expansive open bar and riparian colonization areas relative to the Jefferson (Figure 67).

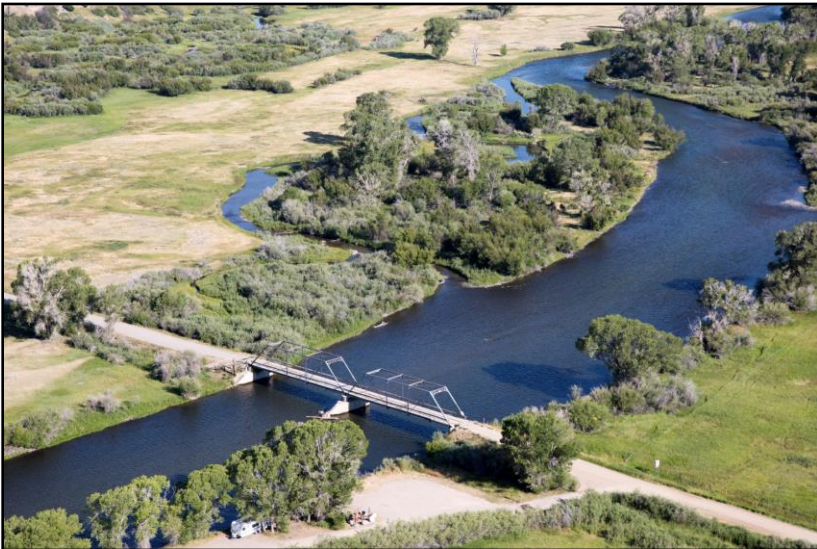
Varney Bridge marks the upstream limit of the project area. According to the U.S. Department of Interior (No Date), the bridge was originally built in 1897 and is “one of the oldest surviving steel truss bridges in Montana.” The original construction costs were \$4,999. It is a two span bridge with a total length of 191.2 feet. The bridge is owned and maintained by Madison County and in 1985 was determined eligible for the National Register of Historic Places, though the application was never submitted to the National Park Service. It is currently due for replacement with a similar structure. Of note, the Blaine Spring Creek Bridge, a single span steel truss bridge over a spring creek just to the west of Varney Bridge, is currently being replaced with a historically similar bridge (Madison County, 2011).

Figure 68. Varney Bridge on July 21, 2016. (Kestrel)

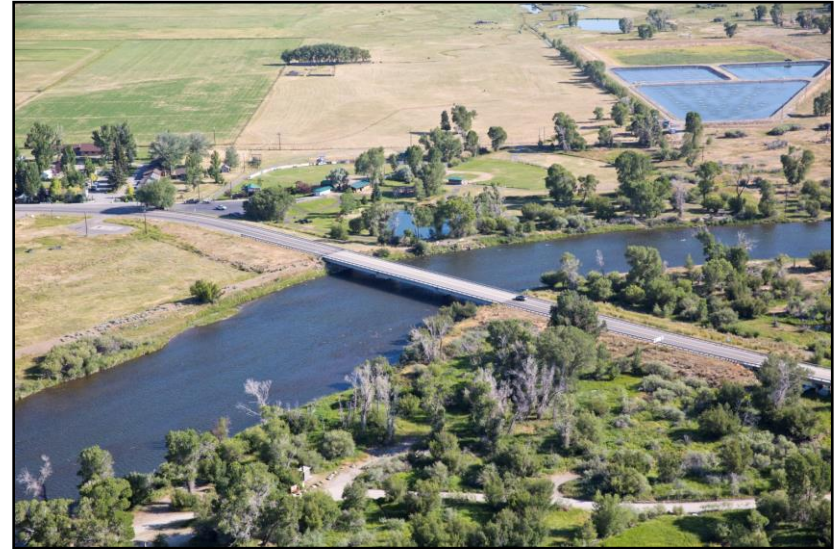
Highway 287 (Ennis)

The current Madison River bridge for Highway 287 in Ennis is an approximately 320 foot, concrete structure, with two supporting piers. It was constructed in 2001; replacing a 294 foot, two span, through truss bridge that was originally constructed in 1935 (bridgehunter.com) that was located slightly downstream.

Figure 69. Highway 287 Bridge on July 21, 2016. (Kestrel)

In the town of Ennis, approximately 0.9 miles of levees protect the town, city park, and sewage treatment lagoons from flooding (Figure 69), though flooding associated with ice gorging is known to overtop the levees below the bridge (Figure 7, Figure 20).

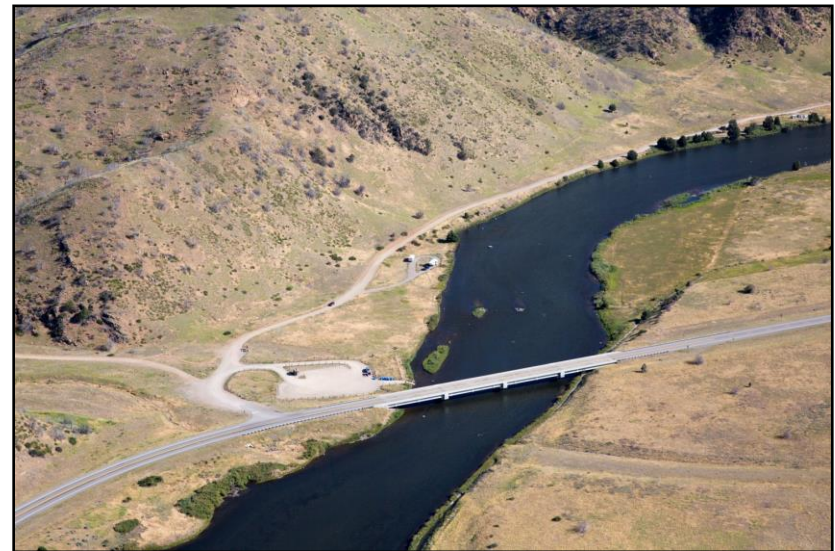
The Norris Road bridge is an approximately 430-foot-long, four span concrete bridge. It is the third bridge in this general location, and the fourth for this section of river. The second bridge was located approximately 1.5 miles upstream (south) in a narrow section of the canyon. The central pier from this bridge remains in the river. The third was located just upstream of the current location and was completely removed when the current bridge was constructed. The channel shows very little movement in the area of the current bridge.

Figure 71. Norris Road (Highway 84) bridge on July 21, 2016. (Kestrel)

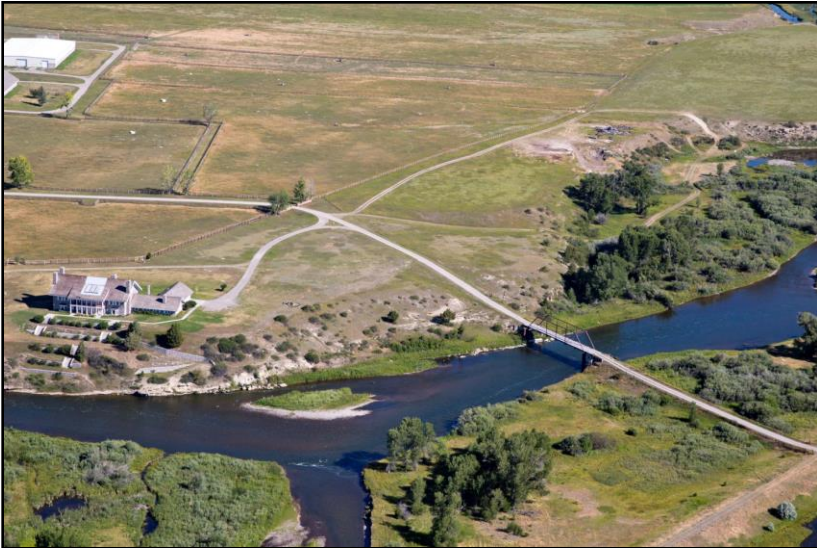
The Climbing Arrow Road Bridge is a typical Pratt through truss design, approximately 130 feet long. The road is private, accessing ranch and farm land on the west side of the river. It is anchored on a bedrock outcrop on the west side, while the eastern approach has approximately 300 feet of available floodplain width before passing over the Madison River levee.

Figure 72. Climbing Arrow Road bridge (private) on July 21, 2016. (Kestrel)

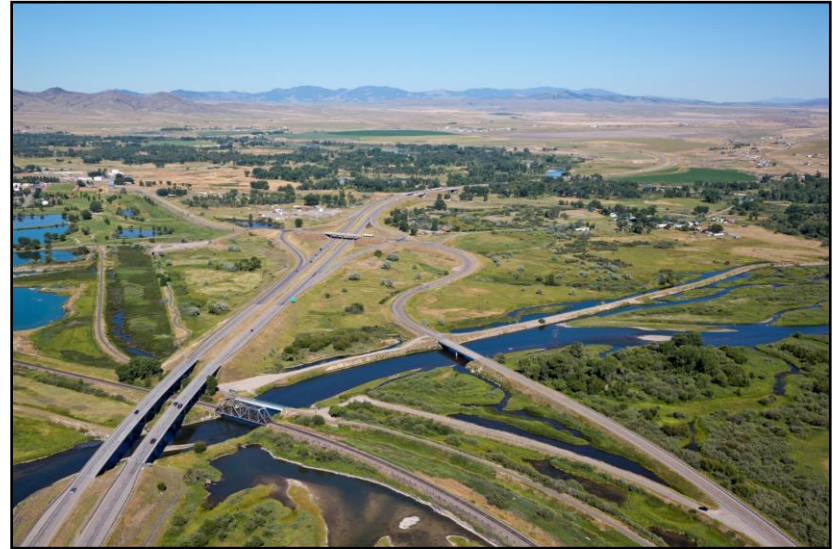
Three Forks Bridges

Five bridges make up a dense set of river crossings at Three Forks: Interstate 90 (2 bridges), railroad, pedestrian, and Frontage Road. All bridges are located within 1,000 feet of each other. A series of levees on the left bank above and below the bridges effectively armors the west bank.

Figure 73. Bridge grouping at Three Forks on July 21, 2016. (Kestrel)
