FINAL Report

November 6, 2008

Yellowstone River Human Impacts Timeline

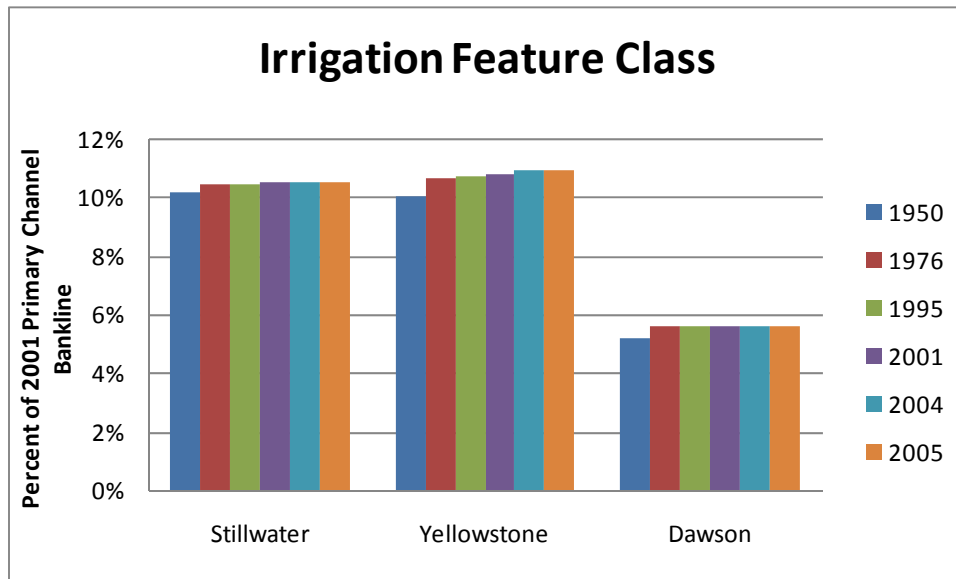
Figure 3-1. Irrigation feature extents for each county as percent of primary channel bankline, 1950-2005.

The majority of irrigation features, which include dikes, levees, ditches, and pump protection armor, were largely in place by 1950 (Figure 3-1). In both Stillwater and Yellowstone Counties, the length of these features is equivalent to just over 10 percent of the 2001 primary channel bank length, and in Dawson County, the length of functional irrigation features is approximately 6 percent of the primary channel bank length.

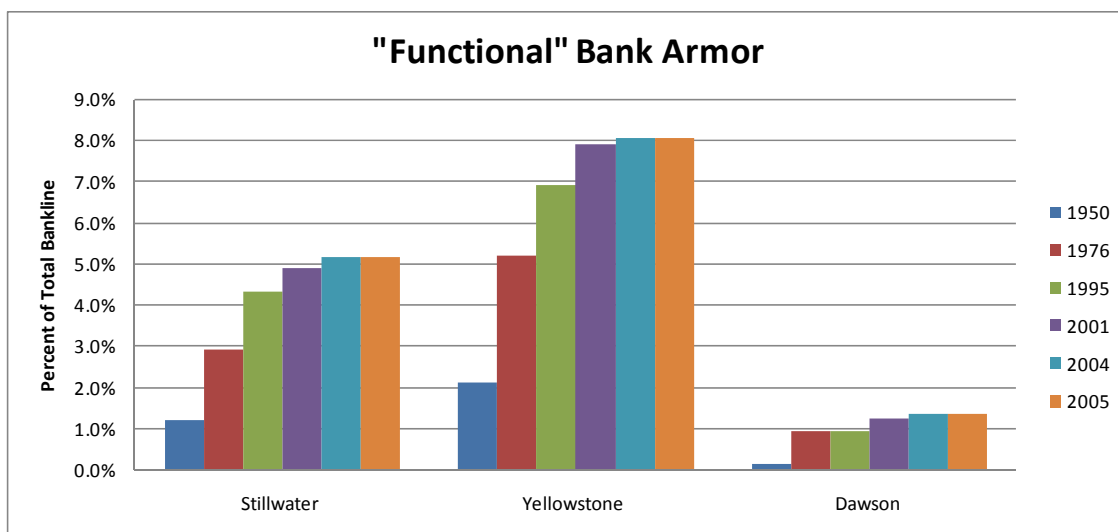
Figure 3-9. Bank armor feature type extents for each county as percent of total available bankline, 1950-2005.

A summary of functional bank armor feature types, which include rock riprap, concrete riprap, flow deflectors, car bodies, and steel retaining walls, shows continual increases through time in all three counties (Figure 3-9). When the total length of mapped armor is normalized in terms of the total bank length provided by both the primary and side (anabranching) channels, approximately 8% of the bankline within Yellowstone County is armored. Just over 5% of the bankline in Stillwater County is armored, and in Dawson County, bank armor is present on less than 2% of the total bankline. These values do not include armor that is along bedrock valley margins.

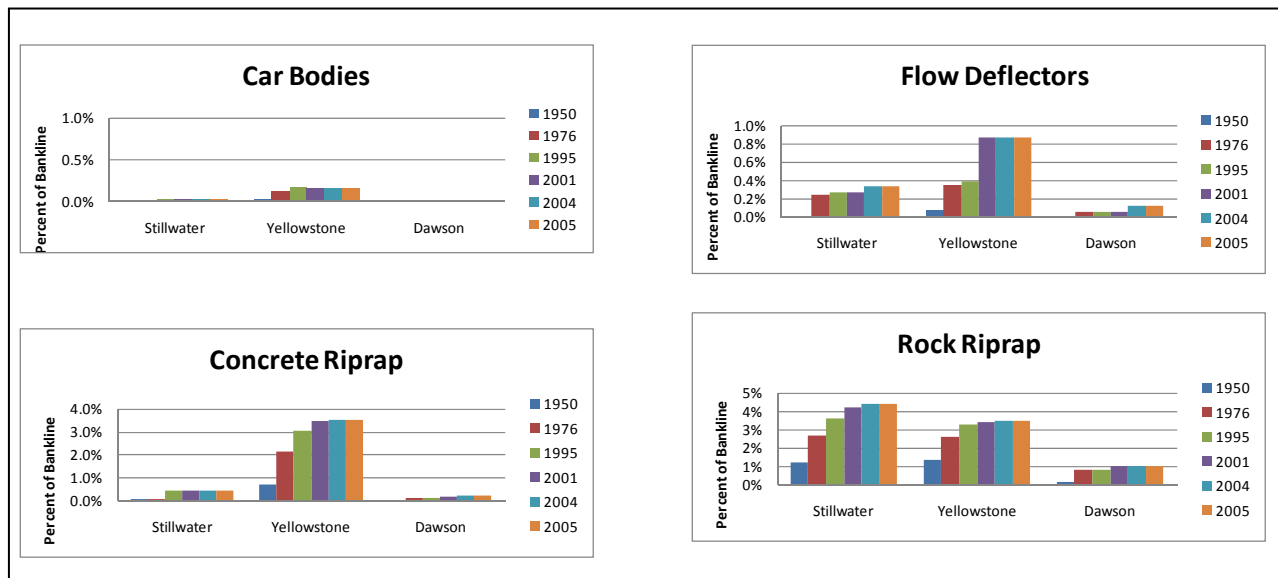
Figure 3-11. Percent of bankline protected by specific types of armor techniques, summarized by county.

A breakdown of types of functional bank armor indicates that car bodies, concrete riprap, and flow deflectors are most prevalent in Yellowstone County, whereas rock riprap is most extensive in Stillwater County (Figure 3-11).

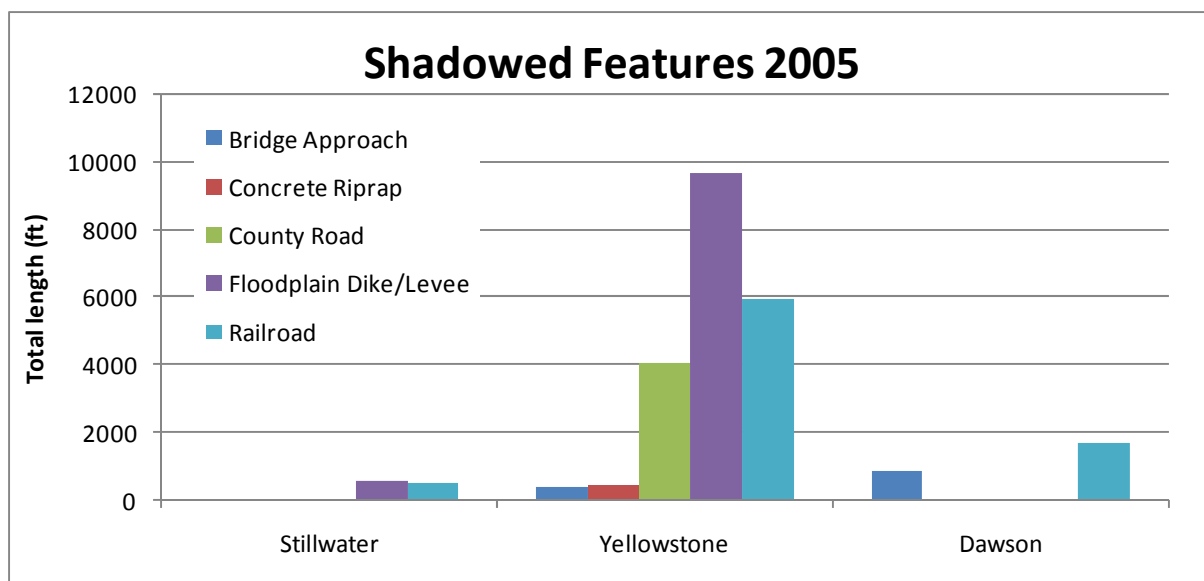
Figure 3-12. Lengths of features that became shadowed by another feature from 1950-2005.

Over the last 55 years, numerous features present in the stream corridor have been superseded by a more recent feature, which has likely made them ineffective with regard to their original purpose. A plot of the types of features that can be described as “shadowed” by another, more recent feature, is shown in Figure 3-12. The results of this summary indicate that the vast majority of shadowed features are located in Yellowstone County, and consist of road embankments, railroad embankments, and dikes and levees. This supports previous comments regarding the variable functionality of dikes and levees (Section 3.1.4).

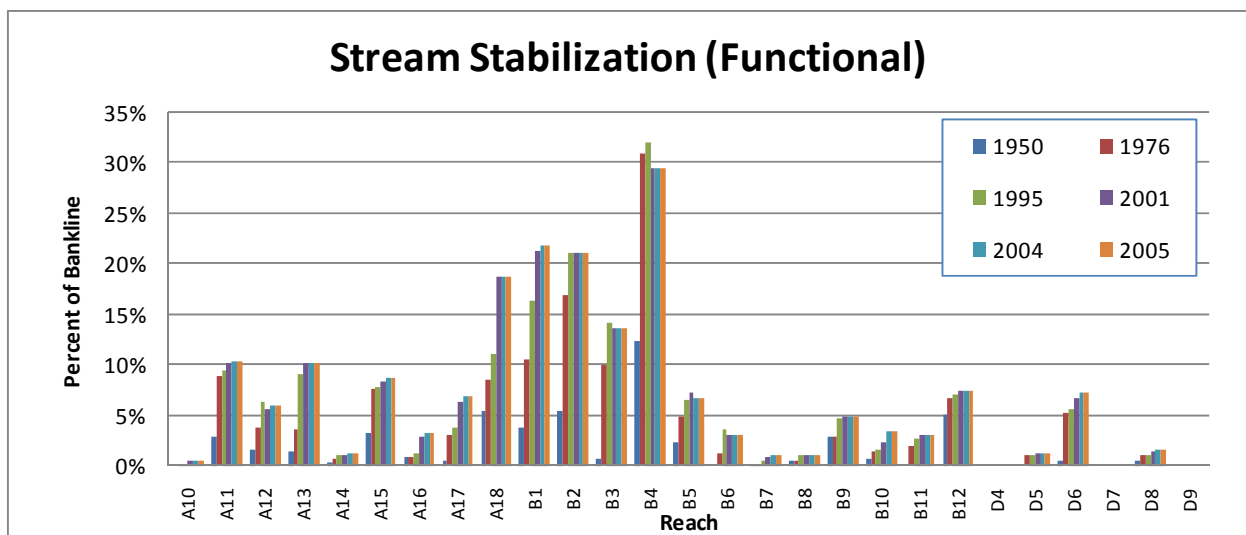
Figure 3-14. Stream stabilization feature class for each reach as percent of total bankline, 1950-2005.

With respect to functional stream stabilization features, Reaches A18 through B4 all show in excess of 10% total bankline affected (Figure 3-14). These reaches extend from Laurel through Billings to the Huntley Diversion Dam.

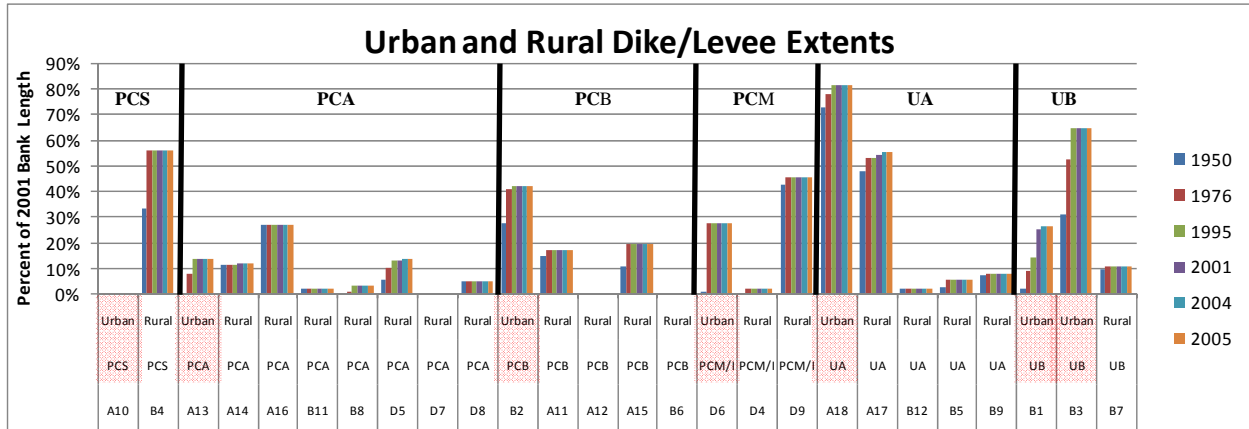
Figure 3-18. Dike and levee extents through time for each reach sorted by reach type, with urban reaches highlighted.

A summary of dike extent for each reach, sorted by channel type, indicates that in most channel types, the urban reaches have a relatively extensive network of dike and levee features. The exceptions to this trend are in rural Reach B4 at Huntley Diversion (PCS channel type), and in rural Reach A17 just upstream of Columbus (UA channel type), both of which have a relatively high extent of dike/levee features.

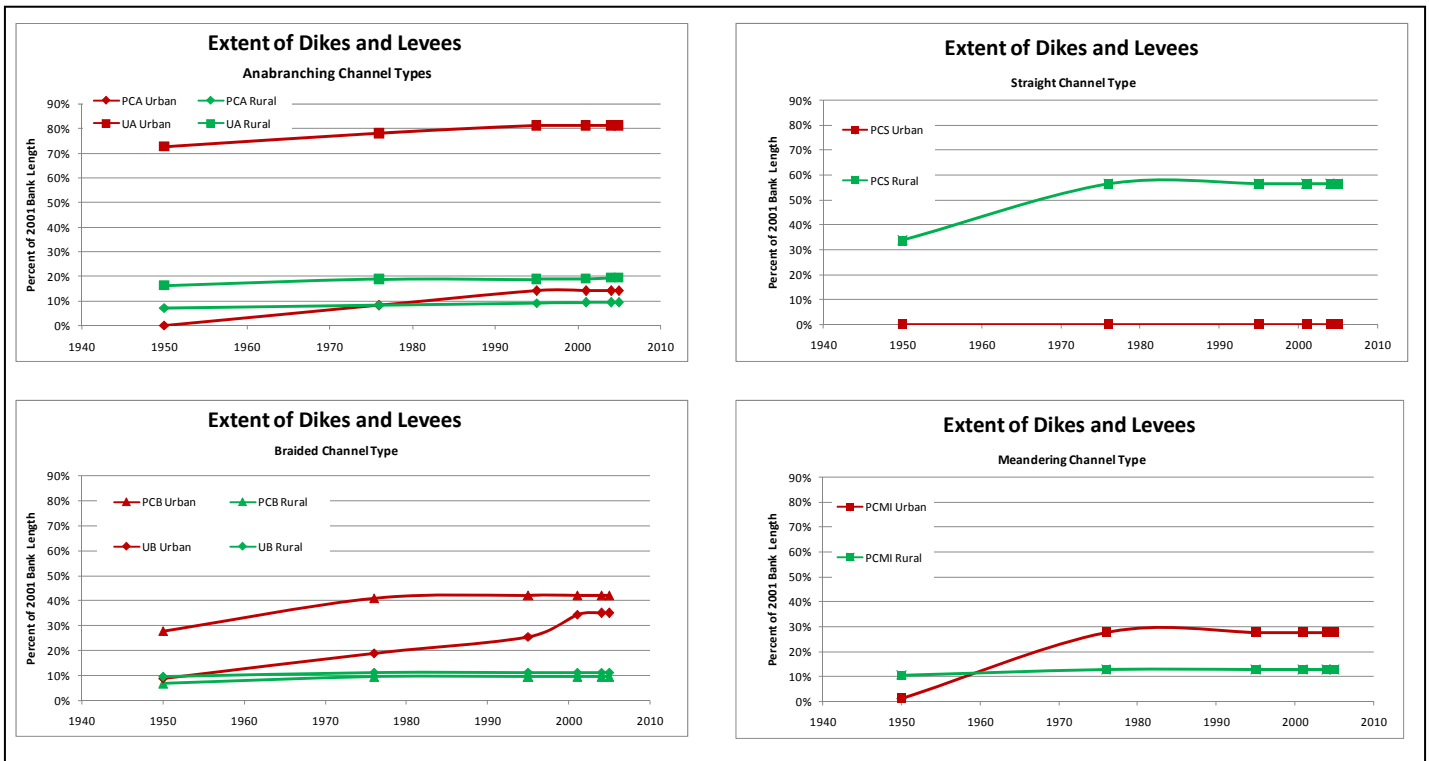
Figure 3-19. Extent of dikes and levees in rural and urban reach types.

A summation of total length of dikes and levees in rural and urban reaches for a given reach type shows that with the exception of straight channel types (PCS), urban reaches cumulatively depict a longer extent of dike features relative to rural reaches of the same type. The anomalous trend in the straight reach type reflects reach B4 at Huntley Diversion, which is a rural reach that shows a large extent of diking (Figure 3-19).

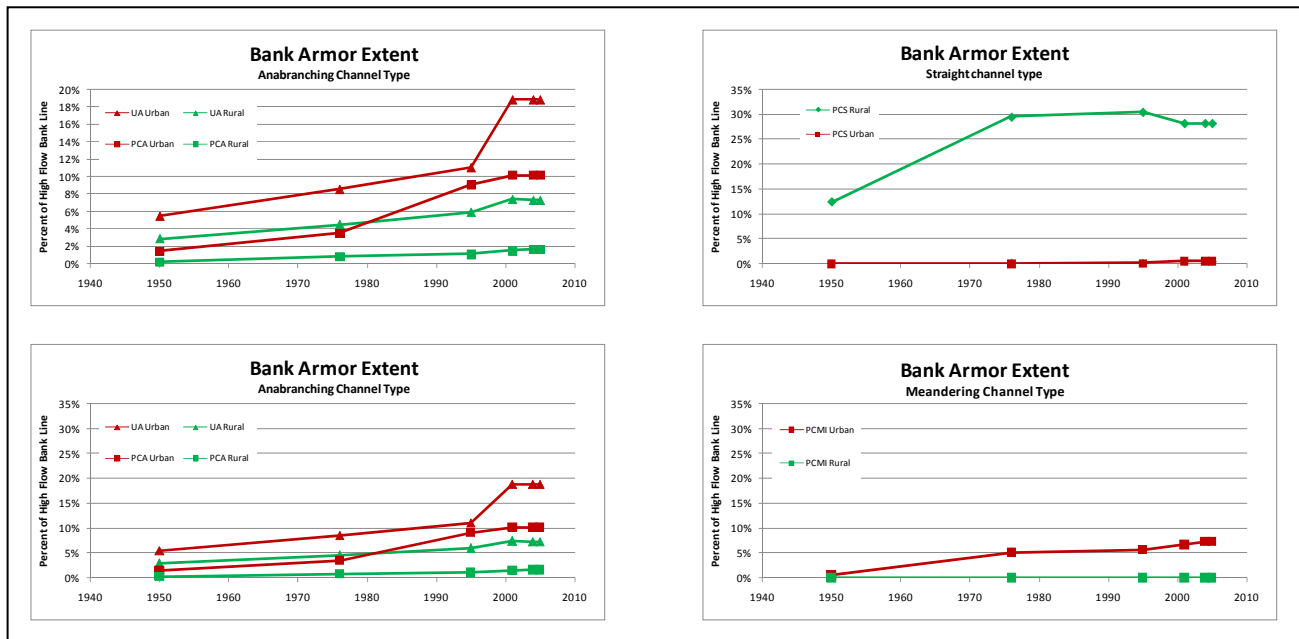
Figure 3-21. Extent of functional bank armor in rural and urban reach types.

Bank armor extents for reaches designated as urban or rural are shown in Figure 3-20 and Figure 3-21. The results indicate that urban reaches tend to have a higher extent of bank armor than rural reaches. The primary exception to this is Reach B4 at Huntley Diversion. Also, Reach D6, which includes portions of Glendive, has relatively low armoring extents.
