December 31, 2017

East Gallatin River Channel Migration Mapping

This report contains the results of a Channel Migration Zone (CMZ) mapping effort for the East Gallatin River from Bridger Creek to its confluence with the Gallatin River north of Manhattan, Montana. The study covers 41.4 river miles. The East Gallatin River has undergone extensive agricultural and residential development within the project reach. About 4.5 miles of bank armor have been mapped between Bridger Creek and the mouth, and that is probably a conservative estimate due to the long history of manipulation on the river. By 1965 much of the riparian corridor had been cleared and substantial sections of river had been channelized (straightened). Although the CMZ has been encroached into by various land uses, segments of the river remain very dynamic, with channel migration and avulsions common. Migration distances measured for the 50 years from 1965-2015 are typically between 50-100 feet, but in some areas migration measurements between 250 and 400 feet are common. Some of the areas of more rapid migration were historically channelized, reflecting the tendency for a straightened stream to regain length and re-es

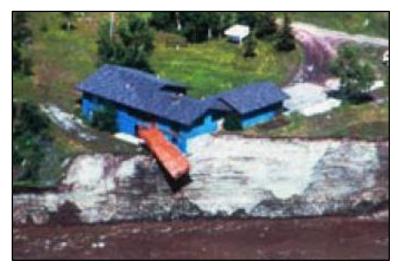
Figure 4 shows a property on the Yellowstone River in Park County that was progressively undermined during the 1996-1997 floods, prompting the owner to burn it down to prevent any liability associated with the structure falling into the river. This has been a chronic problem in river management, as landowners assume that if their home is beyond the mapped floodplain margin, it is removed from all river hazards. After experiencing massive 2005 flood damages in Saint George Utah (Figure 5), several property owners reflected on this issue (www.Utahfloodrelief.com):

Figure 4. Yellowstone River home on high glacial terrace that was burned down in 1997 to prevent its undermining by the river.

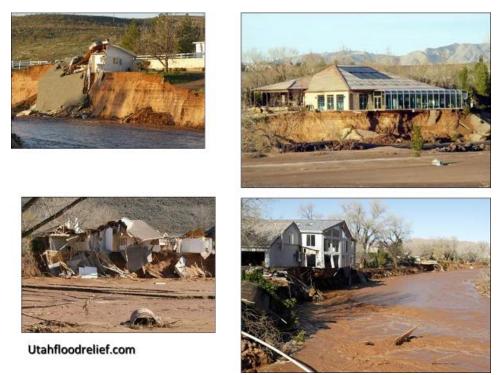
Figure 5. Photos from a 2005 in Saint George Utah, where homes several feet above the mapped floodplain were destroyed by channel migration (www.Utahfloodrelief.com).

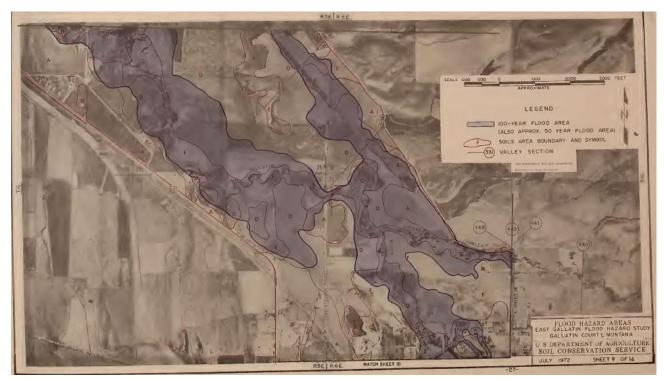
An example floodplain map for the East Gallatin River east of Belgrade is shown in Figure 6, and an older map from 1972 is shown in (Figure 7). On the East Gallatin River, there are few terraces and the CMZ tends to be narrower than the mapped floodplain. As a result, most development within the CMZ is also prone to flood hazards.

Figure 7. 1972 Floodplain mapping of East Gallatin river north of Bozeman --Manley Road is in center of map (SCS, 1972).

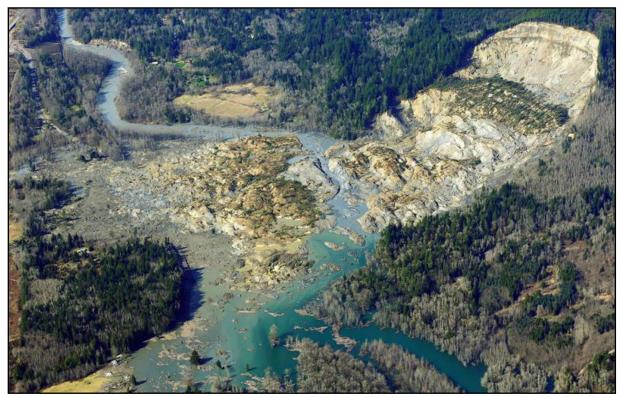
Figure 9 shows an example of a relatively small landslide that occurred in February 2014 on the south wall of the Nooksack River Valley near Bellingham, Washington. The landslide originally blocked the channel, and the effect was seen at a gaging station downstream where river flows rapidly dropped from over 2,000 cubic feet per second to about 400 cubic feet per second in the early morning hours of February 21 (Figure 10). The river breached the landslide and flows returned to normal, however the river was shifted hundreds of feet. Probably the most recently renown landslide into a river system was the 2014 Oso Slide into the North Fork of the Stillaguamish River, which dammed and relocated the river causing extensive flooding upstream (Figure 11).

Figure 11. Massive mudslide in Oso Washington on March 22, 2014, deflecting the North Fork of the Stilliguamish River (AP Photo/Ted Warren).

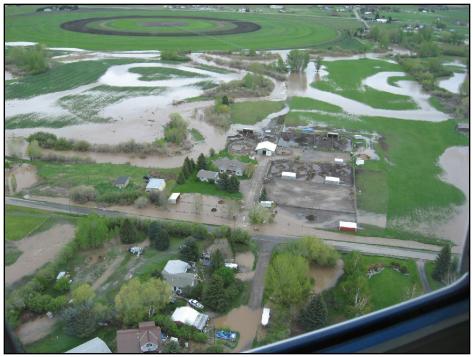
The documented flood of record occurred May 22, 1981, when the East Gallatin peaked at 2,460 cfs, probably reaching about a 30 year event. Gallatin County was one of nine counties declared a flooding disaster area that year (Bozeman Daily Chronicle, 1997). According to FEMA, the second largest flood on the East Gallatin River probably occurred in 1997, although the peak flow was not recorded for that event. The next largest recorded peak flood was the "Mother's Day Flood" of May 28 2008, when the gage at the Water Treatment Plant north of Bozeman recorded 1,900 cfs. The current flood frequency curves indicate that this was just over a 10-year flood, although the DNRC describes it as a 21-25 year event (DNRC.gov). DNRC collected numerous photos from a helicopter during that event, which shows extensive flooding around residences north of Bozeman (Figure 16).

Figure 16. East Gallatin River Flooding, May 2008 (MT DNRC).

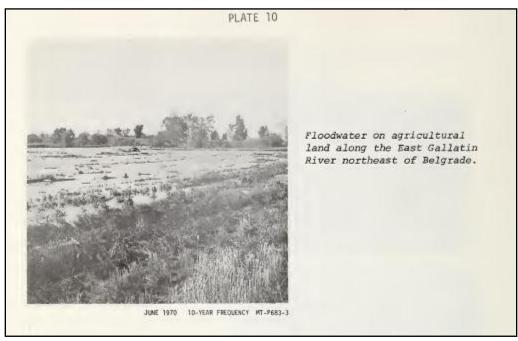
A 1972 Flood Hazard Analysis performed by the Soil Conservation Service (SCS, 1972) documents two other major floods not captured in the USGS gage record. They occurred in 1970 (1,900 cfs) and 1971 (2,100 cfs), and each exceeded a 10-year event. These floods evidently occurred "back-to back" (SCS, 1972). Photos of these two events, with the data and estimated frequency of occurrence as reported by the SCS are shown in Figure 17 and Figure 18.

Figure 17. June 1970 flood, East Gallatin River (SCS, 1972).

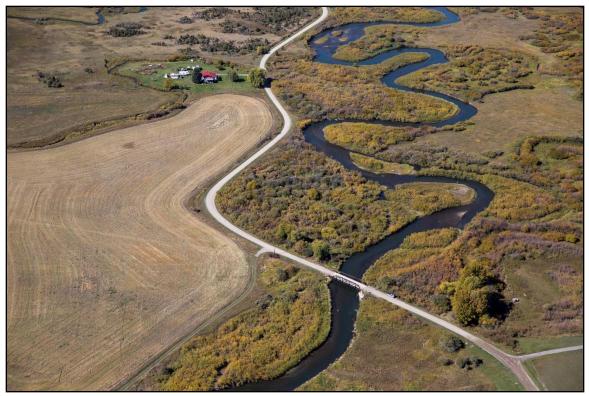
Seventeen bridges span the entire primary channel within the project area. These include 14 road bridges and three small bridges associated with the Riverside Country Club golf course. The bridges are dispersed along the river's length. These bridges and their associated approaches locally constrict the CMZ, and they are commonly armored to manage alignment of the river through the structure (Figure 19).

Figure 19. Right bank armor associated with the Dry Creek School Road bridge approach. (Kestrel)

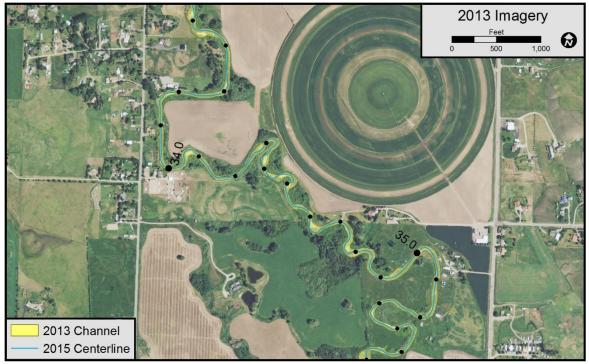
Table 2 lists imagery used for this project from the USDA and archives of current GIS data sets. Examples of the imagery used in the analysis are shown in Figure 21 through Figure 24.

Figure 23. Example 2013 NAIP imagery between Springhill and Nelson Roads, East Gallatin River CMZ development.

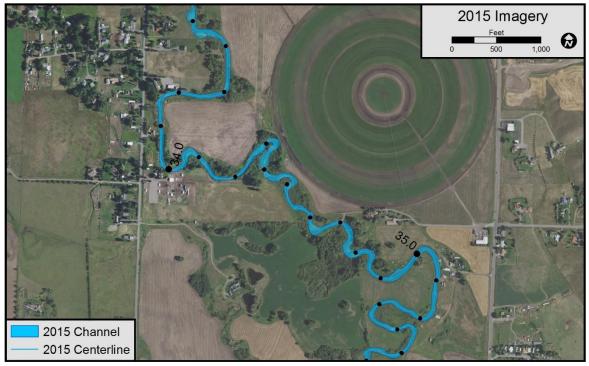
Figure 24. Example 2015 NAIP imagery between Springhill and Nelson Roads, East Gallatin River CMZ development.

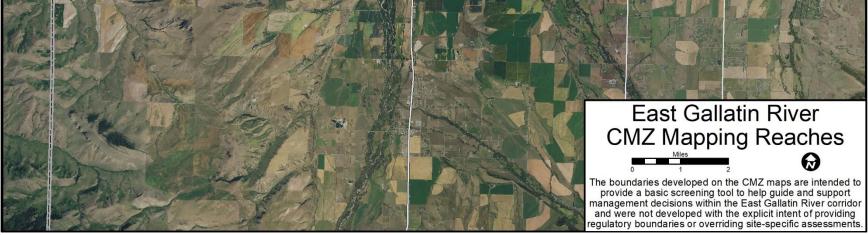
Figure 34. East Gallatin River Channel Migration Zone reaches.

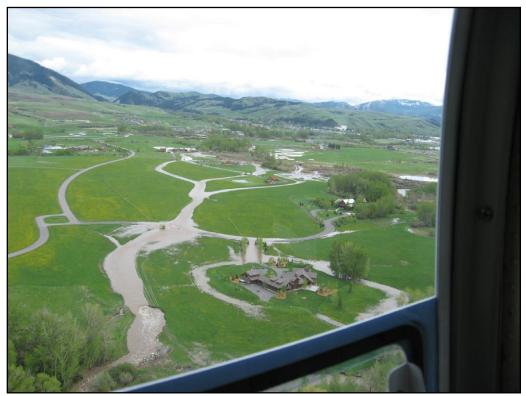
Figure 46. View upstream (east) showing floodplain channel activation south of Old Farm Road during 2008 flood; East Gallatin River is to right of homes in willow corridor (MT DNRC).

Reach EGR7 is almost four miles long and extends from the upstream end of the project reach at Bridger Creek Golf Course downstream to Springhill Road. This section the river flows through rural high-end subdivisions, and several of these areas were isolated by floodwaters during the May 2008 event (Figure 46). The isolation and flooding

of these homes occurred due to the activation of floodplain channels north of the river that create discreet flood paths. Figure 47 shows the floodplain mapping for this area; the channels that visible in Figure 46 can be seen just south of Old Farm Road.

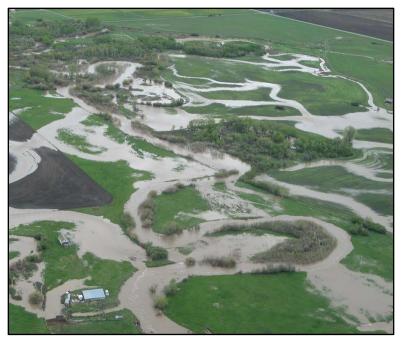
Figure 50. View upstream showing 2008 flooding highlighting floodplain channels, RM 35.3.

Reach GR07 is six miles long, extending from Springhill Road to the Outlaw Subdivision upstream of Airport Road. Similar to Reach EGR7 upstream, this channel segment experienced substantial overbank flooding into floodplain channels in 2008, highlighting the potential extent of avulsion paths in the reach that are difficult to see on imagery alone (Figure 50).

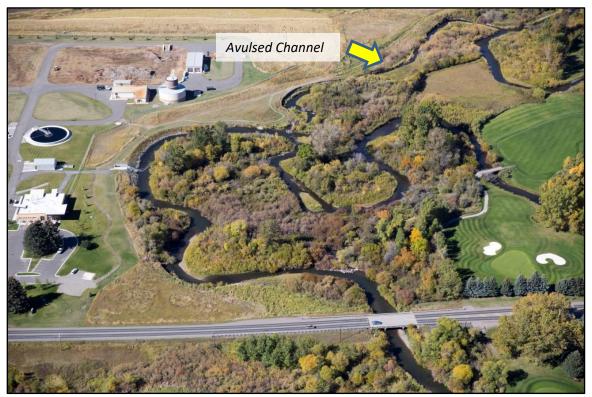
Figure 51. Reach EGR 6 showing avulsion site at Bozeman Water Treatment Plant (Kestrel).

The reach has experienced several avulsions, including a major 1979-1995 avulsion just below the Bozeman Water Treatment Plant Figure 51 and Figure 52. There have been attempts to block this avulsion at its upper end, so it has not yet become the main channel. However, as the avulsion path is 1,600 feet shorter than the main channel, it will eventually capture the main thread without continued management.

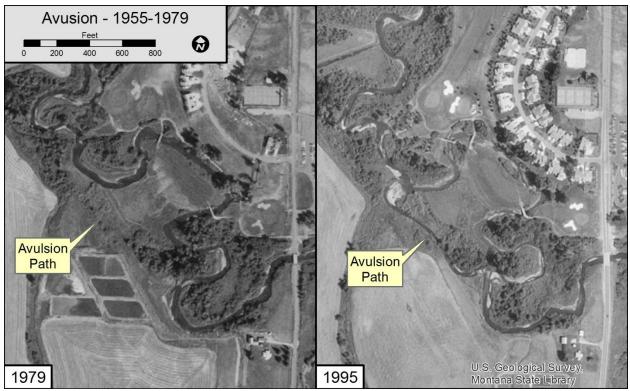
Figure 52. East Gallatin River at Bozeman Water Treatment Plant showing avulsion between 1979 (left) and 1995 (right).

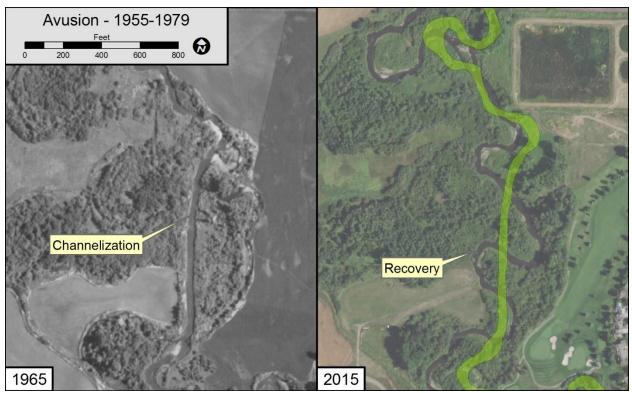
Figure 54. East Gallatin River below Springhill Road, showing channelized segment in 1965 and lengthened channel in 2015.

The erosion buffer width in Reach EGR6 is 201 feet, although the maximum migration distance measured is almost twice that at 385 feet. This area of maximum migration is located at RM 36, which is just downstream of the channelized section shown in Figure 54. This exemplifies the longitudinal impacts of channelization, as the re-gaining of length in a channelized reach transports high sediment loads downstream, which can drive rapid bar formation and bankline migration.

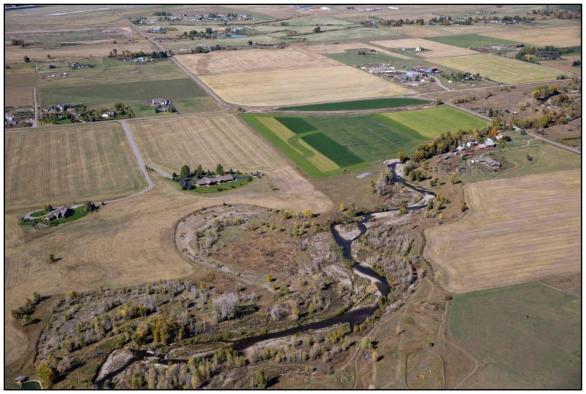
Figure 57. View downstream of Reach EGR5 towards Airport Road Bridge showing avulsion site corridor (Kestrel).

One of the avulsions in Reach EGR5 was about a half mile long, creating a wide historic migration corridor on the CMZ maps. This avulsion abruptly relocated the channel about 300 feet eastward between 1979 and 1995 (Figure 56 and Figure 57). Several avulsions were also mapped at the mouth of Middle Creek (Figure 58). At RM 35.4, the river avulsed into about 400 feet of ditch between 1965 and 1979.

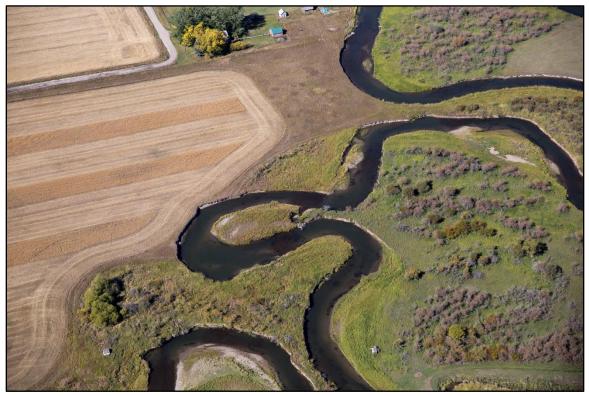
Figure 60. Active meander cutoff, RM 23.

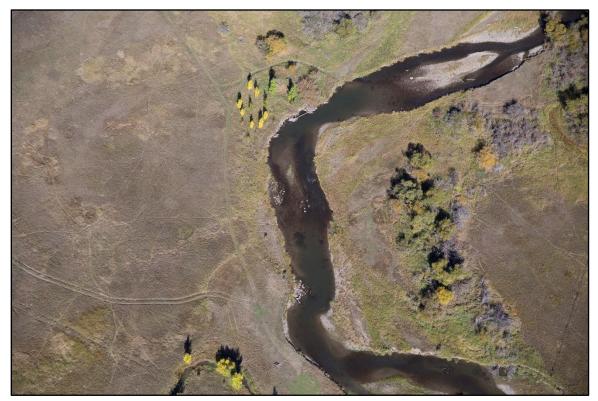
Figure 62. Flanking rock riprap on left bank, Reach EGR4 (Kestrel).

About a half mile (2,382 ft) of bank armor was mapped in Reach EGR4, protecting 5% of the total bankline. Some of that armor is actively flanking (Figure 62). Bank armor restricts about 21 acres of the CMZ, and transportation infrastructure restricts another 2.3 acres.

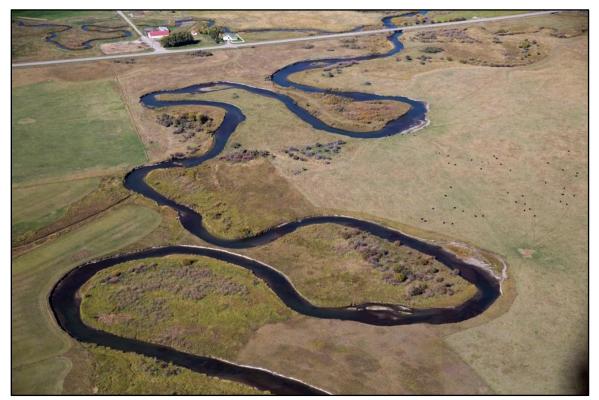
Figure 64. View downstream avulsion prone bendways above Dry Creek Road; Thompson Creek is in distance (Kestrel).

Although migration rates are low, the high sinuosity of Reach EGR3 makes in especially prone to avulsions, especially neck cutoffs where the limbs of a bendway gradually migrate towards one another and eventually "pinch" the meander tab causing a cutoff (Figure 64). This reach has five mapped historic avulsions, with another four areas mapped as "imminent".

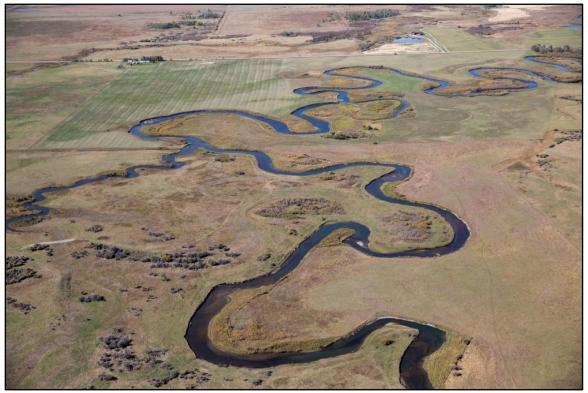
Figure 65. View downstream showing lack of woody vegetation on banklines and floodplain, Reach EGR3 (Kestrel).

Between Dry Creek and Swamp Creek roads, the floodplain in Reach EGR3 has experienced extensive riparian clearing which may contribute to avulsion risk (Figure 65).

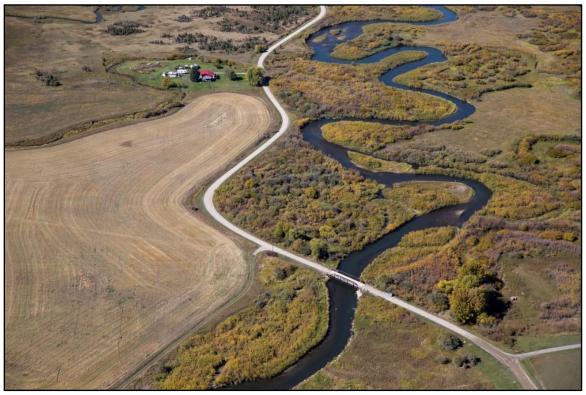
Figure 66. View downstream from Dry Creek School Road Bridge showing healthy riparian corridor (Kestrel).

willow stands evident both on the floodplain and bankline. In some areas the riparian corridor density provides a reference for the overall riparian potential of the lower East Gallatin River (Figure 66).

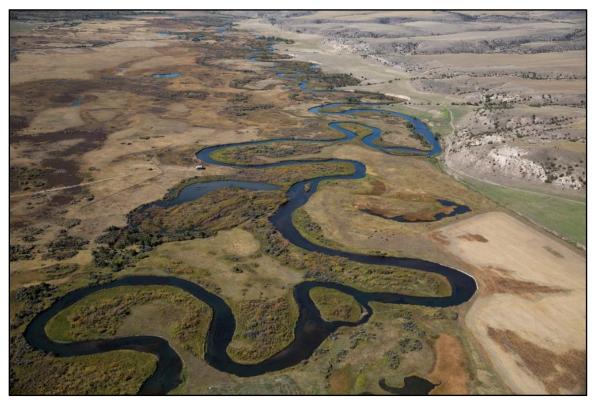
Figure 68. View downstream of lower reach EGR2 approaching Horseshoe Hills bluff line (Kestrel).

As the river approaches the bluff line of the Horseshoe Hills, riparian vegetation becomes discontinuous patches within a highly sinuous corridor, creating substantial avulsion risk (Figure 68).

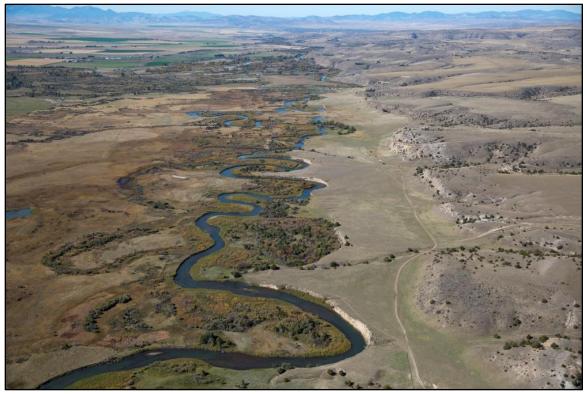
Figure 69. View downstream showing right bank erosion of alluvial fans and terraces (Kestrel).

shows no river erosion and has been clipped out of the CMZ (Figure 69). The bedrock consists of the LaHood Formation, which is a conglomerate that has been described as having clasts (embedded pieces of other rock) that are up to 12 feet in diameter (Vuke, 2014).

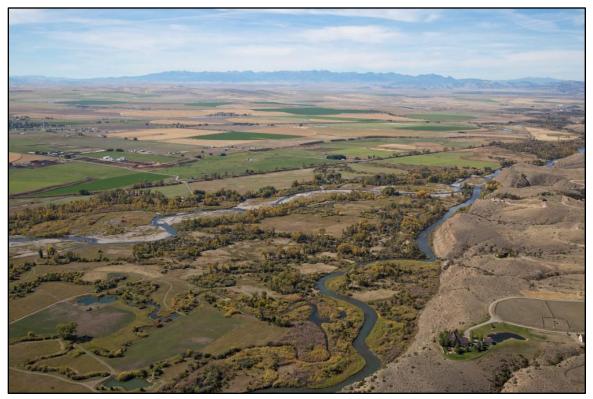
Figure 70. View downstream showing confluence of Gallatin River (left) and East Gallatin River (right) (Kestrel).

At RM 0.2 the East Gallatin flows into a complex channel complex formed by the coalescence of the East Gallatin and Gallatin River floodplains (Figure 70). The main Gallatin River is somewhat perched above the East Gallatin near the mouth, creating a risk of the Gallatin River capturing the lower East Gallatin through avulsion. This is most imminent about 1,200 feet upstream from the current confluence, where about 40 feet of floodplain area separates the two rivers (Figure 71). Figure 70 captures the striking difference in sediment loading between the two rivers; whereas the East Gallatin is a fairly fine grained low bedload system in this area, the Gallatin is a high bedload gravel bed river.

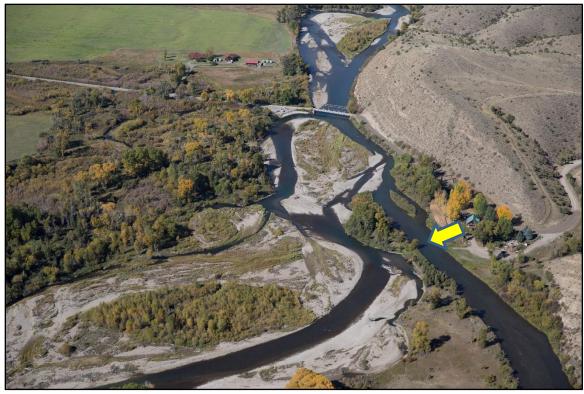
Figure 71. View downstream showing narrow floodplain remnant between Gallatin River (left) and East Gallatin River (right) (Kestrel).

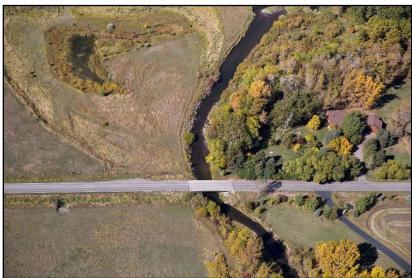
Figure 72. Manley Road bridge on September 26, 2016. (Kestrel)

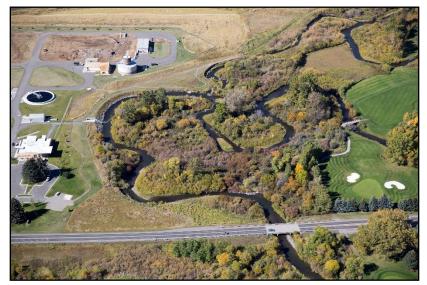
Figure 73. Springhill Road bridge on September 26, 2016. (Kestrel)

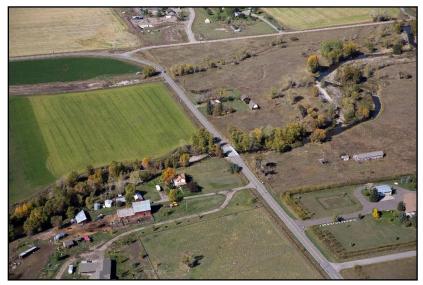
Figure 74. Airport Road bridge on September 26, 2016. (Kestrel)

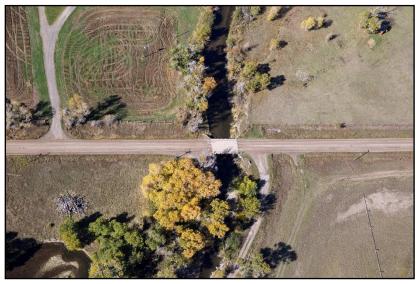
Figure 75. Spain Bridge Road bridge on September 26, 2016. (Kestrel)

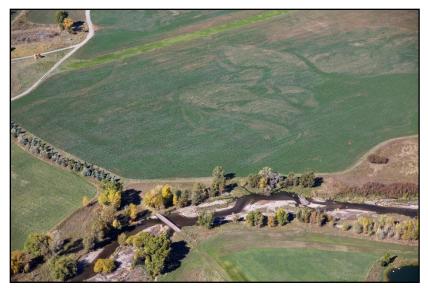
Figure 76. Norris Road bridge on September 26, 2016. (Kestrel)

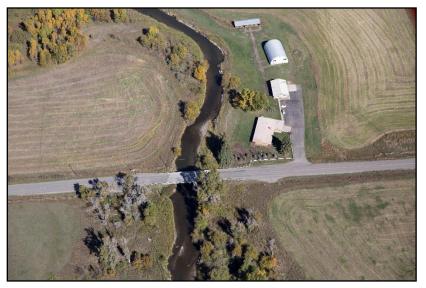
Figure 77. Penwell Bridge Road bridge on September 26, 2016. (Kestrel)

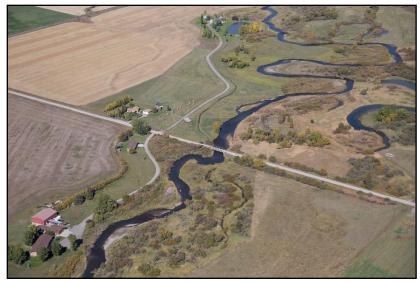
Figure 78. Hamilton Road bridge on September 26, 2016. (Kestrel)

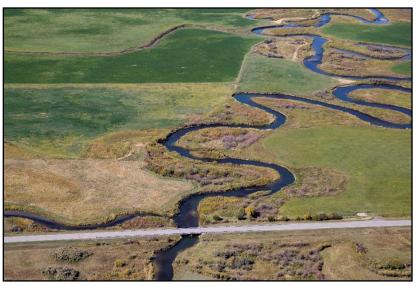
Figure 79. Dry Creek Road (Thompson Spring Creek enters on left) on September 26, 2016. (Kestrel)

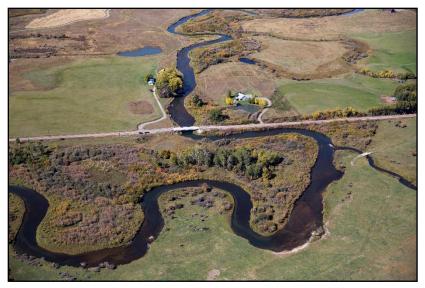
Figure 80. Swamp Road bridge on September 26, 2016. (Kestrel)

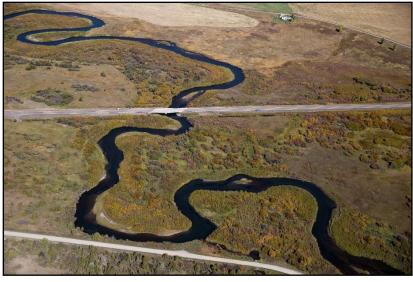
Figure 82. W Dry Creek Road bridge on September 26, 2016. (Kestrel)

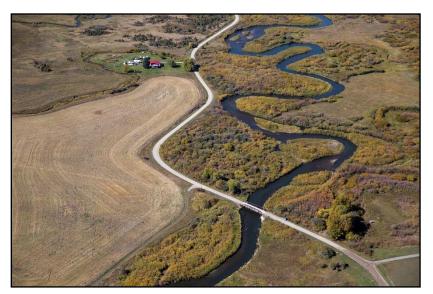
Figure 81. Dry Creek School Road bridge on September 26, 2016. (Kestrel)

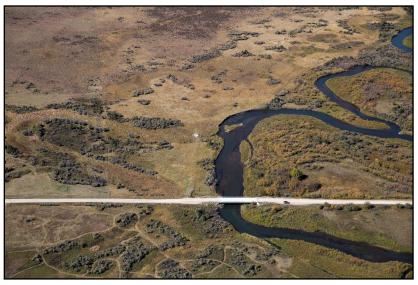
Figure 83. Spaulding Bridge Road bridge on September 26, 2016. (Kestrel)

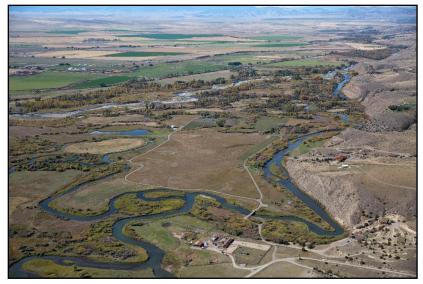
Figure 84. Private bridge at RM 2 on September 26, 2016. (Kestrel)
