Prickly Pear & Tenmile Creek Channel Migration Zone Lewis & Clark County, Montana

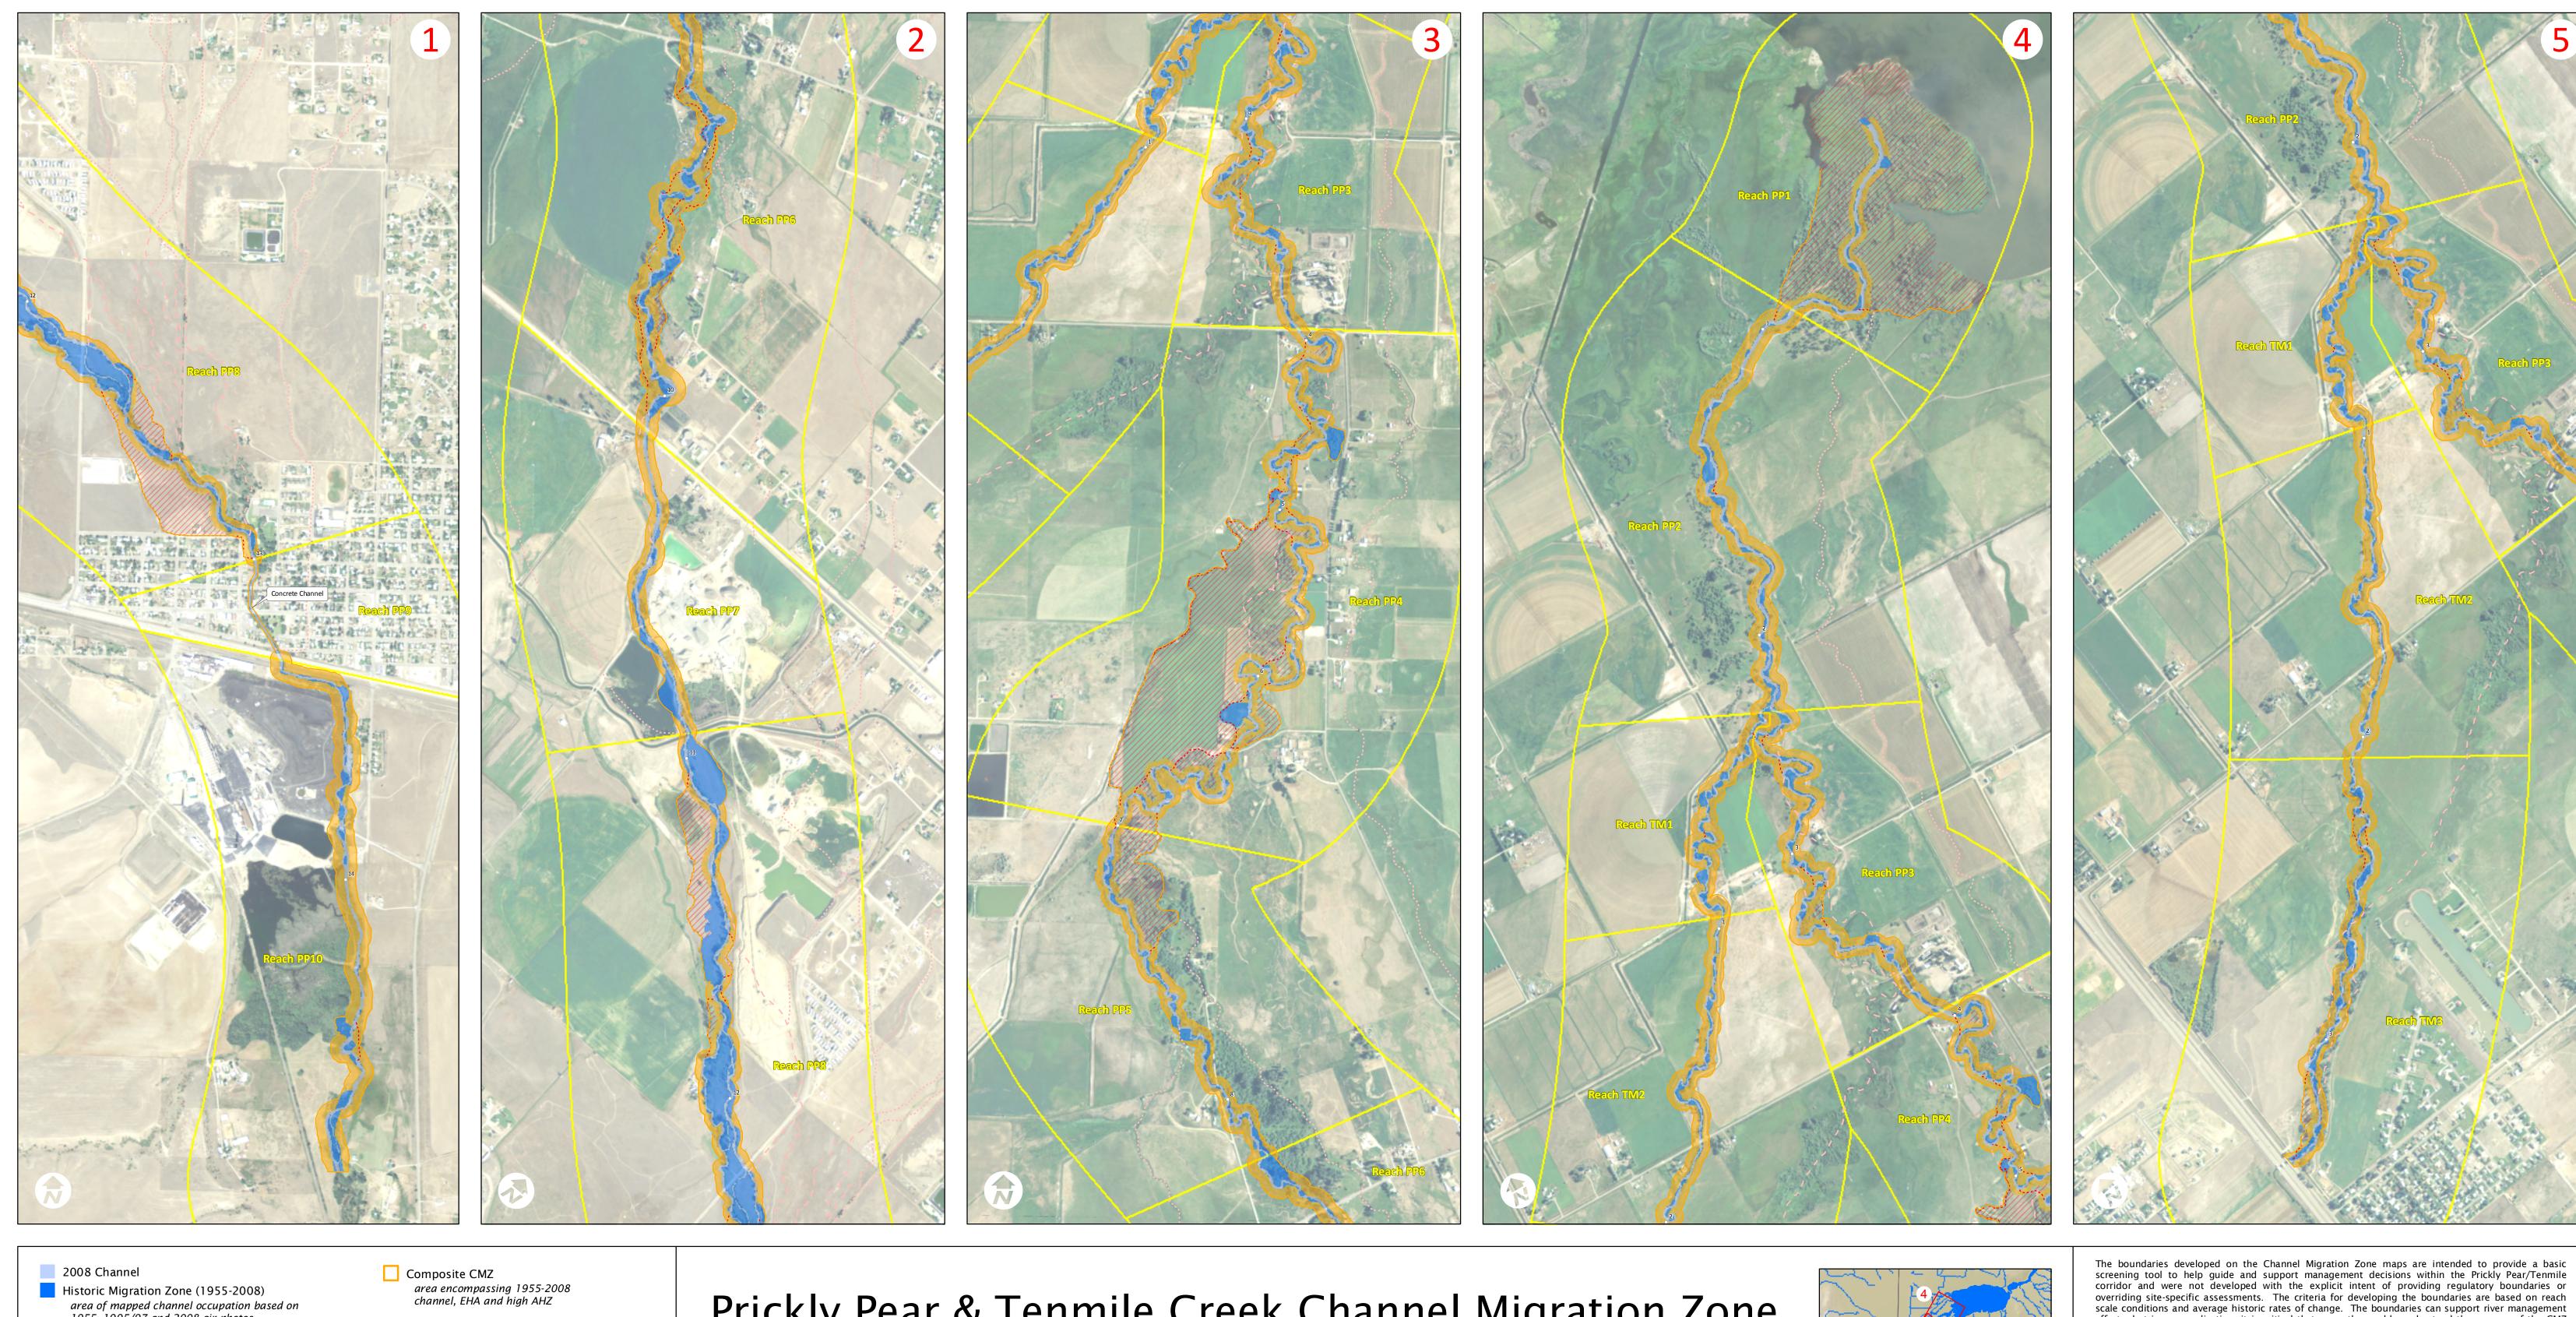
1955, 1995/97 and 2008 air photos Reach Boundaries Erosion Hazard Area 100-yr erosion buffer based on reach-scale mean migration rate; extended from 2008 banklines

Avulsion Hazard Zones and Pathways areas with relic channel remnants prone to reactivation

- High hazard zones/pathways in 100-yr floodplain
- Moderate hazard pathways in 100-yr floodplain Low hazard distributary channels on alluvial fan
- Note: FEMA floodplain boundaries are currently under revision and are not included on these maps.

Primary limitations of this reach-scale mapping approach include: the potential for an underestimation of short-term migration rates in discrete areas that are eroding especially rapidly, the potential for the river to migrate beyond the mapped CMZ boundary, as well as limitations in mapping of site-specific geotechnical attributes of banklines. As such, we recommend that these maps be supplemented by site-specific assessment where near-term migration rates or site geology and associated bankline retreat rates create anomalies in the reach-averaging approach.
